Inquiry 11-204: Container ship MV *Rena* grounding,  
on Astrolabe Reef, 5 October 2011

# Final Report

Marine inquiry 11-204  
Container ship MV Rena grounding  
on Astrolabe Reef, 5 October 2011

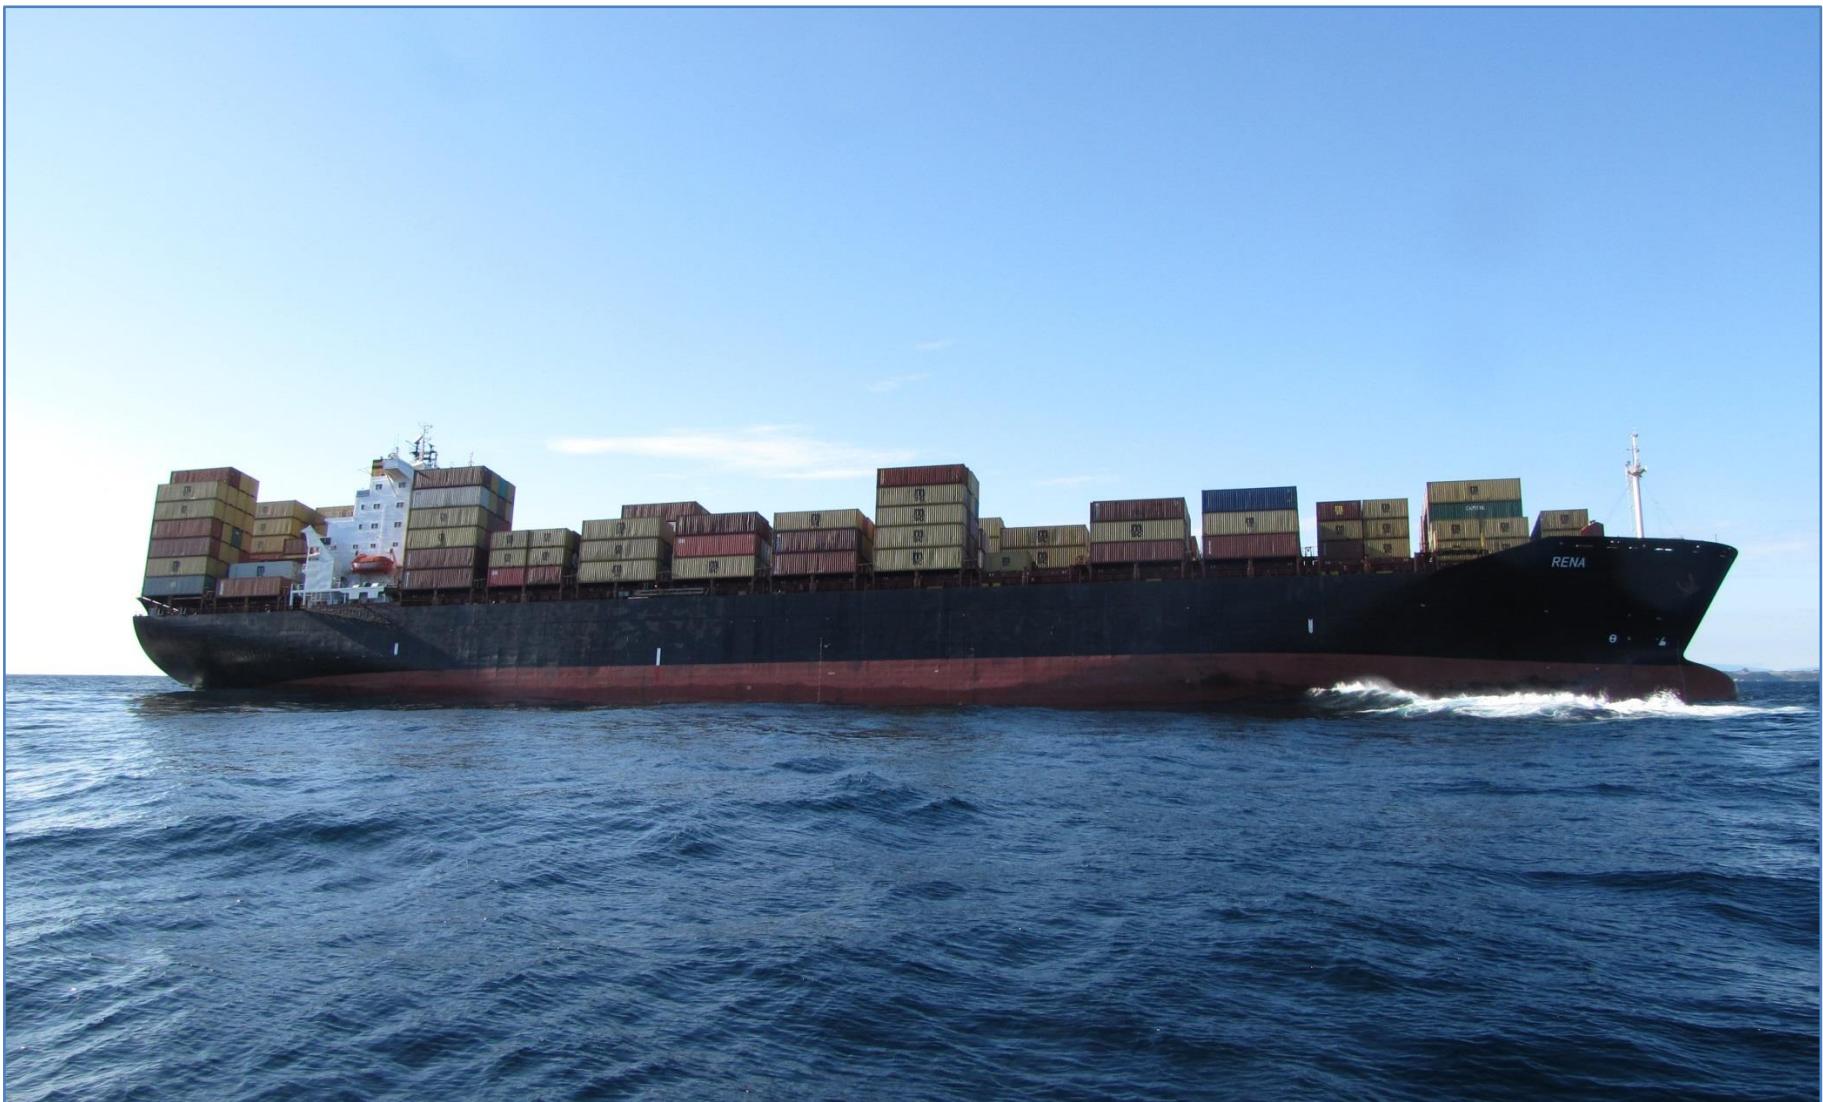
The MV Rena aground on Astrolabe Reef (photograph taken 6 October 2011)

Location:	Astrolabe Reef, Bay of Plenty, New Zealand 37° 32.4'S 176° 25.7'E
Persons involved:	vessel's crew
Injuries:	nil
Damage:	the hull was severely damaged during the initial grounding. The hull girder structure subsequently failed, leading to the vessel breaking in two. The aft section moved off the reef and sank. About 200 tonnes of heavy fuel oil were lost to the sea. A substantial amount of cargo in the containers was lost. The vessel was a total loss

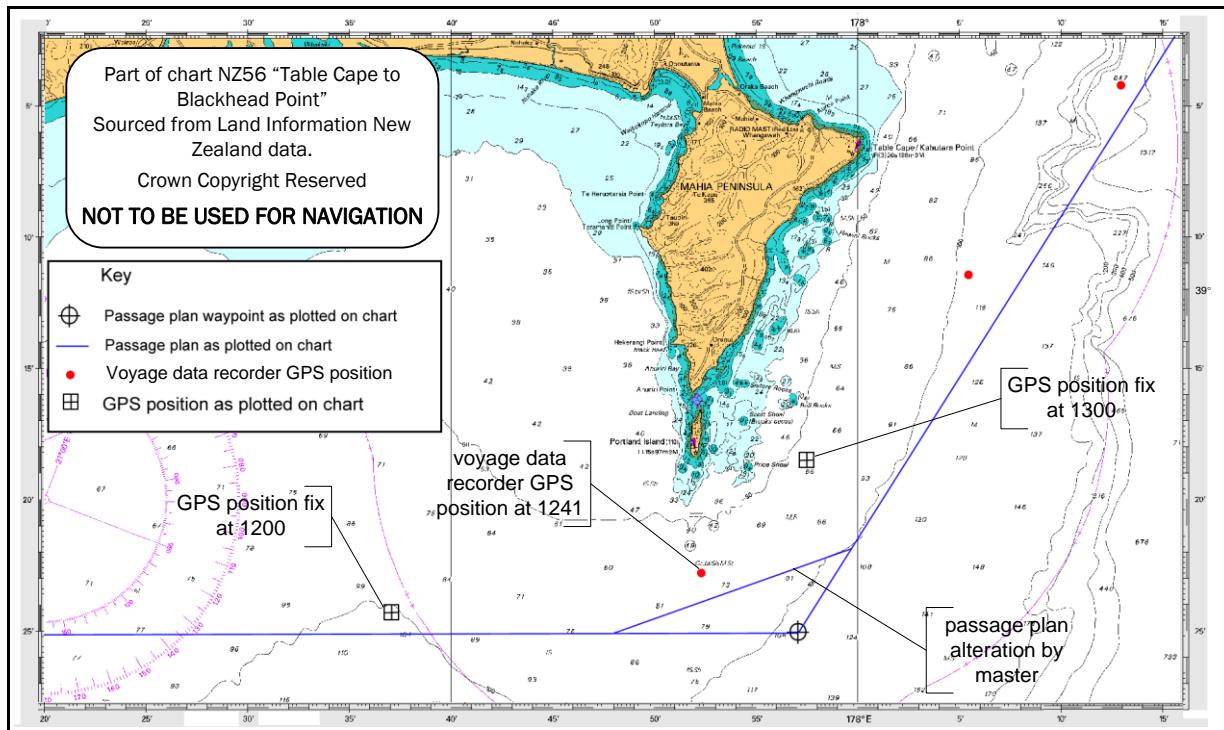
**Figure 1**  
Part of chart NZ56 showing passage plan, plotted positions and GPS positions obtained from voyage data recorder on passage around Mahia Peninsula

- 3.2.5. The master modified the vessel's planned passage on the chart to shorten the distance around Mahia Peninsula, as seen in Figure 1. The master handed control of the Rena to the third mate at 1100 as the vessel approached Mahia Peninsula. The passage plan that was in use during the voyage required that the vessel's position be plotted hourly, which was typically done using co-ordinates from the GPS. At times during the voyage the position was plotted more frequently than hourly.

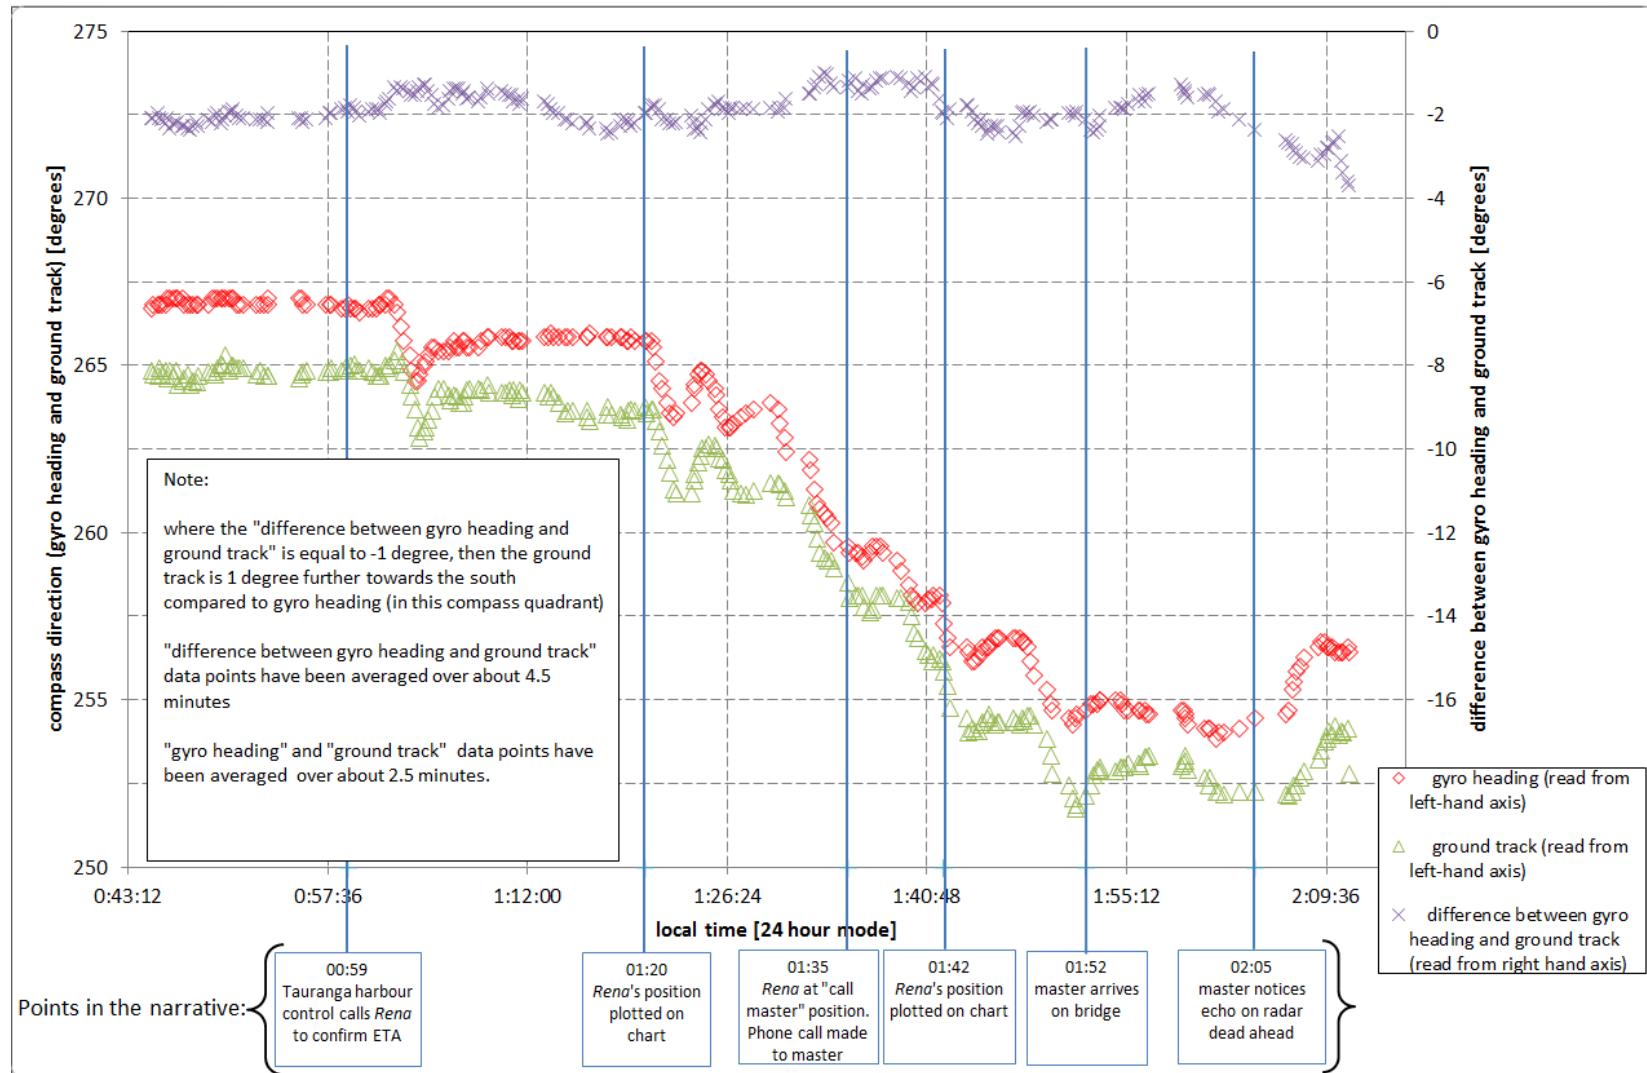
**Figure 2**  
Automatic identification system data showing vessel gyro heading and ground track and the difference between the two.  
Some points of the narrative have been overlaid on the plot (automatic identification system data provided by Marico Marine NZ Limited)

- 3.1.7. The difference between a vessel's gyro heading and its ground track will be caused by any set, leeway and gyrocompass error.
- 3.1.8. The Rena was being steered by autopilot for most of the voyage from Napier, including the whole period from midnight to the time of the grounding. The Rena's autopilot operated off its gyrocompass. The Rena's global positioning [navigation] system (GPS) recorded the vessel's position in relation to the ground and thus calculated the Rena's ground track. This report is concerned, in part, with the difference between the Rena's gyro heading, to which the autopilot was referenced, and the ground track. These two sets of data were obtained from the voyage data recorder and the automatic identification system. A description of these can be found in the glossary.

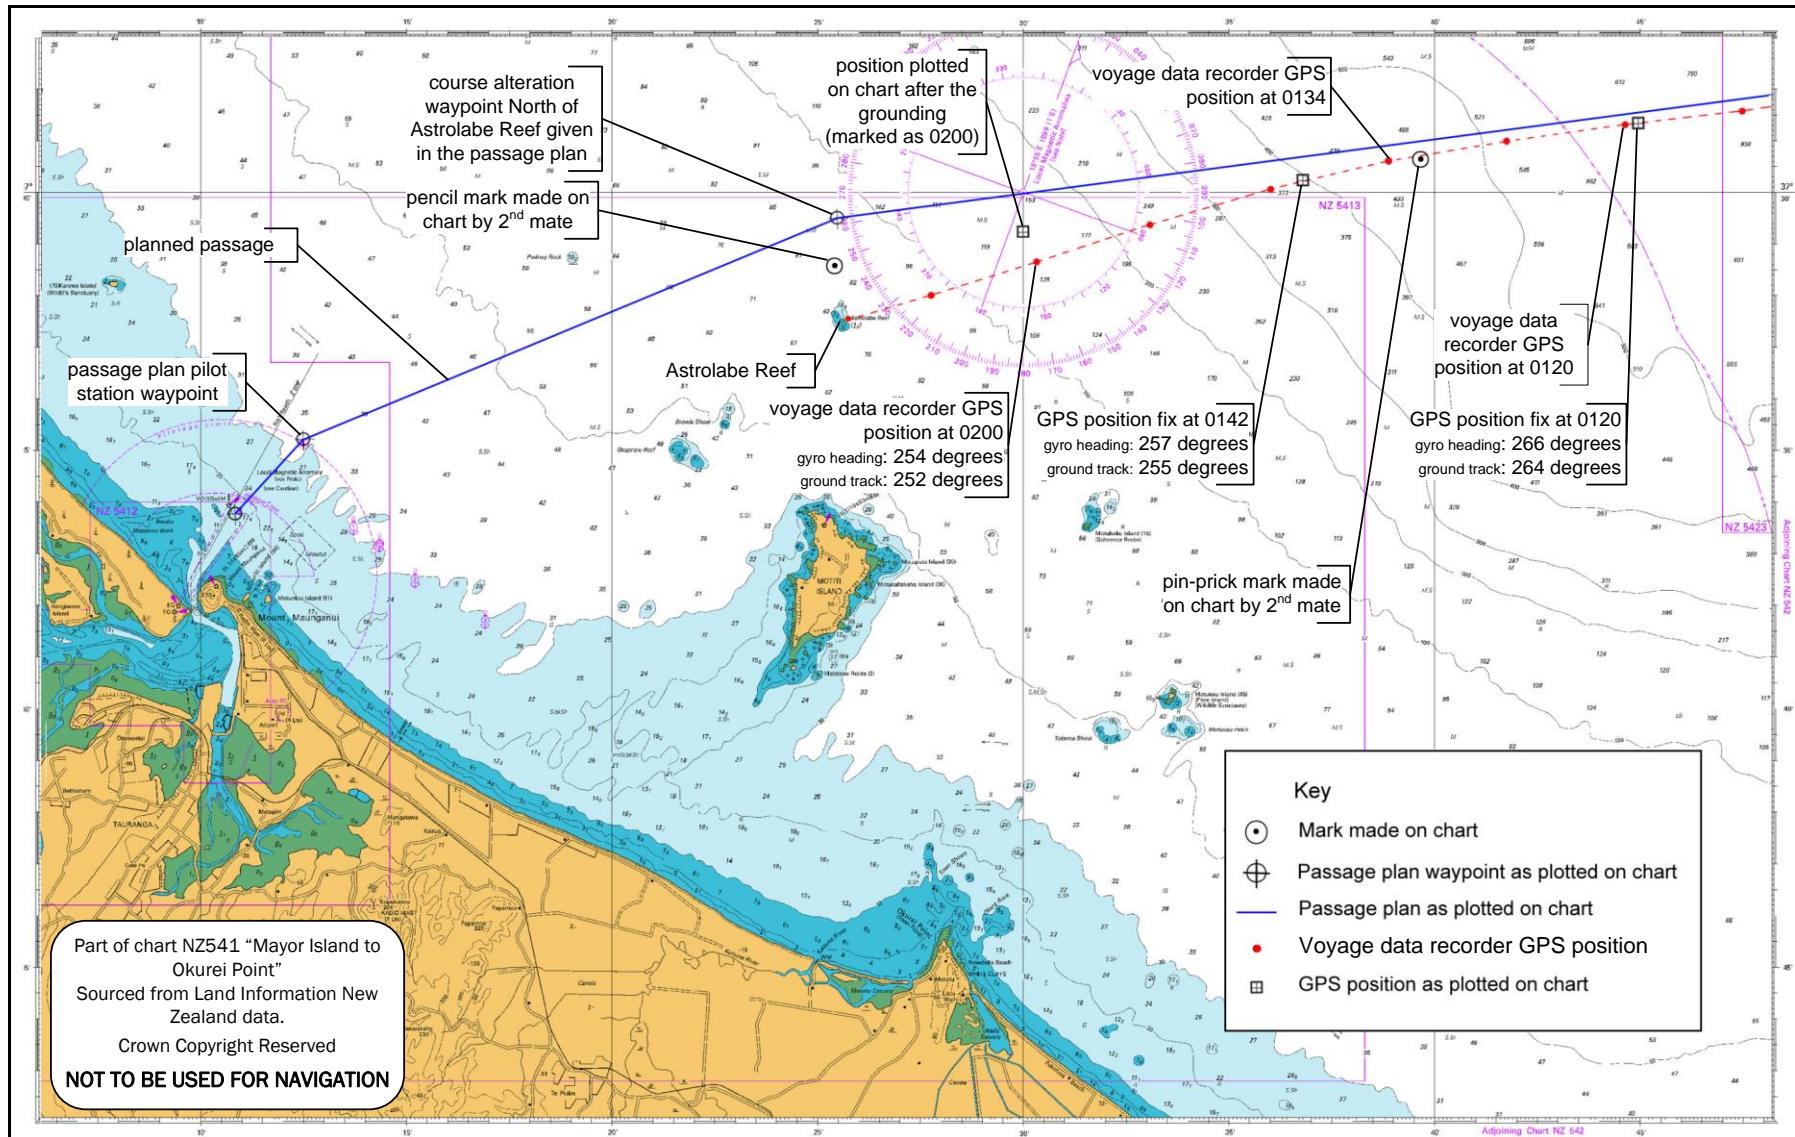
**Figure 3**  
Part of chart NZ541 showing passage plan (course line), plotted positions and voyage data recorder GPS positions on approach to Tauranga

- 3.2.16. The master had placed a mark on the chart, with a written instruction for the second mate to call him when the *Rena* reached that position. At 0135 the vessel reached the marked position and the second mate called the master on the telephone. During the discussion the second mate confirmed that the vessel would be at the pilot station by 0300 and also discussed an alteration of course that would shorten the distance to the pilot station, to which the master agreed. The second mate had already begun to make that alteration progressively to gyro heading.

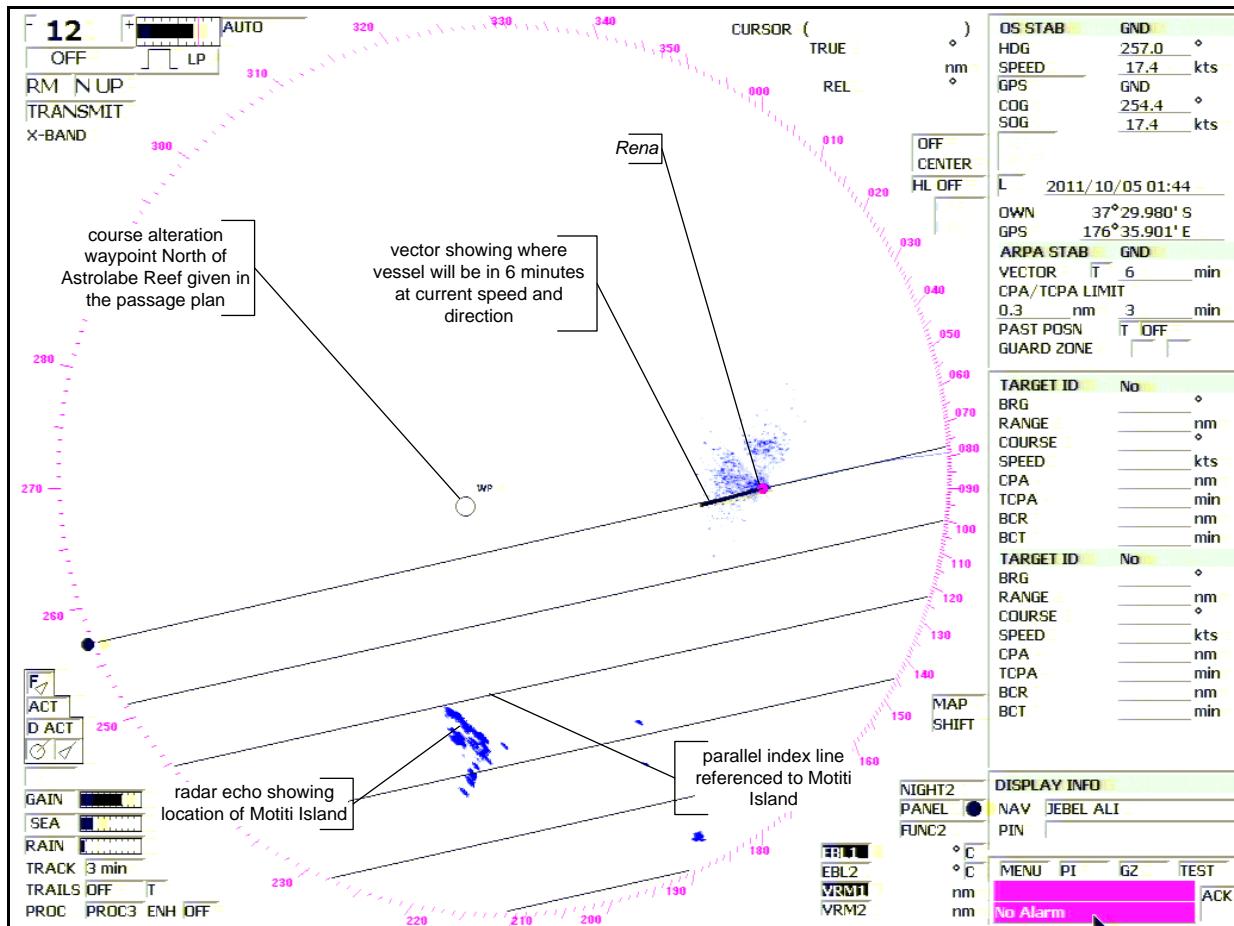
Figure 4  
Annotated screenshot of the Rena's radar (colour reversed for clarity)

- 3.2.24. At about 0205 the master noticed an intermittent echo on the radar. The echo was about 2.6 nautical miles dead ahead of the Rena. The master showed the echo on the radar to the watchkeeping able-bodied seaman and they used binoculars to look through the windows of the bridge for the cause of the echo. They could not see anything, so they moved to the bridge wing to look from there. When again nothing could be seen the master said that he decided to plot the Rena's position on the chart, so began to walk through the wheelhouse to the chartroom.

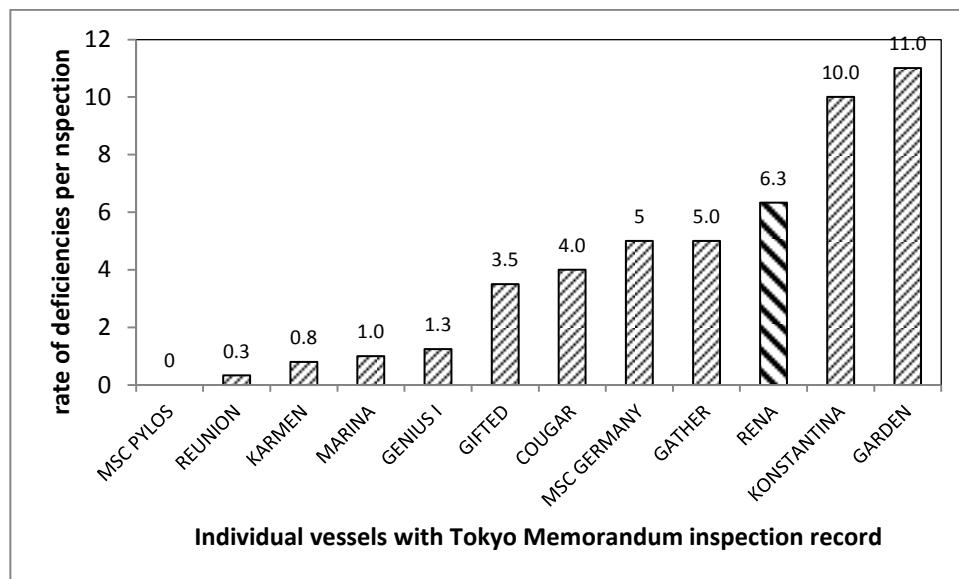
**Figure 7**  
**Rate of deficiencies per inspection for CIEL vessels inspected under  
Tokyo Memorandum of Understanding**

- 4.5.32. CIEL managed 12 vessels that accrued inspection records under the Tokyo Memorandum of Understanding. The deficiency per inspection rate for each of those vessels is given in Figure 7. The average rate of deficiencies per inspection for all vessels inspected under the Tokyo

Memorandum of Understanding was about 3.4 (Table 7). Seven of the 12 vessels inspected accrued rates at or above that average, and five accrued a rate below that average.
