Serious injury on board *Northwest Stormpetrel*

Dampier, Western Australia | 8 November 2014

ATSB Transport Safety Report
Marine Occurrence Investigation
316-MO-2014-013
Final – 30 March 2015

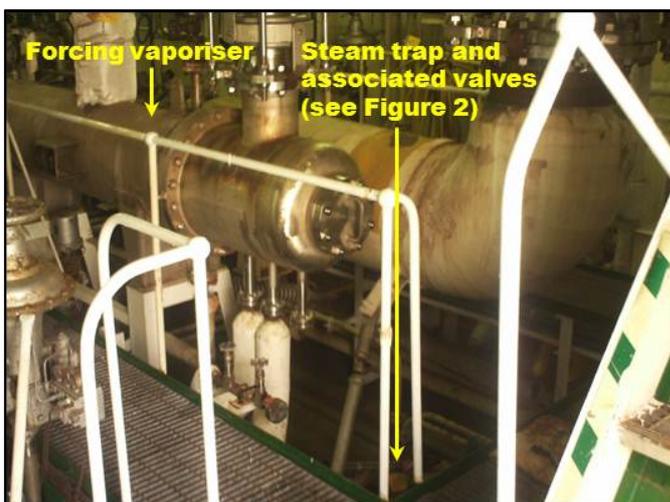
Figure 1: LNG forcing vaporiser

The lifeboat drills and some maintenance tasks were carried out on 7 November. One of the tasks planned for the following day (before the ship sailed from Dampier) was to check the LNG forcing vaporiser's¹ steam trap to resolve recurrent drainage issues with the system (Figures 1 and 2).

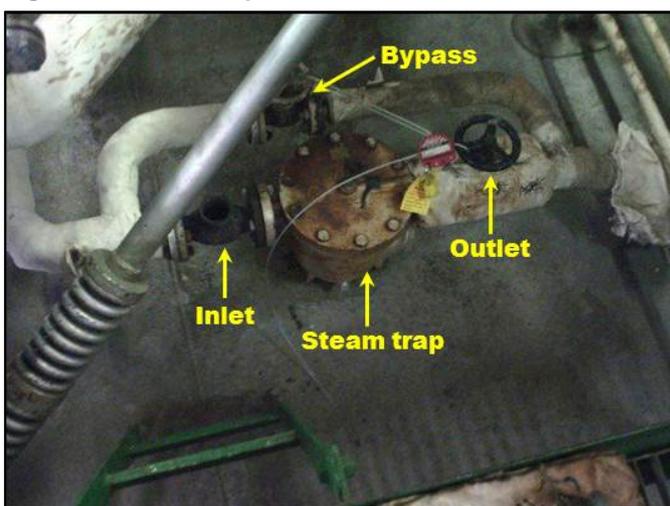
Figure 2: Steam trap and associated valves

The cargo engineer completed the permit to work with the chief engineer, who signed the permit to authorise the work. The cargo engineer then returned to the CMR and started dismantling the steam trap located below the vaporiser (Figure 2).

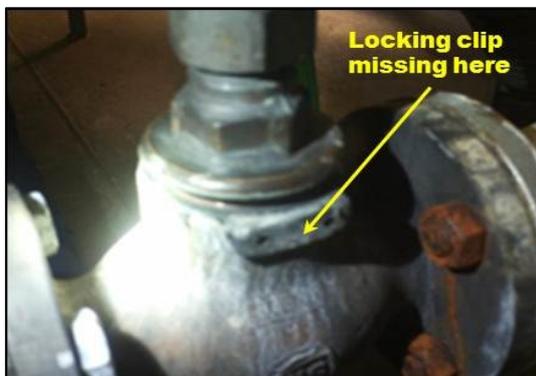
Figure 3: Valve with locking clip missing

The investigations found that the bonnet locking clip on the steam valve was missing (Figures 3 and 4) and this had allowed the bonnet to unscrew and come away from the valve body. The missing clip was not found, nor could it be established when or how it had been lost.

The steam valve's bonnet had several threads and unscrewing it to the point of release would have required turning it several times. However, it was reported that the bonnet came away after the valve's hand wheel was turned only one turn (to open). Therefore, it is likely that when the cargo engineer began to fully open the valve, the bonnet was already partially unscrewed and being held by very little thread. The nearly unscrewed bonnet and its missing locking clip may have been more readily apparent visually and by touch/feel, had the valve's location been less confined, the lighting been better and greater vigilance been exercised.

- Conduct a detailed analysis and review of procedures and precautions whilst working with pressurised systems.
- Specifically address isolation and de-isolation procedures to ensure adequate protection from injury.
