The Hazards of Snap-back

Initial learnings from a serious incident of mooring line failure

September 2015

Oil Companies International Marine Forum

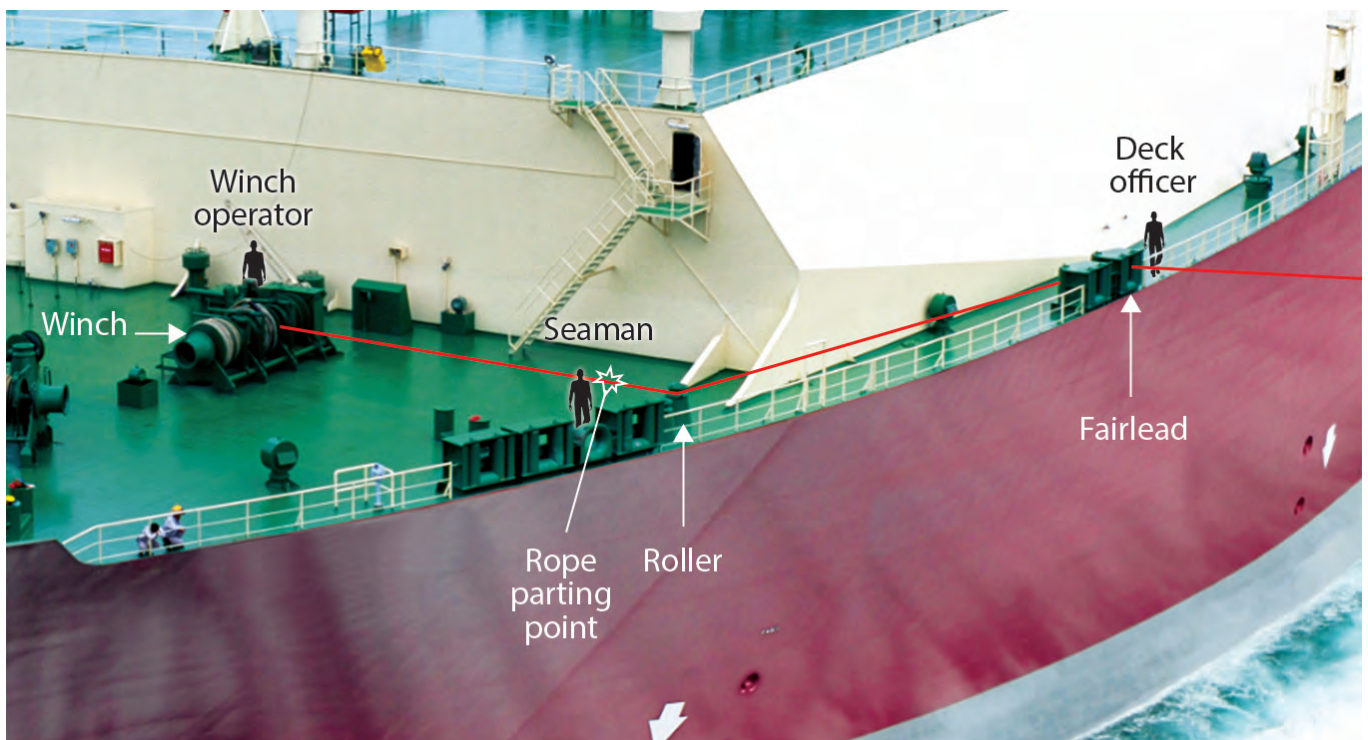
The mooring line parted inboard from a pedestal fairlead. The section of the line between the break and the port shoulder roller fairlead struck the deck officer on the head as it whipped back before going overboard through the fairlead. The deck officer was found lying unconscious forward of the roller fairlead. He had sustained multiple skull fractures.

The mooring line that failed was a 44-millimetre diameter sheathed ultra-high modulus polyethylene (UHMPE) line. The line was fitted with a 22-metre long polyester/polyethylene tail. The section of UHMPE line in use between the winch and the connection with the tail was approximately 68 metres long.

Figure 1: Location of injured deck officer relative to rope parting point

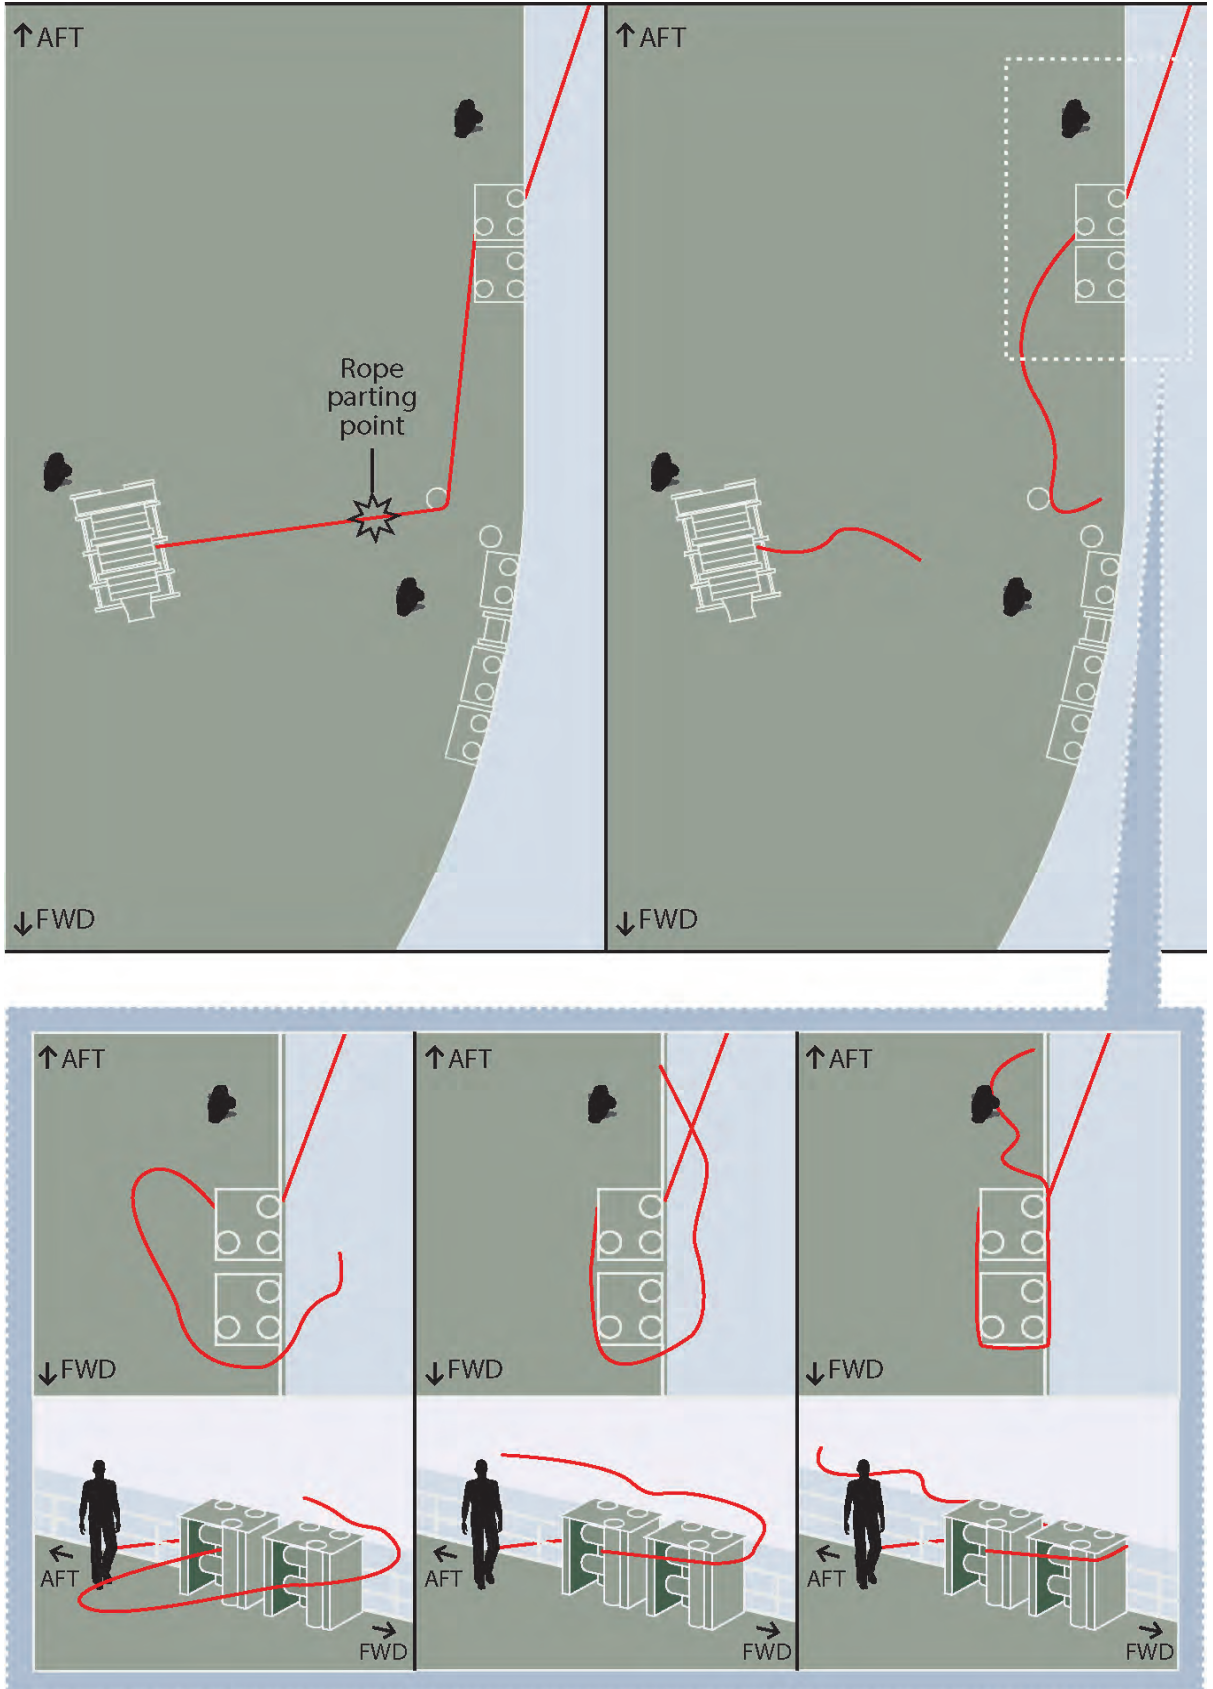
Following the incident, computer modelling was used to assess the dynamic trajectory of the entire length of the UHMPE rope from its point of failure. The modelling indicated that it was highly probable that the rope would go aft of the roller fairlead and wrap around it before finally going outboard. The results support the theory that the deck officer was struck while standing aft of the roller fairlead, and that he was knocked forward to the position where he was found.

Figure 2: Example trajectory of failed line between 0.19 and 0.29 seconds after parting
