Collision between *Royal Pescadores* and *Da Heng Shan*

Gage Roads Anchorage, Fremantle, Western Australia | 8 May 2014

ATSB Transport Safety Report
Marine Occurrence Investigation
308-MO-2014-003
Final – 13 October 2015

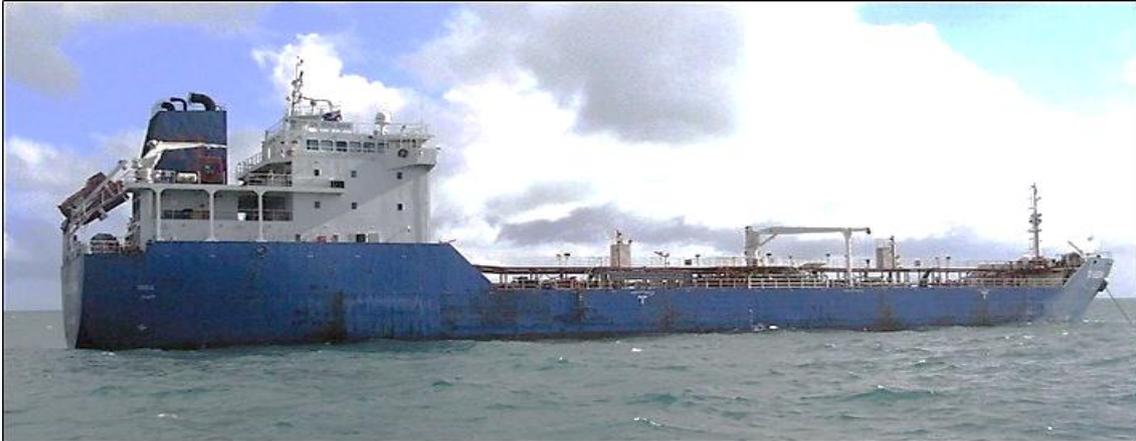
Figure 2: *Da Heng Shan* at anchor

Shortly after, *Da Heng Shan*'s master reported to VTS that the ship's bow and deck structure had been damaged. *Royal Pescadores*' master had reported minimal damage to the starboard quarter shell plating.

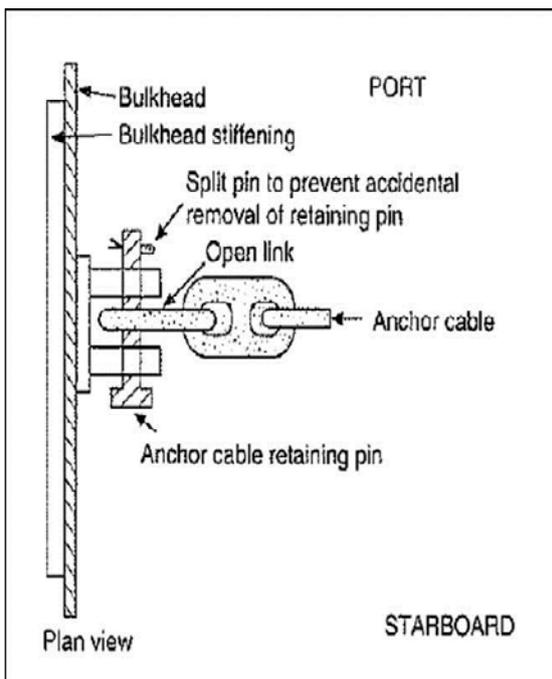
Figure 3: Bitter end arrangement

Royal Pescadores was equipped with two 4.89 tonne anchors, each fitted with 10 shackles of 54 mm diameter anchor chain cable (cable). Each anchor cable's bitter end¹⁰ was secured by a clench system inside the chain locker (Figure 3). Steel lugs were welded to the aft bulkhead in the locker and the open chain link at the end of the cable was attached to the lugs by a retaining pin.

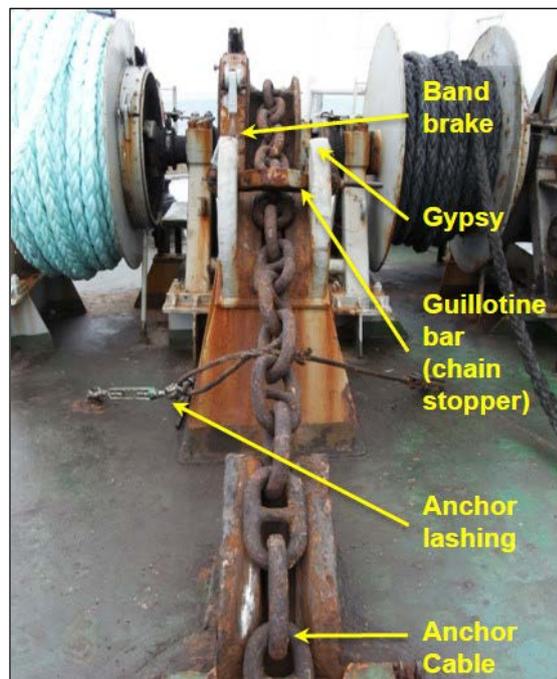
Figure 4: Anchoring equipment on deck

Royal Pescadores' windlasses were fitted with a manual band brake system (Figure 4). Turning the brake handle tightened the band around the brake drum. When properly tightened, the brake lining should provide the necessary friction to prevent the drum and the gypsy¹¹ from turning.

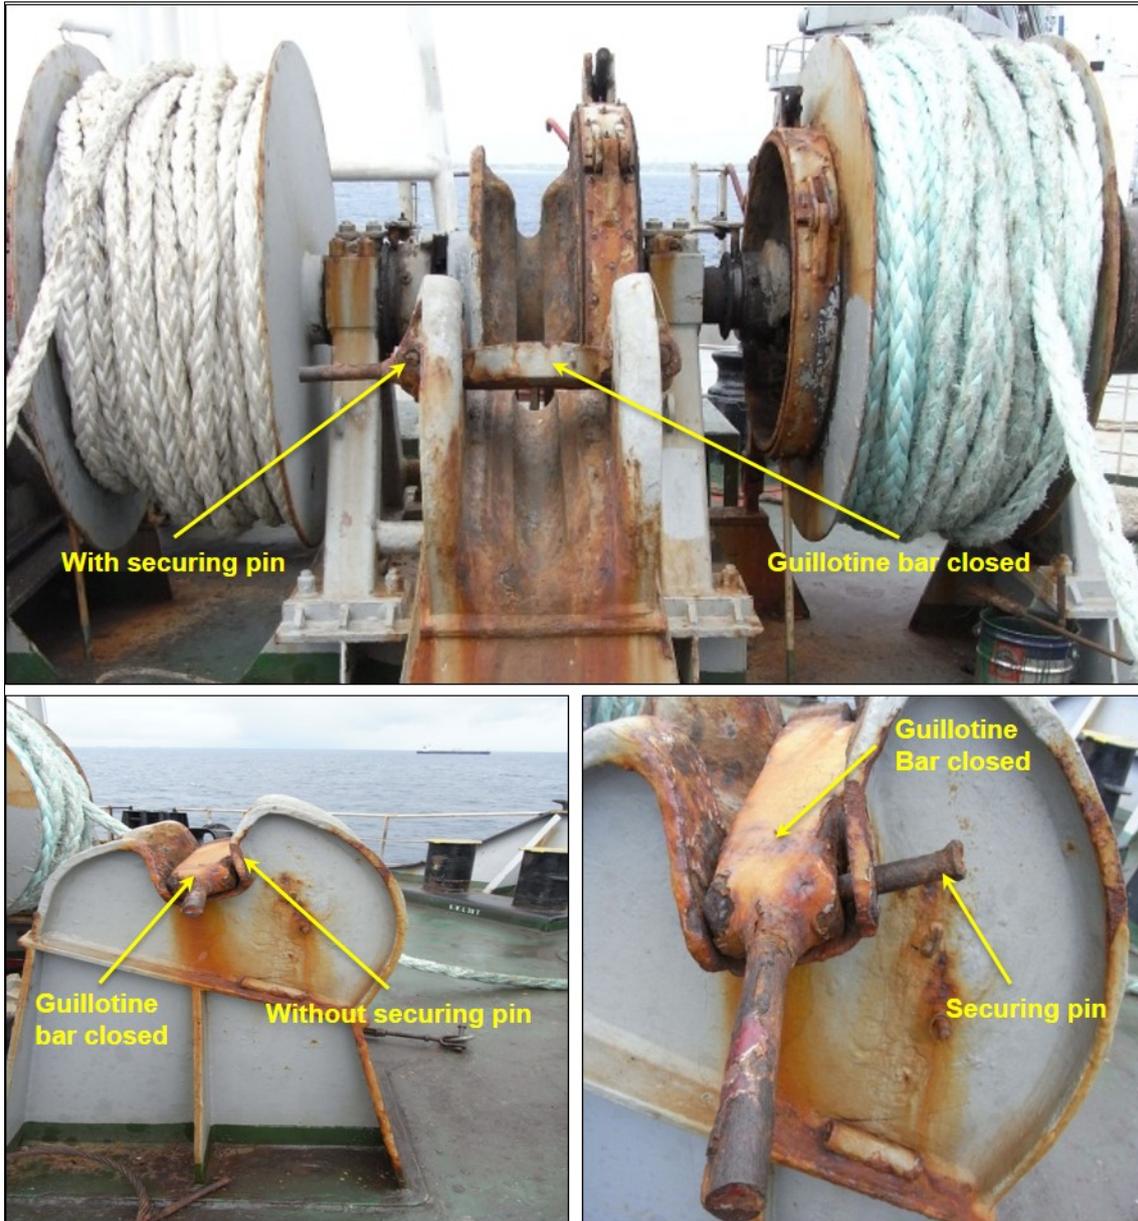
Figure 5: *Royal Pescadores*' port windlass and chain cable stopper arrangement

Royal Pescadores was fitted with hinged bar, guillotine-type cable stoppers, with a grooved track for the chain to pass through (Figure 5). Securing the cable required the guillotine bar to be fully lowered onto a horizontal chain link, with the next inboard vertical link bearing down on the bar. The bar was locked in this position by a securing pin.

A visual inspection of the ship's anchoring equipment found that the port anchor cable stopper, including the guillotine bar and its securing pin and brackets, was corroded and worn. The securing pin and its guide holes were sufficiently corroded for the pin to be a loose fit. The pin itself was slightly bent and its thickness varied noticeably over its length. The securing chain attaching the pin to the stopper structure was missing.

The stopper's physical condition described above allowed sufficient movement of the bar for its securing pin to work free in certain conditions. The constantly changing load on the cable when riding to the anchor in adverse weather, and the resultant movement of the bar, provided a mechanism for the securing pin to move forward and out of its guide holes. The pin did not have any device (such as a split pin or a drop-nose pin) to prevent it from working free and falling out.

On 7 May, the boatswain (bosun) found that the guillotine bar's securing pin had almost worked free and he re-inserted it. After the anchor cable was lost the following day, the bosun found the securing pin on the deck near the stopper. It is evident that the pin fell out after working free in the manner described above, allowing the bar to lift and the load on the cable to come onto the windlass brake. The brake did not hold and the cable ran out to its bitter end.

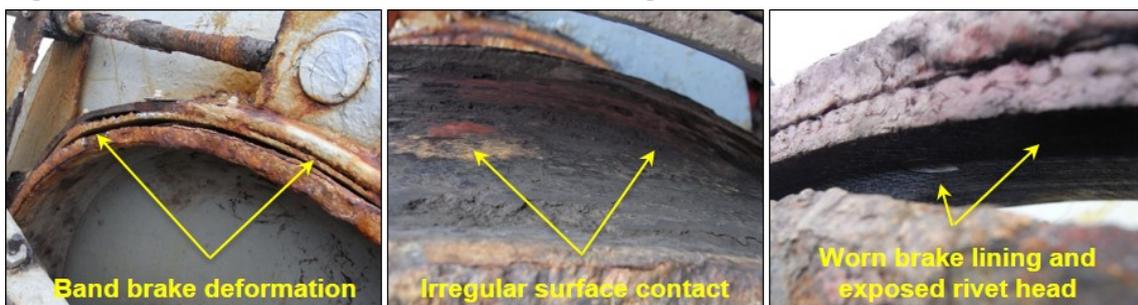
Figure 6: Port windlass band brake drum and lining after the incident

The following conditions (Figure 6) indicated the overall poor condition of the windlass brake:

- band brake lining was hard, polished and thinned, with exposed securing rivet ends
- band brake backing plate was deformed
- brake drum surface was heavily scaled in places and pitted in others.

The deformed brake band meant that significantly less surface area of the lining could contact the drum when the brake was applied – reducing the brake holding capacity. The holding capacity was further reduced because of the hard polished lining, irregular drum surface and exposed rivet heads. These conditions are indicative of inadequate maintenance over a period of time, rather than being attributable to wear on the lining when the cable ran out on 8 May.

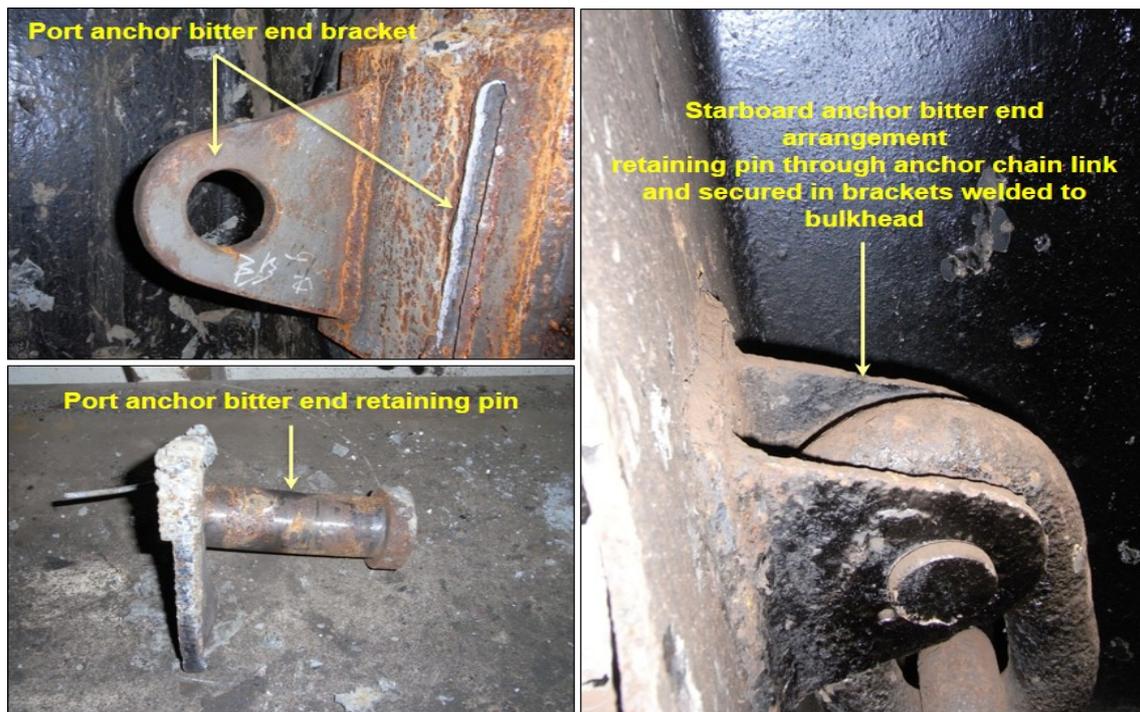
Figure 7: *Royal Pescadores'* bitter end securing arrangements inside the chain locker

While it did not contribute to the incident, *Royal Pescadores'* anchor cable bitter end securing arrangement was contrary to recognised design recommendations intended to reduce risk. The relevant International Association of Classification Societies (IACS) recommendation states:

The bitter end securing arrangement on board *Royal Pescadores* could only be released from inside the chain locker (Figure 7). Therefore, releasing it would involve entering the locker and an exposure to high risk of serious injury, particularly in an emergency.

The Australian Transport Safety Bureau advises the International Association of Classification Societies (IACS) that it should consider the safety implications of there being no requirement for its members to follow best practice with respect to anchor cable bitter end securing arrangements, consistent with IACS Recommendation No. 10, 1.2.2 (b).
