SAFETY DIGEST

**Lessons from Marine
Accident Reports
2/2015**

SAFETY DIGEST
Lessons from Marine Accidents
No 2/2015

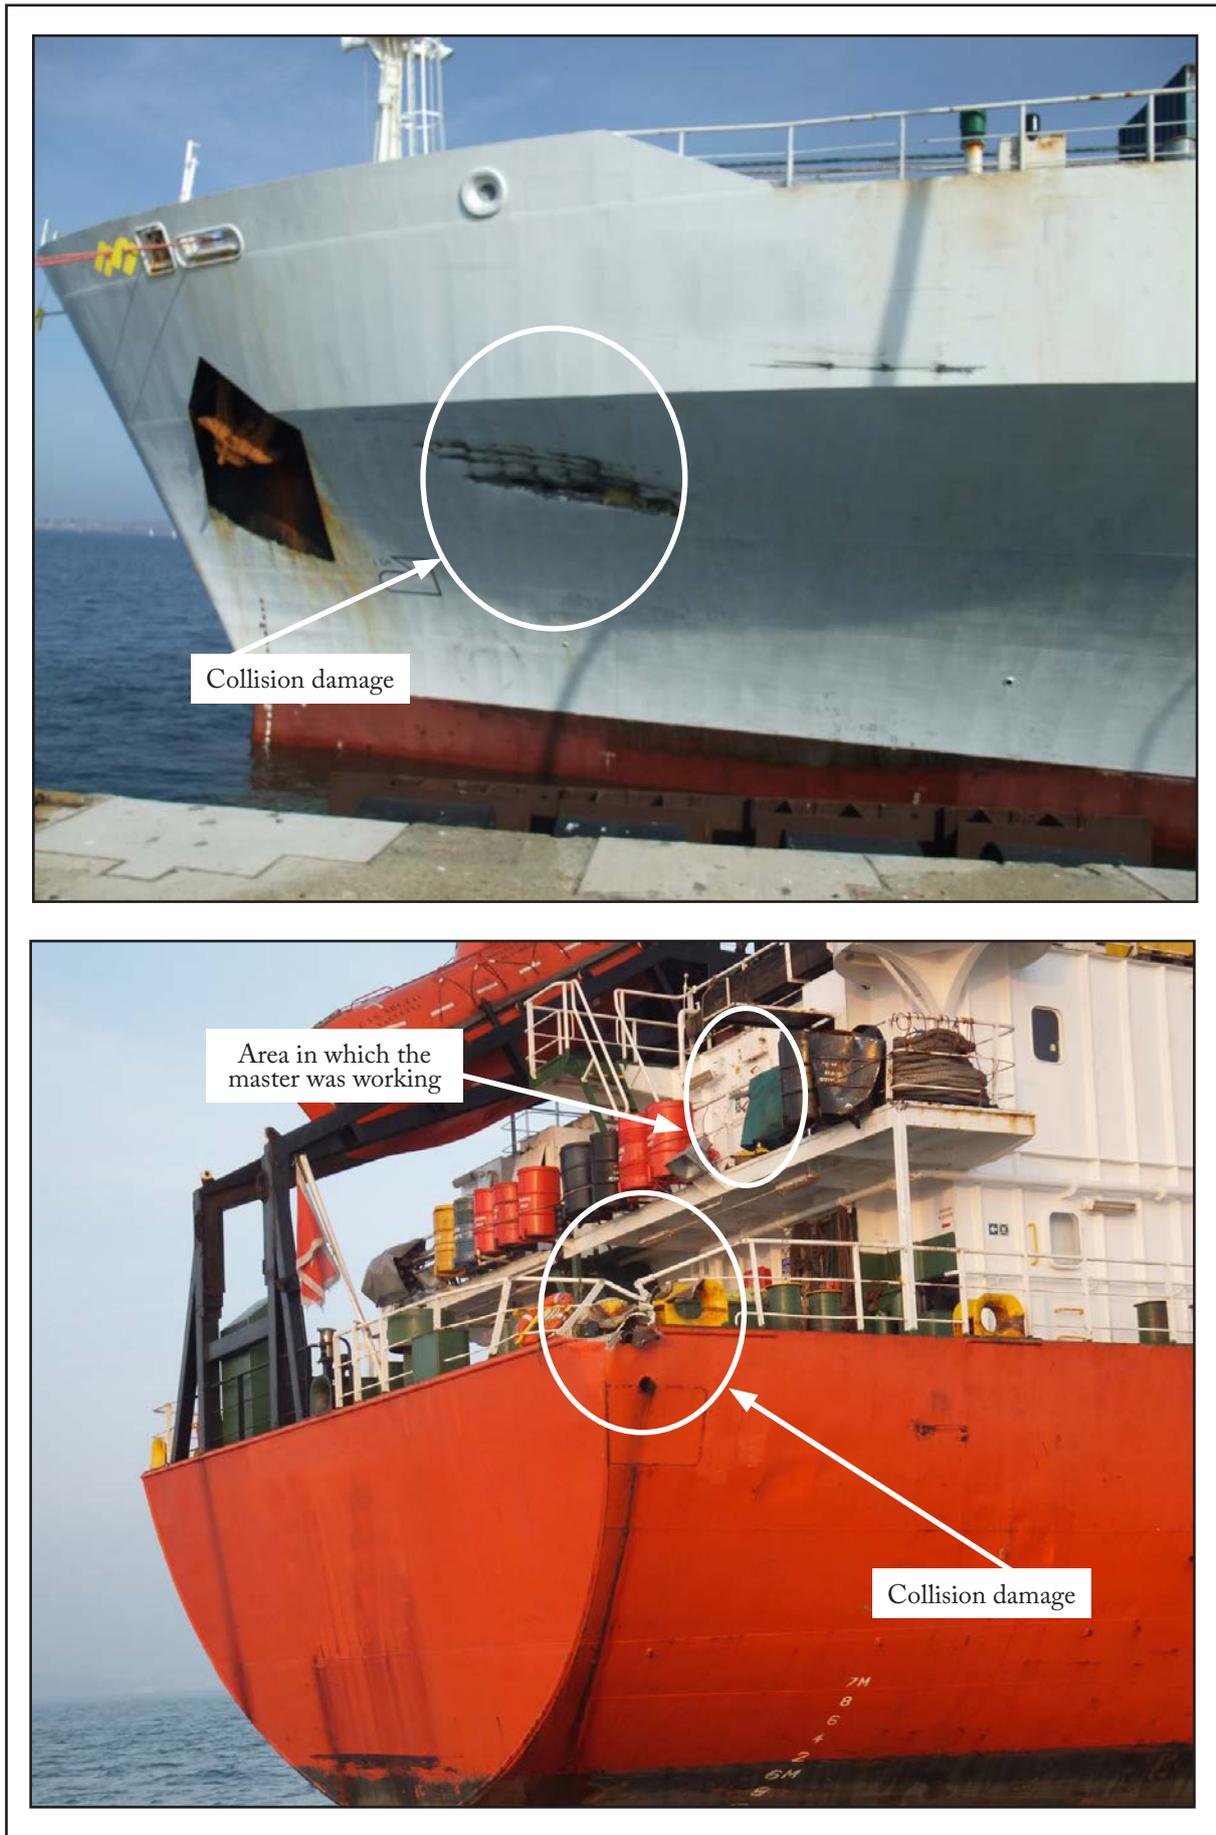
The general cargo vessel's port bow collided with the LPG tanker's port quarter and the hulls of both vessels were breached above their respective waterlines. Both vessels were directed by the coastal state to a nearby port of refuge for inspection and repairs.

Figure 1: Damage to both vessels

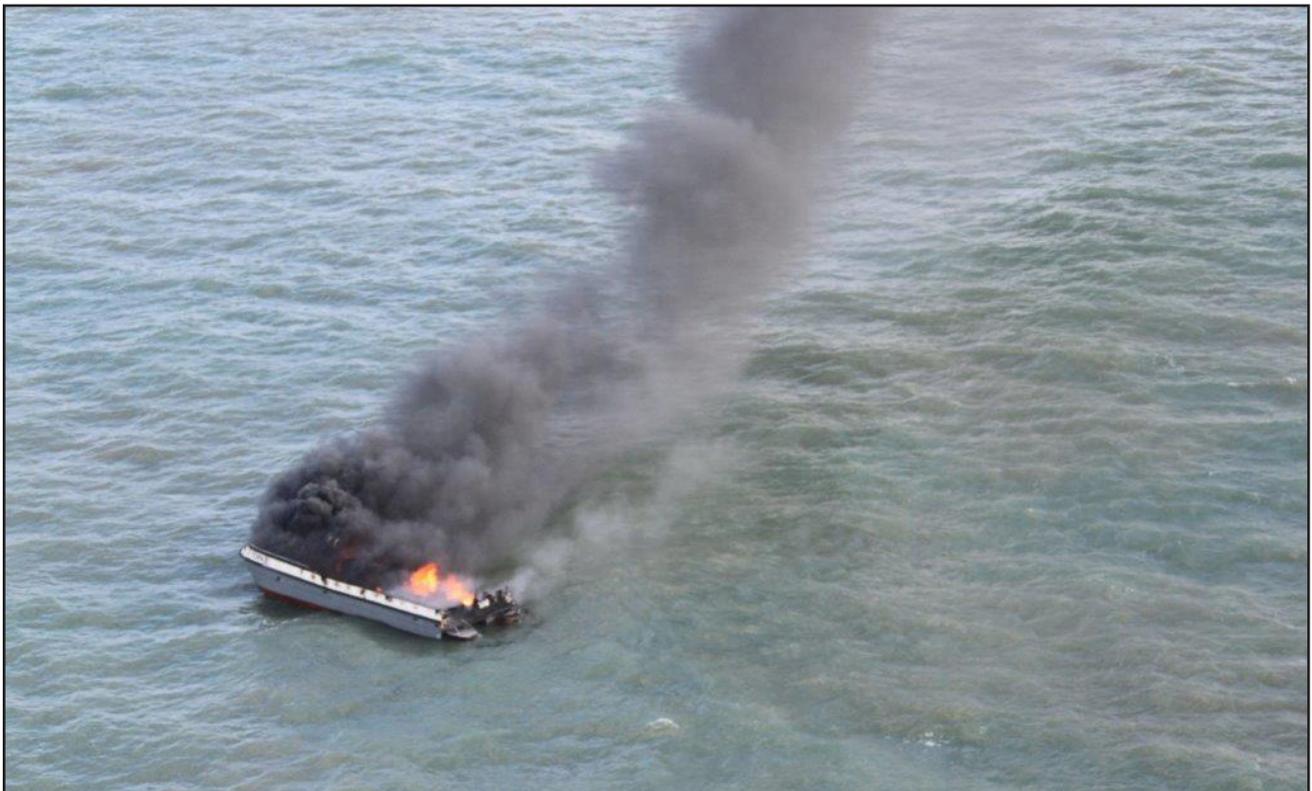
Figure 1: Burning workboat before it sank

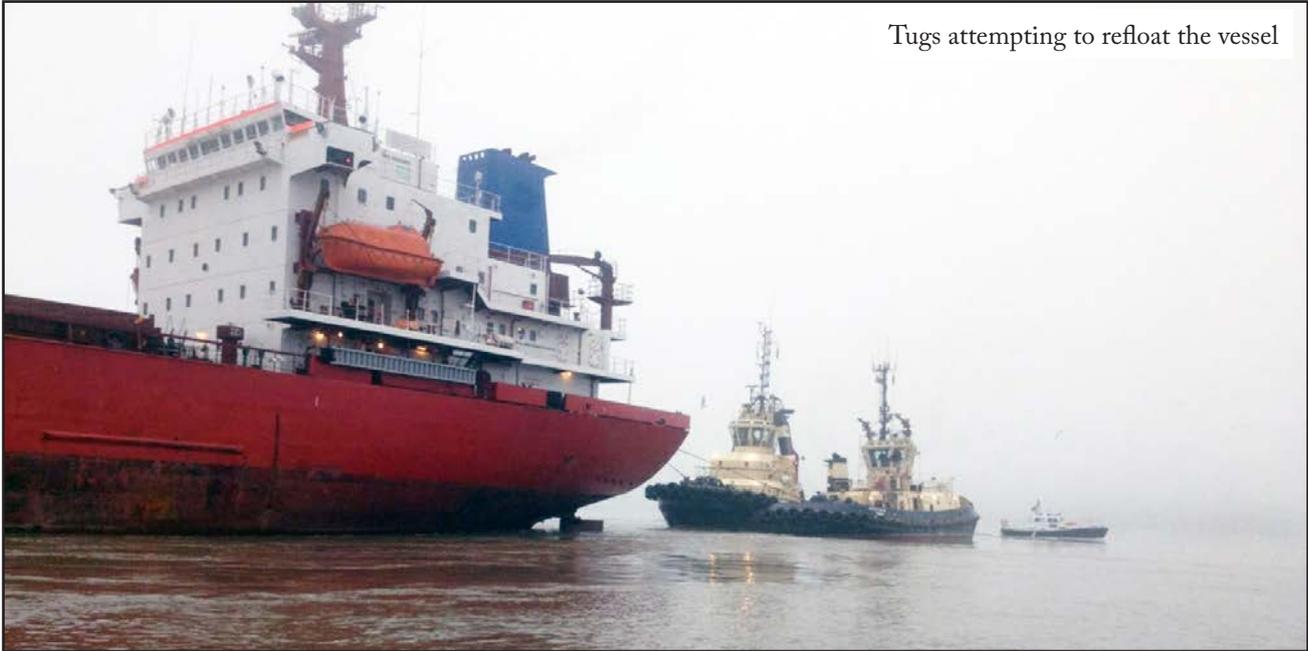
As a result of the contact the vessel was holed above the waterline, but no damage was caused to the hull by the grounding, which occurred in an area of soft mud. The vessel was refloated

Tugs attempting to refloat the vessel

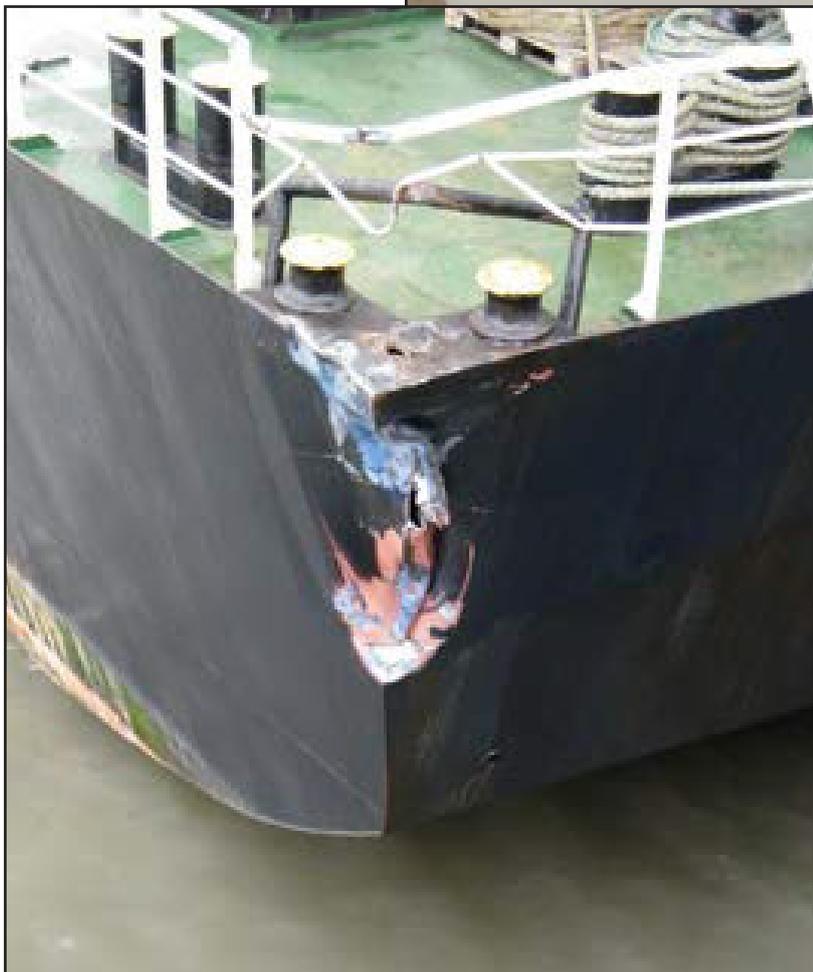
The damage (Figure 3) to the shell plating on both vessels was significant and resulted in the two vessels being out of service for several days for repairs to be undertaken. Fortunately there was no injury to personnel or any pollution as a result of the collision.

Figure 3: Damage to shell plating

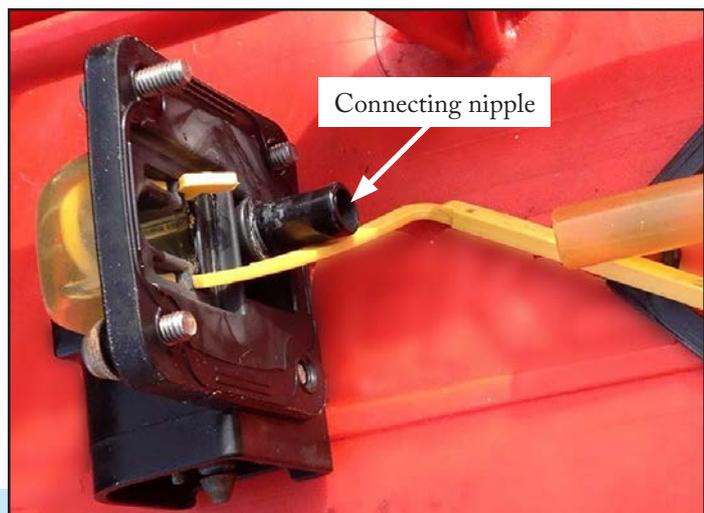
Information from the engine and fuel tank supplier indicated that an annual inspection of the fuel tanks should form part of the boat's maintenance schedule. The pick-up tubes were secured to the tank top assembly by use of an adhesive. The vessel had a diverse operating schedule and, over a period of time, had purchased petrol from a number of different countries. There was a risk that fuel with a high ethanol content could cause the adhesive to deteriorate.

Fuel tank pick-up tube assembly

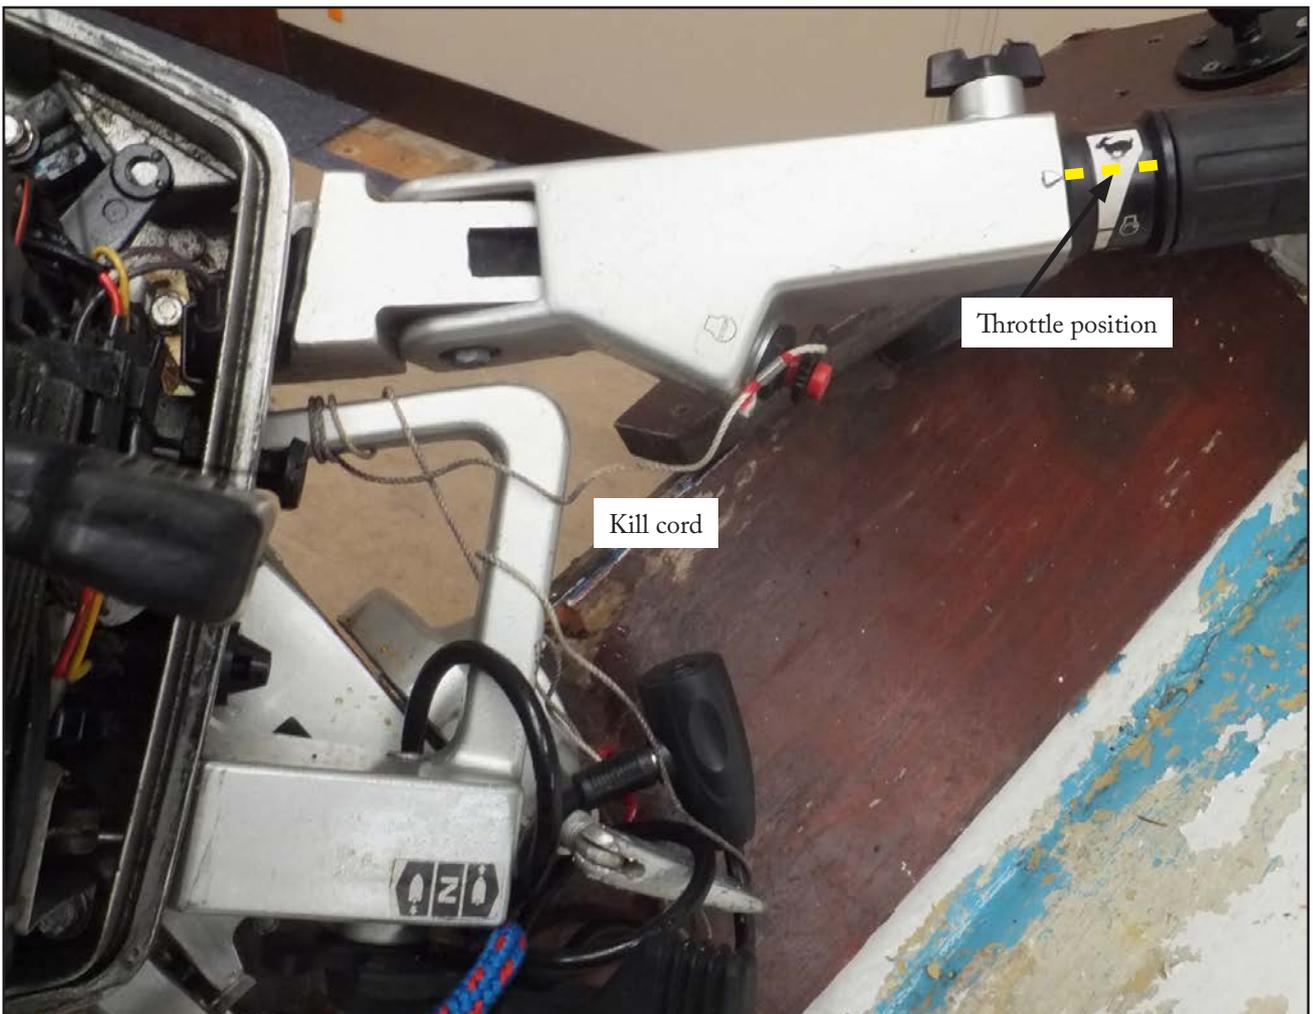
Figure 2: Kill cord and throttle

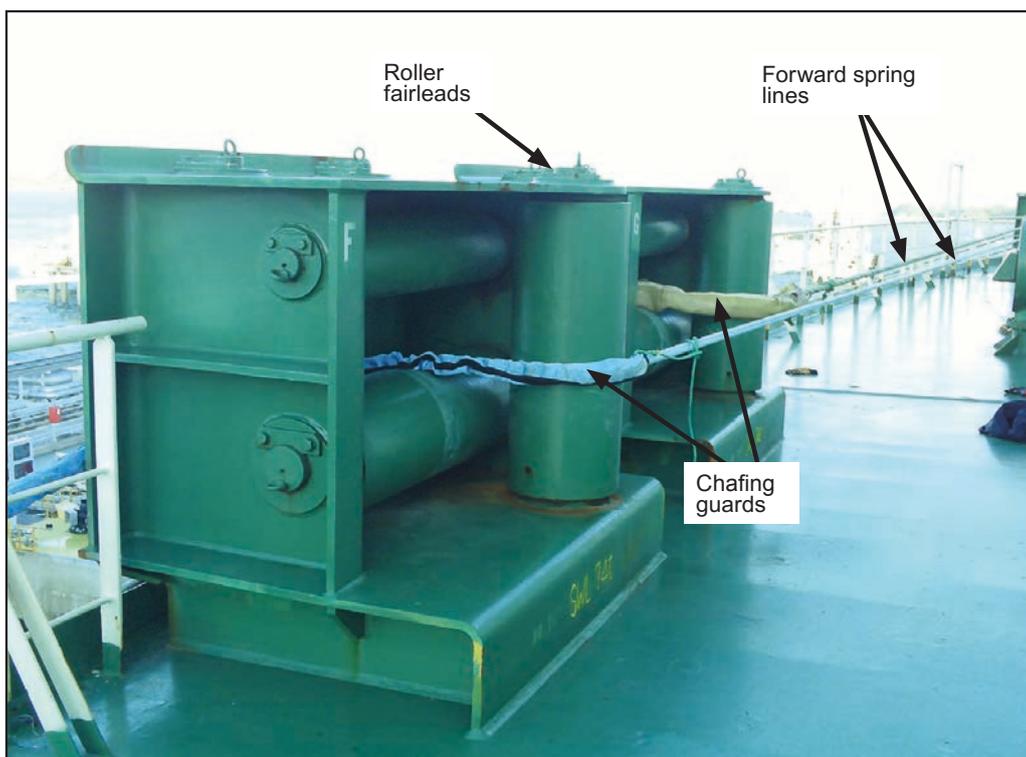
The OIC positioned himself aft of the forward springs' port-shoulder roller fairlead (**Figures 2 and 3**), and positioned a second crewman forward of him in order to relay his orders to the winch operator. As the winch operator attempted to heave in on the springs, the winch repeatedly stalled and rendered¹. After about 10 minutes, one of the spring lines began to rattle and creak, and then suddenly parted (**Figure 4**). The section of the line between the break and the port-shoulder roller fairlead struck the OIC on his head as it whipped back before going overboard through the fairlead.

Figure 2: Port-shoulder roller fairlead
