Report on the investigation of
a main engine room fire on board

Pride of Canterbury

while berthing in Calais

on 29 September 2014

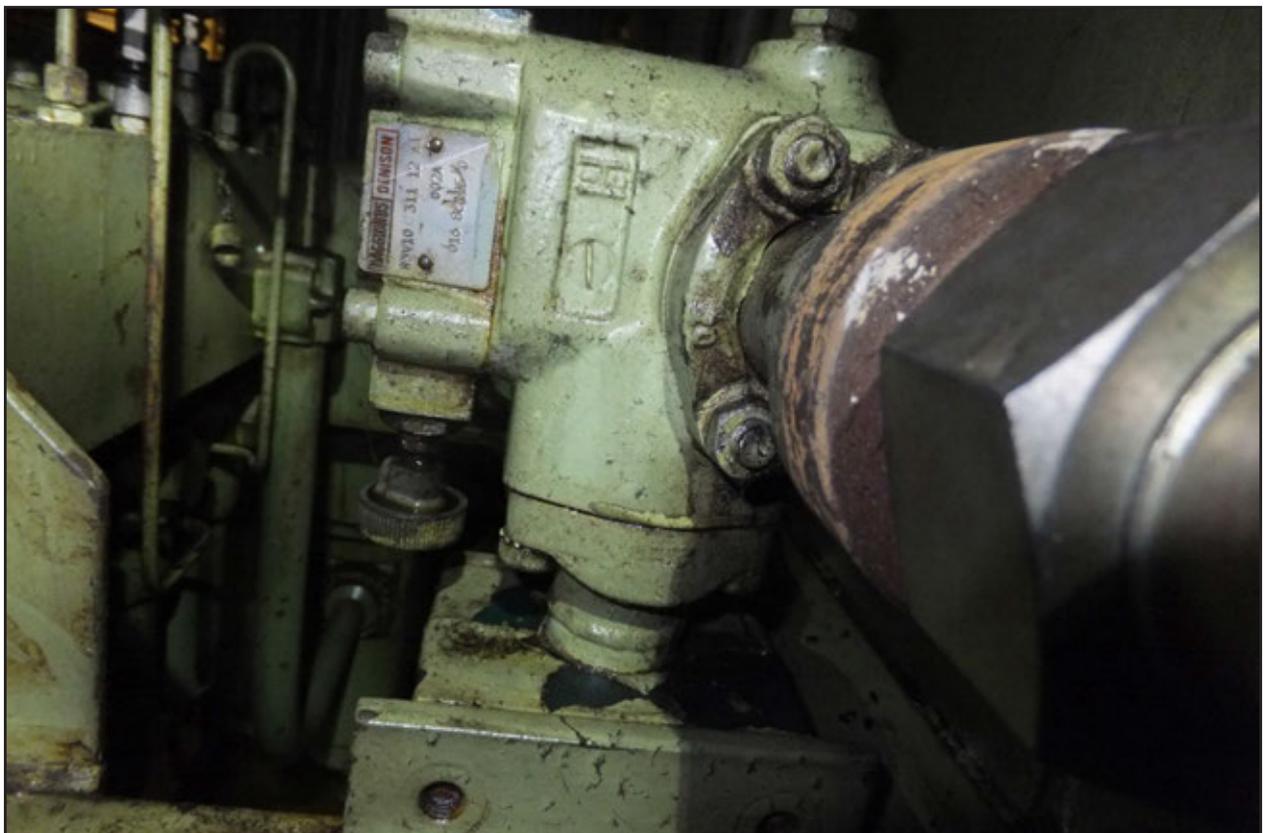
Figure 16: Back pressure valve (PSV 3)

The system oil pressure was regulated by maintaining the return line from the OD box at 8 bar utilising a pressure safety valve (PSV3) termed a back pressure valve (**Figure 16**). A further pressure safety valve (PSV1) was fitted in the supply line to the OD box to enable pressure to be dissipated into the return line if it exceeded 145 bar. **Figure 17** shows the fire-damaged starboard hydraulic module with the relevant components highlighted. An oil cooler was situated after the back pressure valve and a non-return valve (NRV6) was positioned immediately before the return into the reservoir.

The back pressure valve (PSV3), when tested, although intended to release at 6-8 bar, released at much greater pressures, ranging from 20 to 77 bar. When dismantled it was found that the piston was worn, allowing it to tilt and stick sporadically. The valve supplier considered the amount of wear was normal given its 23 years of service. The pressure safety valve (PSV1) was also dismantled and found to be worn, but to a much lesser extent.

The fire was initiated following the spray of hydraulic oil, from a ruptured pipework joint in the starboard CPP system, onto the hot exhaust uptakes of the starboard main engines. The flanged joint ruptured because the CPP system became over-pressurised as a result of the back pressure valve (PSV3) becoming jammed in the closed position.

- Replaced PSV1 and PSV3 on all CPP hydraulic modules.
- Implemented a maintenance programme in which at least PSV1, PSV3 and NRV6 are disabled and their function checked once every 5 years.
- Added a full flow check-valve, with an opening pressure of 10-12 bar, in the return oil circuit by-passing PSV3, the Oil Cooler and NRV6. Also, an additional alarm signal was to be fitted in the control system to give an alarm at 9-10 bar.

Wartsila has issued a Technical Bulletin (**Annex C**) instructing operators to replace back pressure valves at least every 15 years.

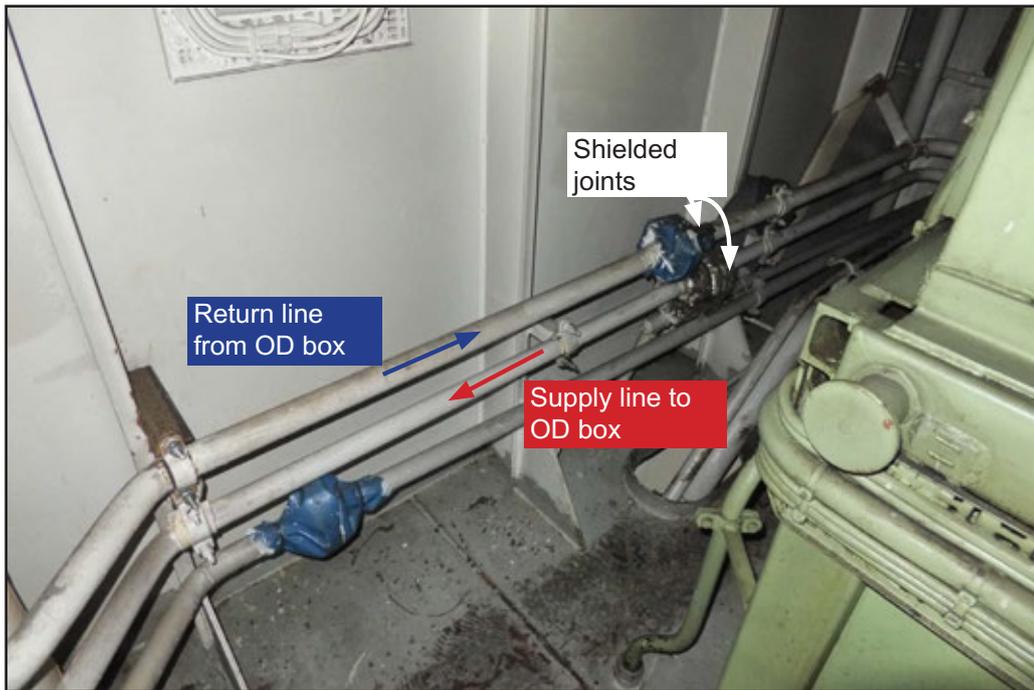
Figure 18: Shielded joints on port controllable pitch propeller system

The pipework joints on the supply line to the OD box, which experienced 100 bar in normal operation, were made using hydraulic couplings and were shielded to prevent a spray of oil in the event of leakage (**Figure 18**). The return line from the OD box, which normally experienced up to 8 bar, employed flanged joints and, although some of these joints were shielded, not all of them were protected in this way. In particular, the return line joints positioned between the main engine turbochargers were not shielded (**Figure 19**).
