SAFETY FLYER

Hoegh Osaka: Listing, flooding and grounding on 3 January 2015

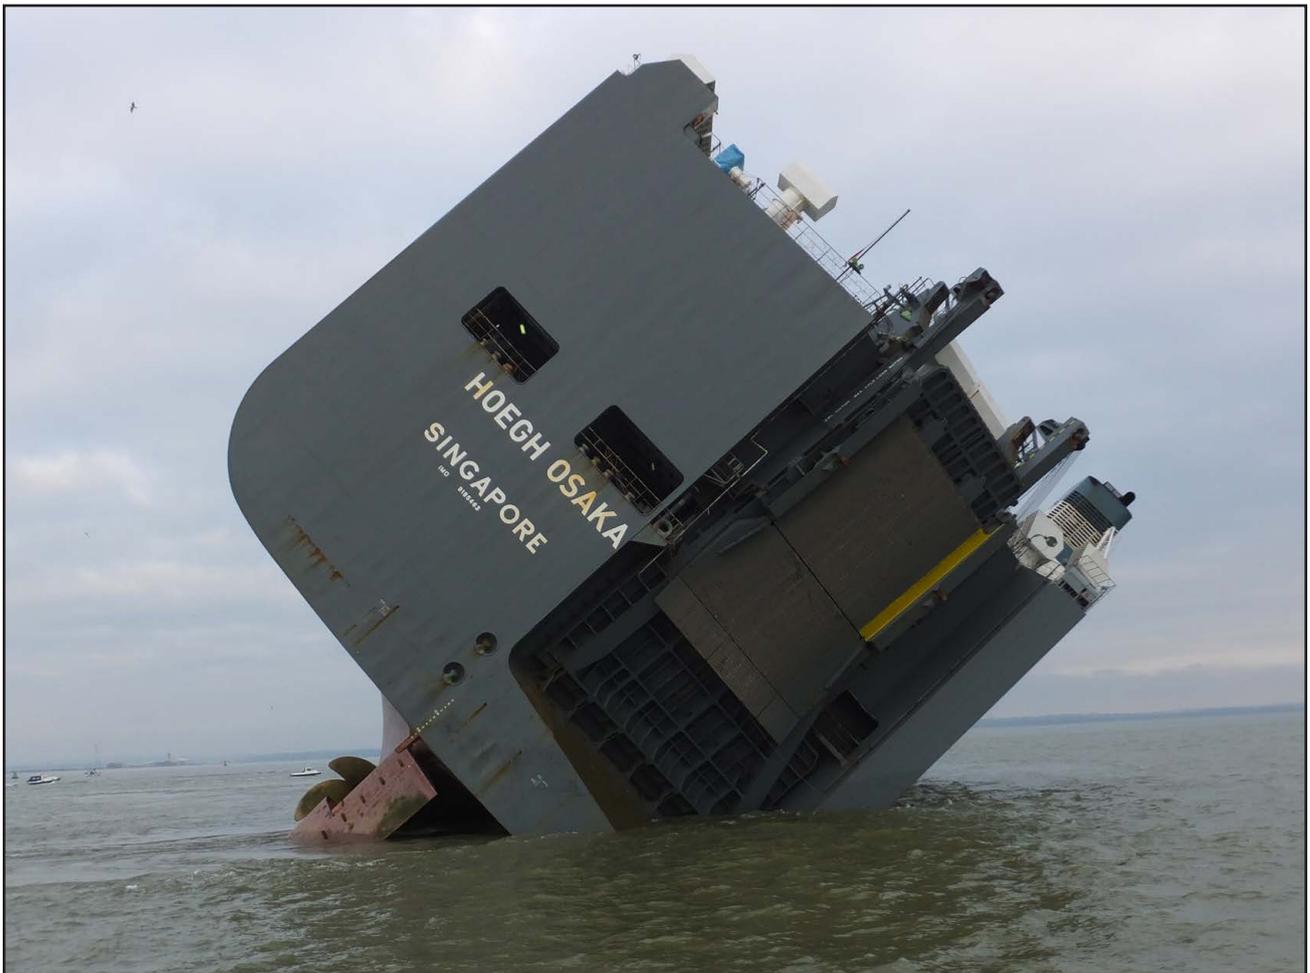
Hoegh Osaka

At 2109 (UTC) on 3 January 2015, the pure car and truck carrier (PCTC) *Hoegh Osaka* was departing Southampton, UK, and turning to port around the Bramble Bank when the vessel developed a significant starboard list. As the list increased in excess of 40° the ship lost steerage and propulsion, and subsequently drifted aground on Bramble Bank. A cargo shift as the vessel listed resulted in breaches to the hull and consequent flooding. All crew were safely evacuated from the ship and surrounding waters. There was no resulting pollution, and the ship was later successfully salvaged.

Stability modelling and analysis following the accident show that *Hoegh Osaka* heeled heavily to starboard while turning as a result of having departed port with inadequate stability. Cargo distribution was such that the upper vehicle decks were full while the lower vehicle decks were lightly loaded. *Hoegh Osaka* was low on bunker fuel oil, which was stored low down in the ship, and the ship's overall vertical centre of gravity (VCG) was relatively high.

Hoegh Osaka's inadequate stability had not been identified prior to departure. The figures in the pre-stowage plan were significantly different to the final cargo tally; the estimated weight of many items of cargo was less than their actual weight; and no allowance was made for the VCG of the cargo loaded being above deck level. Finally, it was onboard practice to alter the ballast tank quantity readings on the loading computer so its output would match the observed draught readings. It would have been possible to embark additional ballast prior to departure to reduce the ship's VCG as necessary, but as the shortcoming in stability had not been identified this was not done.

- Assessing a ship has adequate stability for its intended voyage on completion of cargo operations and before it sails is a fundamental principle of seamanship that must not be neglected. Sufficient time must be made before departure for an accurate stability calculation to be completed.
- A loading computer is an effective and useful tool for the safe running of a ship. However, its output can only be as accurate as the information entered into it.
- The master has ultimate responsibility for the safety of his/her ship. This responsibility cannot be delegated to shore-based managers or charterers' representatives.
