Fire on board the livestock carrier *Ocean Drover*

Fremantle, Western Australia | 9 October 2014

ATSB Transport Safety Report
Marine Occurrence Investigation
315-MO-2014-012
Final – 11 March 2016

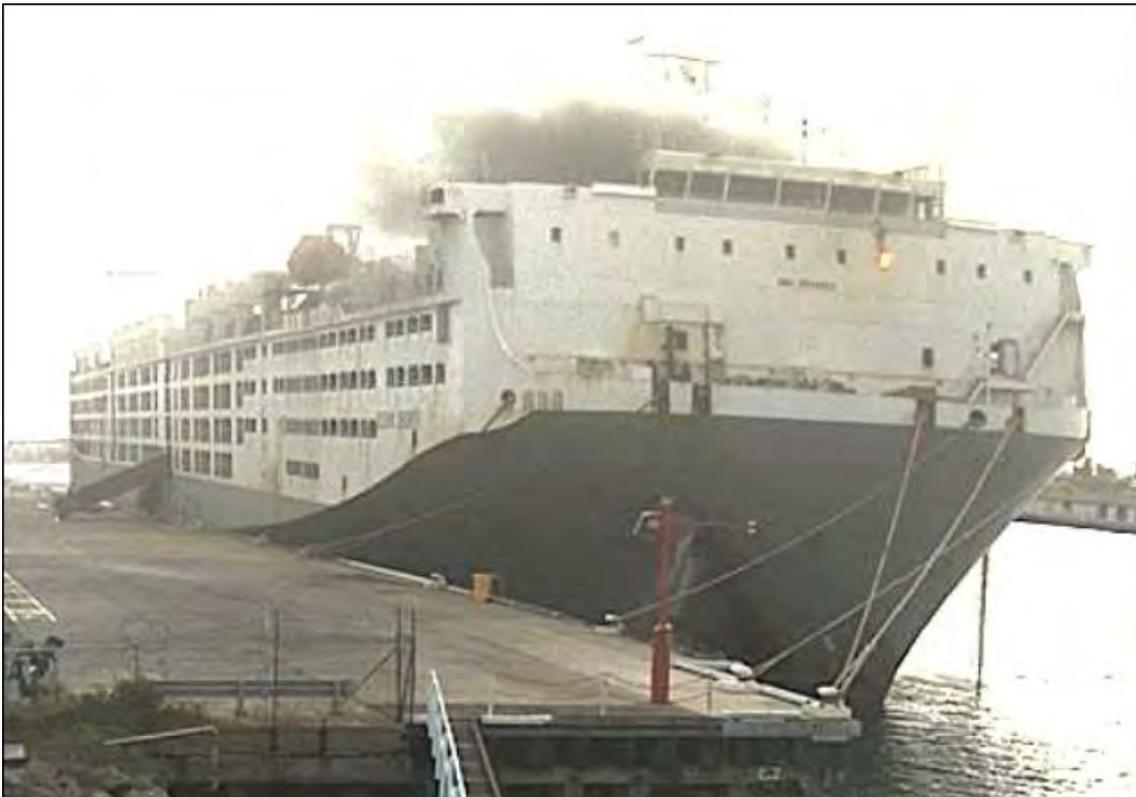
Figure 4: Wharf CCTV footage at about 0800 clearly shows flames in cabin 4

The fire was discovered after it was well alight and had been burning for some time. The cabin door then remained open as the crewmember hurried away to raise the alarm. The open door allowed the smoke and fire to spread to other areas of the accommodation, and to trigger the fire detection system.

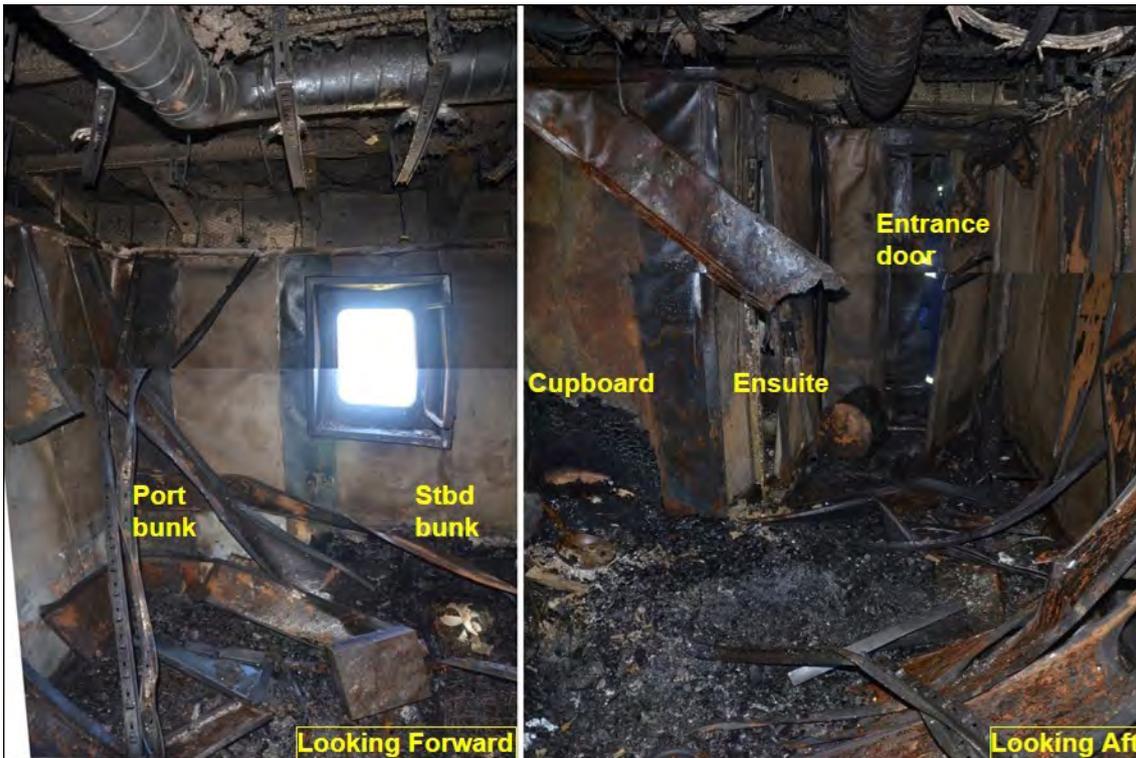
The fire burned for several hours at temperatures that exceeded 1,100 °C. As a result of the intensity of the fire and the severity of the damage, an exact point of origin or source of the fire could not be identified. However, the evidence, including witness statements, indicates that the fire originated in cabin 4 (Figure 5). The arson squad did not find any evidence of suspicious activity.

Figure 5: Interior of cabin 4 when first accessed after the fire

Further, parts of cabin 4's ceiling mounted ventilation system ducting melted allowing the fire into the space between the cabin ceiling and the deck above. The fire was then able to spread across the top and down into adjacent cabins and passageways. This pattern of top-down burn damage was found throughout both decks.

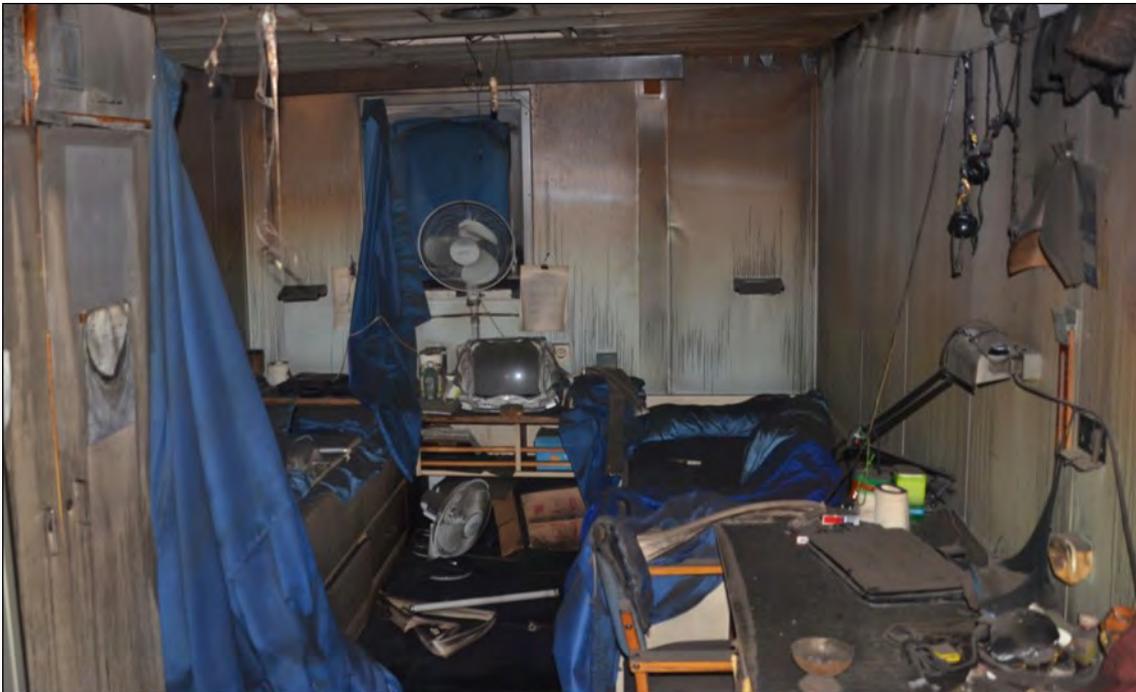
Self-extinguishing safety ashtrays were provided for use. However, evidence was found that unapproved items, such as plastic water bottles used as makeshift ashtrays, were also used in cabins. This indicates that the smoking policy and associated risk controls on board *Ocean Drover* were not effectively managed.

Furthermore, *Ocean Drover* had multi-berth cabins. Such cabins increased the density of the combustible materials within the accommodation space. Therefore, once the fire began, there was a significant amount of closely stowed, combustible material available to burn.

Figure 6: A two-berth cabin after the fire (note fuel load and possible ignition sources)

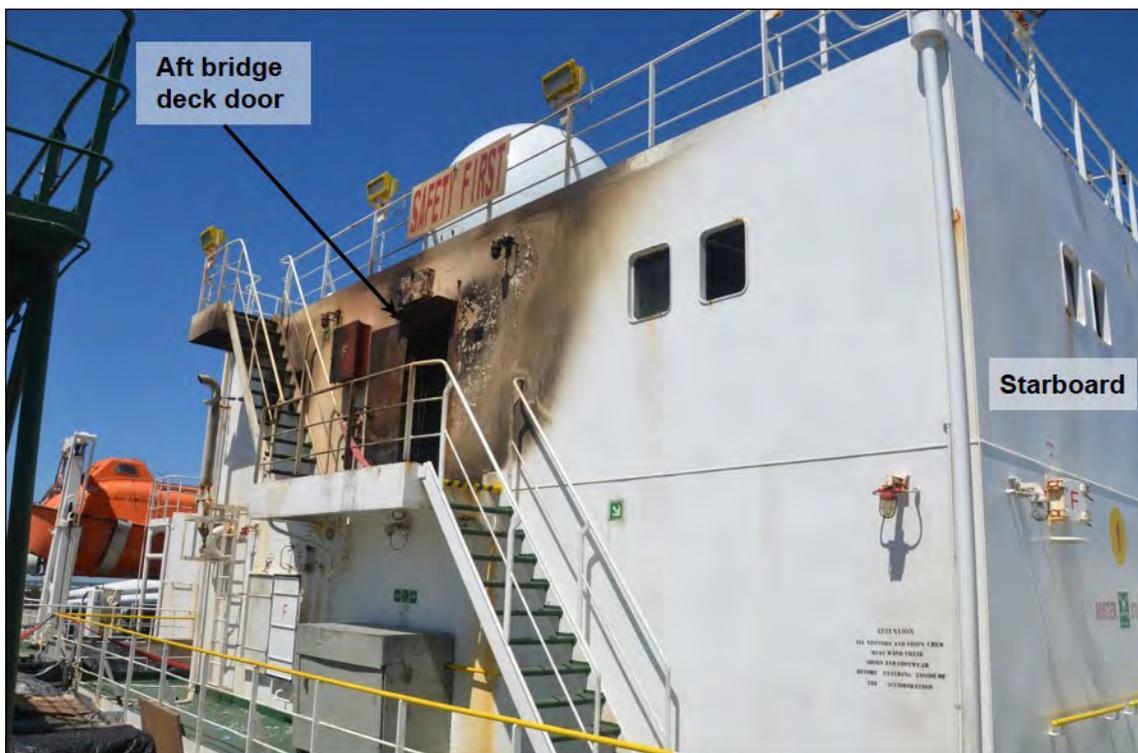
A fundamental firefighting technique is to ensure a fire is confined within its compartment of origin by closing all compartment openings such as doors and windows. On *Ocean Drover*, the fire would not have spread as easily as it did, and the damage would not have been as severe as it was, if the cabin door and the bridge deck fire doors had been closed.

Figure 7: Bridge deck aft (note the damage near the door, which was initially open)

During the post-fire repairs to the ship, the bridge deck stairwell fire door was replaced. In compliance with mandatory international regulations, this self-closing door is not fitted with a hold back arrangement. Notices posted on both sides of the door require it to be kept closed. The door is also fitted with a viewing window for additional safety.

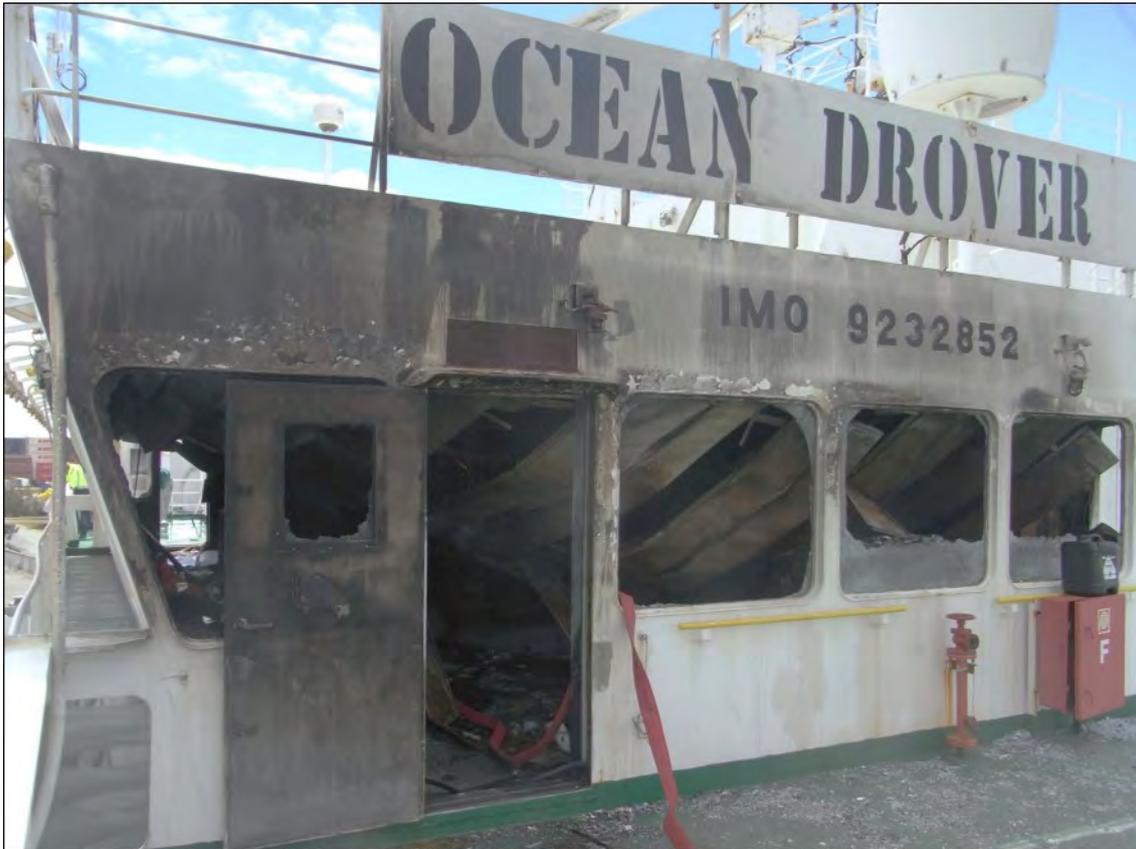
damaged by fire more than 3 hours after the fire was discovered. Shortly after, the wheelhouse caught fire and was severely damaged (Figure 8).

No evidence was found to suggest that the fire breached the wheelhouse deck or aft bulkhead. The DFES investigation found that the most severe damage was in the area adjoining the ship's office. Firefighters also observed that the wheelhouse was at the point of imminent flashover at about 1200. It is likely, therefore, that a combination of the intensity and duration of the fire exceeded the fire rating of the wheelhouse boundaries. This led to ignition of combustible materials and the destruction of the wheelhouse.

Figure 8: Burnt out wheelhouse viewed from the port bridge wing (chartroom is aft)
