TECHNICAL AND REGULATORY NEWS No. 08/2016 – Rules & standards

ENHANCING FIRE SAFETY AWARENESS

May 2016

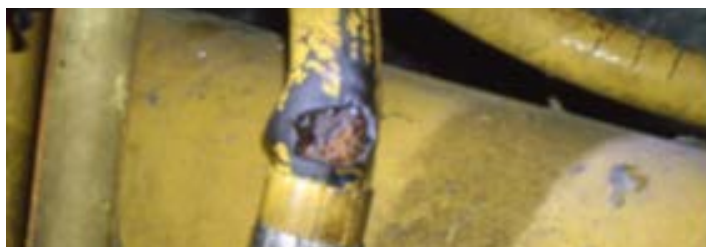
Figure 1: Failed flexible hose which caused an engine fire

Flexible hoses have a limited lifetime under normal conditions, but this lifetime is greatly reduced if the installation is arranged outside acceptable tolerances, for instance when the radius of a bend is less than the minimum required or when the tightening of the connection introduces a twist in the hose. See MSc.1/Circ.1321 for examples of good and bad flexible hose installations.

Since flexible hoses are typically installed in locations with relative movement, care should be taken to prevent scuffing of the hoses. The hoses should preferably not have any contact with other pipes, hoses or machinery parts in order to minimize the risk of scuffing damage.

Because of the limited lifetime of flexible hoses, it is recommended to screen the entire hose and not just the connections.

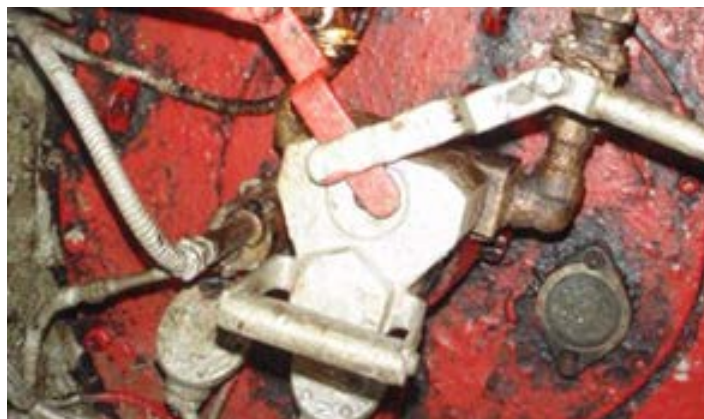
Figure 2: Missing screening of boiler fuel piping connections

MSc.1/Circ.1321 states that spray shields should be applied both for piping systems and for pressurized equipment and/or fittings on oil fuel systems, such as heat exchangers, tube plates and filter or strainer body joints. By extending this stipulation to include other flammable liquids, a higher fire safety level can be obtained. For example, lubrication oil filters located in the vicinity of the turbo charger should be shielded to prevent leakage from the filter reaching the turbo charger. Please note that fuel oil filters fitted on the engine may not be located near rotating parts or hot components.
