**Lessons from Marine
Accident Reports
2/2017**

SAFETY DIGEST
Lessons from Marine Accidents
No 2/2017

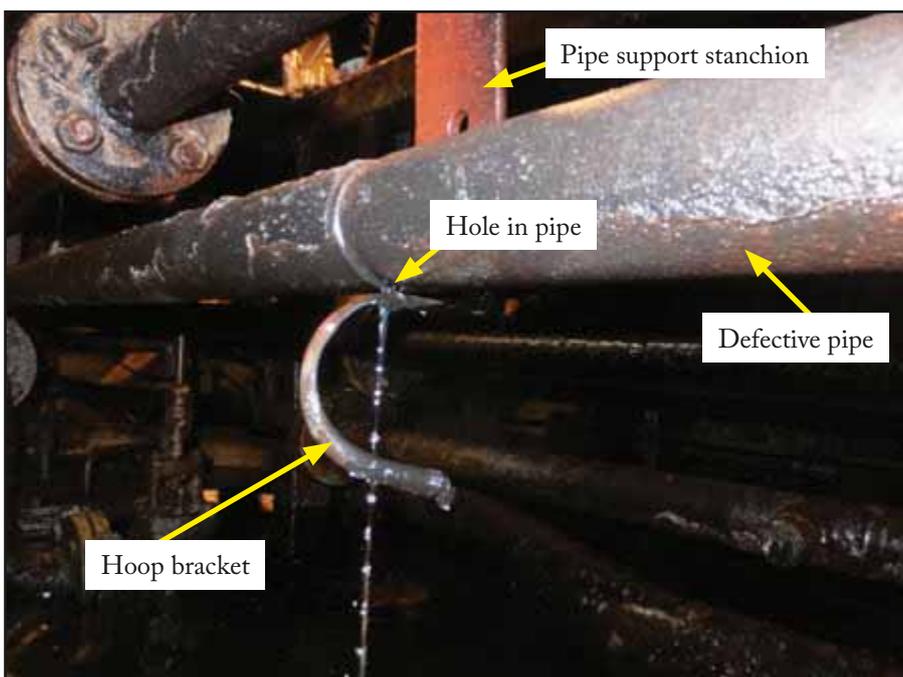
Having discovered a fuel leak on the low pressure fuel return from the main engine, the duty engineer decided that he could complete a temporary repair without needing to shut down the engine. He collected tools from the workshop and began the task. It became apparent that to access the leak he would need to remove a pipe support bracket. The pipe run was under the engine room floorplates, and on inspection the pipe, bracket and securing bolts were found to be in poor condition. In order to remove the bracket, he decided to crop the support using a portable angle grinder (Figure 1).

In order to progress the repair, the engineer climbed into the bilge to access the bracket. Fuel from the leaking pipe atomised on contact with the surrounding structure (Figure 2) and soaked the engineer's coverall with diesel. Sparks generated during the cutting process ignited the atomised diesel, setting light to the engineer's coverall and starting a fire in the engine room.

Figure 1: Leaking low pressure fuel pipe

4. Like on board many other vessels, the low pressure fuel pipework ran beneath the engine room floorplates and was therefore out of normal sight. The contents of IMO circular MSC.1/Circ.1321 - a paper aimed at reducing the risk of fires in pump rooms and engine rooms - recommends a 6-monthly inspection of all low pressure fuel system components to be included in a vessel's SMS.

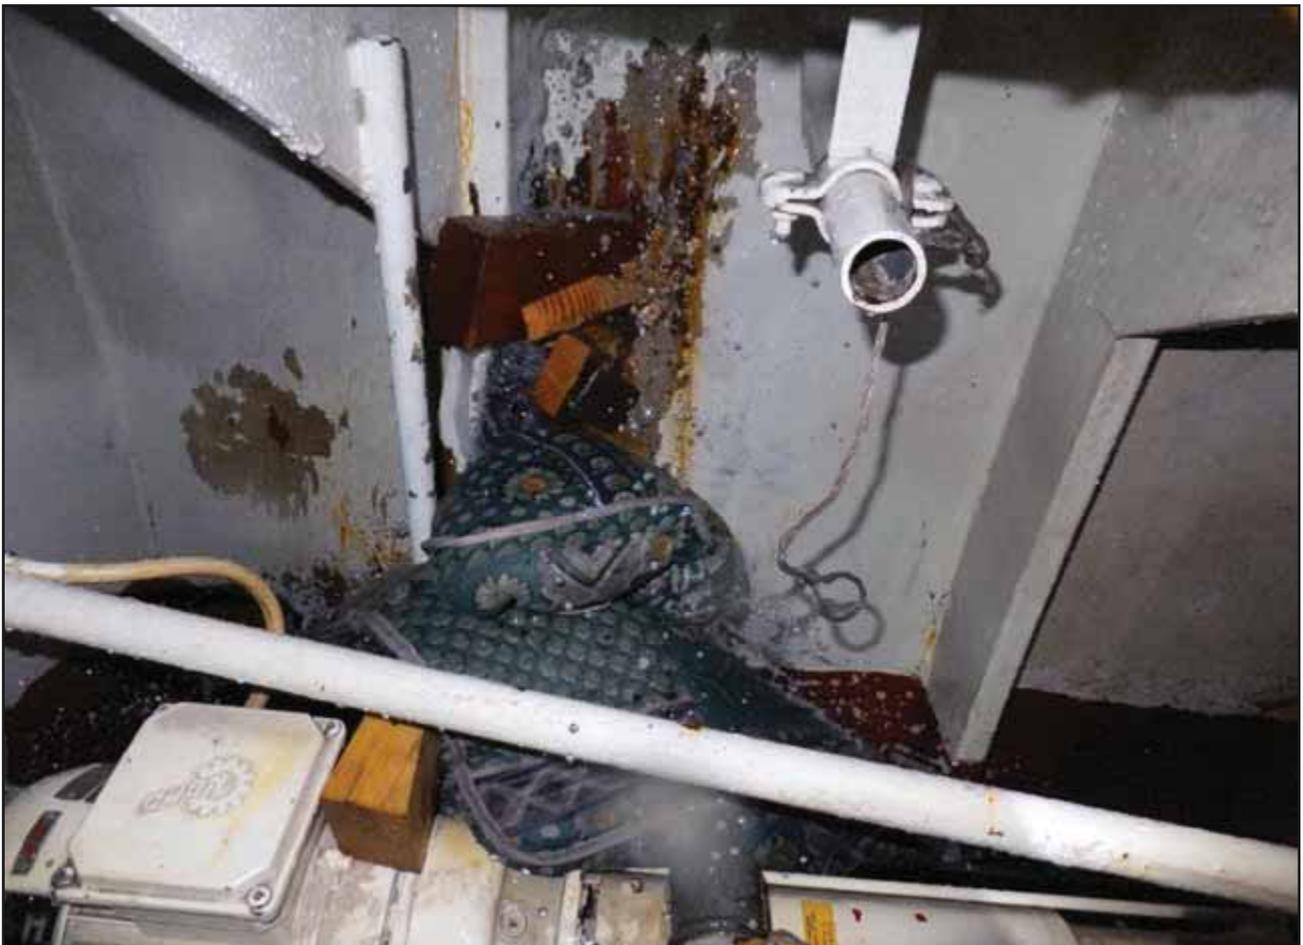
started to use the tug's searchlight to find the towed vessel, only to see it bearing down on the tug. He immediately took evasive action using the tug's engines and bow thruster, but was unable to avoid the towed vessel, which struck and holed the tug just aft of midships. The damage was below the waterline and in way of the engine room (Figure 2).

Figure 2: Damage to shell plating in engine room

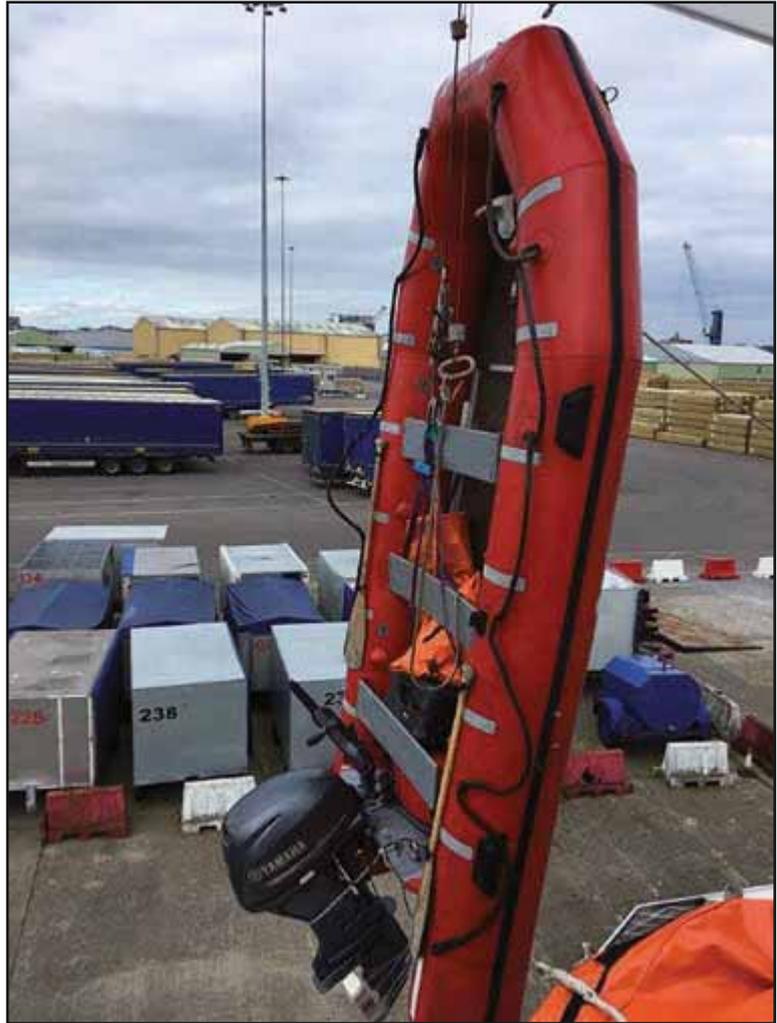
or not it was an issue that affected both boats, the crew repeated the procedure using the starboard boat. The result was the same. On further investigation it was found that this class of inflatable rescue boat was fitted with multiple lifting points, and discussions with the senior master of a similar ship revealed that the new lifting strops had been fitted incorrectly. Specifically, the rear pair of strops had been connected to the lifting points on the boats' decks rather than the boats' transoms.

Figure 1: Lifting straps incorrectly fitted unbalance the boat and cause it to flip up

1. Replacing or repairing equipment without reference to technical documentation is always fraught with risk. In this instance the crew attached the strops to what they genuinely thought were the correct lifting points, inadvertently creating a dangerous situation. The owner has now addressed this by reviewing the ship's documentation to ensure that details, such as how to attach the rescue boat strops, are properly recorded. The lifting points within the boat have also been clearly marked.

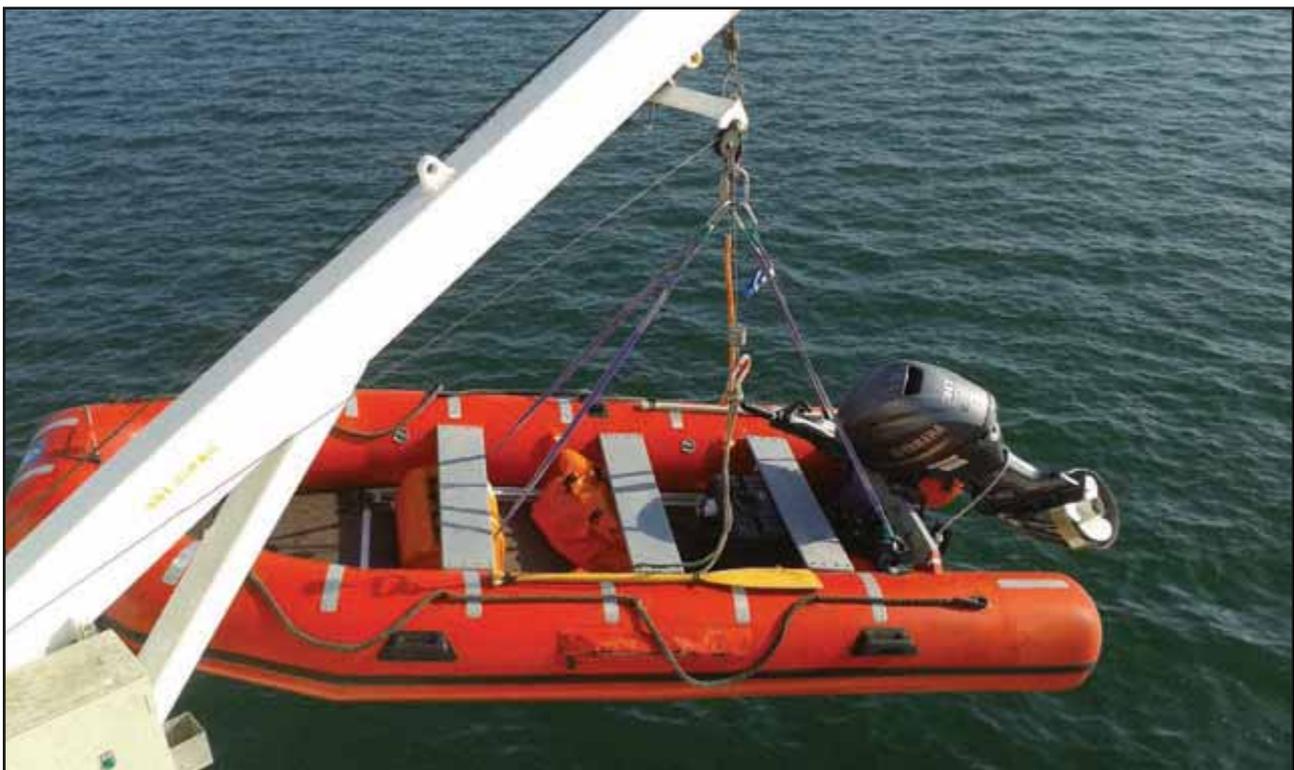
Figure 2: Lifting straps correctly fitted to inflatable rescue boat

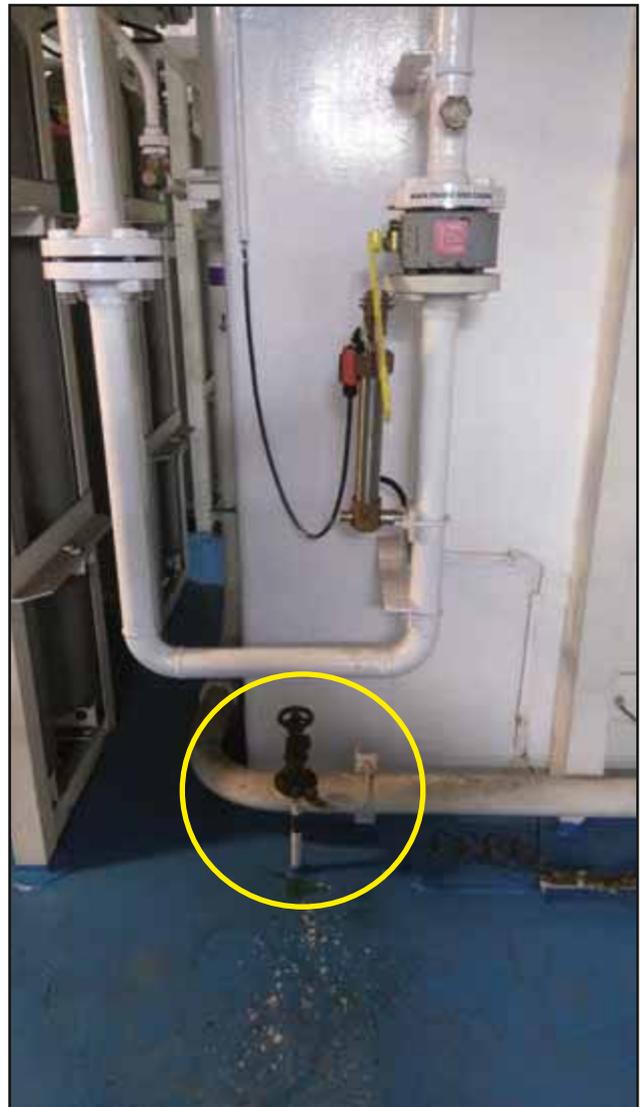
Figure 1: Compressed air hose connection

Following the incident, security of the access to the CO₂ space (Figure 2) was improved. The compressed air hose connection inside the space was also blanked off to control its use.

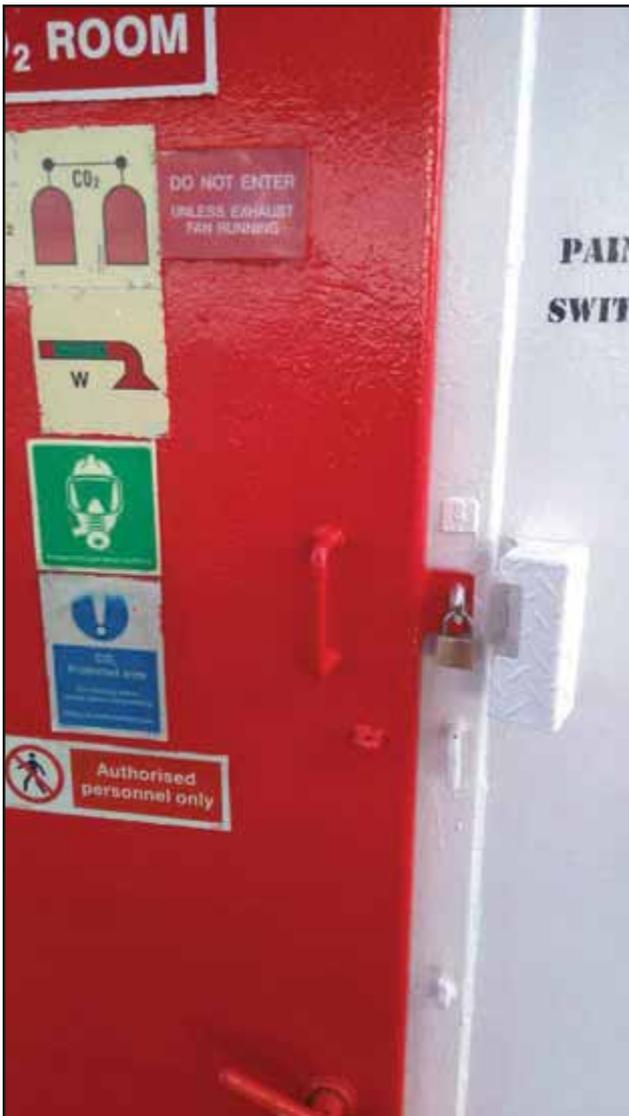
Figure 2: Access to CO₂ space

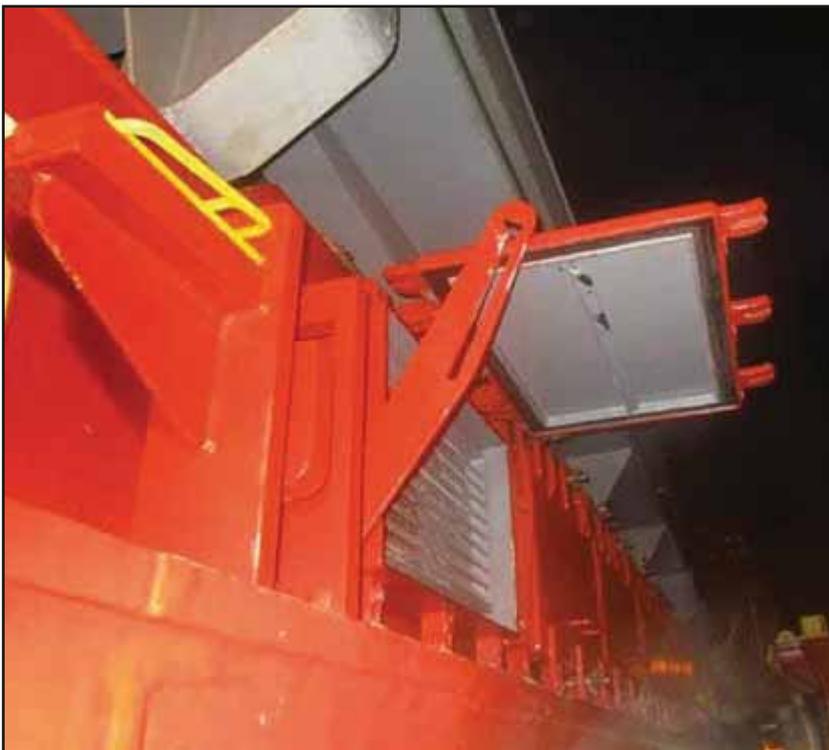
Figure 1: Cargo bay ventilation cover

The cargo bay vents were located on the sides of the hatch cover, 2.5m above the main deck (Figure 1). To close them, the officer climbed onto the hatch cover. He then went to the edge of the hatch, bent down and released the ventilation cover. As he did so, he lost his balance and almost fell off the side of the hatch cover. A stevedore, who witnessed the event, asked the officer if he was okay. In reply, the officer gave the stevedore a 'thumbs up' signal.

2. In this case, the task could have been carried out from the main deck below the vents; the vessel carried step ladders specifically for the task. It is always better to avoid hazards rather than trying to control them, and working close to the edges of unprotected hatch covers should be avoided whenever possible.

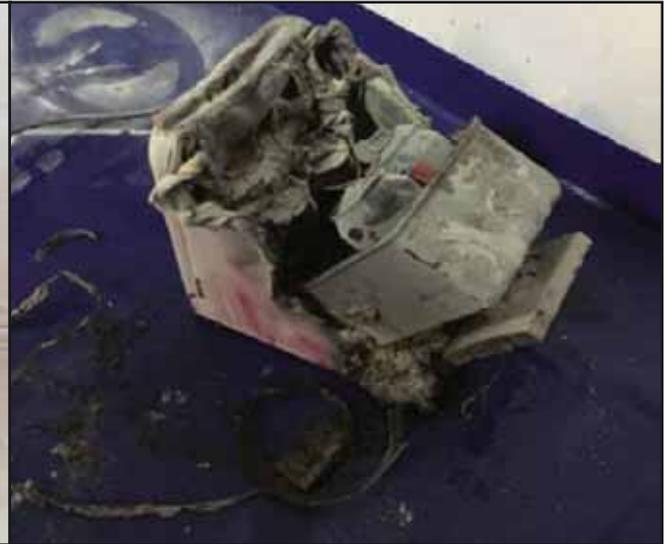
Once the area was declared safe, the ship's fire investigation discovered that the seat of the fire was located where a mini fridge (Figure 1) had been placed. The carpet, cabin furniture and surrounding bulkheads were damaged, with smoke deposits and scorch marks clearly indicating that the fridge was the source of the fire. The fridge's plastic casing had melted and its power cable had suffered severe damage (Figure 2). The metal centre core of the fridge and the cans of juice inside were almost undamaged.

The fridge had been in the cabin for about 4 years, and always located in the same position - on top of the carpet, against the wardrobe. The investigation concluded that, due to its location, the fridge didn't have proper ventilation around it, and therefore this could have caused it to overheat. The investigation further found that the cabin inspection routine had neither identified this hazard nor picked up that personal electrical equipment was not being inspected.

Figure 2: Remains of the fridge after the fire

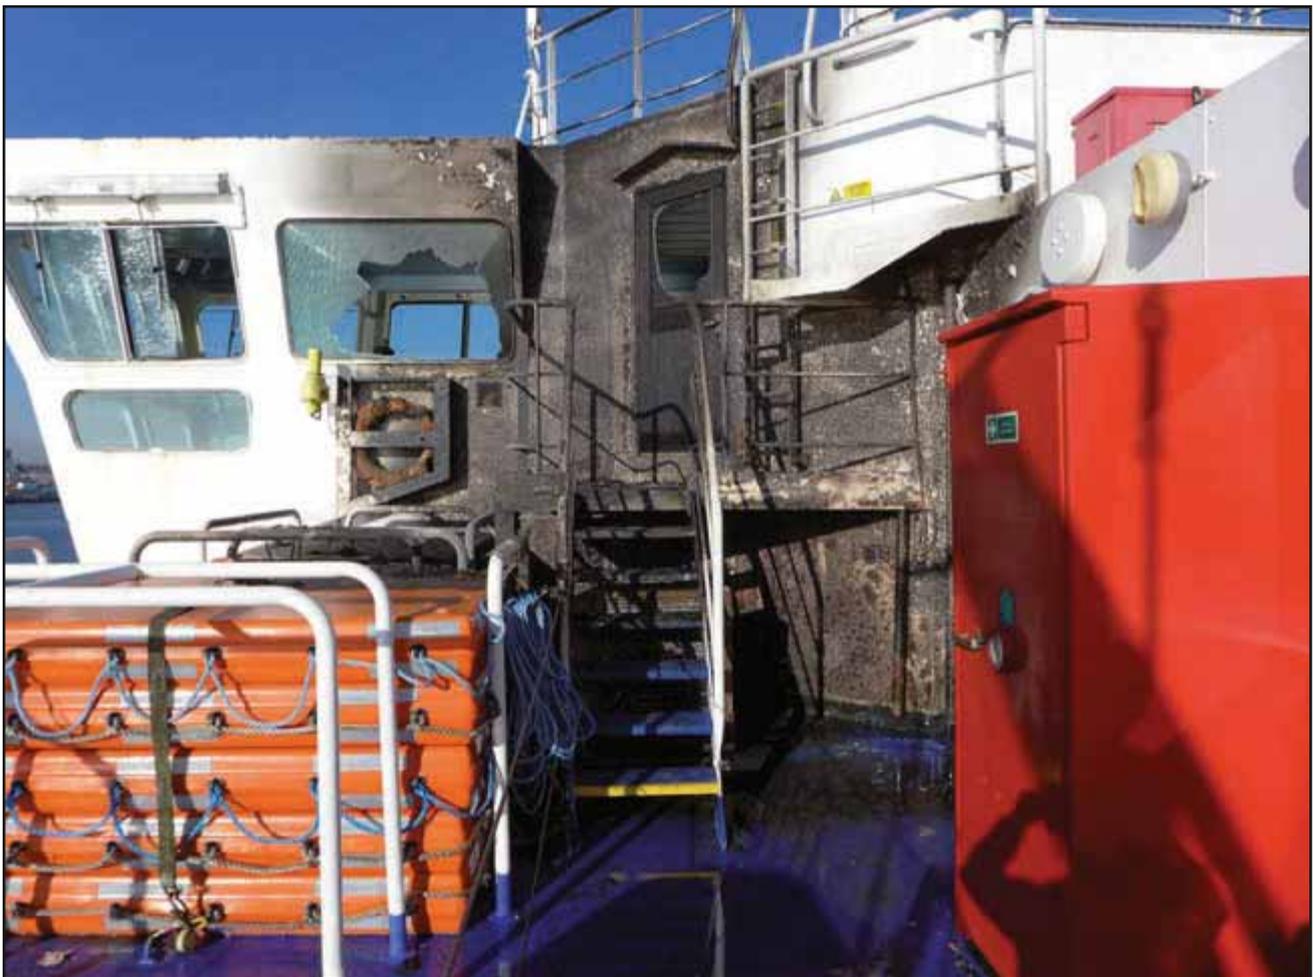
The damage caused by the fire was significant and included shattered bridge windows, scorched paintwork, and damaged wiring and equipment (Figure 1). Thankfully, due to the crew's prompt action the fire was quickly contained and the ferry was out of service for only a few days while repairs were carried out.

The investigation discovered that the fire had started when a cigarette bin caught fire. Further investigation found that the bin caught fire because its metal liner was missing, which caused the plastic exterior to melt. This melting plastic then fell into an open container of highly flammable paint thinners that had been left underneath the bin, causing the

Figure 1: Damage caused by the fire

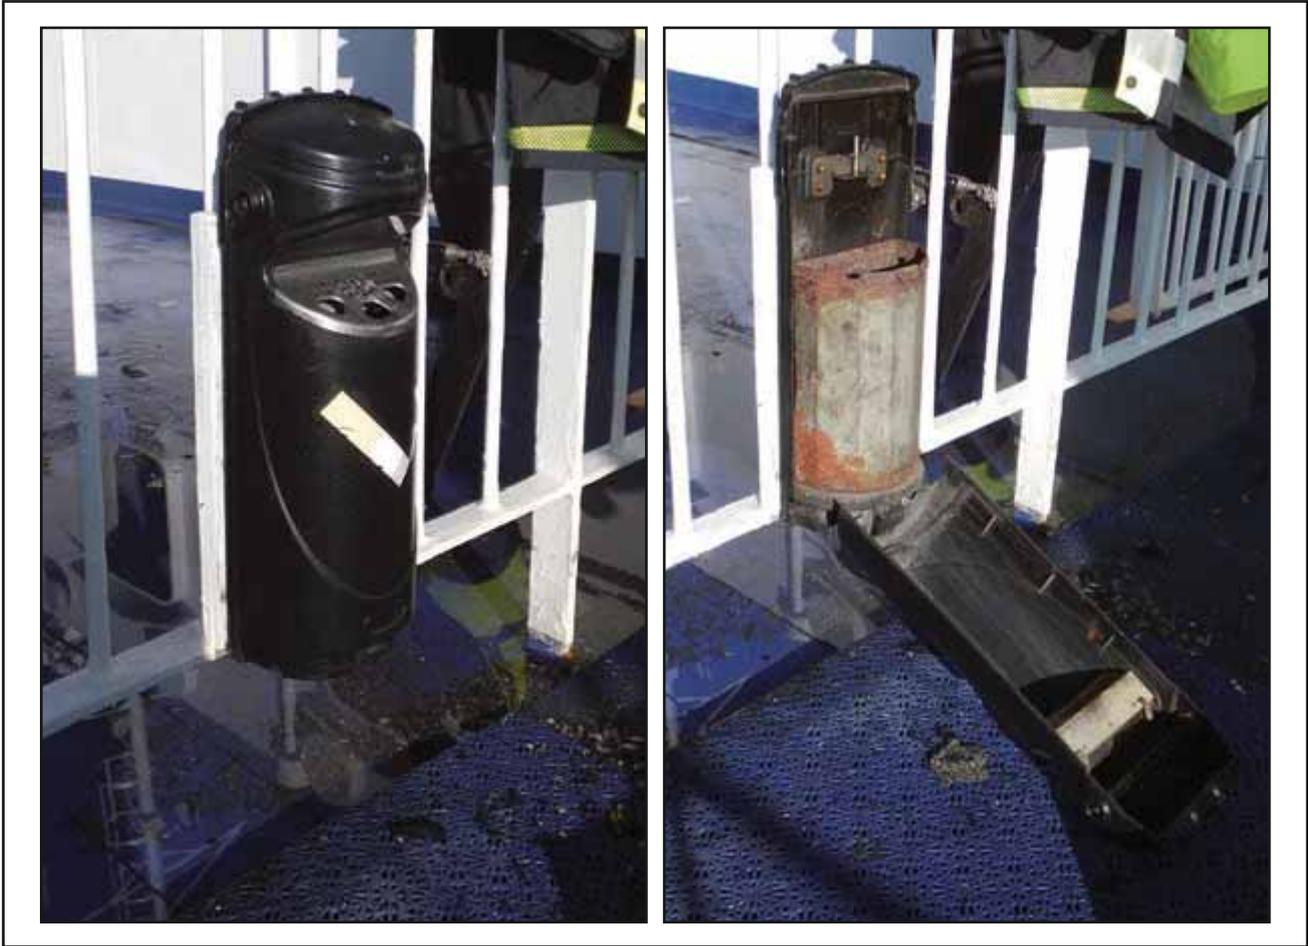
fire to really take hold (Figure 2). After the incident the ship operator introduced a more frequent routine to empty and inspect these bins, discovering in the process that other bins were missing metal liners.

Figure 2: Cigarette bin and open bin with liner, which was missing from the bin that caught fire

1. Cigarette bins require regular housekeeping to prevent them becoming a fire hazard. Owners and operators should require that regular safety rounds of smoking areas are conducted, and that cigarette bins are emptied and inspected. They must also encourage a culture where all incidents are reported so that action can be taken to prevent more serious accidents from taking place.

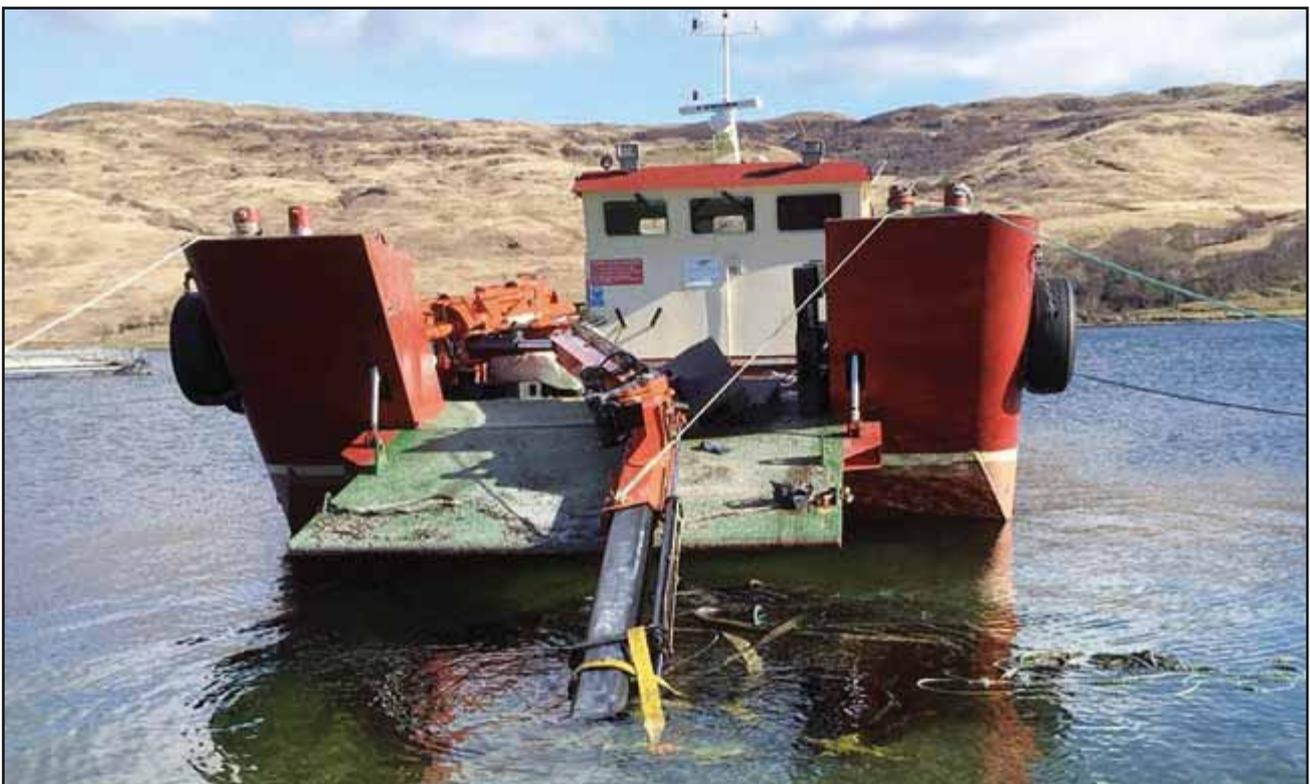
- No installation guidance was provided with the crane.
- The crane was installed with smaller and fewer tie bolts than intended by its manufacturer.
- The lock nuts were of a lower grade material strength than indicated by their markings.
- The statutory thorough examination and test of the crane following its installation did not identify the inadequacy of the mounting arrangement.

Figure 1: Collapsed crane

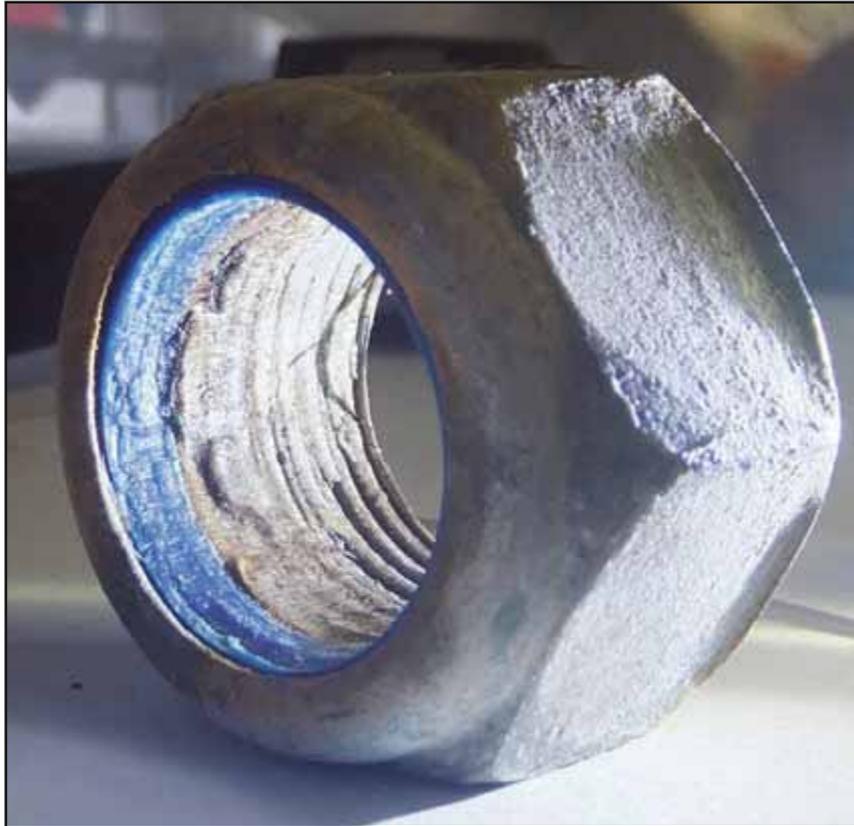
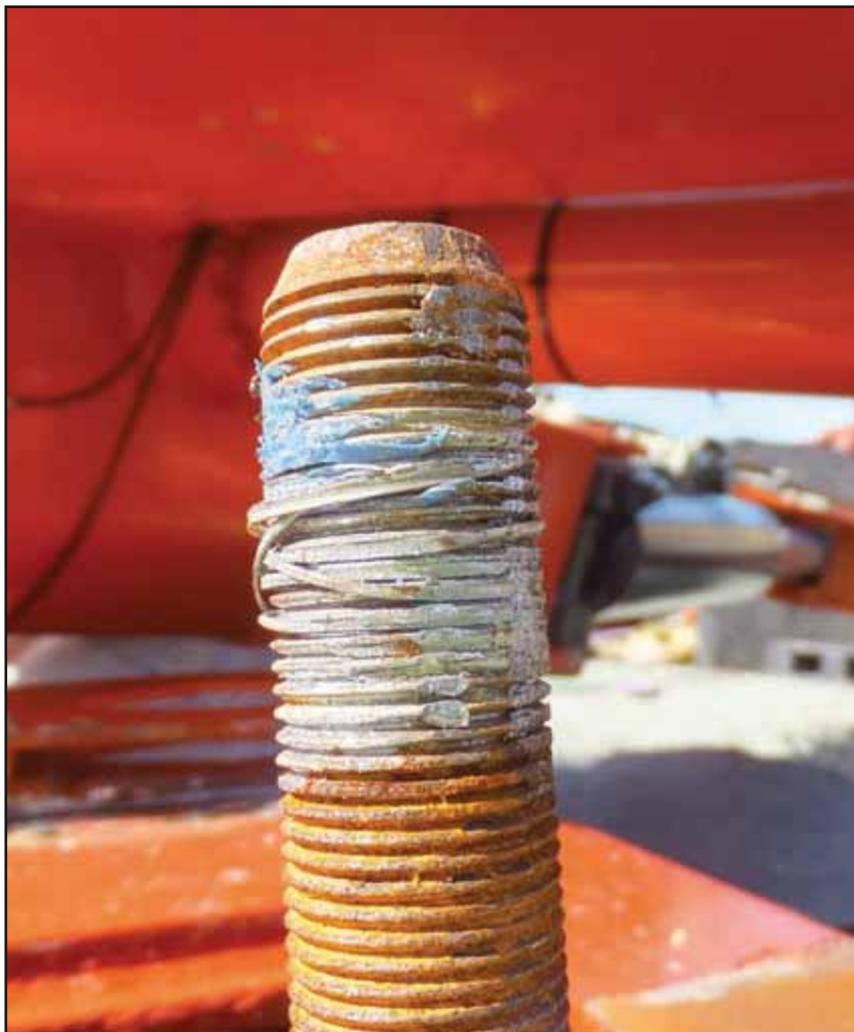
Figures 2 and 3: Failed nut and tie bolt

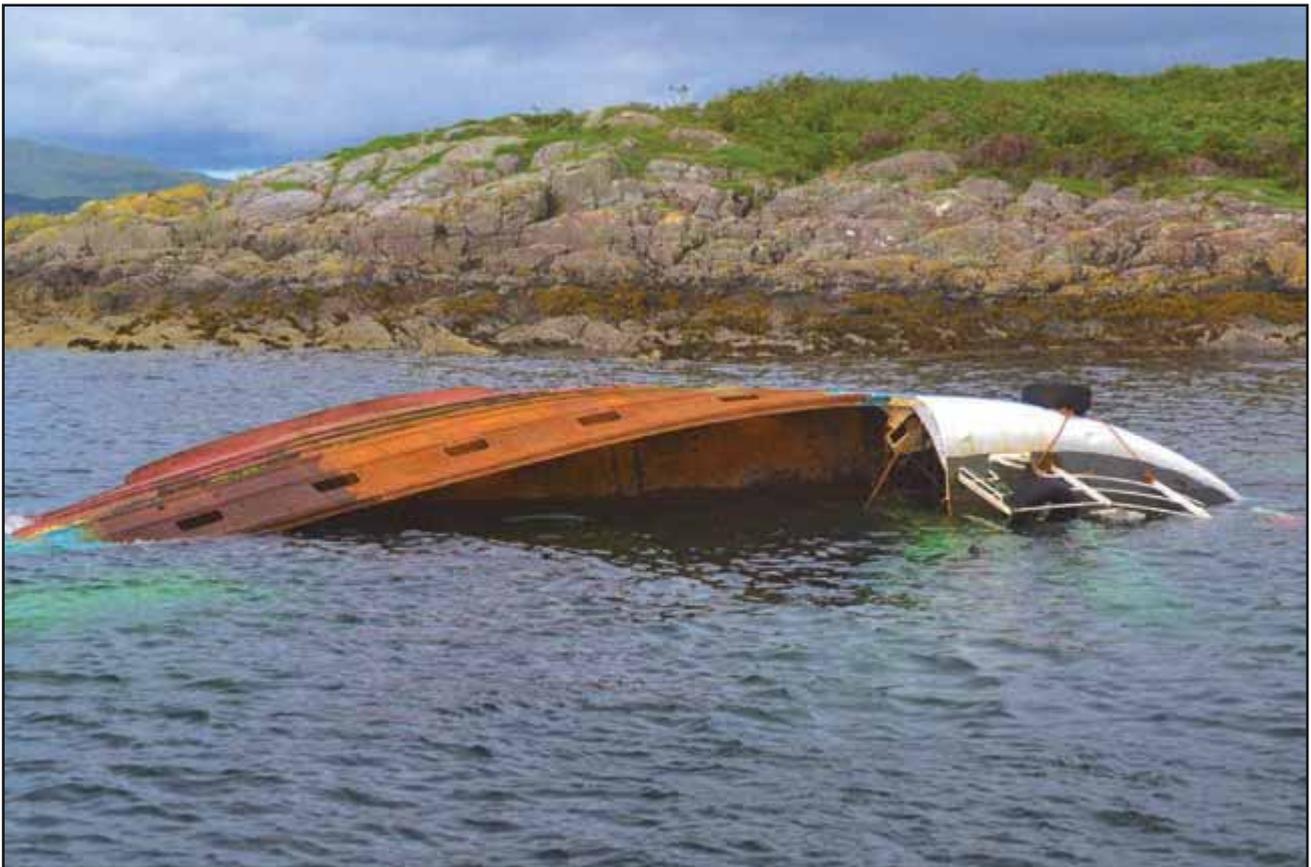
A short time later, the scalloper began to flood and it eventually settled on its starboard side in shallow water (Figure 2). The vessel was later salvaged, but the cost of repair meant that it did not return to service. The cause of the scalloper's sudden deviation from the planned heading is not known.

Figure 2: The partially submerged vessel

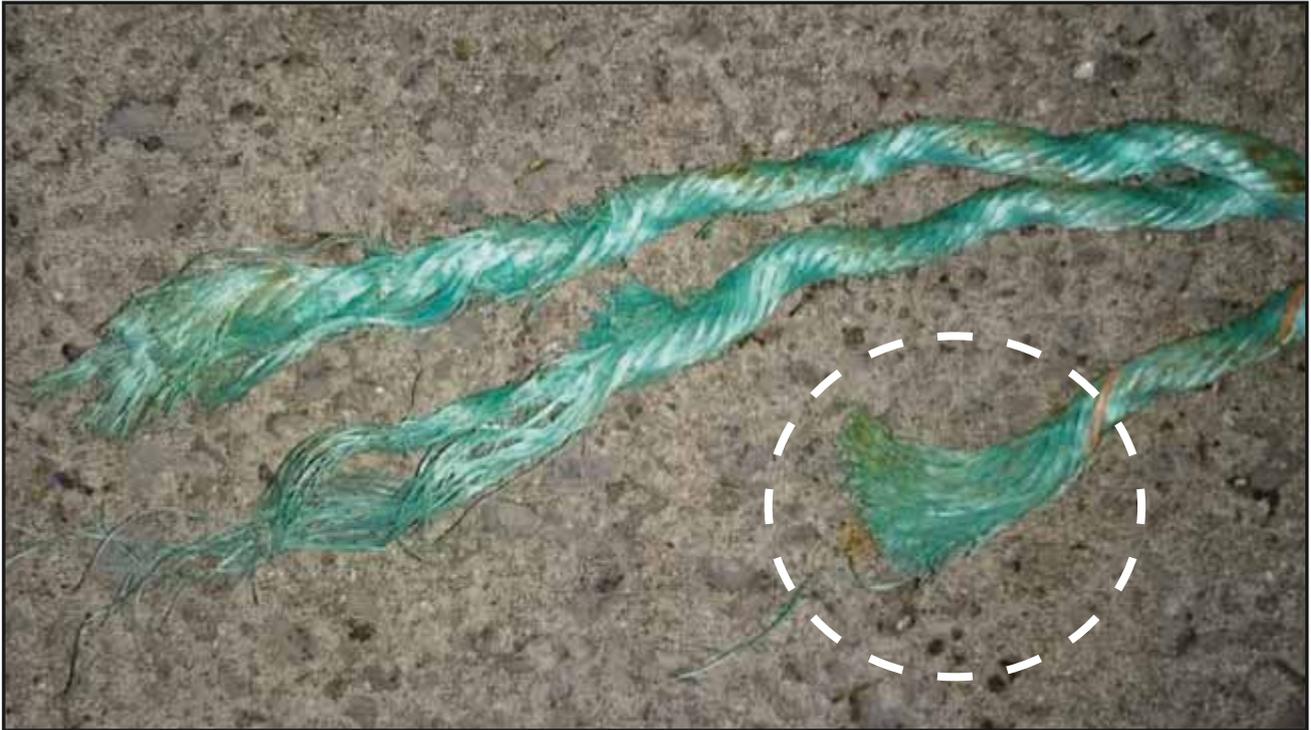
The boat's pots were hauled by other local fishing boats in the days after the accident. One string of pots recovered from the fishing grounds indicated that an attempt might have been made to cut the back rope on one of the strings of pots (Figure 2).

Figure 2: Broken back rope, indication that at least one strand had been cut

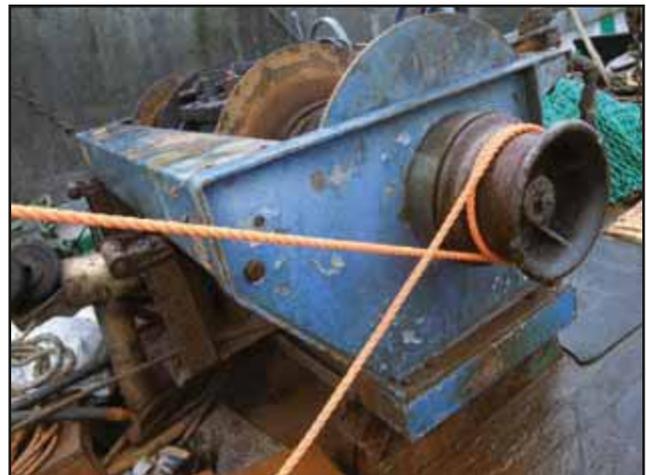
The skipper had his back to the winch, but saw the dredge bar being lifted towards the derrick head, and looked around. At the same time, the other crew member heard a shout and ran to the winch to stop it. Unfortunately, the injuries sustained by the young deckhand led to him losing his hand.

Starboard whipping drum with 1.5 turns of rope
