Report on the investigation of the

grounding of

Muros

Haisborough Sand

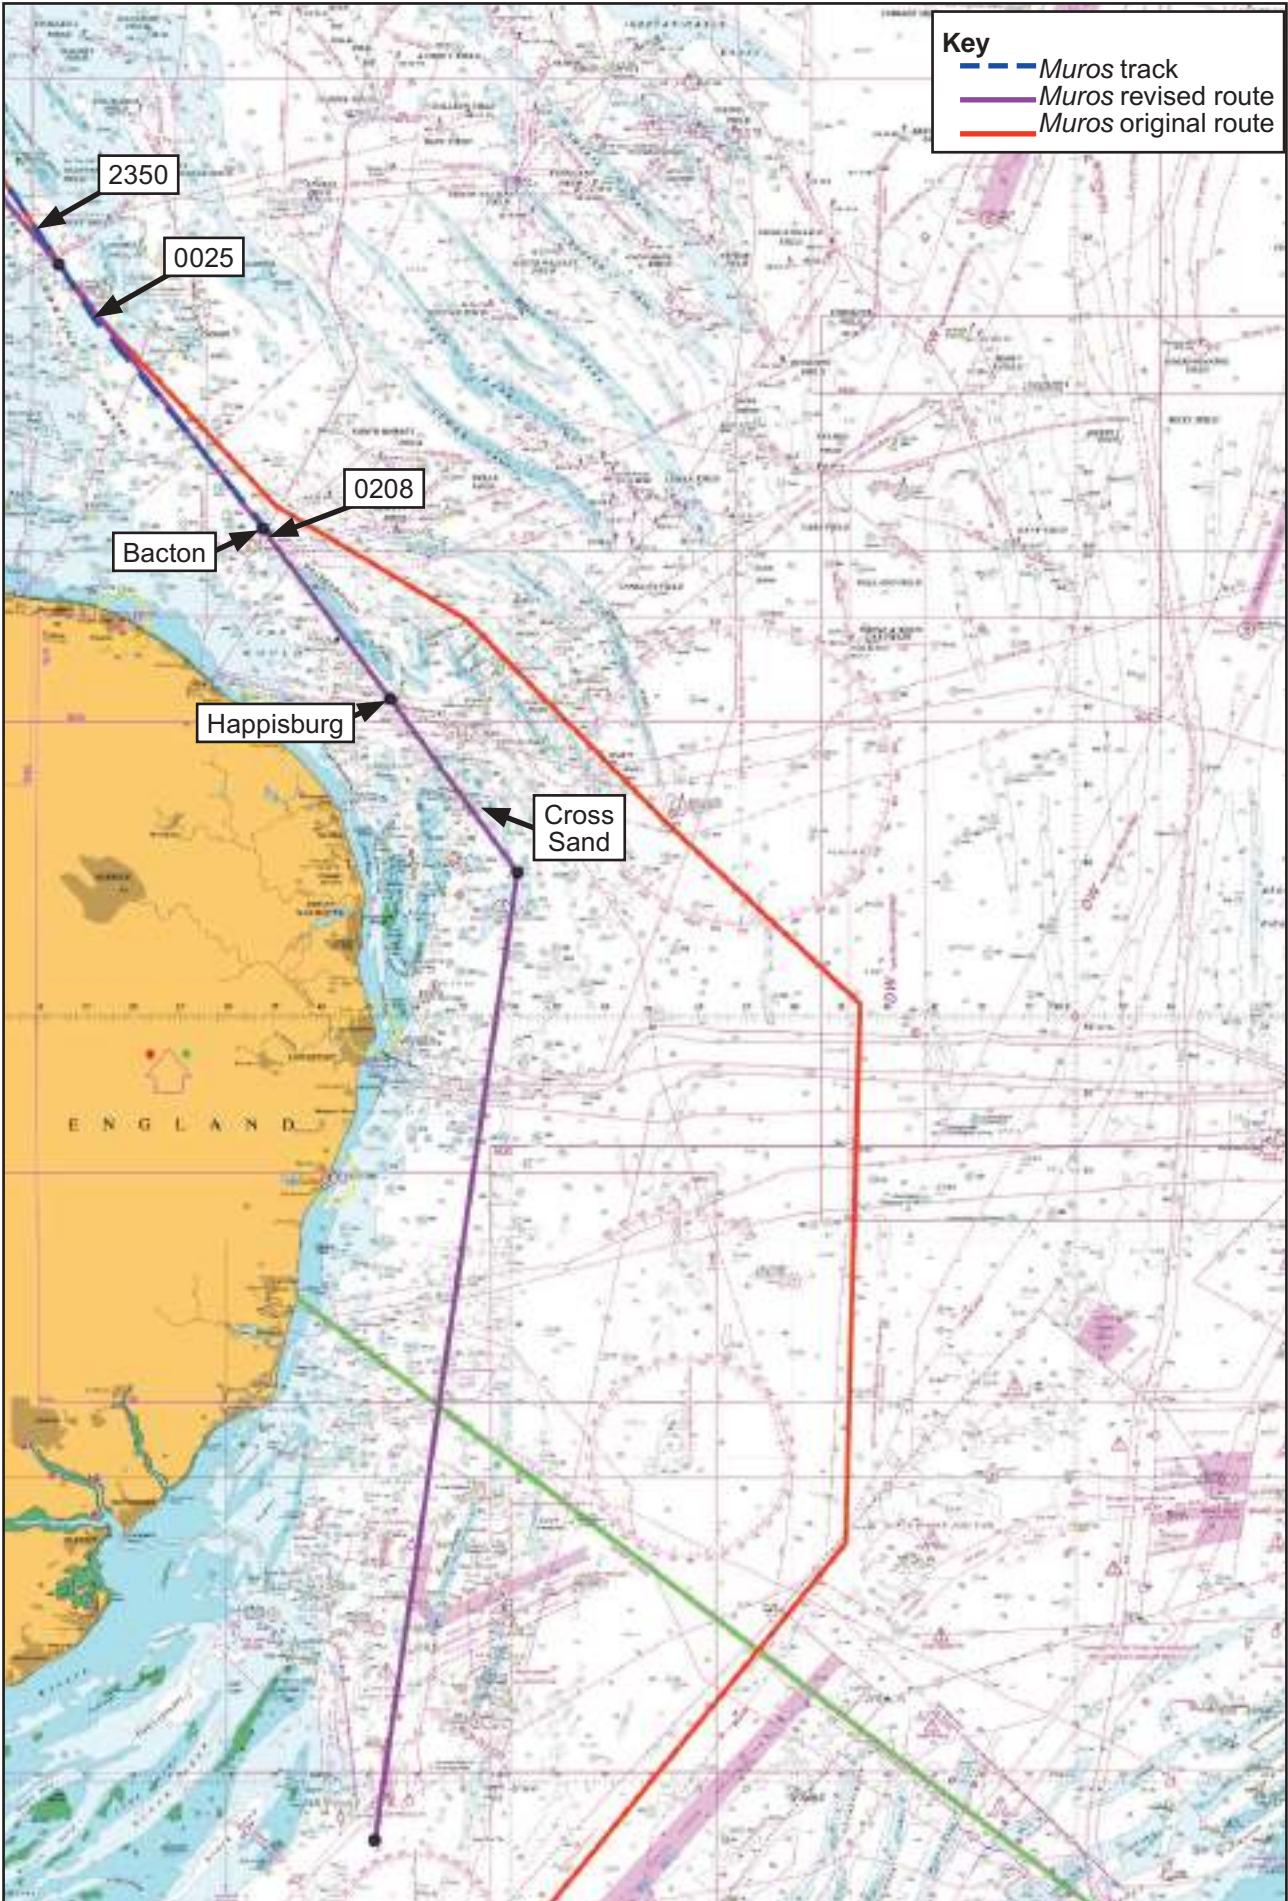
Figure 1: Extract of original and revised passage plans (note: all times UTC+1)

The 2/O used the ECDIS mouse and cursor to 'drag and drop'⁸ several waypoints included in the original voyage plan (including waypoints 'Bacton' and 'Happisburg') further to the west (Figures 1 and 4). She then scanned over the amended route starting at the Sunk TSS and working towards the north.

While scanning the route, the 2/O noticed that the revised track appeared to pass close to Cross Sand, the shallows to the south of Haisborough Sand. The 2/O zoomed onto a larger chart scale that provided better clarity and saw that the course line was more than one mile from the shoal water indicated by the safety contour.

The 2/O zoomed back out to a smaller chart scale and thought that the intended course line also passed close to the shallows of Haisborough Sand. However, the proximity of the course line was similar to the course line she had recently checked further to the south, and she did not zoom onto a larger scale to obtain a more accurate assessment. The 2/O assumed that the course line would be clear of the safety contour by a similar margin to that near Cross Sand.

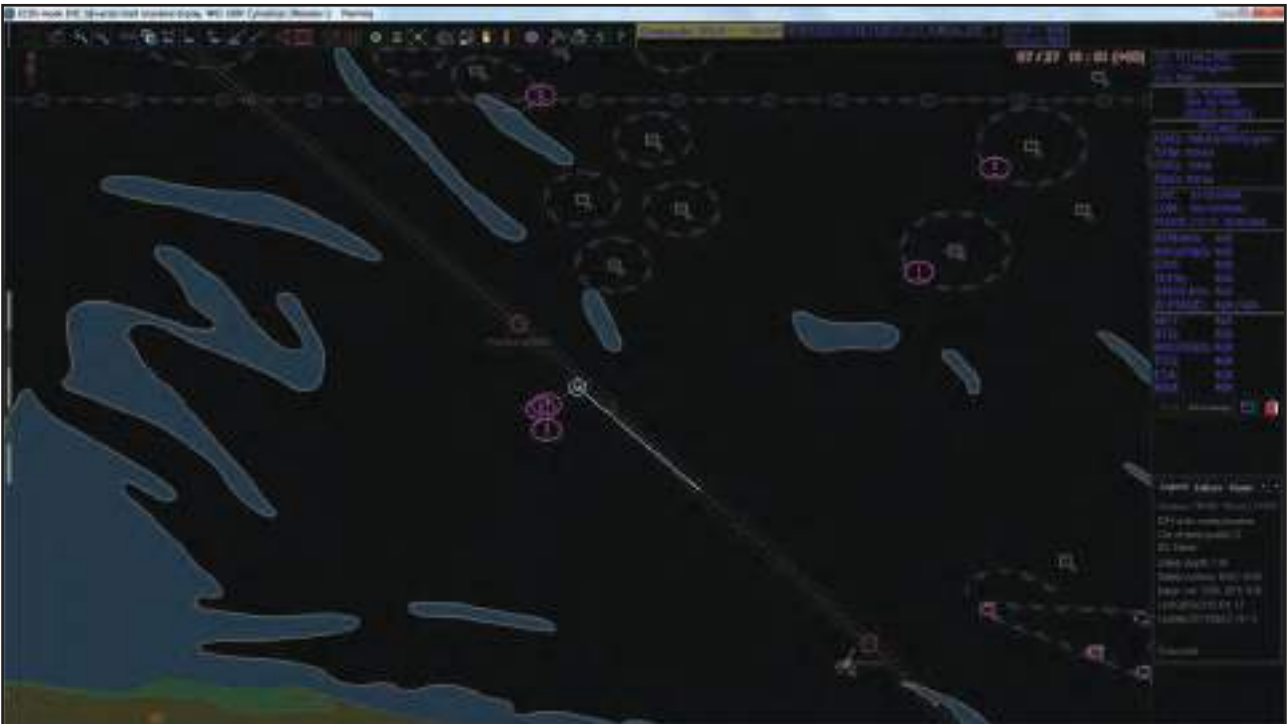
Figure 3: Reconstruction of ECDIS display at 0025

The 2/O amended the passage plan on the ECDIS at the starboard bridge conning position (**Figure 2**) and at 0025 she adjusted the vessel's heading set on the autopilot to 140° to follow the revised track (**Figure 3**). The 2/O then sat in the starboard chair. The lookout alternated between standing on the bridge's port side and sitting in the port chair. He routinely reset the BNWAS.

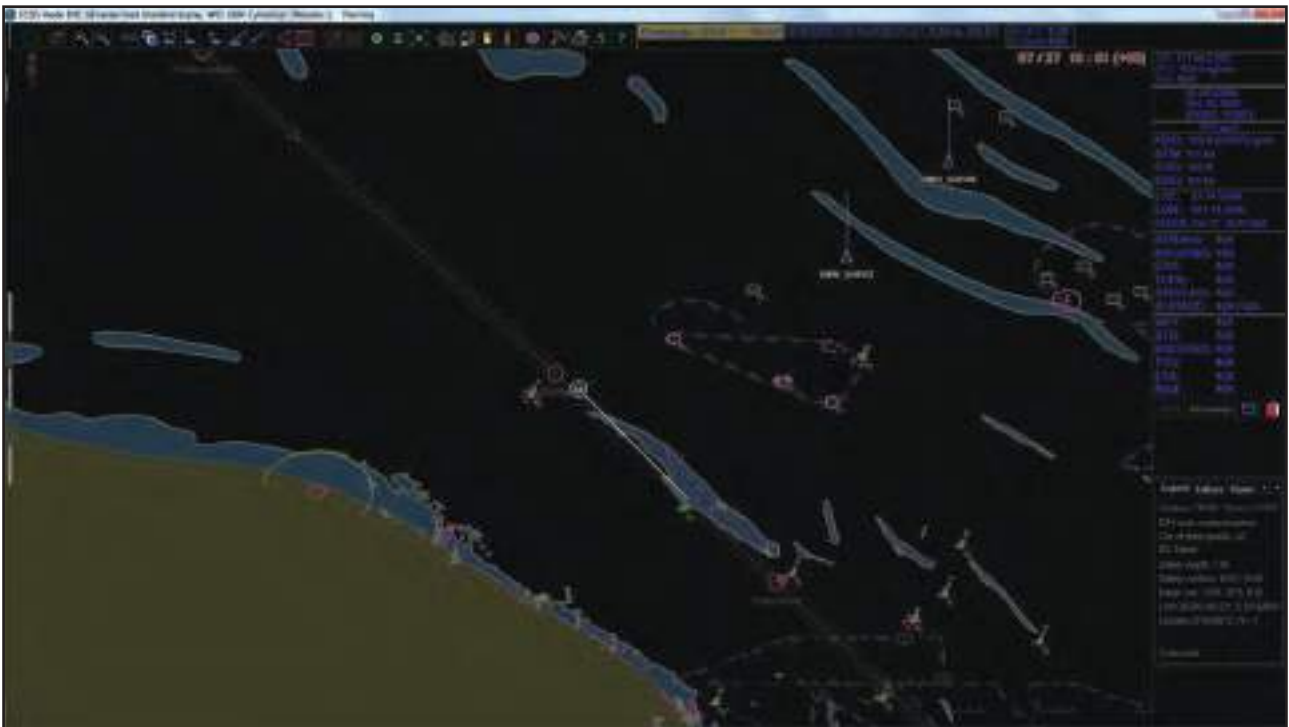
Figure 4: Reconstruction of ECDIS display at 0208

Over the next 1½ hours, the bridge watch remained very quiet with only a few other vessels in the vicinity. At 0208, *Muros* was 600m to the north-east of the revised track and was making good a speed of 10.1kts when the 2/O adjusted *Muros*'s heading to 146° towards waypoint 'Happisburg' to the south of Haisborough Sand (**Figure 4**).

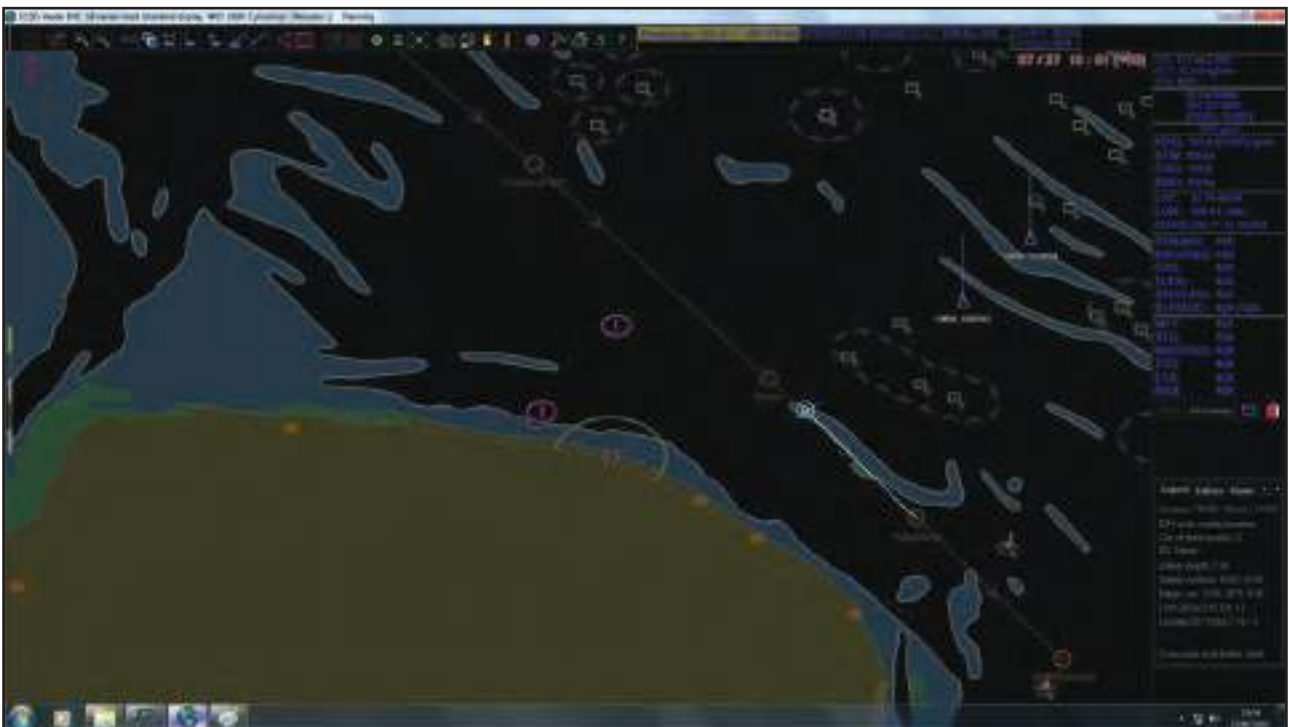
Figure 5: Reconstruction of ECDIS display at 0220

At 0220 (**Figure 5**), the 2/O noticed that *Muros*'s speed shown on the ECDIS display had reduced to 9.1kts. She thought this was unusual as there had been no change in the wind or sea conditions. At 0248 (**Figure 6**), the 2/O felt a change in the vessel's motion and saw its speed quickly reduce. In response, she selected manual steering. The 2/O also called the master and informed him that the vessel's speed was only 0.8kt, but that she did not know why. The master told the 2/O to inform the chief engineer.

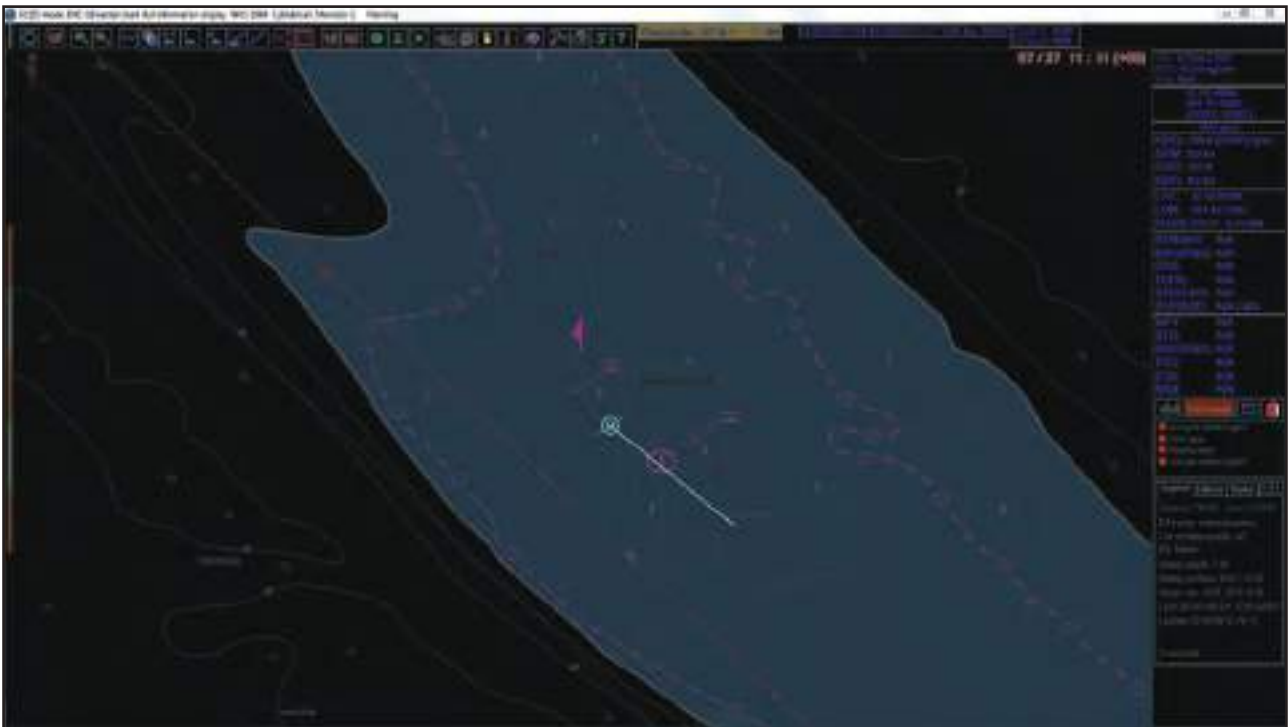
Figure 7: Reconstruction of ECDIS display at 0250 (zoomed in and 'all')

Within 1 minute of being called by the 2/O, *Muros's* master and chief engineer arrived on the bridge. Meanwhile, the 2/O had zoomed in the ECDIS display and changed the chart view from 'standard' to 'all'³, which showed more detailed depth information (**Figure 7**). The master realised that the vessel was aground and put the engine telegraph control to stop.

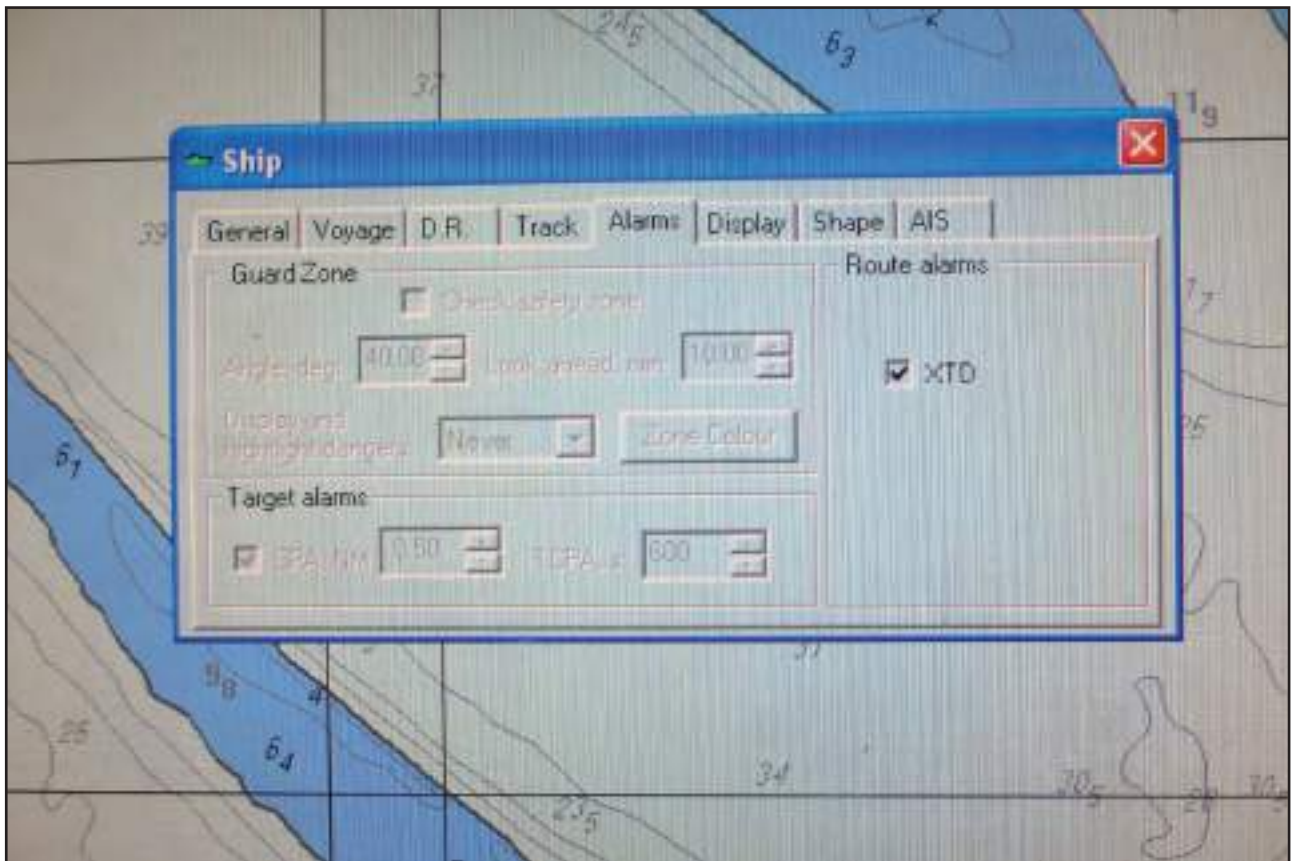
Figure 8: Maris ECDIS900 showing the 'guard zone' settings

- The depth settings were:
 - Deep contour¹⁰: 10m
 - Safety contour: 8.5m
 - Shallow contour: 10m
 - Safety depth¹¹: 7m.
- The guard zone was set to 40° and 10 minutes. However, the ‘Check safety zone’ check box was not ticked and the ‘Highlight and display dangers’ box was set to ‘never’ (**Figure 8**). Therefore, the guard zone was not active.

- The settings in the ‘guard zone’ and the ‘target alarms’ areas of the ‘ship alarms’ page and the contours and depth settings were ‘locked’. The adjustment of these settings was password protected and *Muros*’s deck officers reportedly were unaware of the password. The crew considered the resulting absence of alarms to be beneficial.

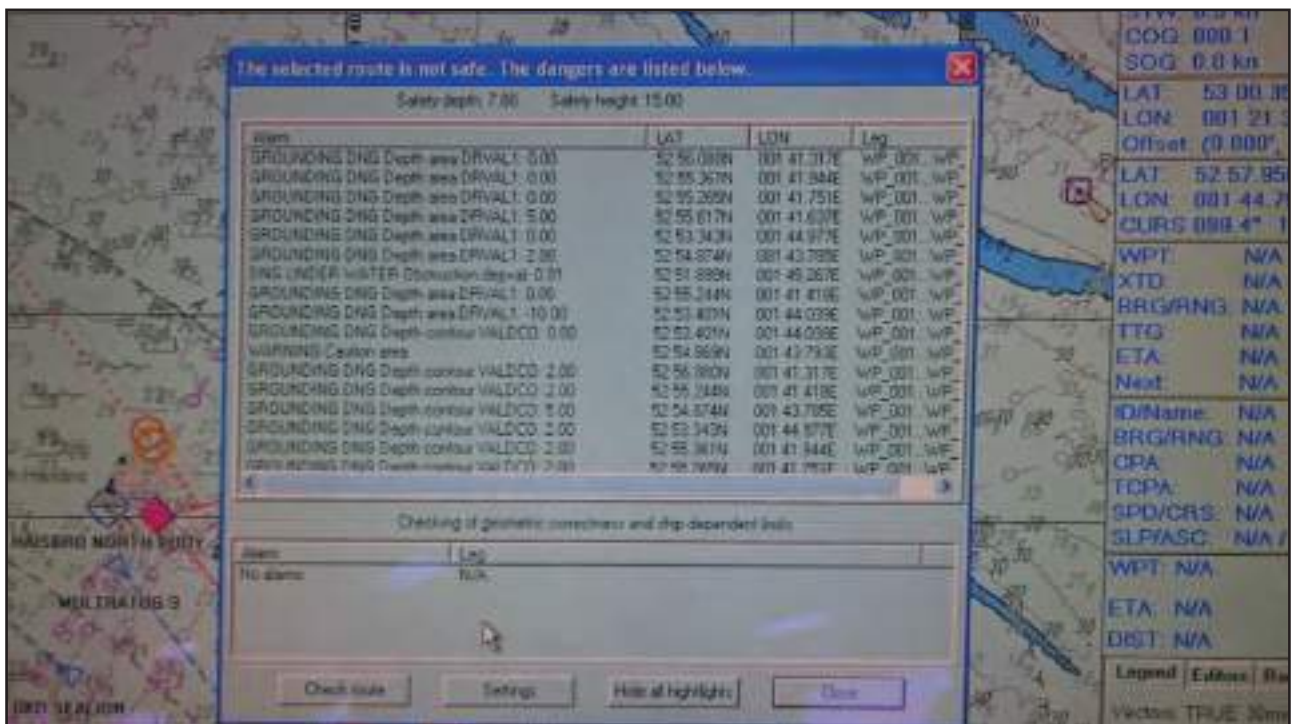
Figure 9: Maris ECDIS900 showing alarms generated on the 'check route' page

- The cross-track distance (XTD)¹² was set to 0.5 mile and route alarms were selected.
- With the Teesport - Rochefort route selected, over 3000 warnings were indicated on the ‘check route’ page, including the risk of grounding on Haisborough Sand (**Figure 9**).

- The 2/O was able to navigate the Maris ECDIS900 menus and sub-menus to good effect. She was familiar with the system’s functions but did not routinely use the ‘check route’ function due to the apparent irrelevance and triviality of many of the dangers highlighted. She was aware that the ‘check route’ function could be applied to individual legs of a voyage plan.
