Fatal accident during cargo discharge of the bulk carrier *Graig Rotterdam* Alexandria Port, Egypt 18 December 2016

SUMMARY

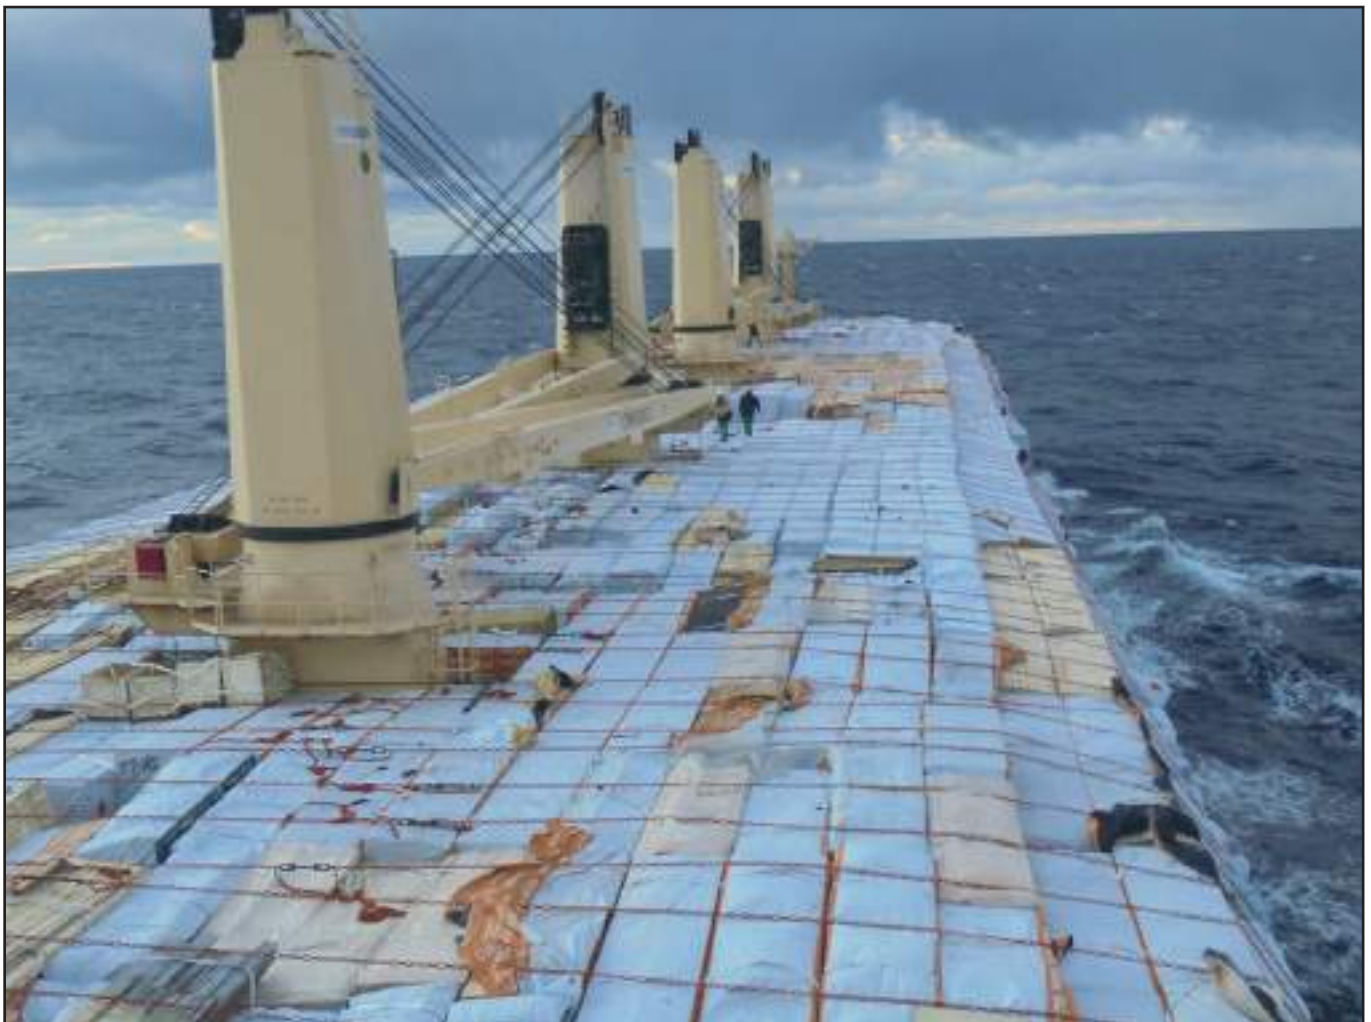
The deck cargo was stacked four packages high on top of the hatch covers and six high on deck. Following the supercargo's instruction, the ship's crew secured the deck cargo by means of top-over lashings³ using chains and turnbuckles supplied by the charterer (**Figure 2**).

Figure 2: *Graig Rotterdam* at sea with timber deck cargo secured by top-over lashings

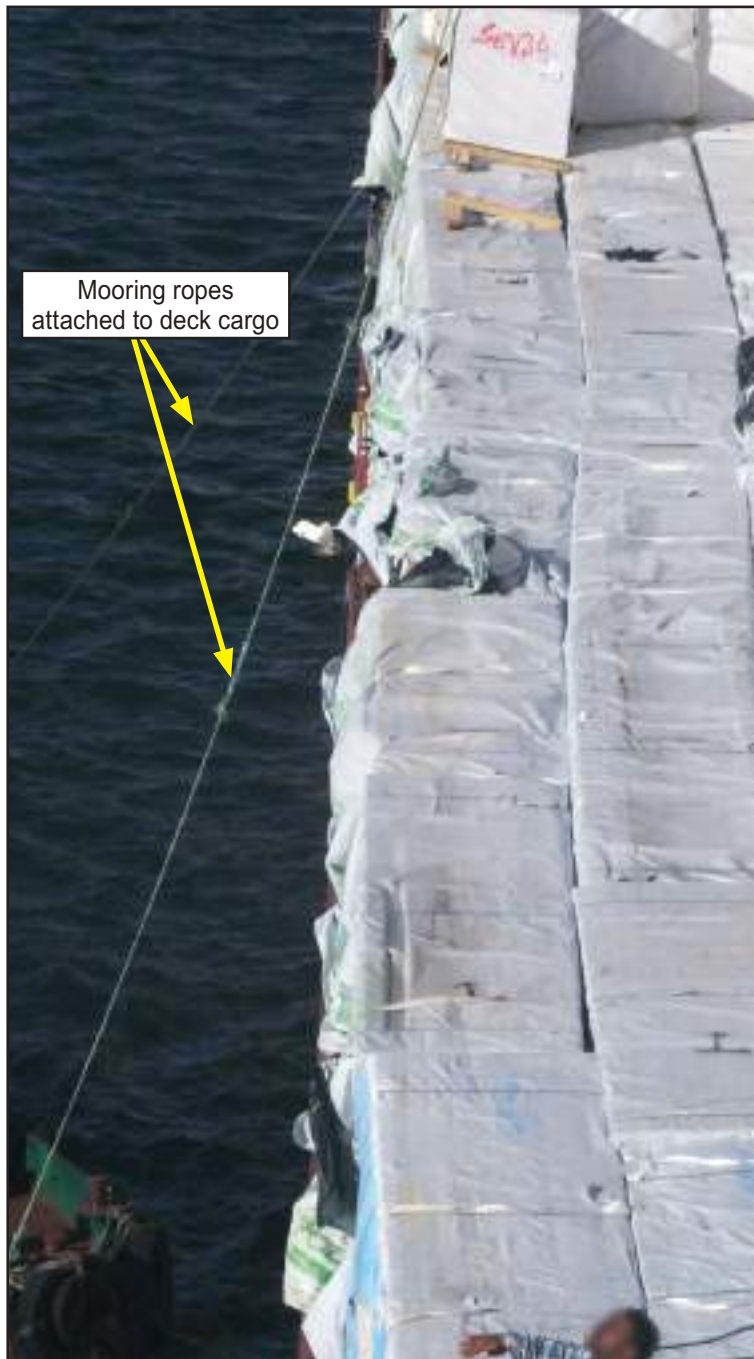
Two barges were located on *Graig Rotterdam's* starboard side, and one barge was positioned on its port side forward. The barges were secured with mooring ropes attached to the deck cargo packages (**Figure 3**). Deck cargo was being discharged from the stacks on top of numbers 2 and 3 hatch covers into the two barges located on the ship's starboard side using two of the ship's cranes.

Figure 3: Cargo barges secured to deck cargo packages

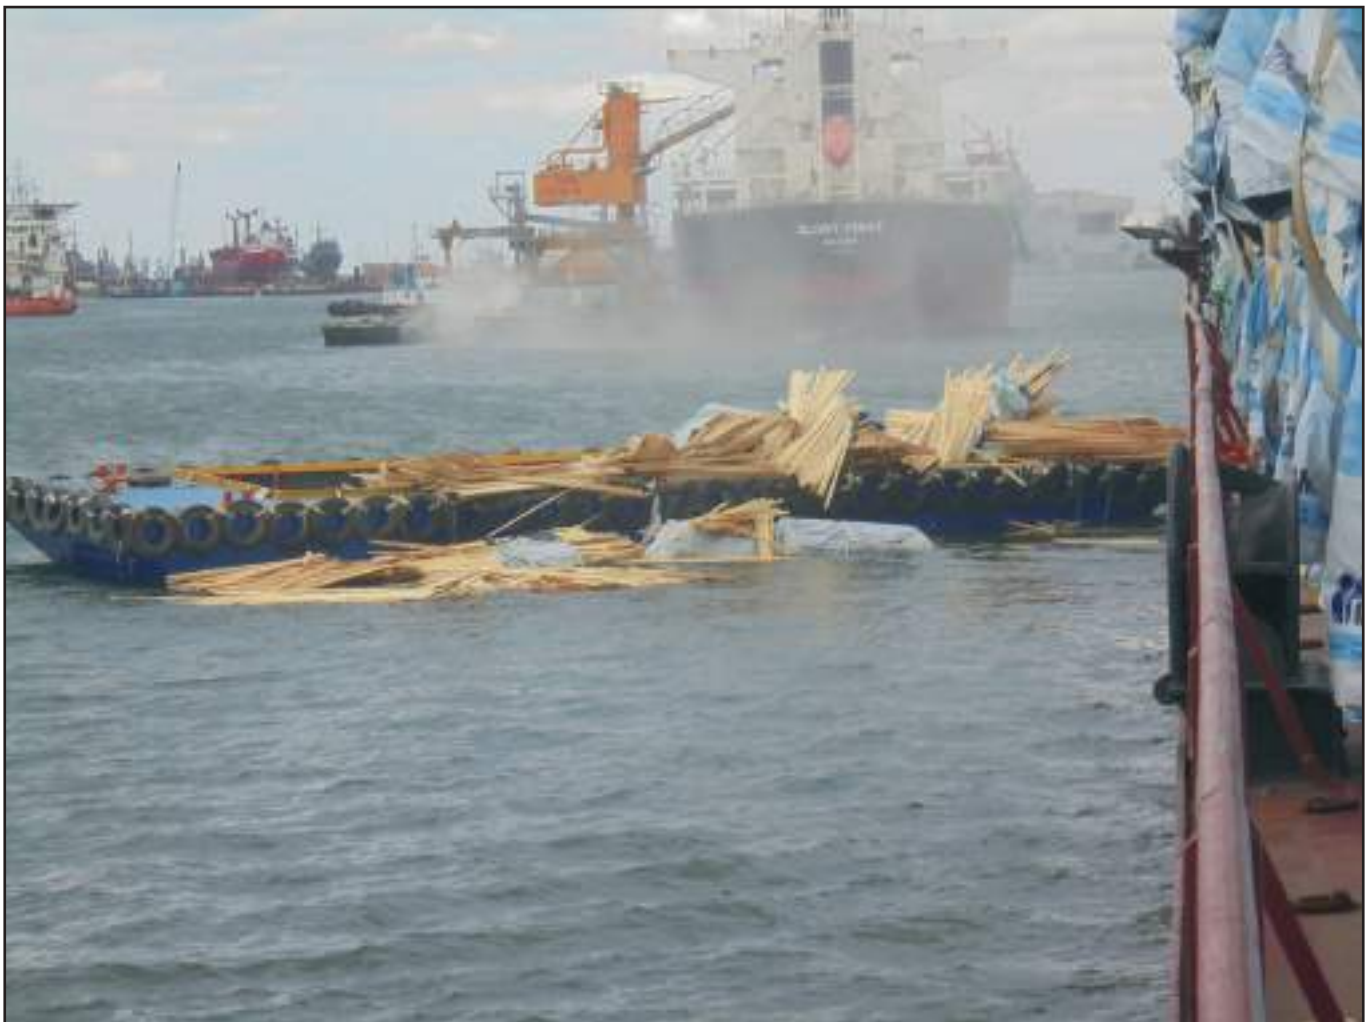
Approximately 20 packages of timber fell from the port side of the stack on top of number 1 hatch cover. Some of the packages fell into the water and the remainder fell into the barge that was secured on *Graig Rotterdam's* port side forward (**Figure 4**).

The barge was unmanned at the time of the accident and already contained some packages.

Figure 4: Port side cargo barge, immediately after cargo collapse

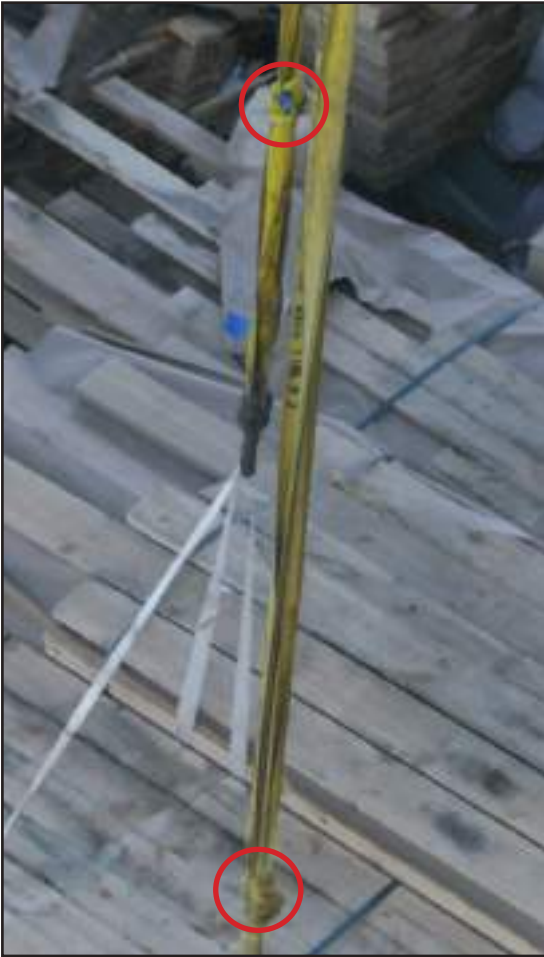
- Knotted cargo slings (**Figure 5**) and open shackles being used as hooks (**Figure 6**) to lift cargo.
- Walking on the edge of deck cargo stacks (**Figure 7**).

Figure 5: Knotted cargo slings

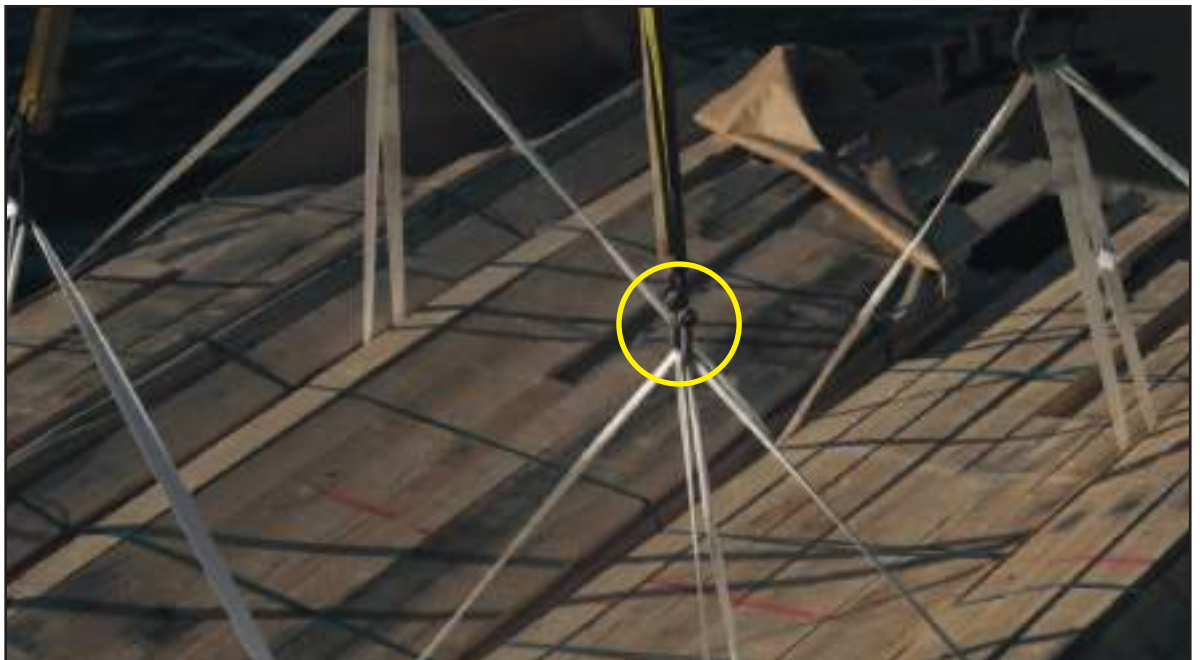
Figure 6: Open shackles used as cargo hooks

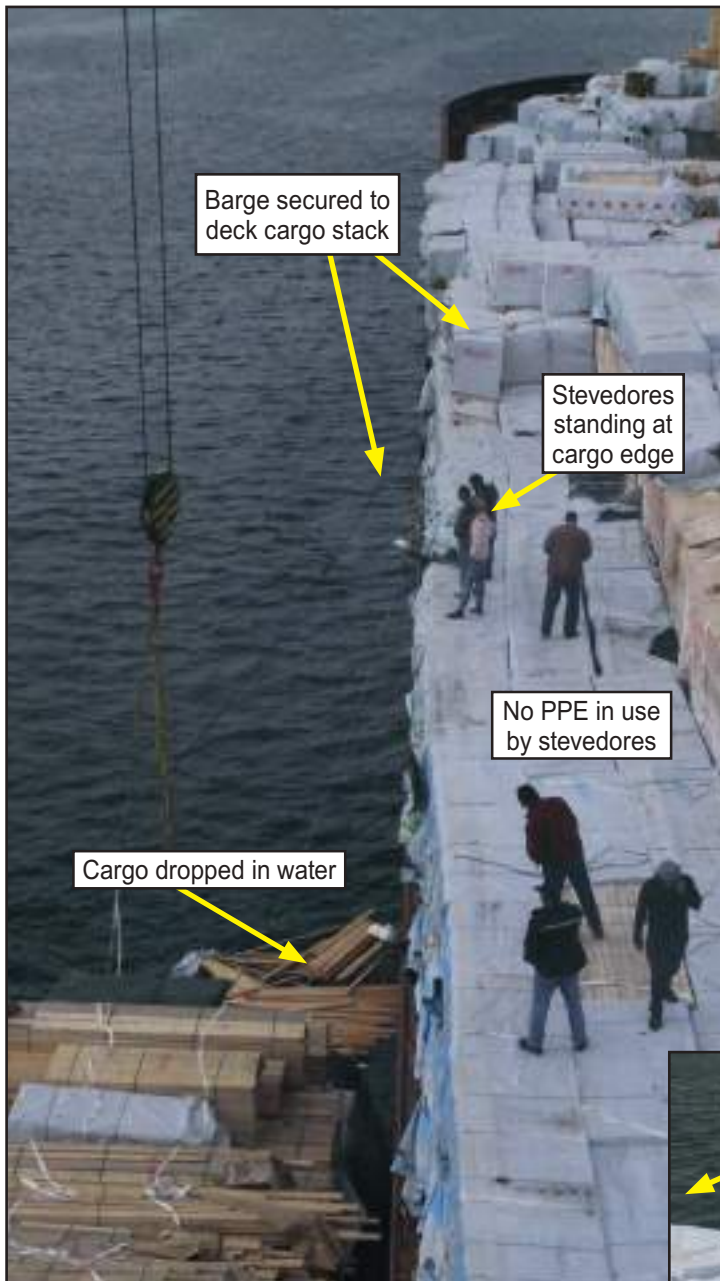
- Personal protective equipment (PPE) not being worn (**Figure 7**).
- Cargo packages being dropped onto the deck or into the water (**Figure 7**).
- Barges being secured to deck cargo stacks (**Figures 7, 8 and 9**).
- Smoking while on the deck cargo stacks.
- Climbing and being lifted by crane from barges to the ship.

Figure 7: Poor stevedoring practices

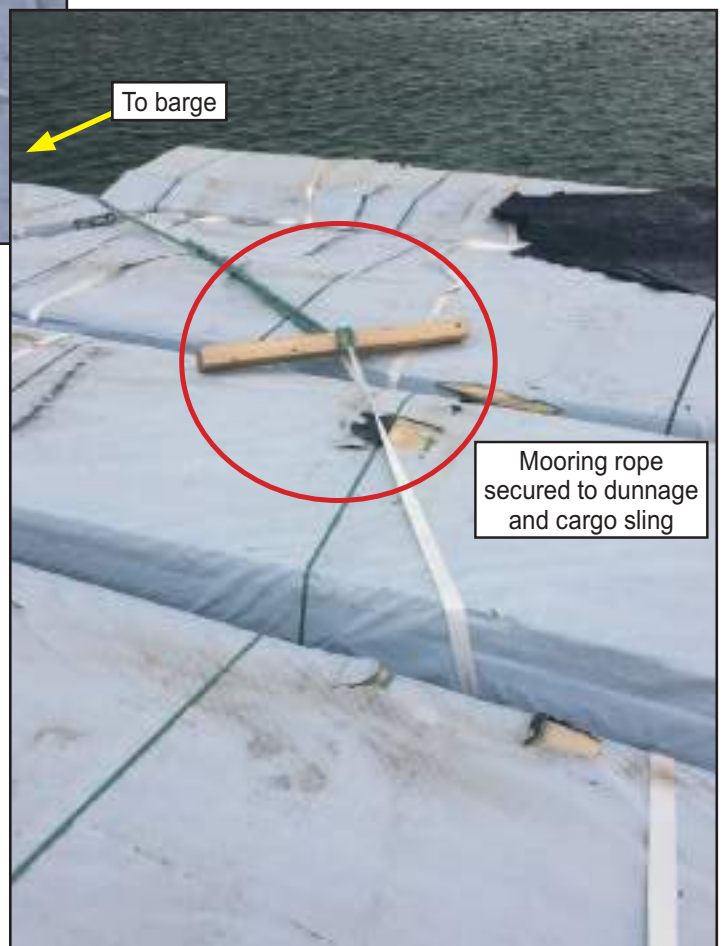
Figure 8: Barge mooring rope attached to deck cargo stack

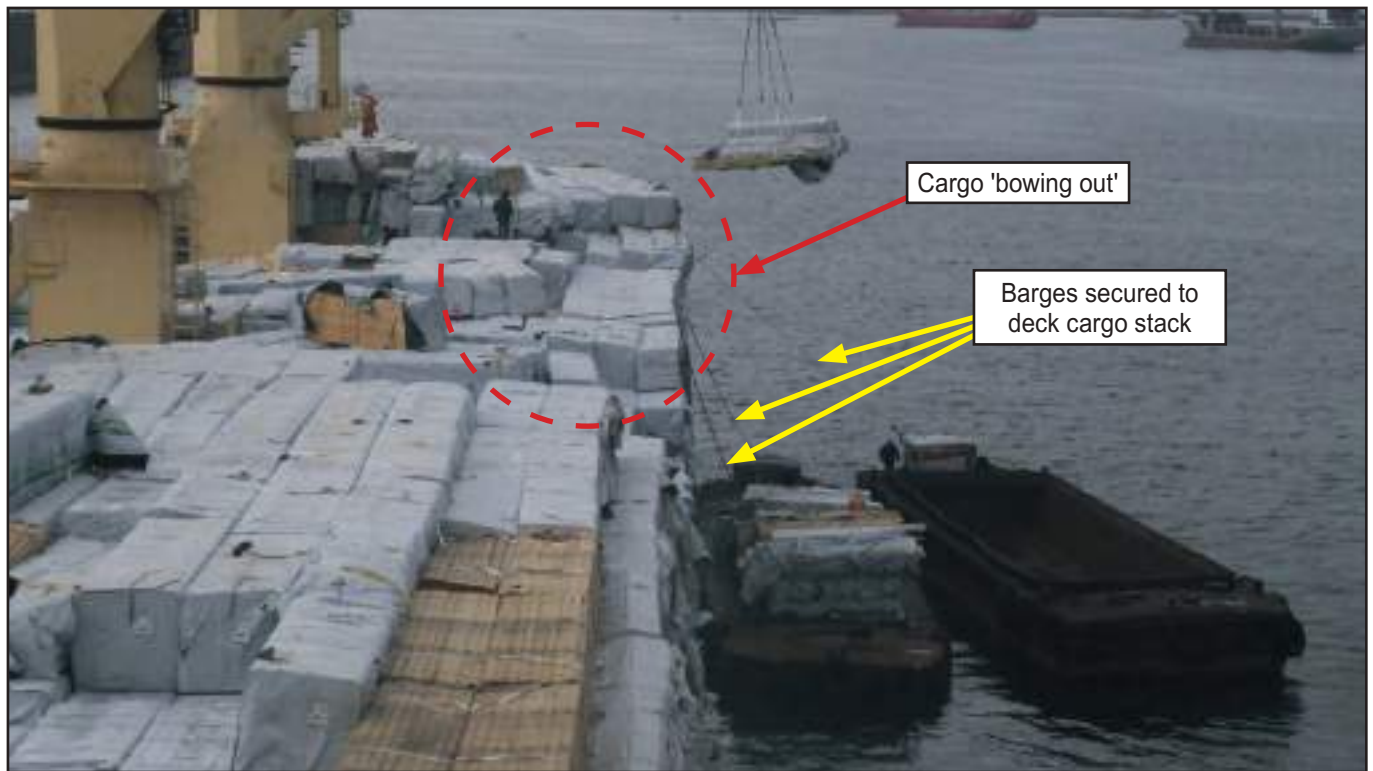
Figure 9: Cargo 'bowing out' in fore part of vessel

The deck cargo had been secured for passage in accordance with the ship's CSM, which assumed the packages had sufficient racking strength so as not to require the use of uprights. Consequently, when all cargo lashings were removed prior to commencing cargo discharge, nothing other than friction and the strength of the metal banded package construction was left to hold the timber deck cargo in place. While the stability of the deck cargo stow when secured with top-over lashings on passage was sufficient, the stability of the stow once the lashings had been removed was insufficient to counter the effects of ship movement, cargo repositioning, dunnage displacement, barges securing to deck cargo stacks, and cargo discharge operations over a prolonged period. In this regard, there was evidence that the cargo was 'bowing out' after the securing lashings had been removed, particularly in the fore part of the vessel (**Figure 9**).

The rigidity of timber packages is of great importance for the stability of the deck cargo and the racking strength of the timber packages should be taken into consideration when securing systems are designed. *Graig Rotterdam's* master was not advised of the cargo package racking strength prior to the cargo being loaded in Finland.

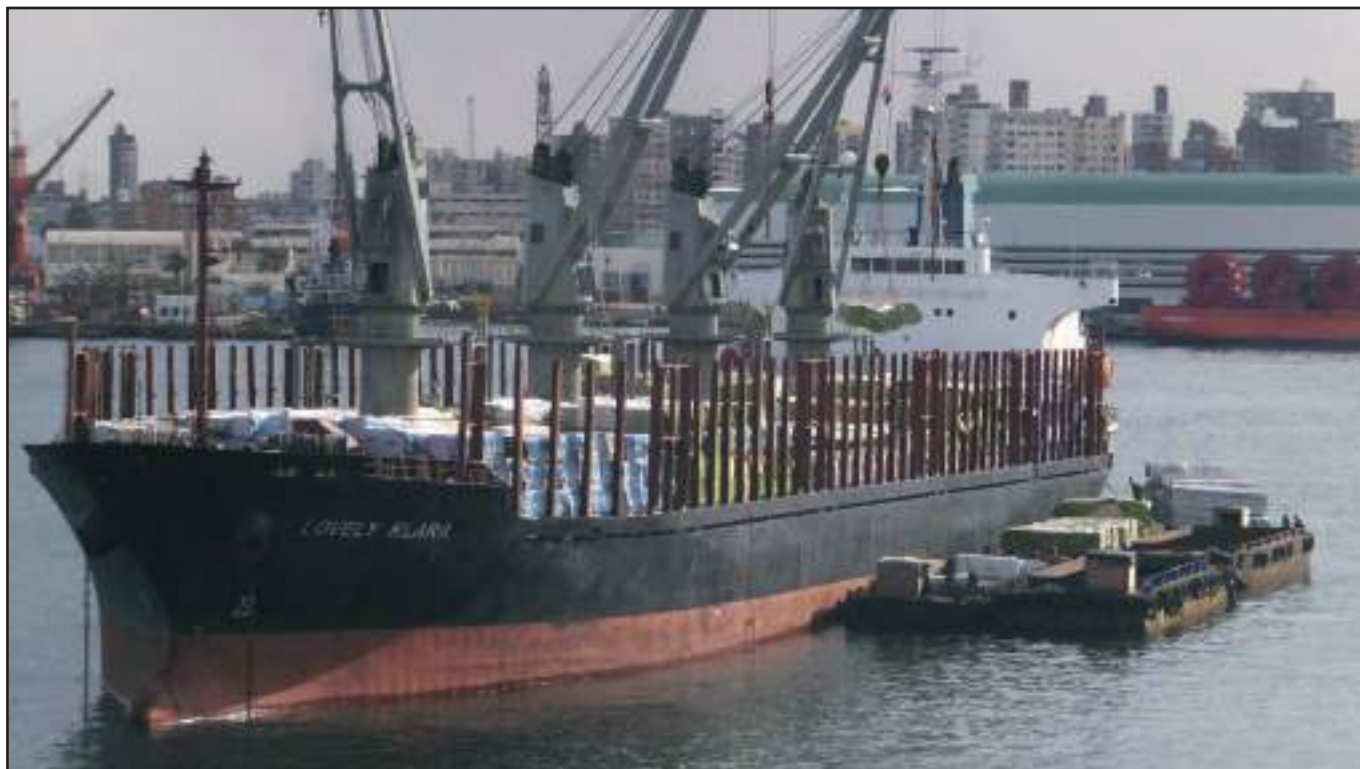
Uprights provide an additional means of securing timber deck cargo packages with limited racking strength for passage, in accordance with the TDC Code. There is no evidence that the cargo packages carried on *Graig Rotterdam* had insufficient racking strength so as to require them to be supported by uprights while on passage. However, provision of uprights would have helped prevent a deck cargo stack from collapsing once the securing lashings had been removed in circumstances such as those faced by *Graig Rotterdam* in Alexandria Port, Egypt. There were two other ships discharging packaged timber cargoes to the same terminal in Alexandria at the time of the accident. Both ships were fitted with steel uprights (**Figure 10**).

Figure 10: A vessel, with steel uprights, discharging a timber deck cargo at the same anchorage
