DEPARTMENT OF THE NAVY
OFFICE OF THE CHIEF OF NAVAL OPERATIONS
2000 NAVY PENTAGON
WASHINGTON, DC 20350-2000

Enclosure (1) Report on the Collision between USS FITZGERALD (DDG 62) and Motor Vessel ACX CRYSTAL

Enclosure (2) Report on the Collision between USS JOHN S MCCAIN (DDG 56) and Motor Vessel ALNIC MC

REPORT ON THE COLLISION BETWEEN USS FITZGERALD (DDG 62)
AND MOTOR VESSEL ACX CRYSTAL

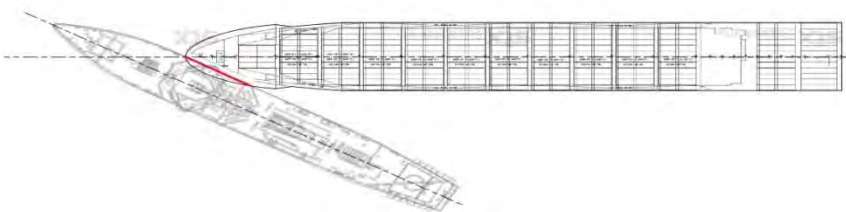
Figure 6 – Diagram of Approximate Collision Geometry

The port (left) side of CRYSTAL's bow, near the top where the anchor hangs, struck FITZGERALD's starboard (right) side above the waterline. CRYSTAL's bulbous bow, under the water, struck FITZGERALD on the starboard side just forward of the middle part of the ship. CRYSTAL's bulbous bow struck the starboard access trunk, an entry space that opens into Berthing 2 through a non-watertight door.

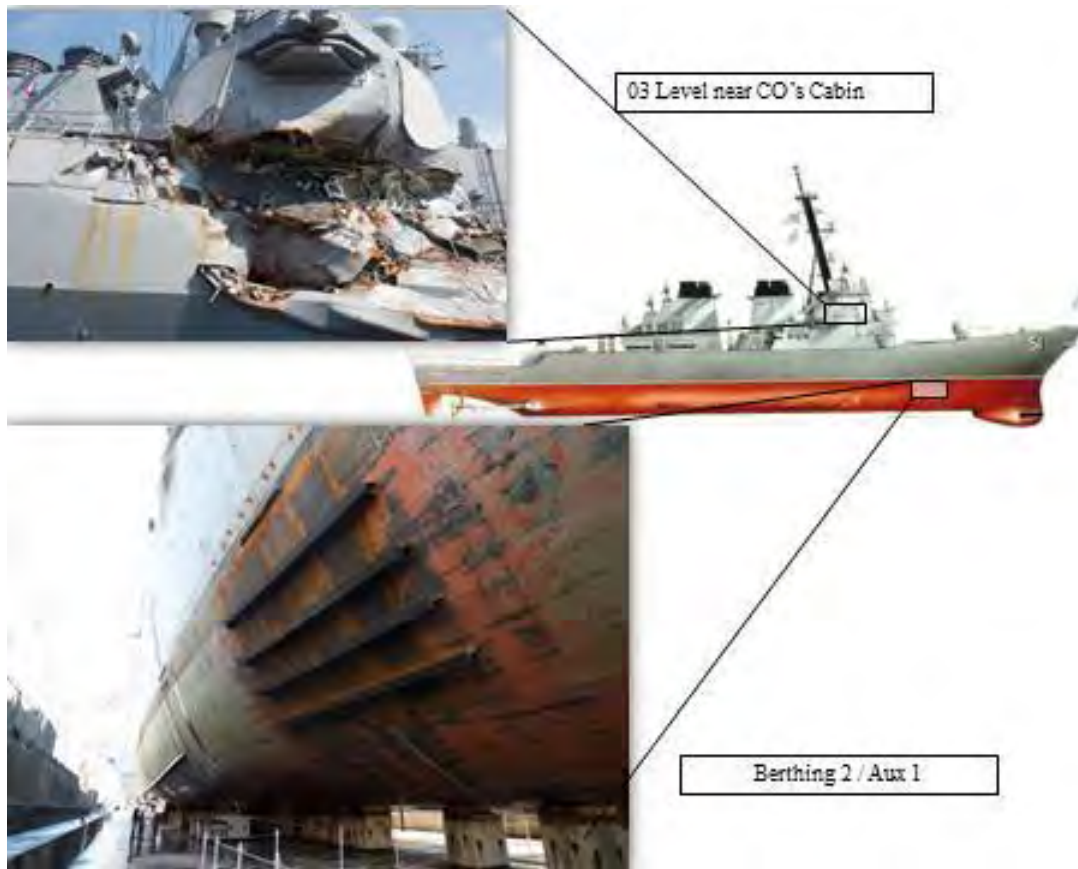
Figure 8 - Starboard side of FITZGERALD

The impact of the top of CRYSTAL's bow above the waterline crushed the false bulkhead (a non-structural steel wall that is the shipboard equivalent of a non-load bearing wall in a house, used to divide a space) and non-watertight door within the Commanding Officer's cabin. The Commanding Officer's cabin is composed of two small rooms: an office area with a desk, table, and couch with seating for several people; and his bedroom. The two rooms are separated by this false bulkhead and door. The outer wall was pushed in and torn open by the impact.

Inset Above: Damage to FITZGERALD above the waterline at the 03 Level near CO's Cabin

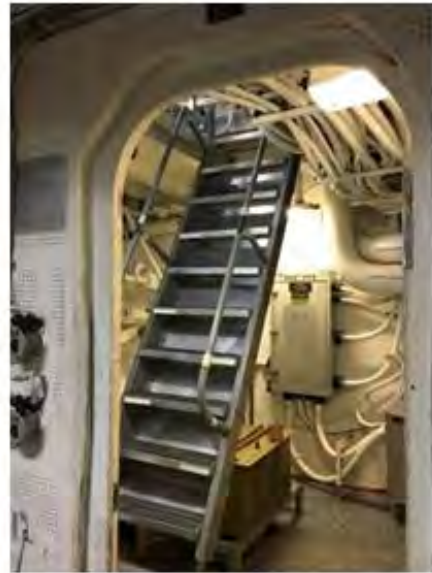
Figure 9 – Non-watertight door frame from Berthing 2 to the ladder going up to Berthing 1 Access Trunk. There is no hatch at the top of this ladder to prevent water from flooding up into Berthing 1.

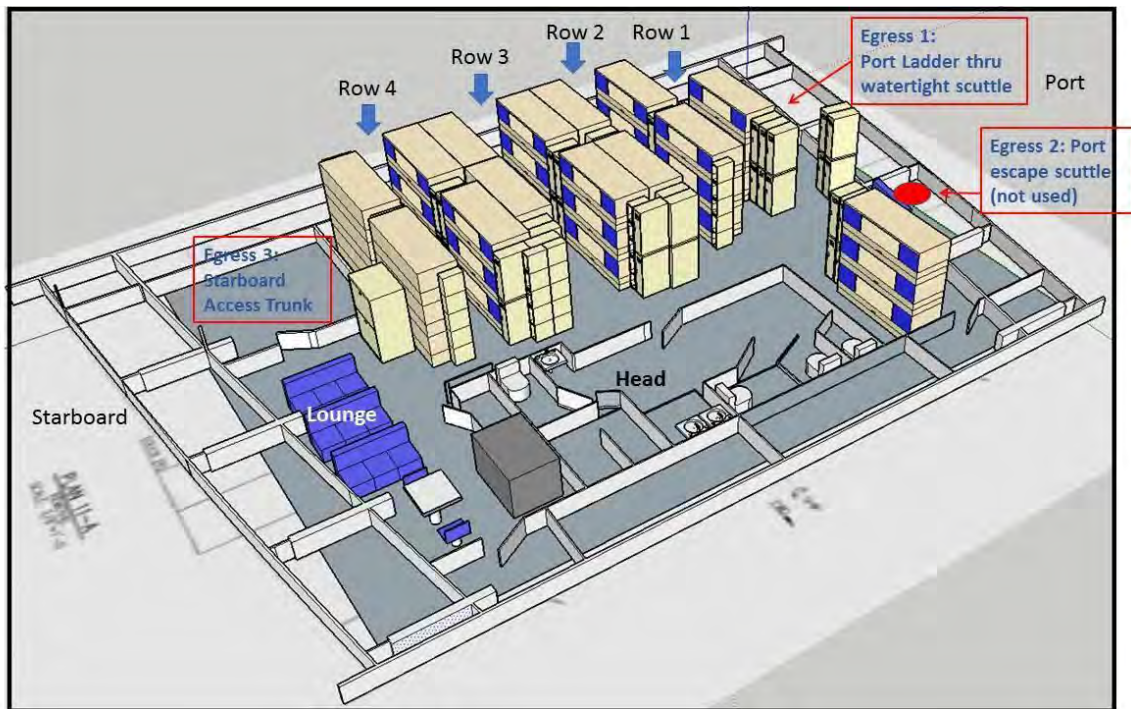
Figure 15 – Berthing 2 Layout of Racks and Lockers (facing aft)

The flooding of Berthing 2 resulted in the deaths of seven FITZGERALD Sailors. The racks of these seven Sailors were located in Rows 3 and 4, the area closest to the starboard access trunk and egress point and directly in the path of the onrushing water, as depicted in Figure 15.

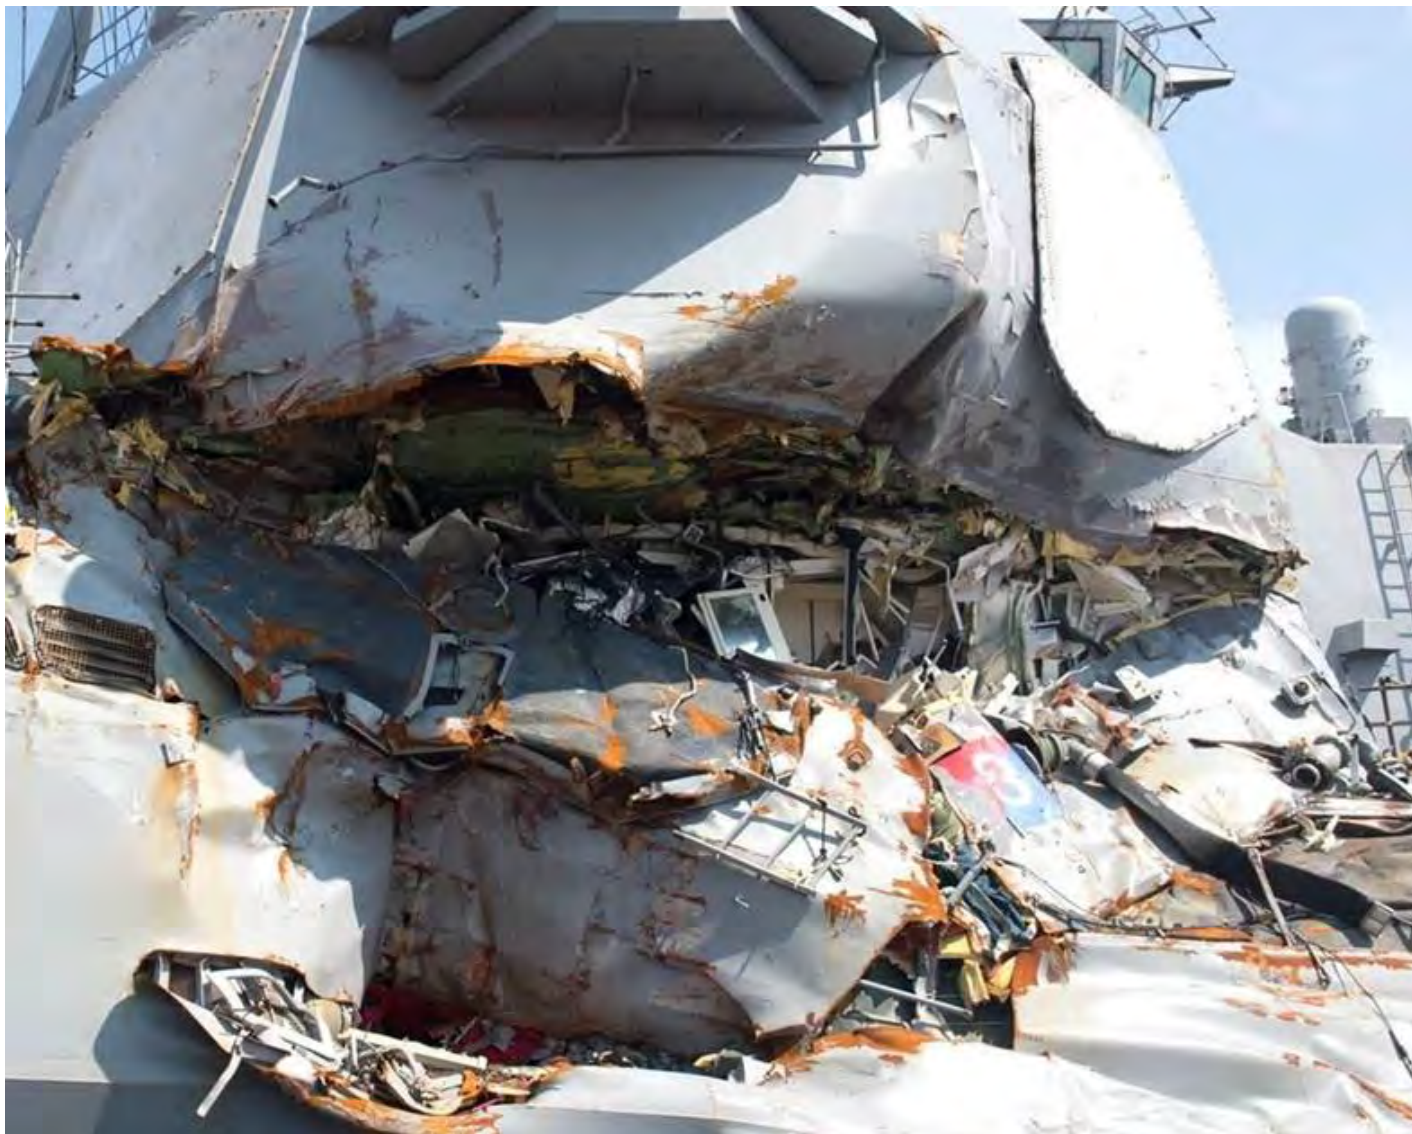
B2: Commanding Officer's Stateroom on FTZ - Interior view

The Commanding Officer was in his cabin at the time of the collision. The CRYSTAL's bow directly struck his cabin, located above the waterline. The impact severely damaged his cabin, trapping him inside. The CO called the bridge requesting assistance.

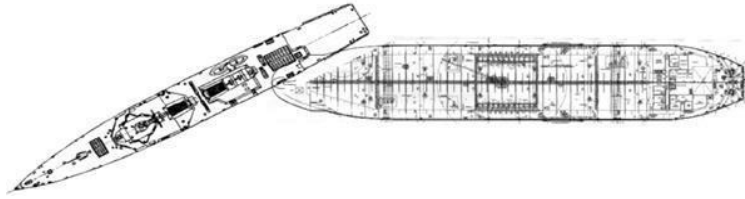
**Figure 7 – Approximate Geometry and Point of Impact
between USS JOHN S MCCAIN and ALNIC MC**

Approximately three minutes after the reported loss of steering, JOHN S MCCAIN regained positive steering control at another control station, known as Aft Steering, and the Lee Helm gained control of both throttles for speed and corrected the mismatch between the port and starboard shafts. These actions were too late, and at approximately 0524 JOHN S MCCAIN crossed in front of ALNIC's bow and collided. See Figure 6.

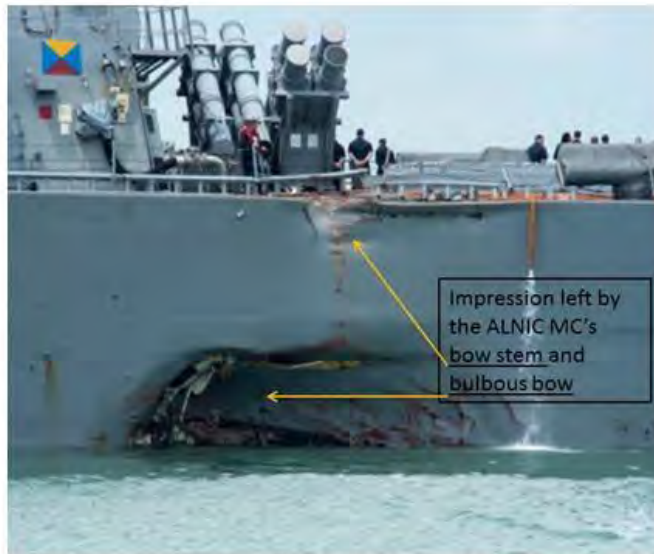
**Figure 9 – Point of impact on JOHN S MCCAIN
from ALINIC MC**

The point of impact was centered on Berthings 3 and 5 as noted in Figure 9. All significant injuries occurred to Sailors that were in Berthing 3 at the time of the impact. All ten of the fallen Sailors were in Berthing 5 at the time of impact.

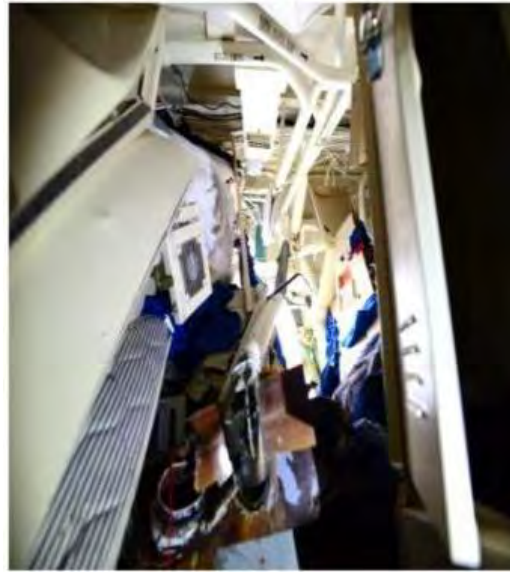
At 0530, the DCA began receiving reports of a ruptured fire main and water and fuel flooding into Berthing 3. The port side of Berthing 3 suffered substantial damage, including a large hole in the bulkhead. See Figure 13. Racks and lockers detached from the walls and were thrown about, leaving jagged metal throughout the space. Cables and debris hung from the ceiling.

Figure 16 – Berthing 3 facing port after collision

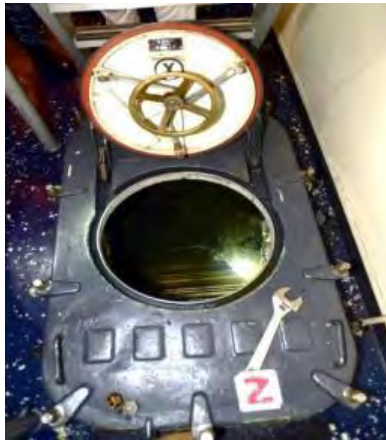
All Sailors in Berthing 4 were able to evacuate. At 0544, Sailors reported 4 inches of water on the deck in Berthing 4. Sailors in Berthing 4 were thrown about their racks by the force of the collision. By 0627, the berthing space was lost. See Figures 16 and 17.

Figure 17—Scuttle and hatch into Berthing 4 showing the space completely flooded

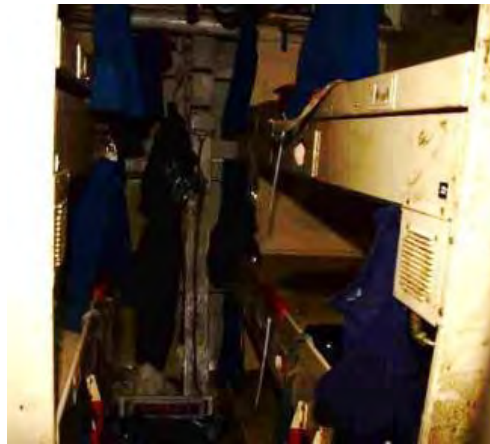
Figure 18—Berthing 4 racks after dewatering

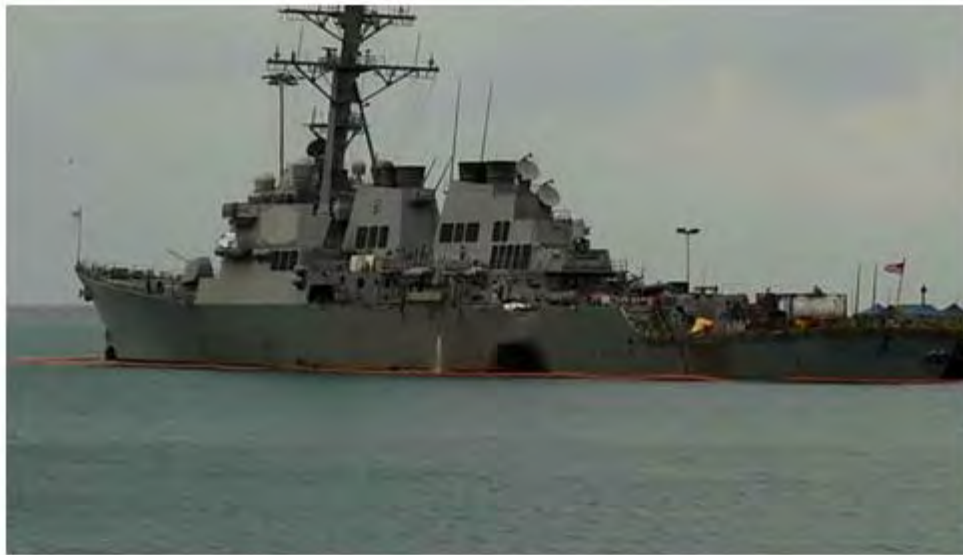
Figure 19 – Port side of JOHN S MCCAIN post-collision

A team of Navy Divers arrived on JOHN S MCCAIN as the ship entered the harbor in Singapore at approximately 1200 on 21 August 2017. They began inspecting the ship to determine how best to proceed with a dive inside the ship. The leader of the dive team inspected Berthing 3 and saw waves breaking into the ship. The divers discovered the hole in the port side of JOHN S MCCAIN that was approximately 28 feet wide. See Figure 18.

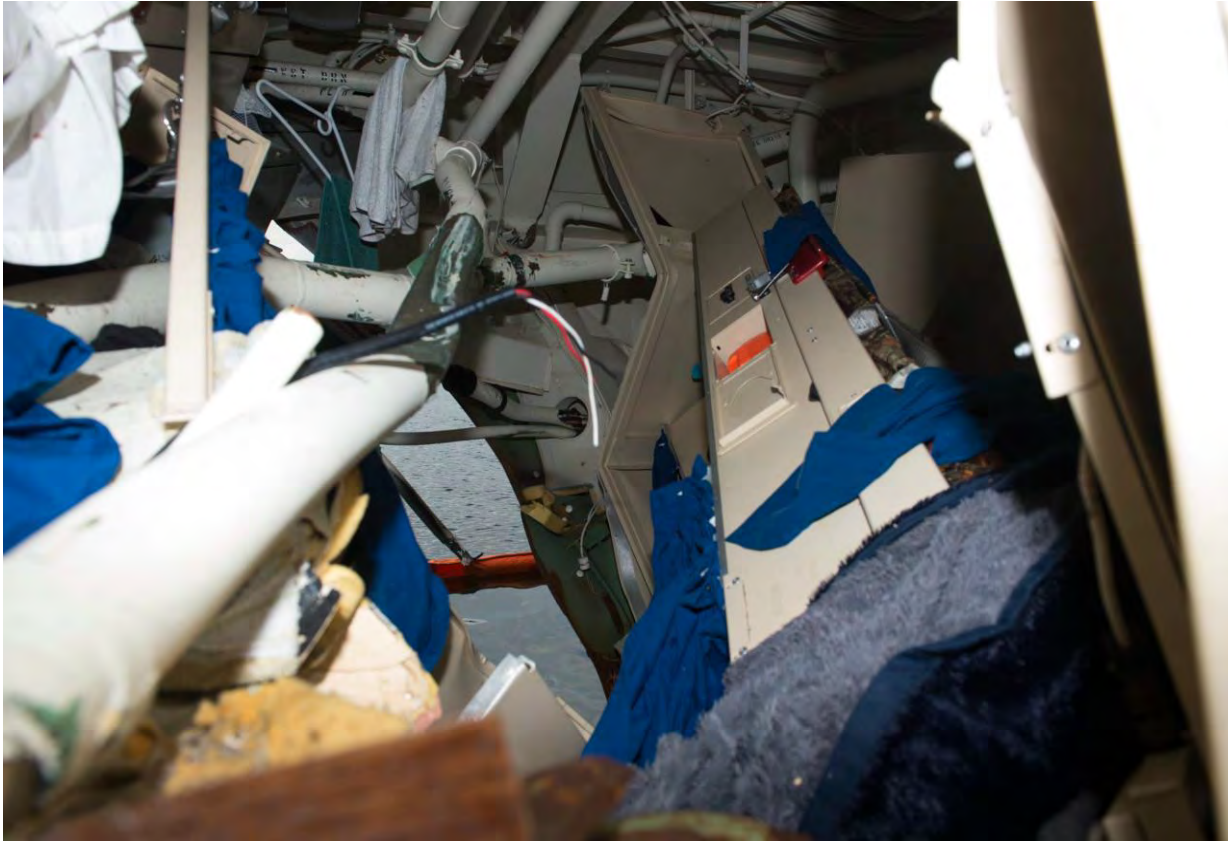
Internal view through Berthing 3 to point of impact; ocean visible

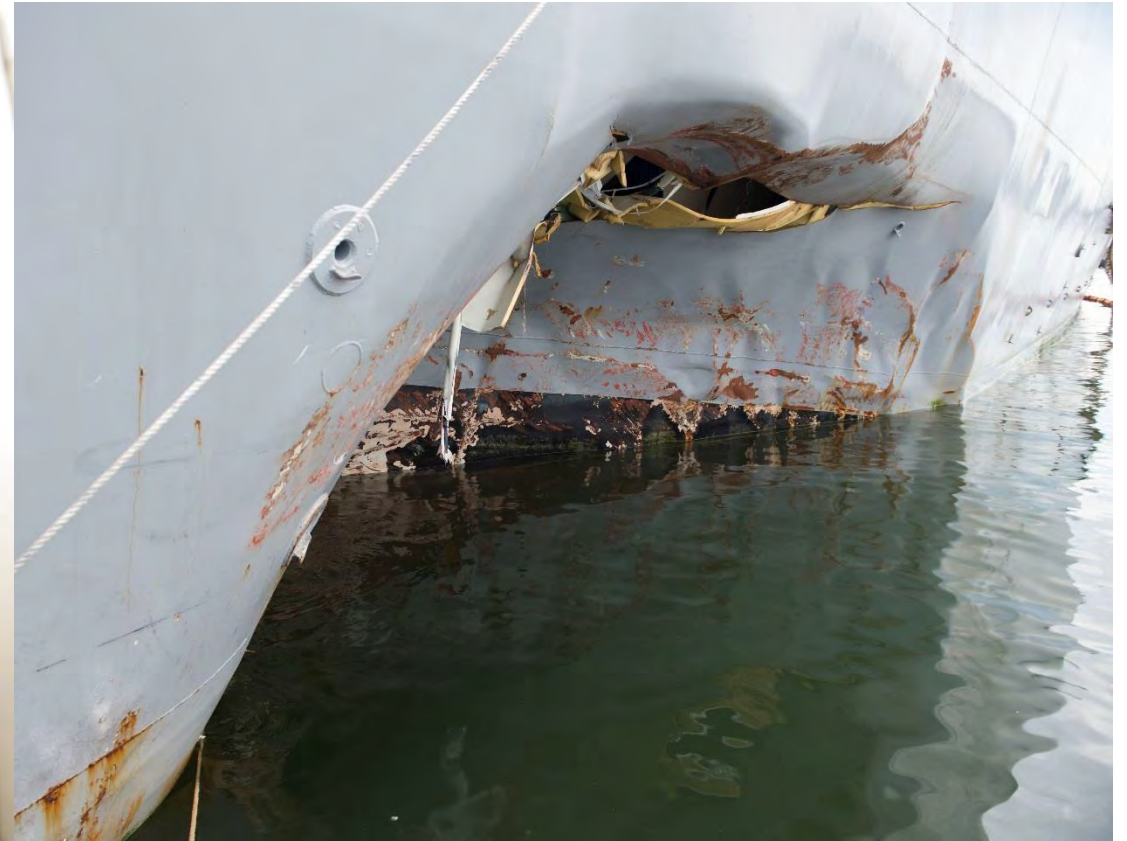
External view of point of impact; rupture in hull of the ship visible
