Report on the investigation of the
explosion of gas released from a cargo
of unprocessed incinerator bottom ash on

Nortrader

at anchorage in Plymouth Sound

on 13 January 2017

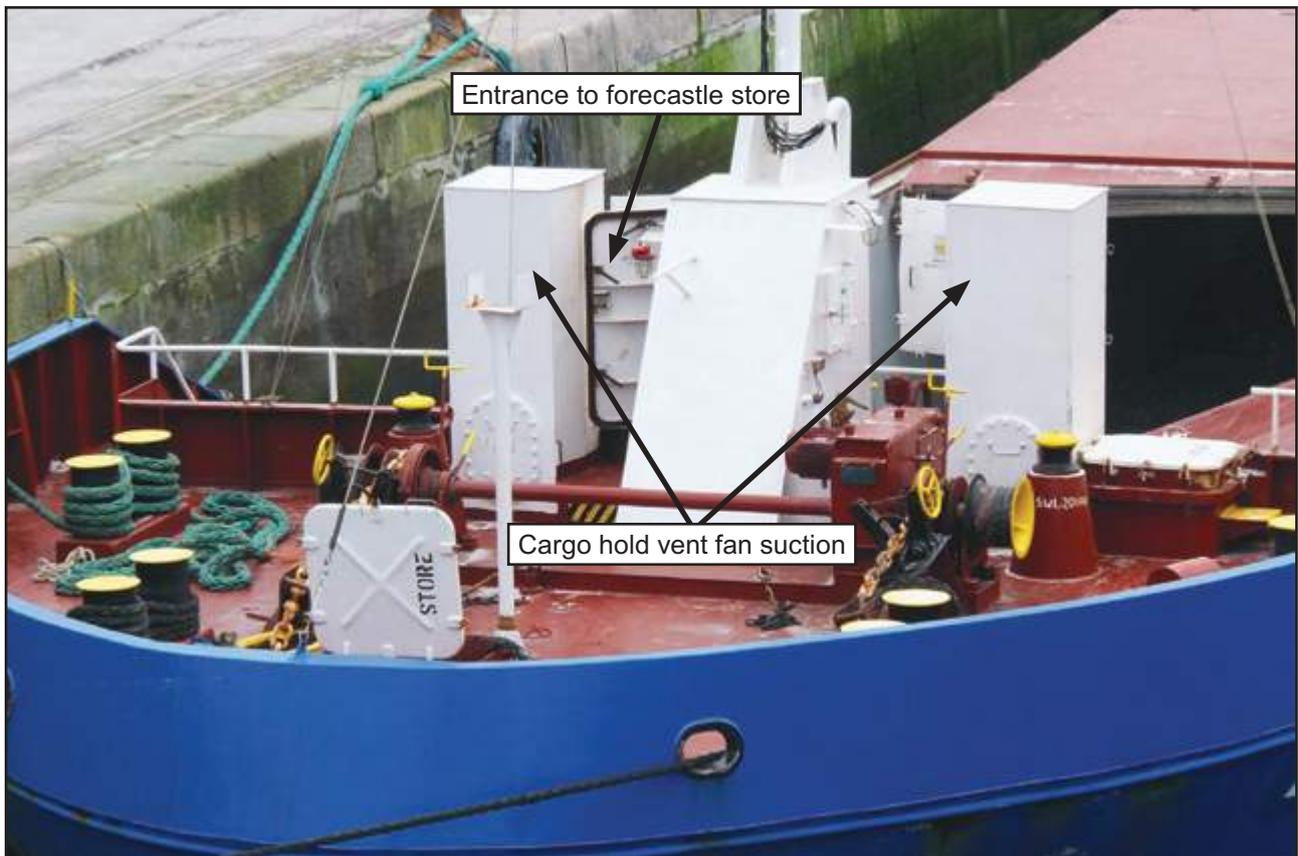
At approximately 1440, the chief engineer went to the forecandle store (**Figure 3**) where the emergency fire pump main starter panel was located. He opened the door to enter the store and used the hook on its outside to secure the door in the open position. He then went down the ladder into the store and started the emergency fire pump. From the sound of its operation he suspected that the pump was running dry and so he returned to the forecandle and opened a fire hydrant, to confirm that no water was being pumped. He then returned to the store and stopped the emergency fire pump using the stop button on the starter panel (**Figure 4**).

Figure 3: Forecandle deck and entrance to forecandle store

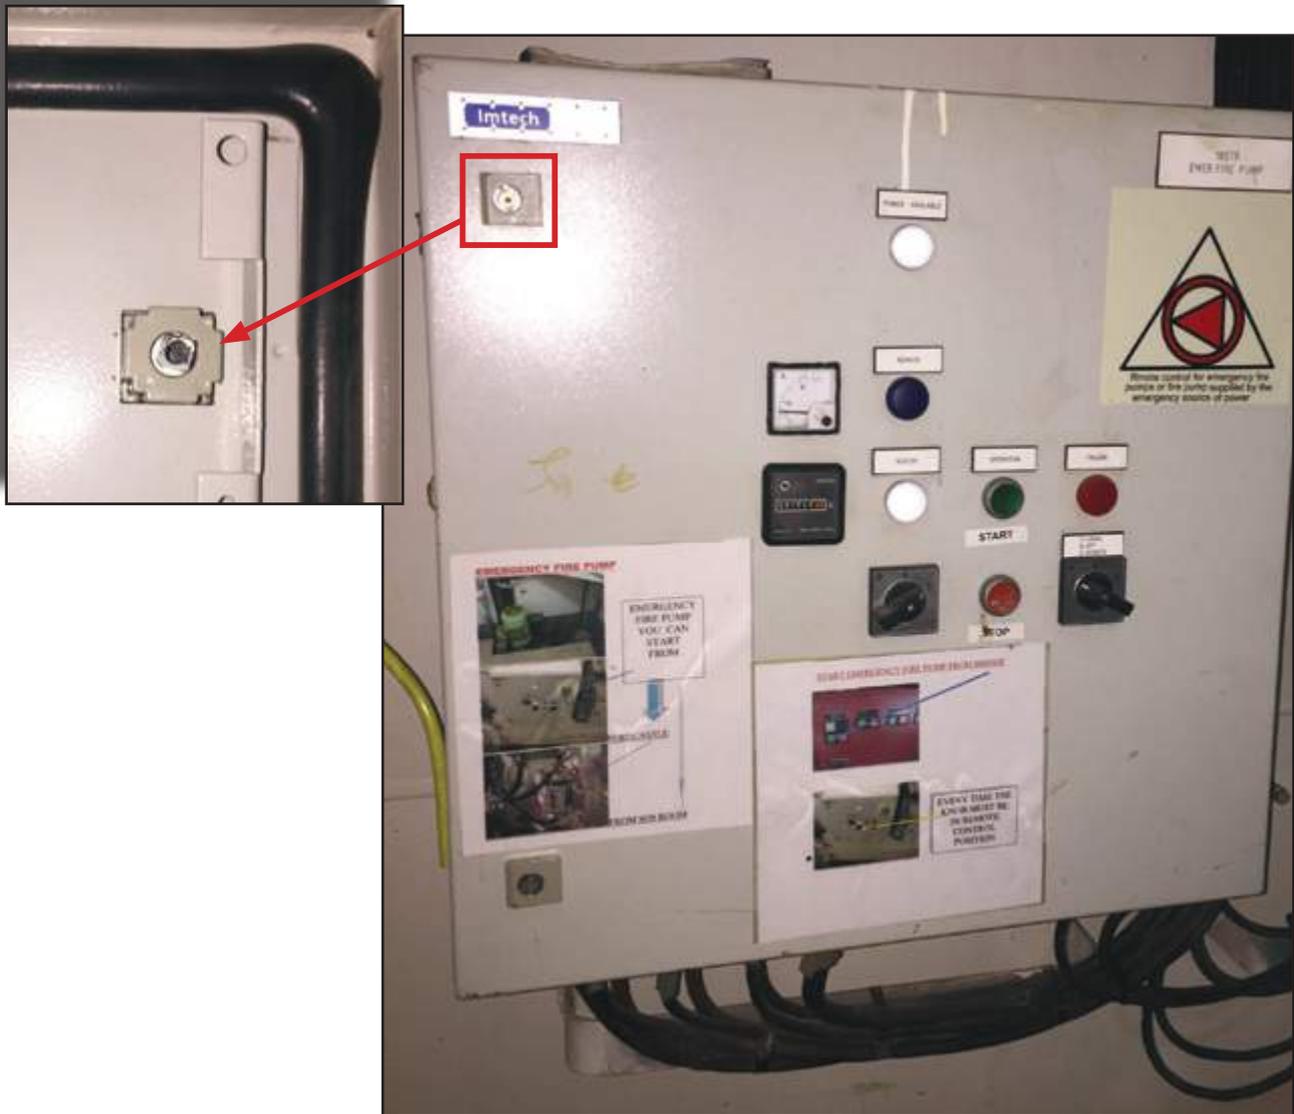
Figure 4: Emergency fire pump starter panel (**inset:** reverse of door, showing broken door lug)

The forecastle store was located in a compartment forward of the hold. It was accessed via a door on the forecastle deck and down a short stairway. The starter panels for various equipment, including the emergency fire pump and cargo hold ventilation fans, were located in the forecastle store. The emergency fire pump and bow thruster were located at the bottom of the compartment and were accessed by a vertical ladder from the store. At the time of the accident, the emergency fire pump starter panel door was not properly closed as one of its two fastening lugs was broken.

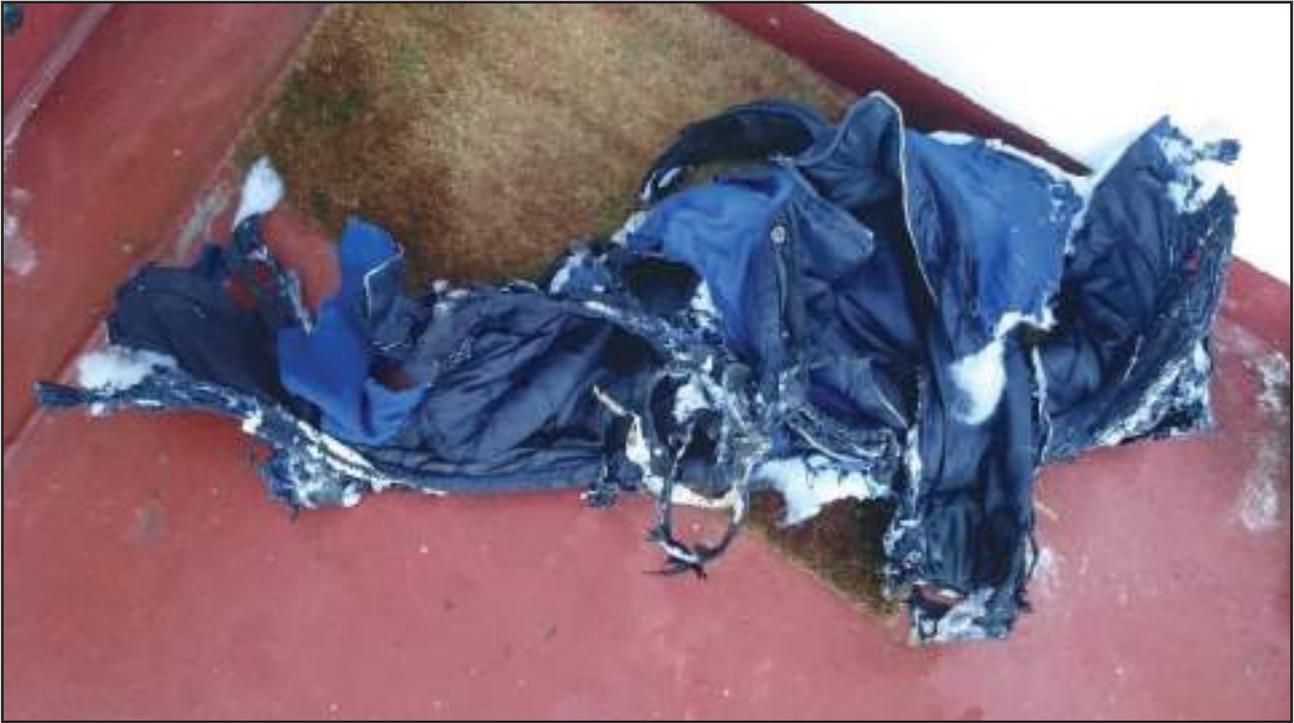
Figure 5: The chief engineer's burnt parka coat

HHU estimated the flame front temperature to have been 1000°C. However, the passage of the flame front would have been very quick as the accumulated hydrogen burned. The chief engineer appeared to have suffered the full brunt of the first explosion, causing the synthetic fibre-filled coat he was wearing to melt onto his body.

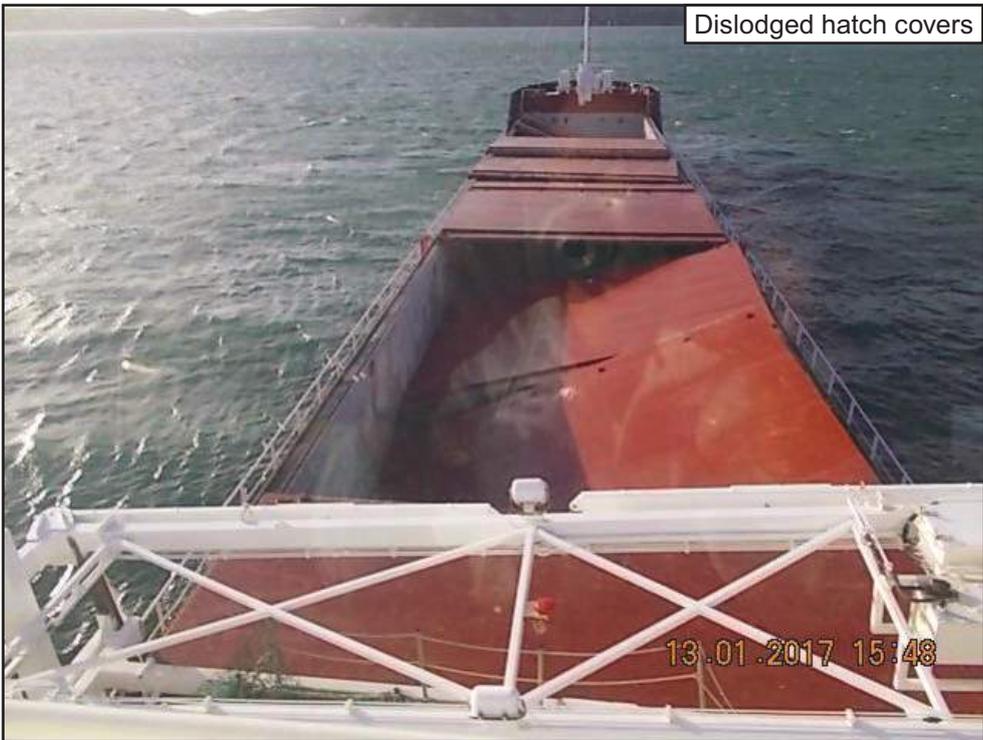
The explosions dislodged and distorted all nine of the vessel's steel hatch covers, breaking all but one of the 66 hatch cleats in the process (**Figure 6**). Some of the hatch covers dropped into the cargo hold and were found resting on top of the cargo. The cargo hold coaming bar was also damaged in several locations and the cargo ventilation trunking tower flaps were deformed.

Dislodged hatch covers

Figure 6: Damage caused by the explosion

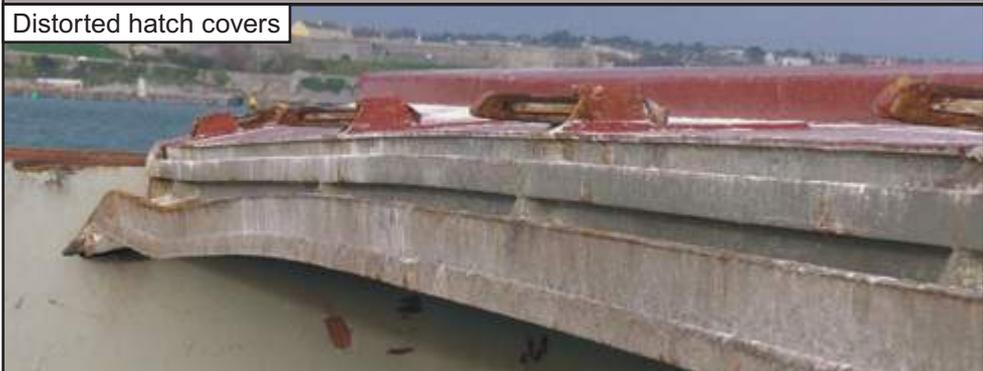
Distorted hatch covers

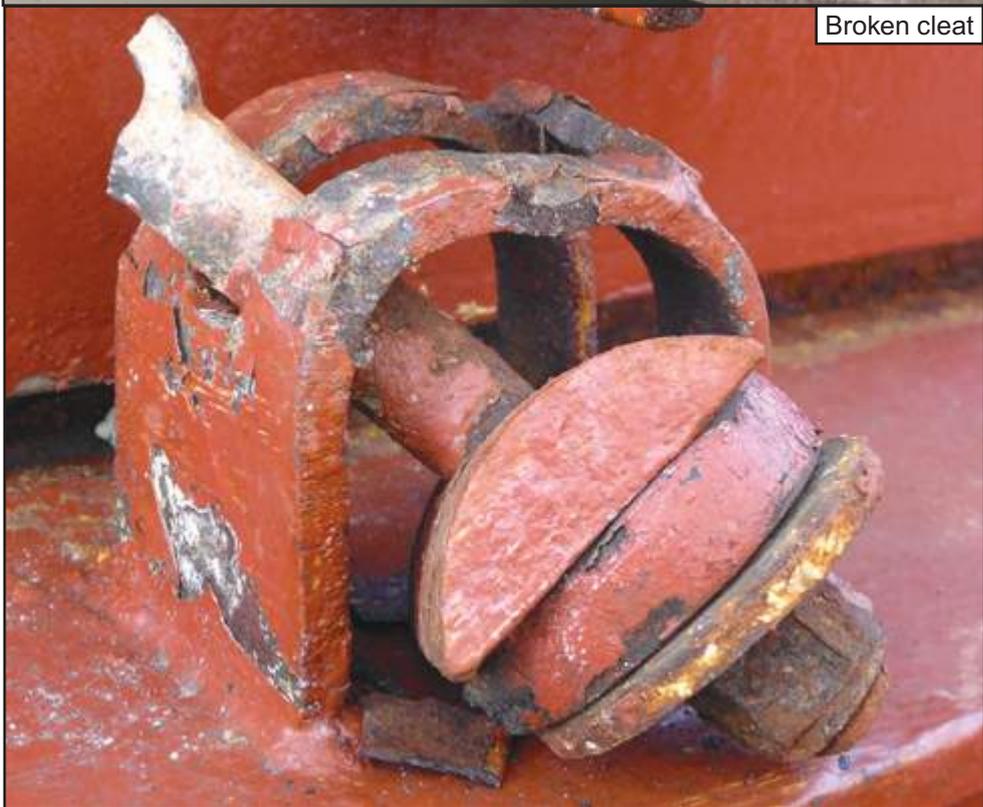
Broken cleat

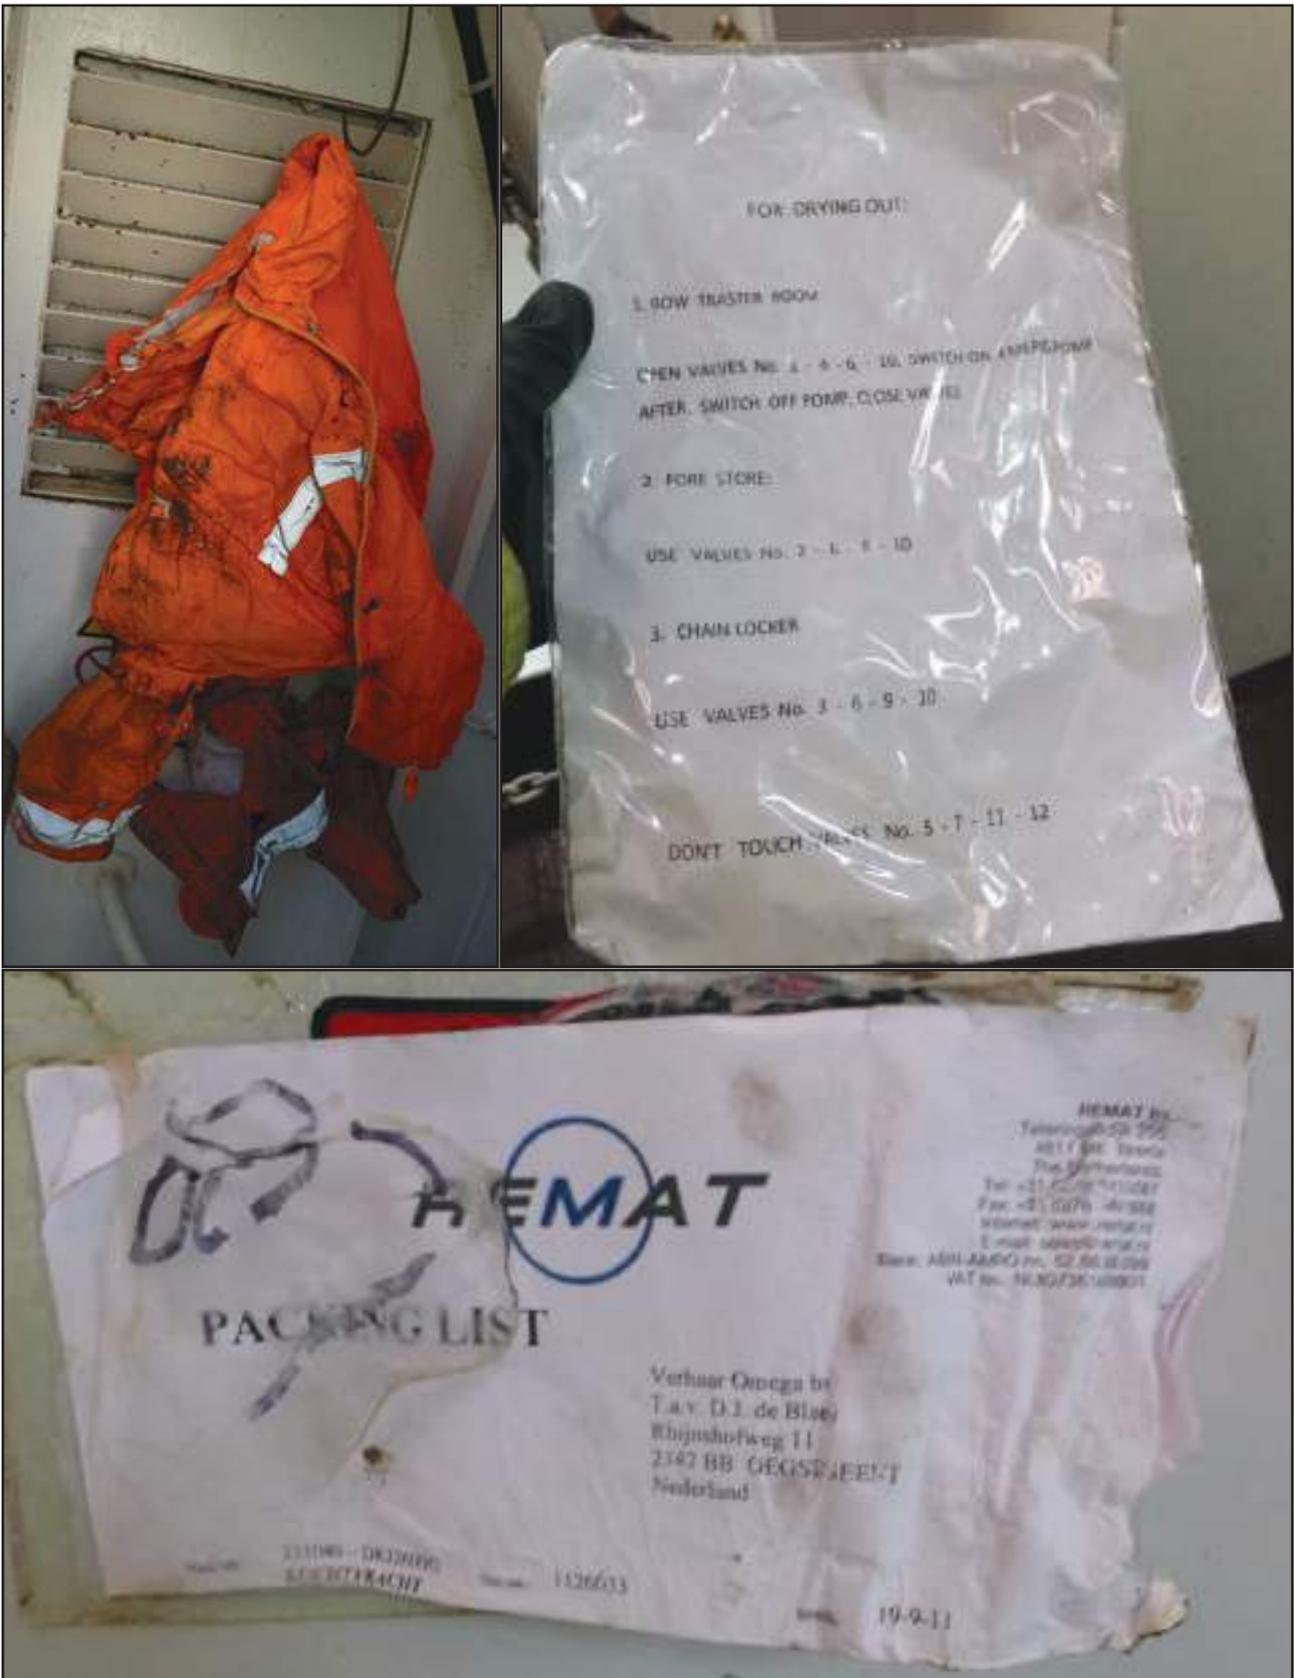
There was no fire damage, although there was evidence of intense heat within the forecastle store. A parka coat, like that worn by the chief engineer, which had been hung at the entrance to the forecastle store, had been severely melted and several laminated sheets and plastic document wallets were heat damaged (**Figure 7**).

Figure 7: Evidence of short-lived heat damage

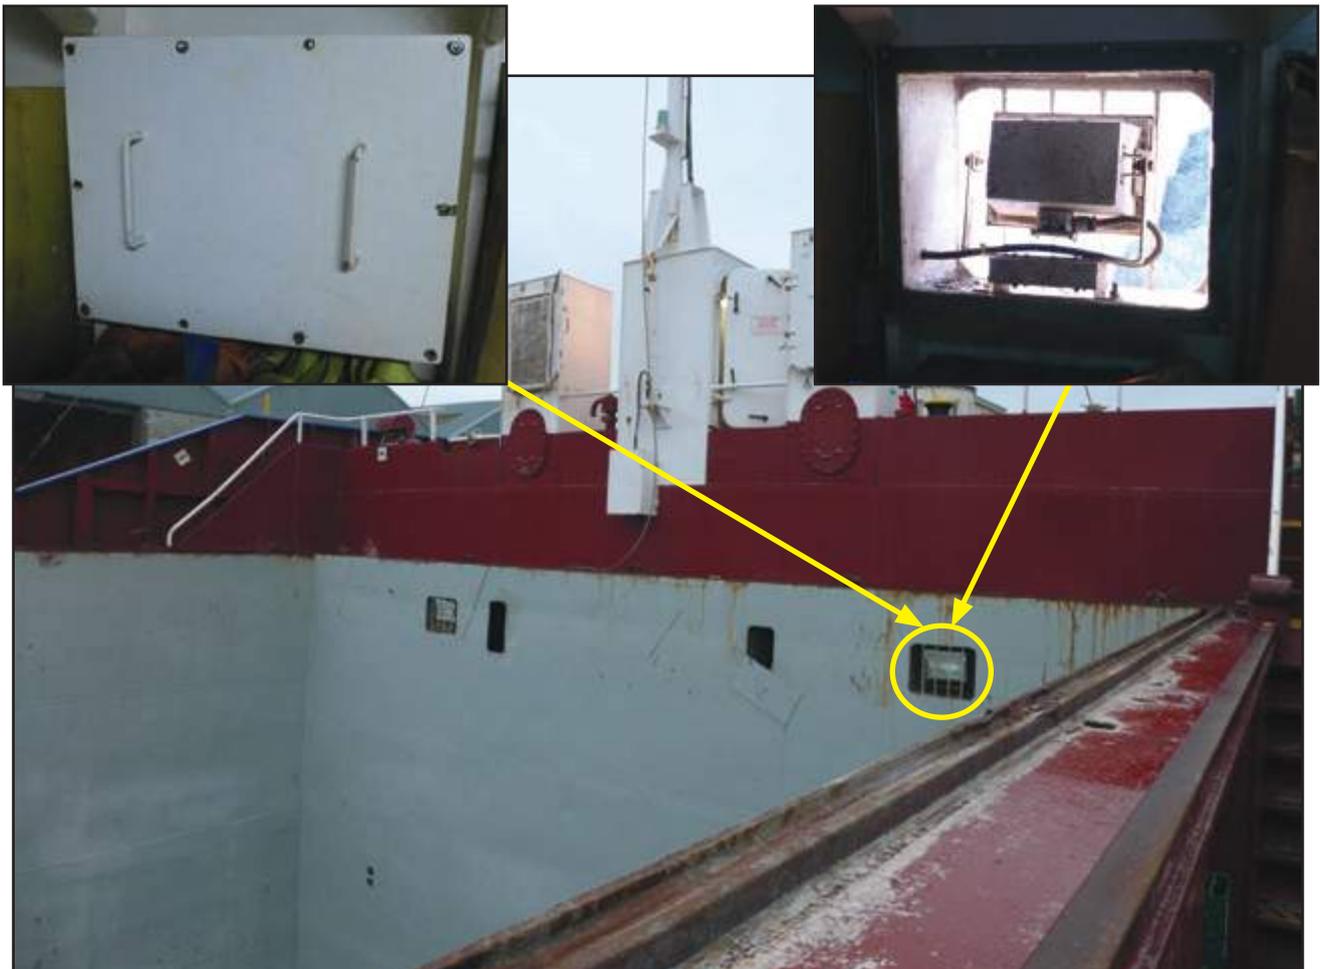
There were two cargo lamps at the forward end of the hold. The access to the starboard lamp was from within the forecandle store. The access plate for this was found loosely fitted using two of ten bolts, and the sealing gasket was missing (**Figure 8**).

Figure 8: Cargo hold lamp access
(insets: views from forecandle store with maintenance hatch closed and removed)

The access plate for the starboard cargo hold lamp fitting had been left loosely secured by two bolts with no gasket. It is likely that the bulb in this fitting was prone to regular failure, due to the vibration generated in the area during the bow thruster operation, resulting in a need for frequent access. However, leaving the access plate slack and unsealed effectively connected the cargo hold with the forecastle store, allowing the atmosphere of both spaces to equalise. Had *Nortrader* been certified to carry dangerous goods, the access to the cargo lamps might have been better designed and more strictly controlled.

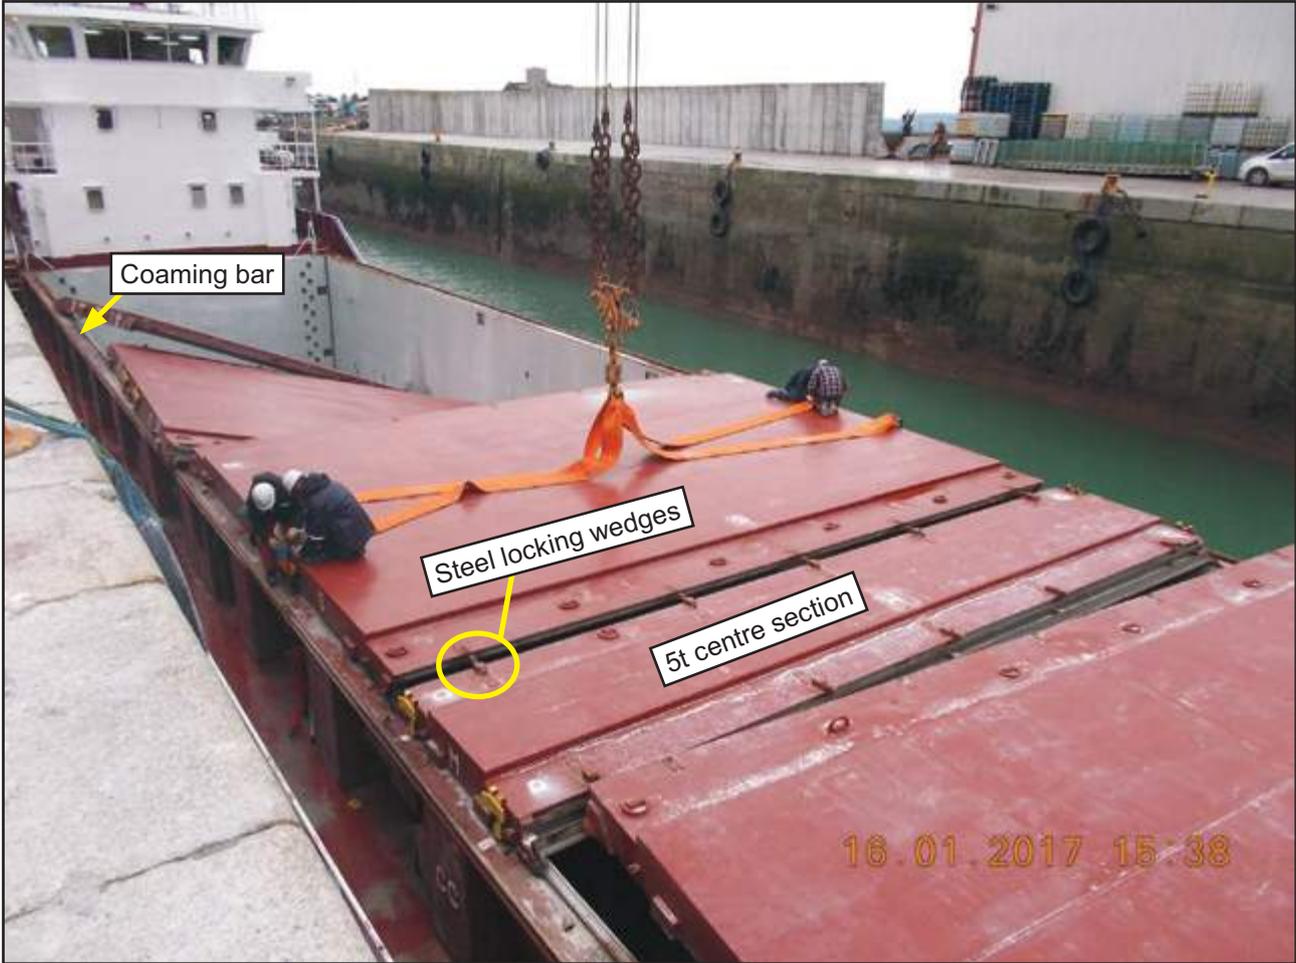
Figure 9b: Hatch covers undergoing temporary repairs

Nortrader's Classification Society, Bureau Veritas, carried out a damage assessment survey, which concluded that the vessel had not sustained any structural damage, and it was granted a dispensation to sail to Rotterdam for repair. Five of the nine hatch covers were replaced along with all of the hatch cleats and the cargo hold coaming bar. The cargo ventilation trunking tower flaps were repaired. The vessel returned to service on 20 April.

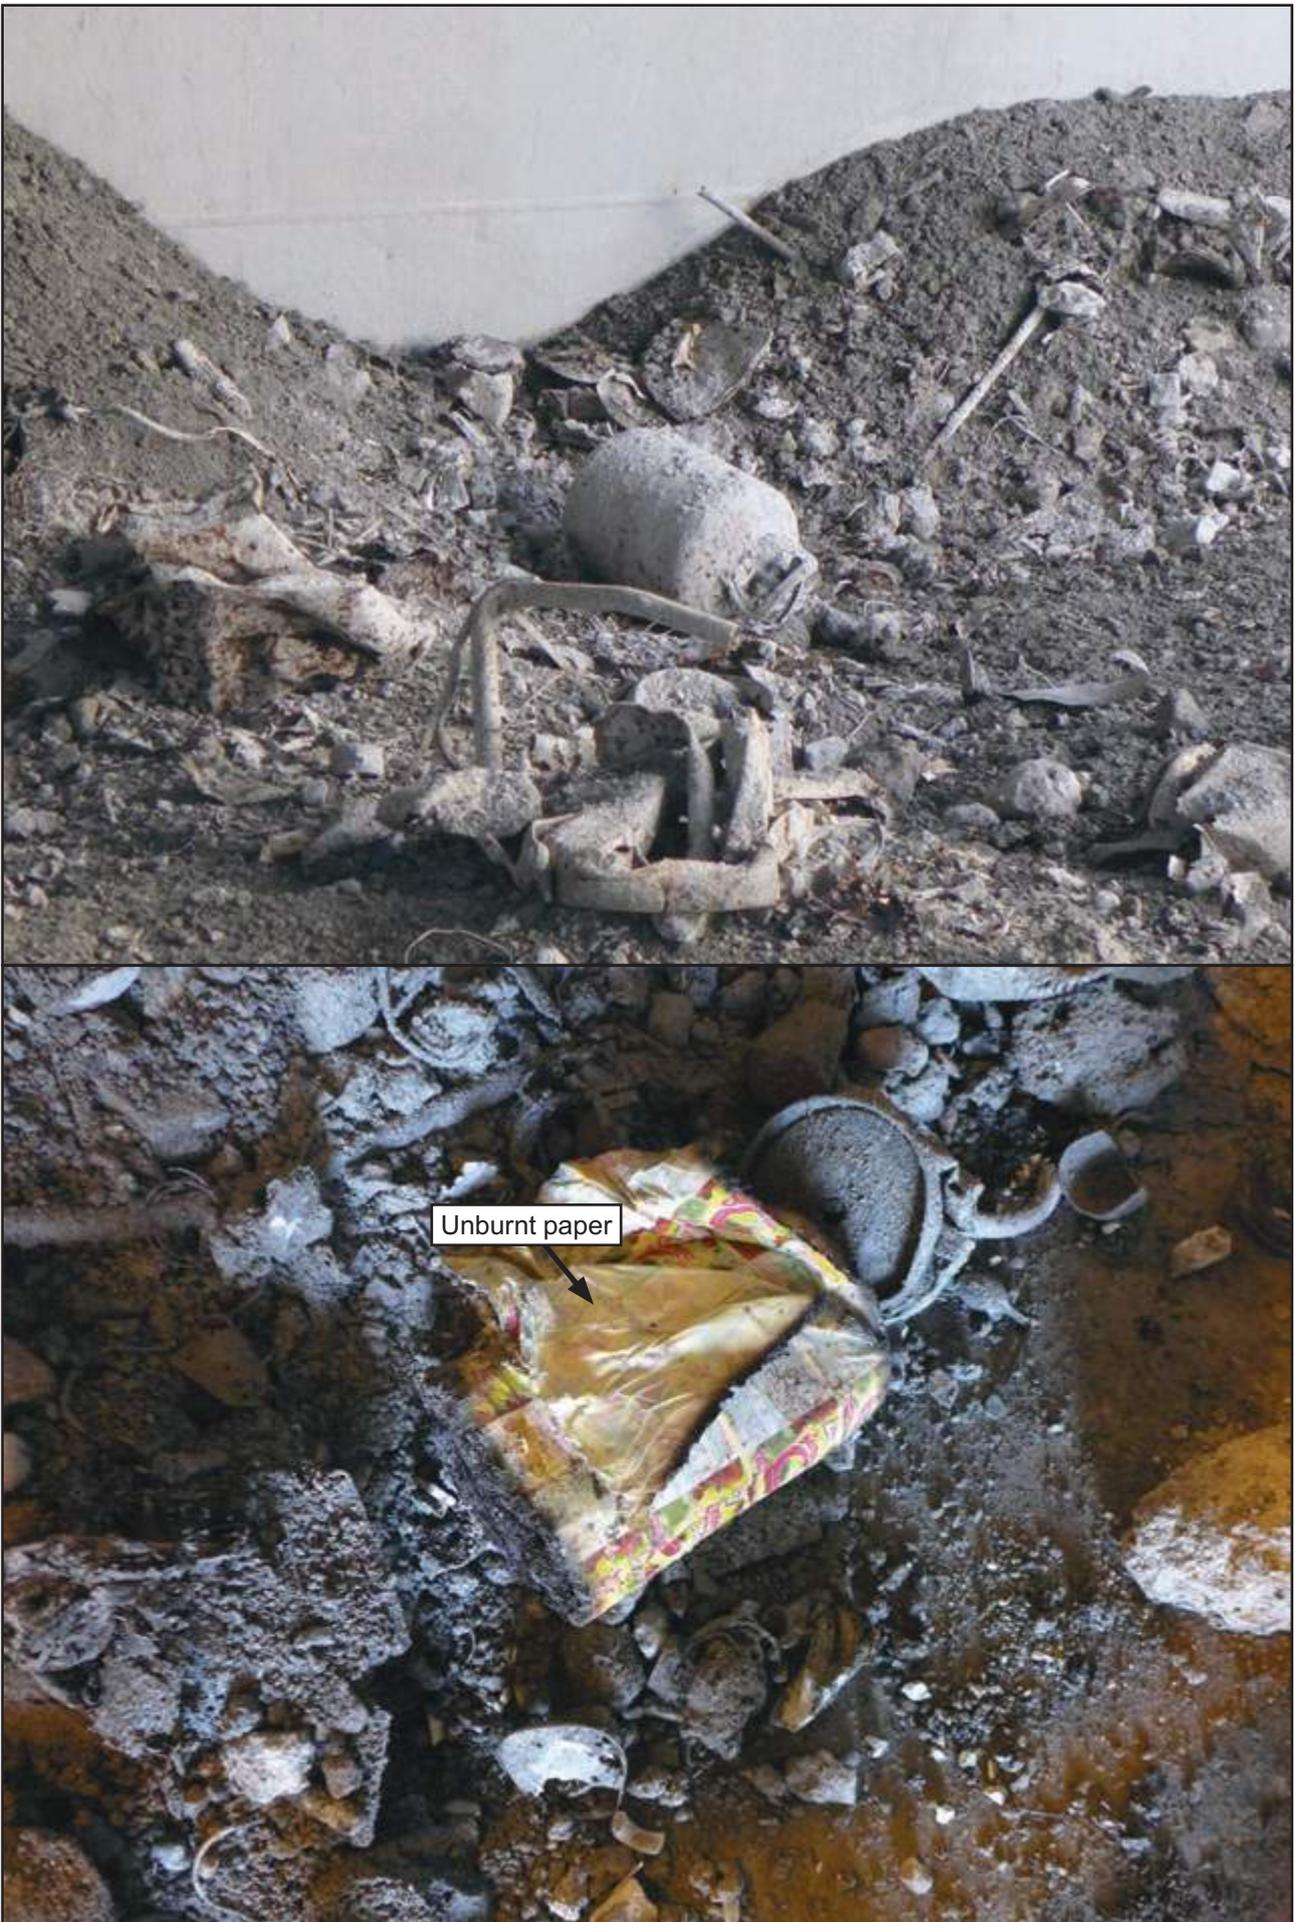
Figure 10: U-IBA from *Nortrader* after the explosion
