**FINAL REPORT**

**SAFETY INVESTIGATION INTO  
COLLISION BETWEEN ALNIC MC AND THE USS JOHN S MCCAIN  
IN SINGAPORE TERRITORIAL WATERS  
ON 21 AUGUST 2017**

**MIB/MAI/CAS.021**

**Transport Safety Investigation Bureau  
Ministry of Transport  
Singapore  
8 March 2018**

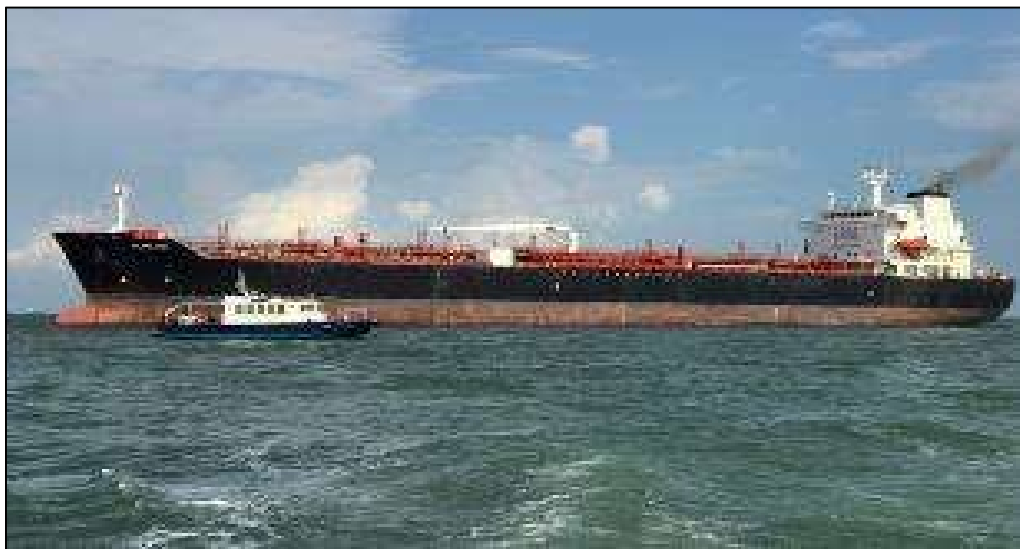
*Figure 1 - ALNIC MC at Singapore anchorage after the collision*

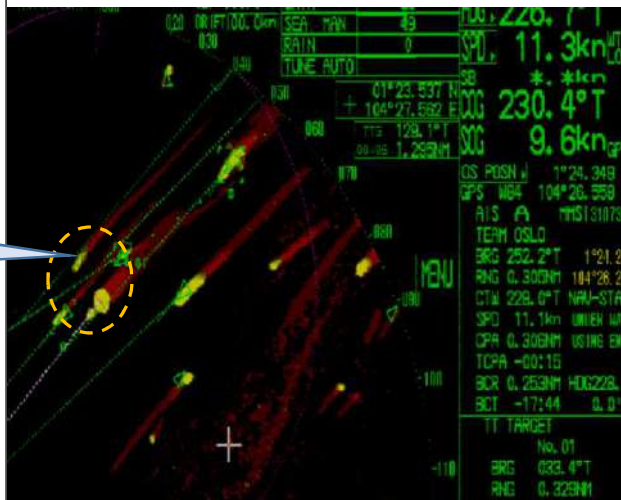
5:21:17	Master attempts to call JSM on Ch 20. No response recorded.	
5:22:04	JSM abeam of AM at a range of 0.27 nm showing a slight turn to Port.	AM's position – 1° 24.349'N 104° 26.558'E Course 230° (T) Speed 9.6 knots JSM not acquired on ARPA.
	JSM abeam of AM showing a slight turn to Port

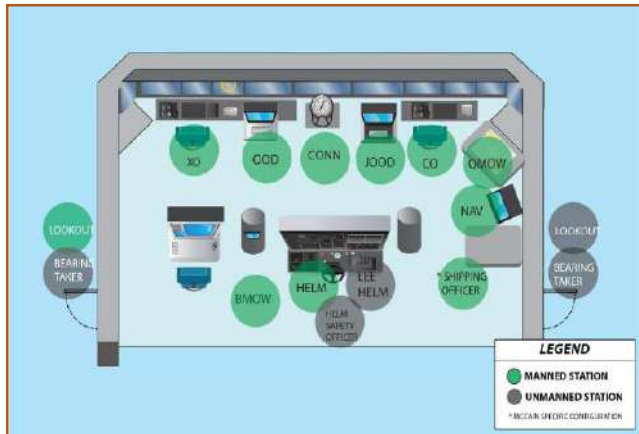
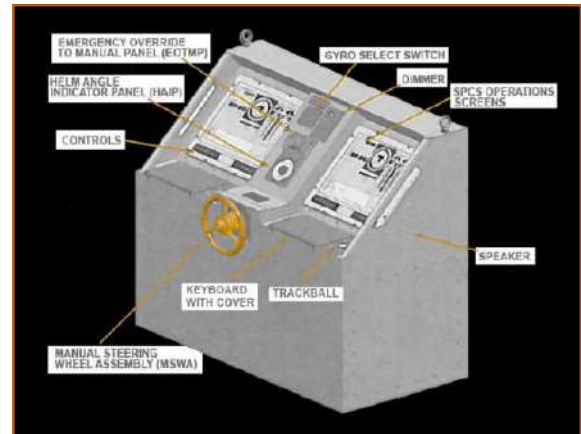
Figure 5 – JSM’s Steering and Propulsion Control System (source: the US Navy’s report)

- 2.2.3 JSM's difficulties began with the transfer of propulsion control from the "Helm" station to "Lee Helm" station. Until then the "Helm" station had been controlling the steering of the vessel and concurrently handling the propulsion of the vessel. When the CO noted the Helmsman struggling to perform both tasks, he ordered the propulsion to be taken over from him. While this unplanned shift was not abnormal, it was not properly executed, and resulted in the transfer of steering control from the "Helm" station to the "Lee Helm" station<sup>54</sup>.

- 2.2.6 The “Aft Steering” took over the controls from the “Helm” station twice at about 0523H within a span of 17 seconds. During the second takeover, the rudder position was at Port 33° as a result of the conduct of a positive steering test at the “Aft Steering” station. The rudder was not returned to zero prior to the change from backup manual mode to computer assisted manual mode at the “Aft Steering” station. This caused an increase in JSM’s rate of turn to Port.

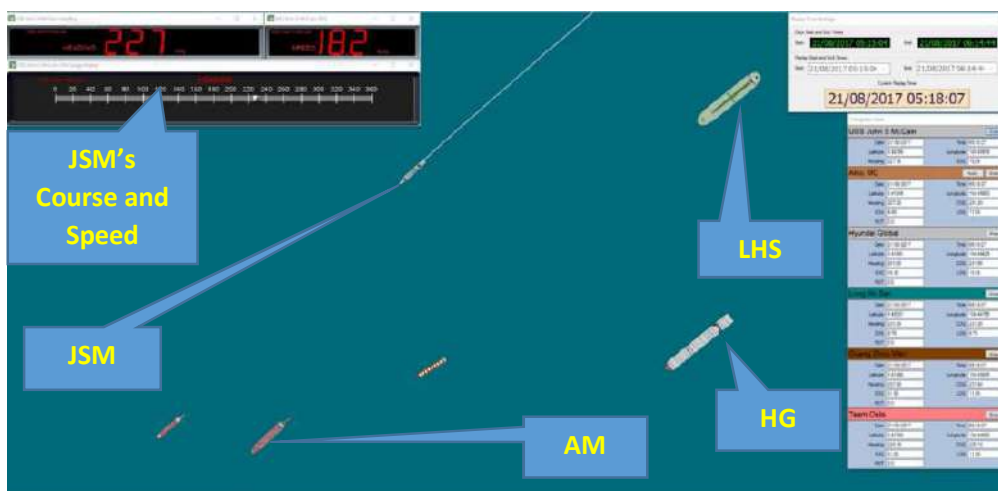
Figure 6 - Graphical representation of position of AM in relation to JSM at about 0518H

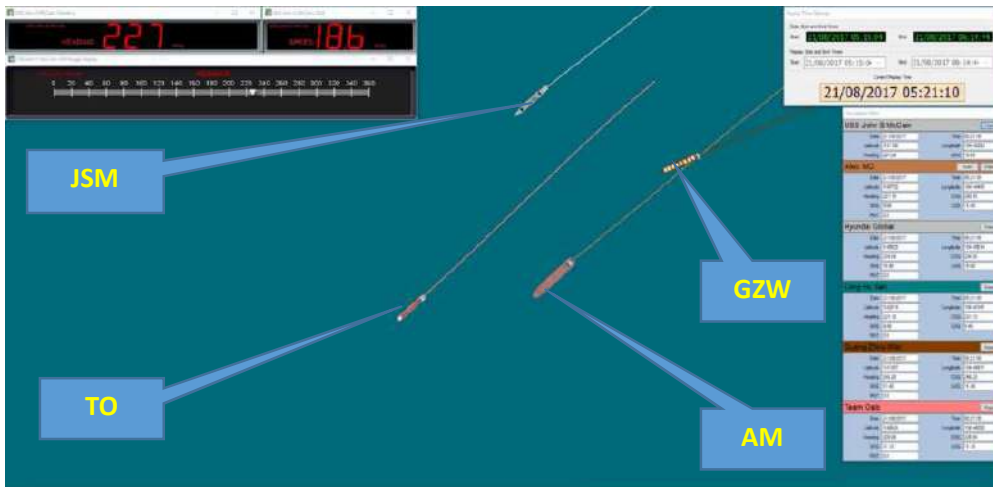
1.7.2 At 0521H, JSM was on a course of 227.8° (T) and engines were full ahead for 20 knots. At 0522H, JSM was making 18.4 knots. About five seconds later, the CO ordered a speed of 10 knots. At 15 seconds prior to 0523H, the CO further ordered a speed of 5 knots. About 15 seconds before the collision, JSM had slowed to 11.8 knots.

Figure 7 - Graphical representation of position of AM in relation to JSM at about 0521H

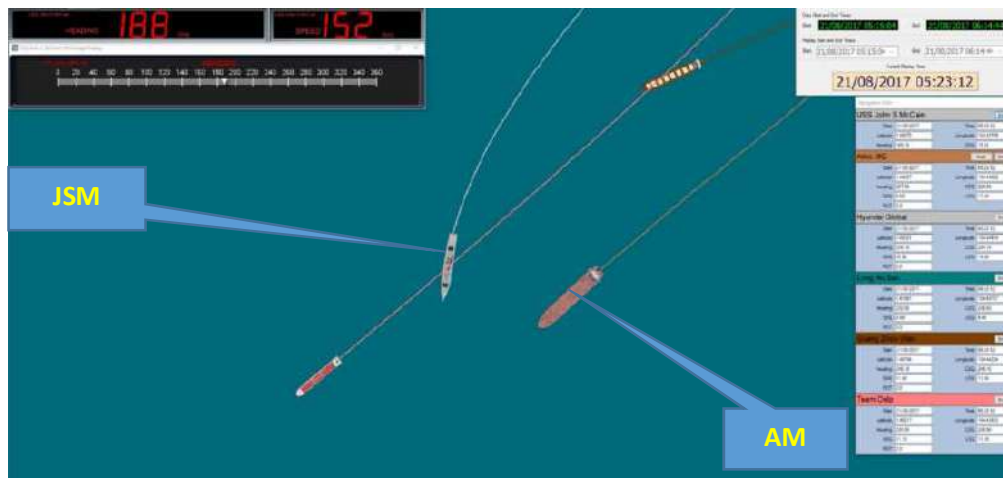
- 1.7.3 Logged data indicates that the first reduction of propulsion took place at about two minutes before the collision. The operating revolutions<sup>39</sup> at this time for Port engine and Starboard engine were 66 SRPM and 90 SRPM respectively. Both engines were operating with 100% pitch<sup>40</sup>.

Figure 8 - Graphical representation of position of AM in relation to JSM at about 0523H

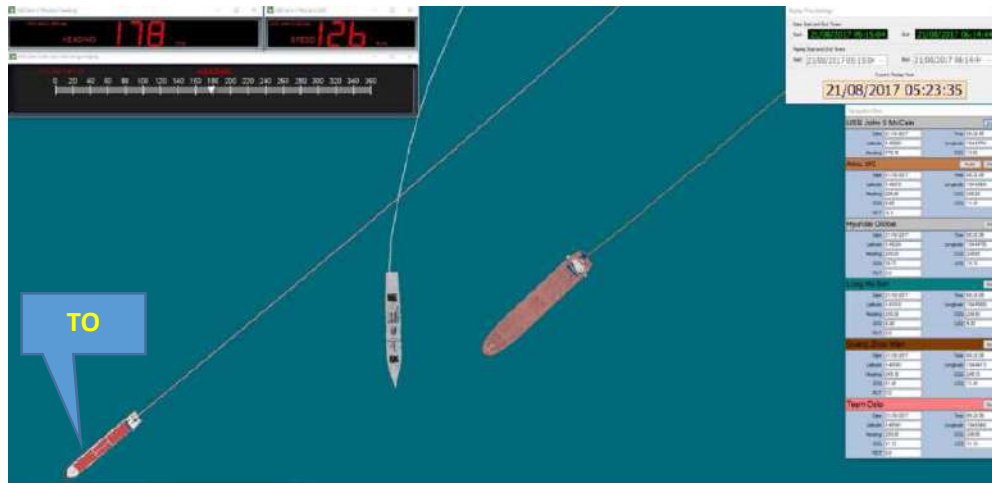
- 1.7.4 Thereafter, command revolutions<sup>41</sup> for the engines were 32 SRPM<sup>42</sup> with 87% pitch followed by an order of 38 SRPM with 48% pitch on both engines<sup>43</sup>.

Figure 9 - Graphical representation of position of AM in relation to JSM at about 0523H

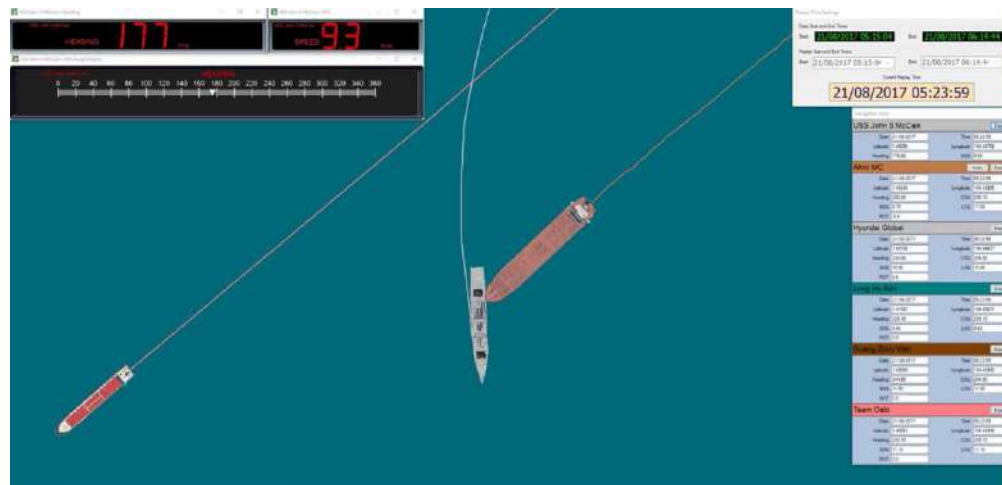
- 1.7.5 Prior to the collision the command revolutions remained as 36 SRPM with 59% pitch and the operating revolutions were at 63 SRPM with 60% pitch on the Port engine, and 64 SRPM with 59% pitch on the Starboard engine.

Figure 10 - Graphical representation of collision between AM and JSM at about 0524H

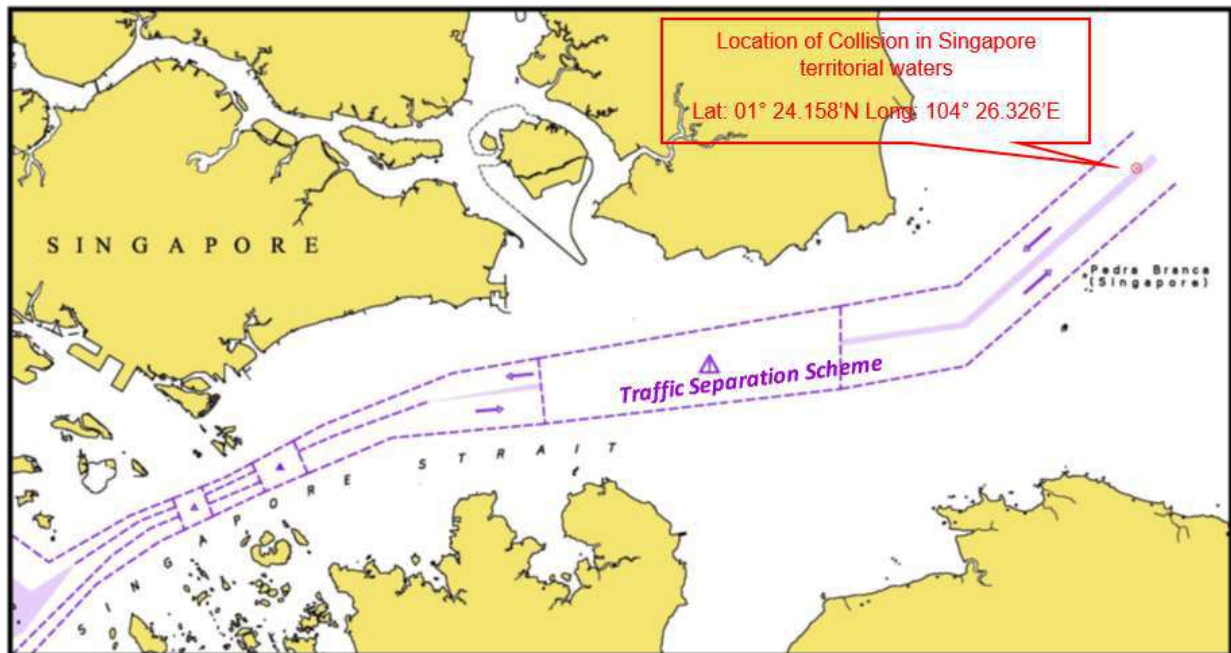
- 1.8.1 The collision occurred in the westbound lane of the Singapore Strait TSS adopted by the IMO, in Singapore territorial waters in position Lat: 1° 24.158'N Long: 104° 26.326'E, at about 4.6 nm NNE of Horsburgh Lighthouse (Pedra Branca).

Figure 11 – Collision location (source: Maritime and Port Authority of Singapore)

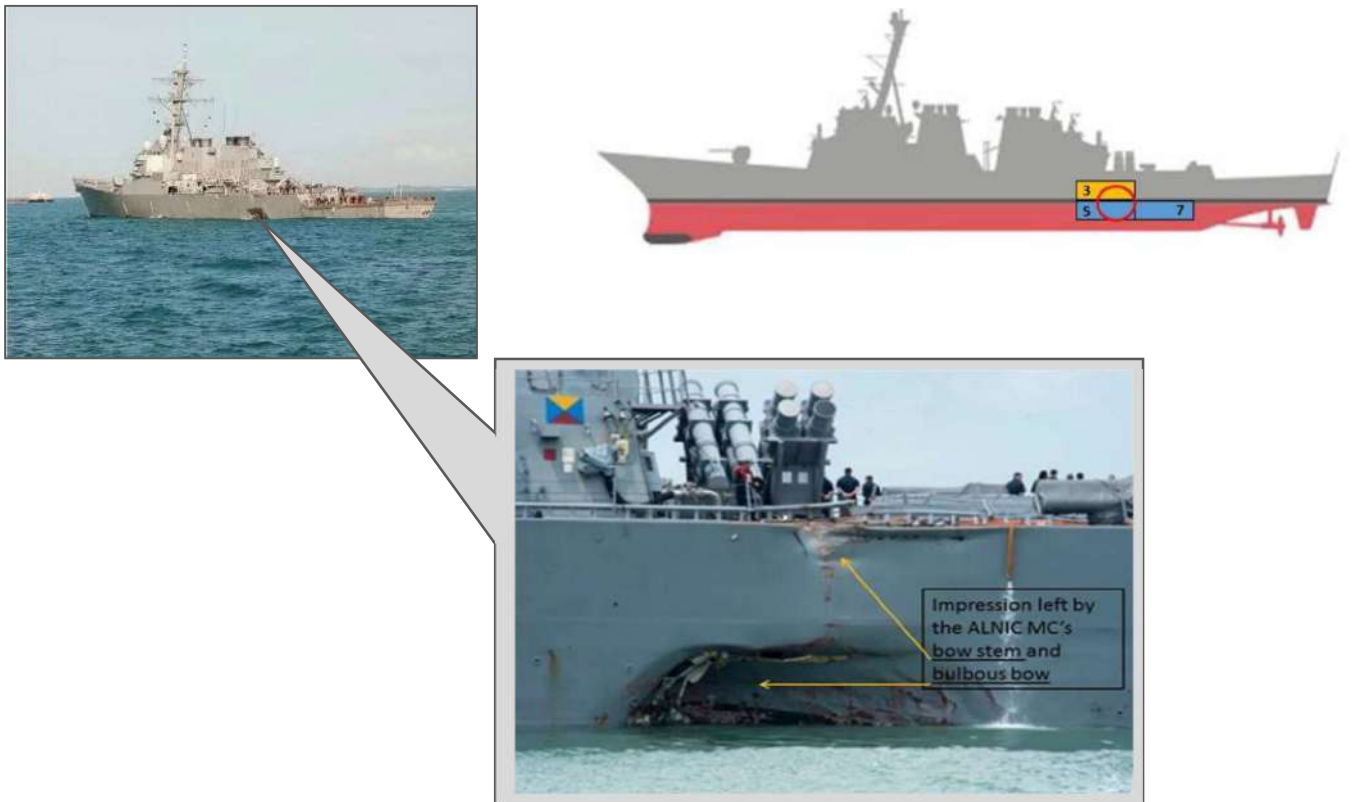
Figure 12 – Source: US Navy

- 1.9.1 The bow of AM collided with the Port aft of midship section of JSM, impacting her berthing 3 and 5 below the waterline (see **Figure 12**).
- 1.9.2 As a result of the collision, AM sustained damages on its Starboard bow (holed about two to three meters long and about seven meters above water level) and some indentation along the Port side. There was no reports of pollution from AM.
- 1.9.3 10 sailors from JSM were reported to be unaccounted for, and five sailors sustained injuries that required medical attention. Search and rescue (SAR) efforts and MEDEVAC procedures were initiated.
