Sinking of the US Cargo Vessel *El Faro*

Illustrated Digest

This digest of the National Transportation Safety Board's (NTSB's) Marine Accident Report **NTSB/MAR-17/01** contains a description of the accident and safety issues, and summarizes some of the safety recommendations intended to prevent such an accident from happening again. The full report and docket can be found at www.nts.gov.

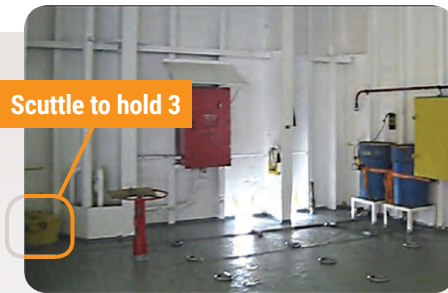
Scuttle to hold 3

Scuttles are small hatches that allow crewmembers to transit between decks. However, the scuttles on the weather deck (second deck) had to be securely fastened to ensure the ship's watertight integrity. *El Faro* did not have remote open/close indicators for its scuttles (see Recommendations, p. 13).

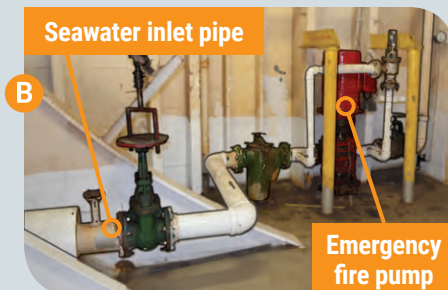
Seawater inlet pipe

Cargo hold 3 housed the emergency fire pump, which was connected to a seawater inlet pipe **B** (photo at left is of *El Yunque*'s emergency fire pump and unprotected inlet piping). Similar components, although arranged differently, made up the corresponding system on board *El Faro*. Hold 3 was also used for vehicle stowage. **C**

One or more of the vehicles in hold 3 had likely struck the emergency fire pump, or “fire main” piping, at the starboard side of hold 3. The inlet piping to the fire main system was designed to supply seawater to the suction side of the emergency fire pump. With a severe breach, seawater would have flowed into hold 3 at a rate that would inevitably overwhelm the capabilities of *El Faro*’s bilge pumps. It is likely that the piping was breached earlier than 0714, based on the continued flooding of hold 3 after the scuttle was secured and the hold was being dewatered by bilge pumps. (Vehicles had likely been adrift at

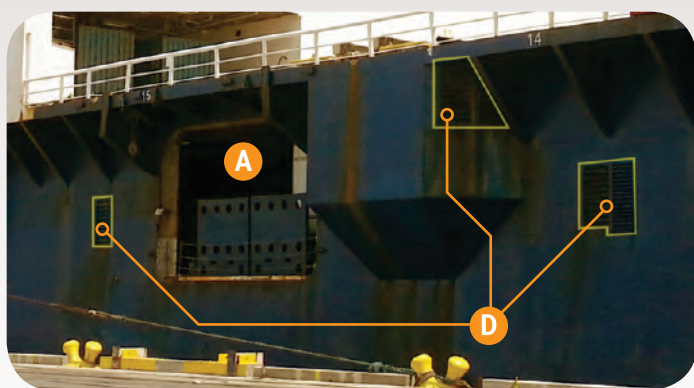
Louvered openings in the hull **D** allowed air to flow in and out of the cargo holds via ventilation ducts. These were required to be opened under way, but could have been shut in heavy weather. Pictured at left is the starboard side of *El Faro*, just above hold 3. Louvered vents are outlined in yellow and a large trailer opening **A** is also visible.

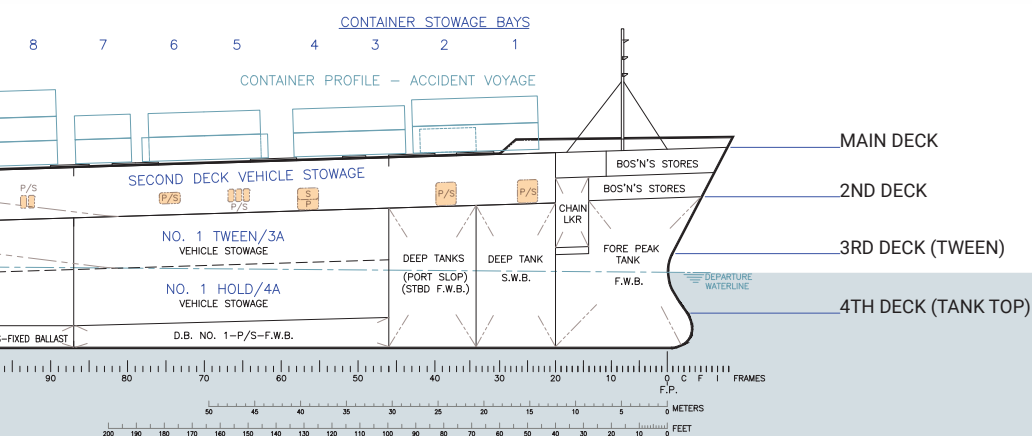
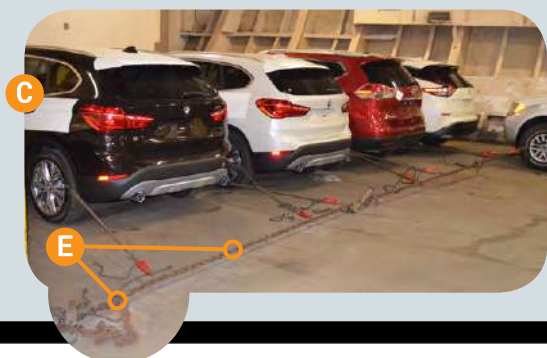
Instead of each automobile being secured to the deck at each corner, they were secured to a long chain across the width of the ship **E** (photo at left is from a similar lashing arrangement on board *El Yunque*). As the ship encountered heavy weather, vessel motion increased and lashings would have failed more easily as the deck became wet and the ship rolled (see How the water got in, p. 6).

At **0544**, the captain was heard on the VDR saying “We got cars loose,” likely referring to automobiles that had broken free from their lashings. The automobile-lashing arrangement did not meet the requirements of the vessel’s approved cargo-securing manual, making automobiles more likely to shift in heavy weather.

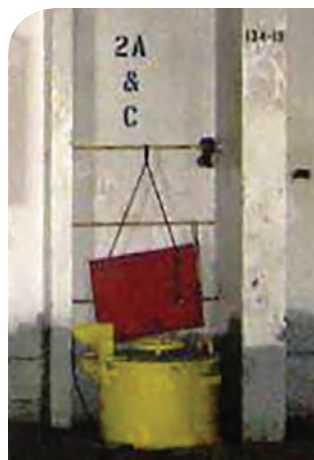
The crew found that a scuttle (small watertight hatch) on the second deck, starboard side, was open and seawater on deck was flowing over it and down into cargo hold 3. The ship’s list to starboard was causing seawater to pool near the scuttle located on the starboard side. The captain told an engineer to begin transferring ballast water from the starboard ramp tank to the port ramp tank.

Second deck scuttle to hold 2A, similar to hold 3 scuttle
Photo: Herbert Engineering

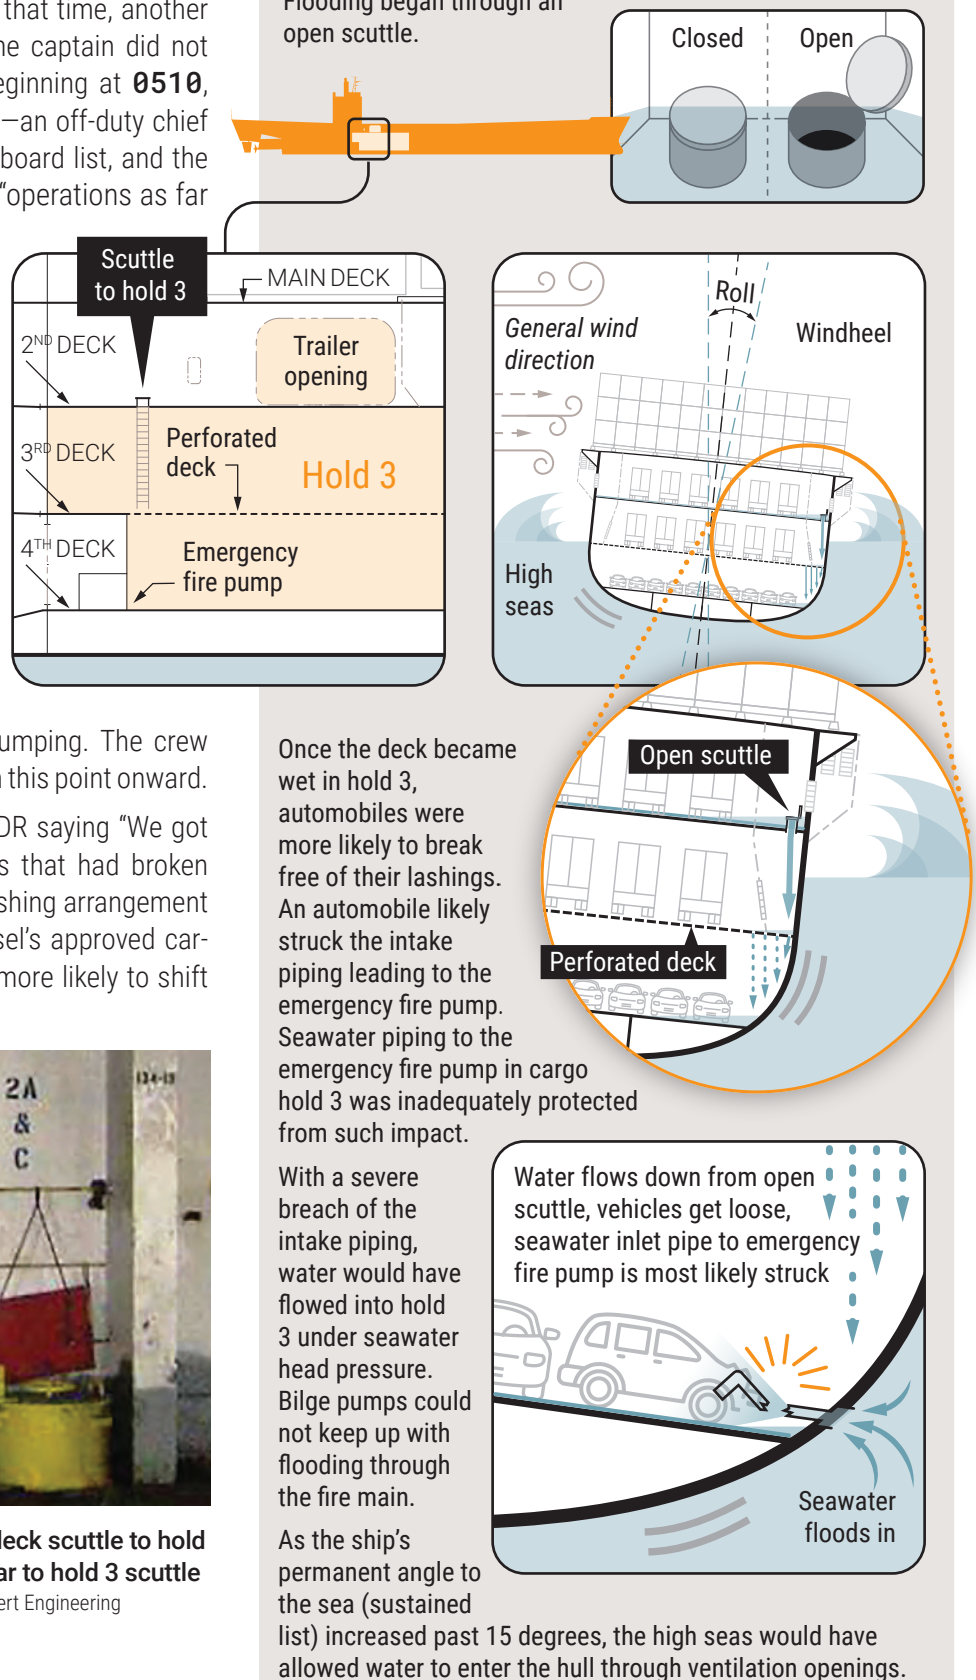
How the water got in

El Faro’s partially enclosed second deck had a number of scuttles that had to be closed and fastened (“dogged”). Flooding began through an open scuttle.

Water initially flooded into the cargo holds through an open scuttle. This lowered deck friction coefficients and likely contributed to loose vehicles in hold 3, which likely damaged the emergency fire pump piping in the hold, allowing seawater to flood the hold faster than the bilge pumps could remove it. The continued hold flooding and increasing list in heavy seas allowed seawater to downflood through the cargo hold ventilation system (see *How the water got in*, p. 6).

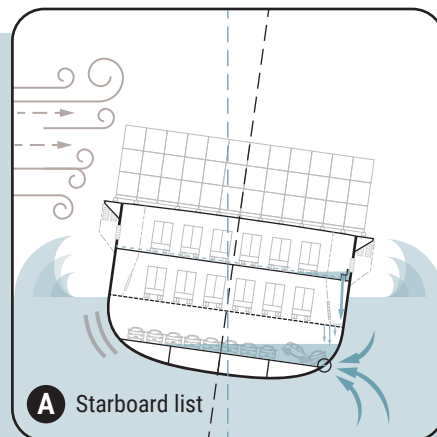
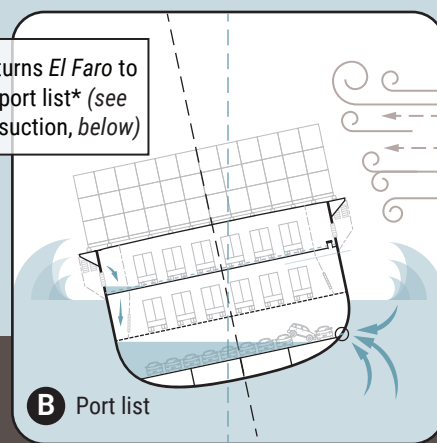
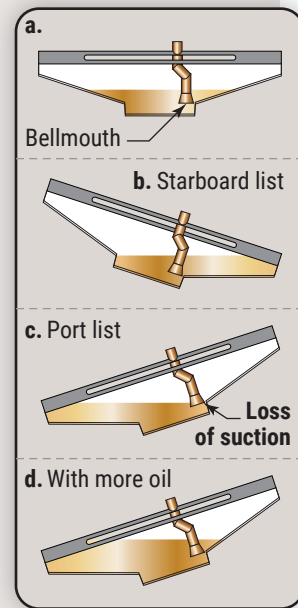
Loss of lube oil suction

Because the bellmouth (intake) for the main propulsion engine lube oil pump was located toward the starboard side, it mattered whether the ship was listing to port or starboard. (The trim of the ship also affected the oil suction; forward trim was worse). It also mattered how much lube oil was in the sump.

Log books indicated no more than 26 inches of oil in the sump in the months before the accident (a). With this oil level, the bellmouth would not take in air (lose suction) with an 18-degree list to starboard (b), but would lose suction with an equivalent list to port (c). With 32 inches of oil in the sump, the bellmouth would continue to take in oil with the same 18-degree list to port (d) allowing normal functioning.

The loss of lube oil pressure would have triggered a protective device, the low lube oil pressure switch, which would have shut off the flow of steam to the main engine. (However, steam continued to flow to turbogenerators for lights and other systems.) To reset the switch, lube oil pressure would have to be restored. Without propulsion, *El Faro* could not maneuver and was at the mercy of the storm.

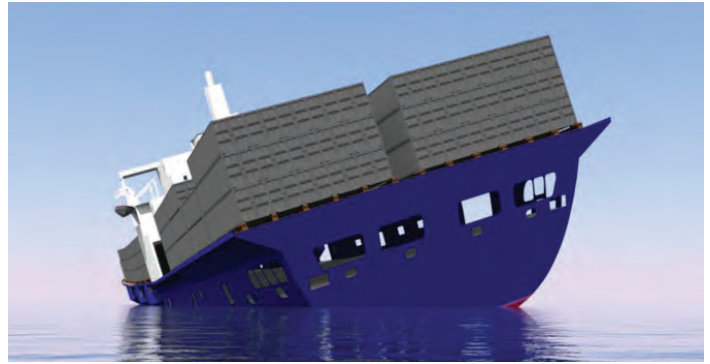
***El Faro* computer rendering in static surface water showing list to port of 18° with departure trim 5.8 feet by the stern due to flooding of hold 3 estimated at 20% and windheel.**

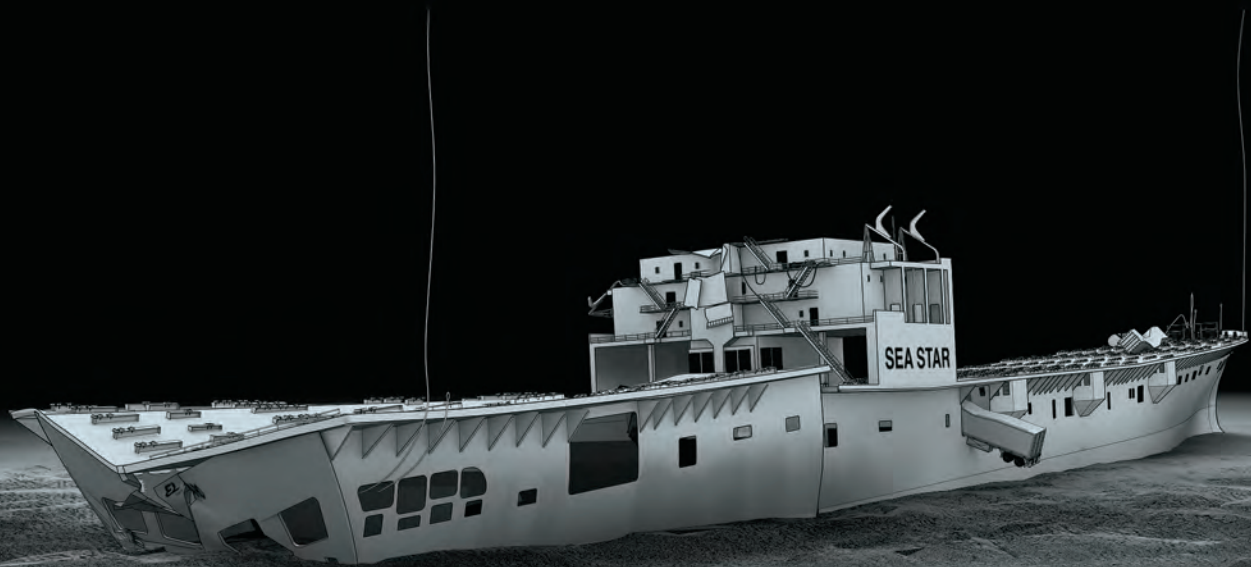
Artist's rendering of *El Faro* at final rest
based on data collected during search and recovery missions
