## Final Report

Marine inquiry MO-2016-202  
Passenger ship, *Azamara Quest*, contact with  
Wheki Rock, Tory Channel  
27 January 2016

Approved for publication: March 2018

# Transport Accident Investigation Commission

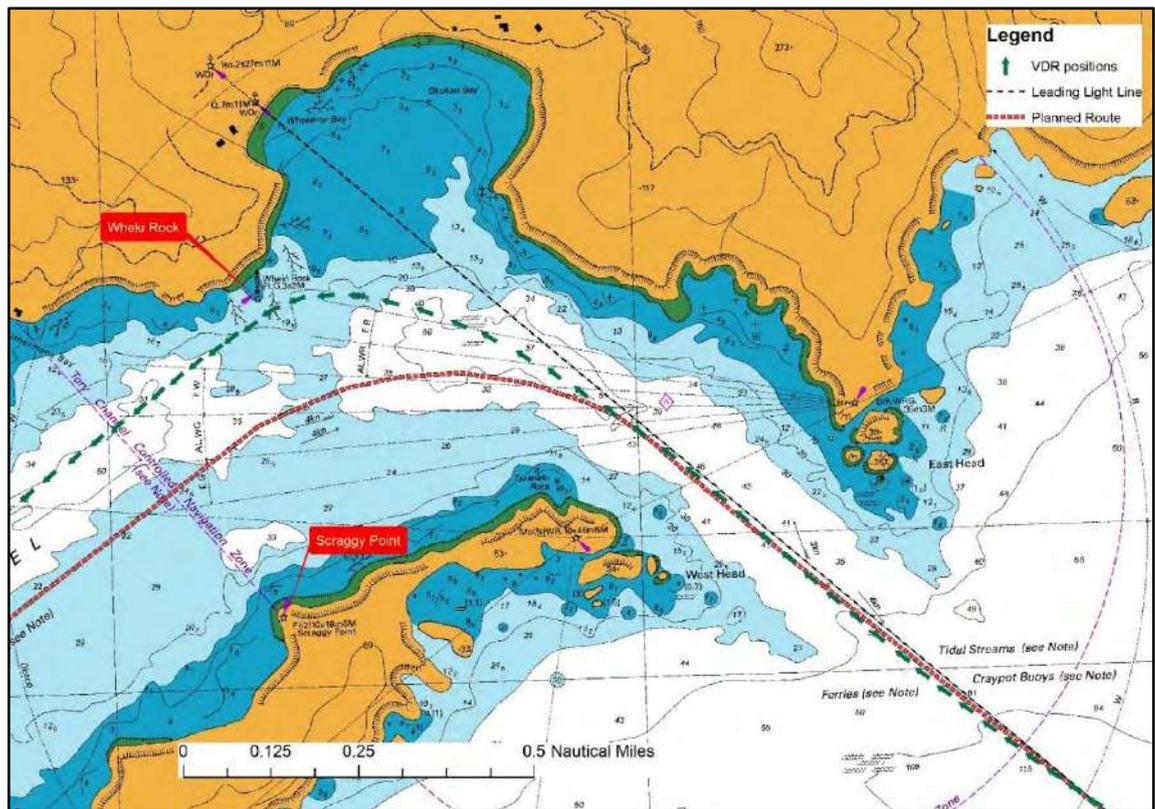
**Figure 2**  
Voyage data recorder positions showing deviation from the planned track

- 3.2.9. The pilot initiated the turn using three degrees of port rudder, followed by successive increases to five and 10 degrees' rudder when he realised the ship was wide in the turn (to starboard of the planned track).

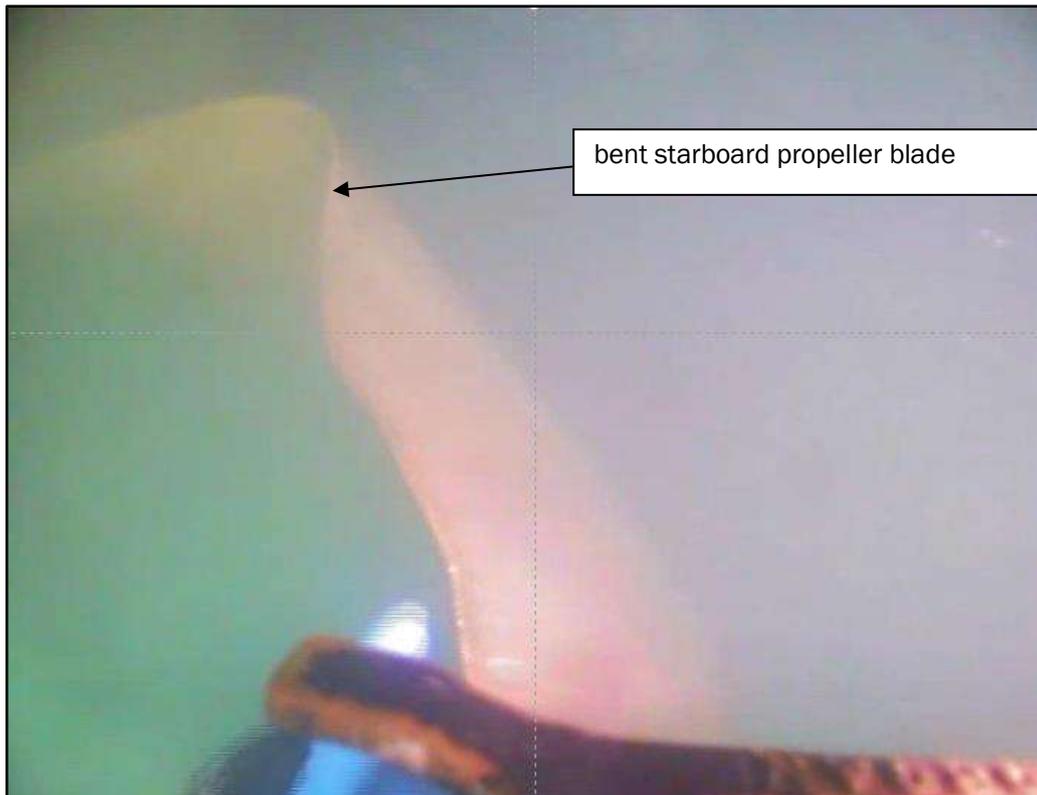
- 3.2.13. The underwater survey found damage on the starboard aft side near double-bottom tank 7804 and the starboard propeller, indicating that the ship had made contact with Wheki Rock (see Figures 3 and 4). Bending damage was observed on the starboard bilge keel and starboard propeller blades. However, there was no indication that the watertight integrity of the hull had been breached.
- 3.2.14. The *Azamara Quest* departed Picton after the classification society<sup>11</sup> had reviewed the damage report and was satisfied that the ship was safe to sail.

**Figure 3**  
**Bent starboard propeller blade**

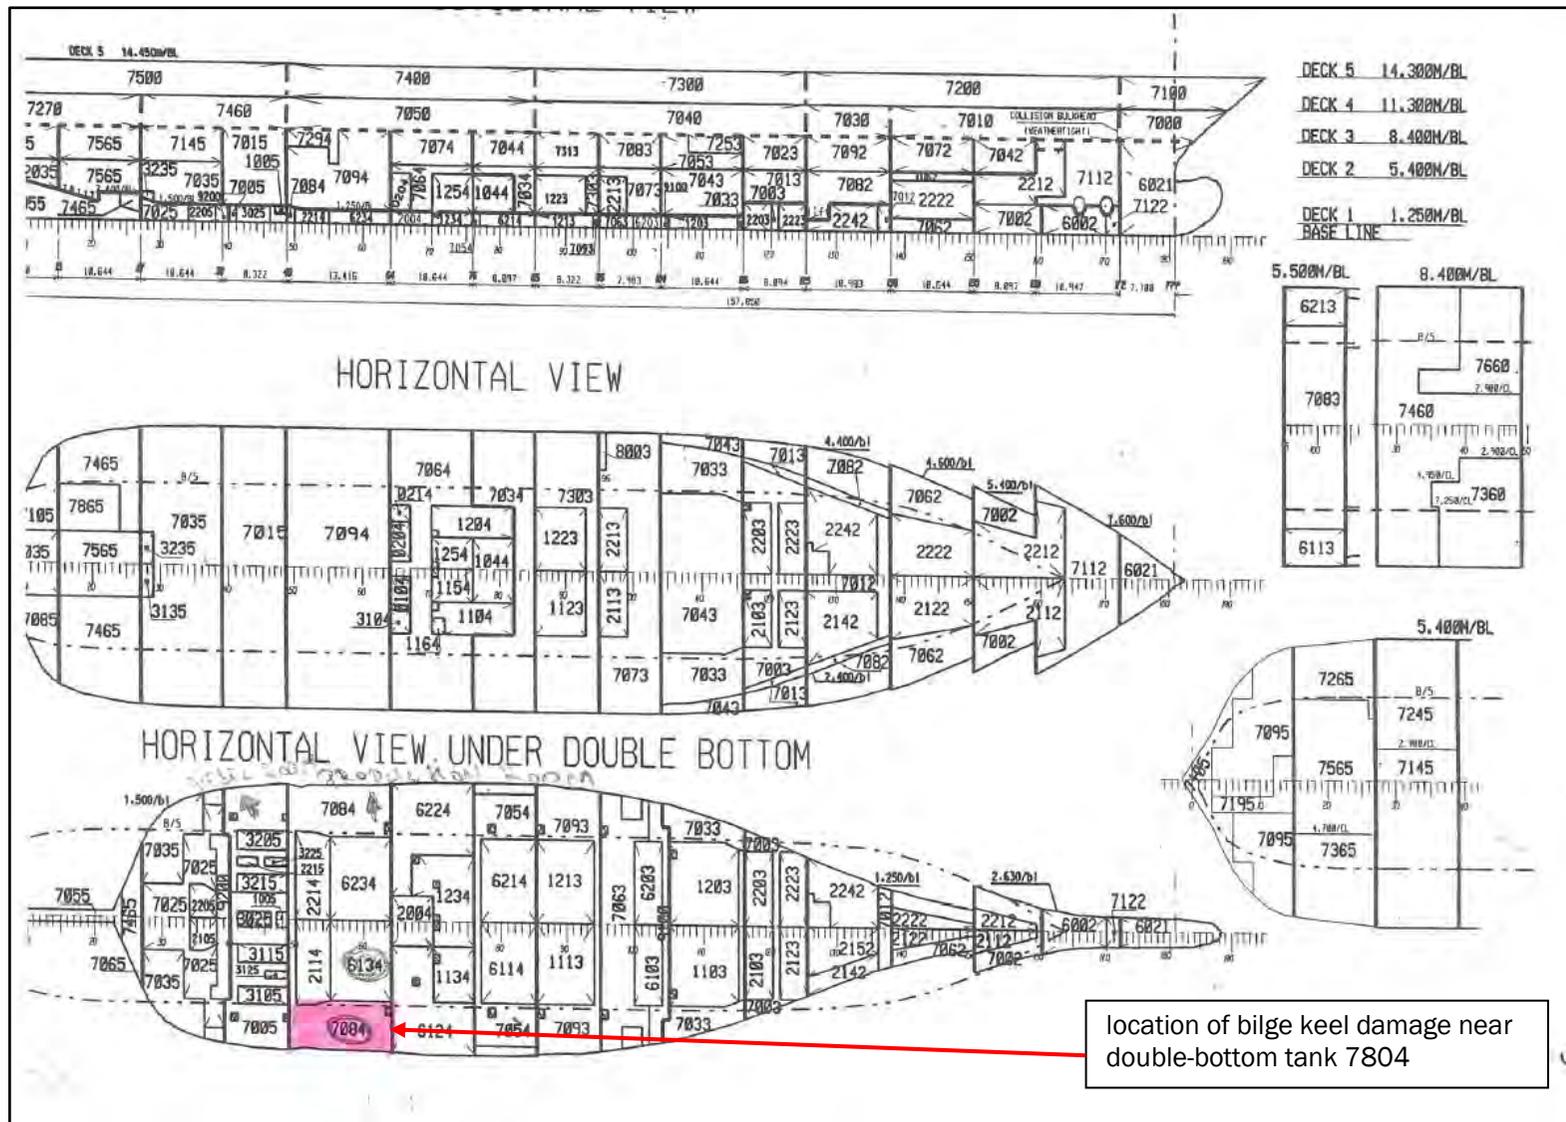
Figure 4  
 Damage to bilge keel near double-bottom tank 7804

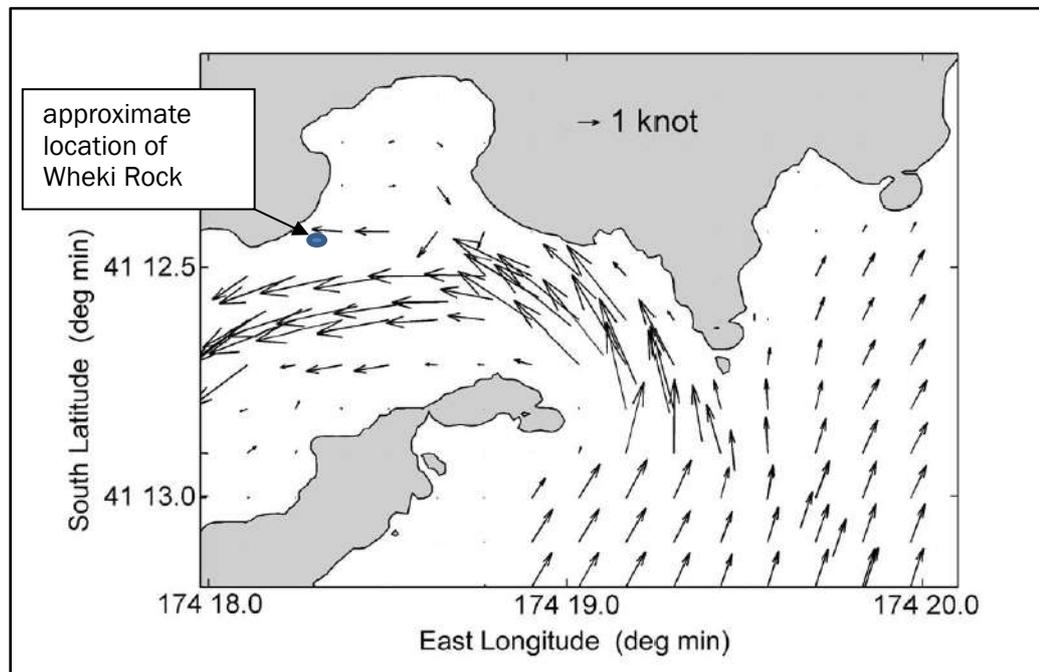
**Figure 5**  
Tory Channel entrance, tidal stream at spring tide, three hours before high water  
(the length of the arrows is representative of the strength of the tidal stream)

- 3.3.2. The tidal stream was about 6 knots<sup>12</sup> through the eastern entrance to Tory Channel. Land Information New Zealand described the tidal conditions as:

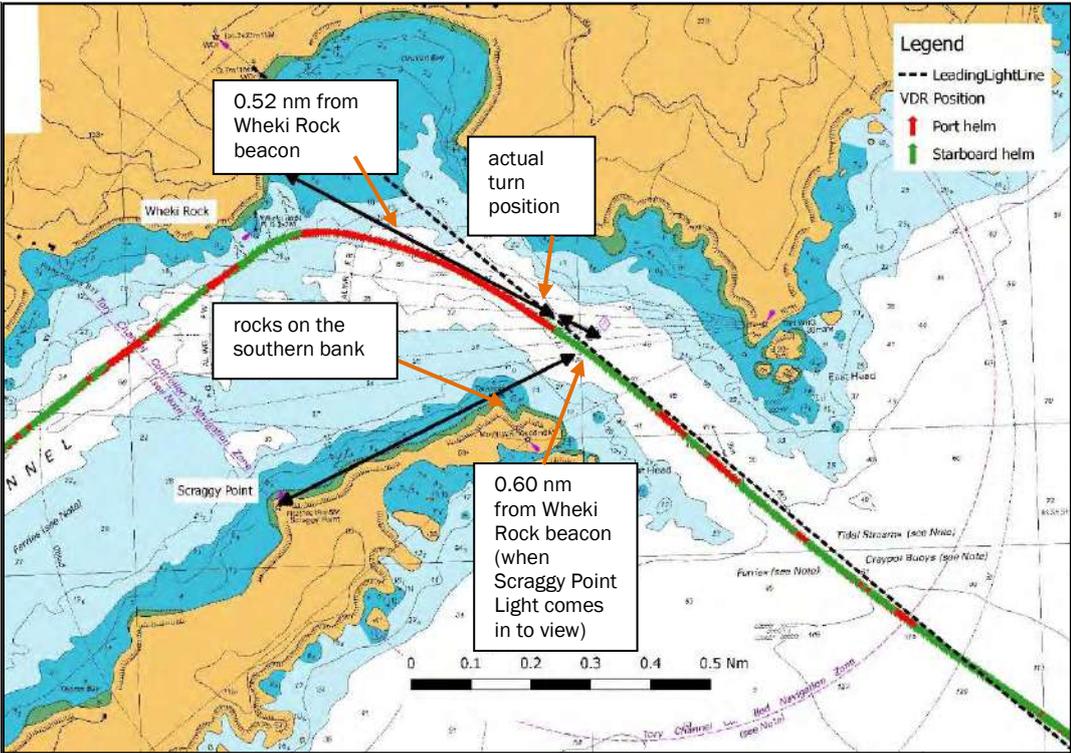
- 4.2.9. The pilot intended to commence the turn when the light on Scraggy Point light came in to sight; this was about 0.60 nautical miles from the line of Wheki Rock. However, the voyage data recorder showed that the pilot gave a port helm order about 21 seconds after Scraggy Point light came in to sight, when the bridge was about 0.52 nautical miles from Wheki Rock. This meant that the ship had advanced about 210 metres past the point where the pilot intended to start the turn. The pilot thought he had started the turn at his intended wheel-over position; he stated that it was not credible that 21 seconds could have passed without his or the master noticing that the wheel-over position had been overreached, and questioned the accuracy of the data sourced from the voyage data recorder and bridge microphones.

**Figure 8**  
 Delay in ordering the start of turn

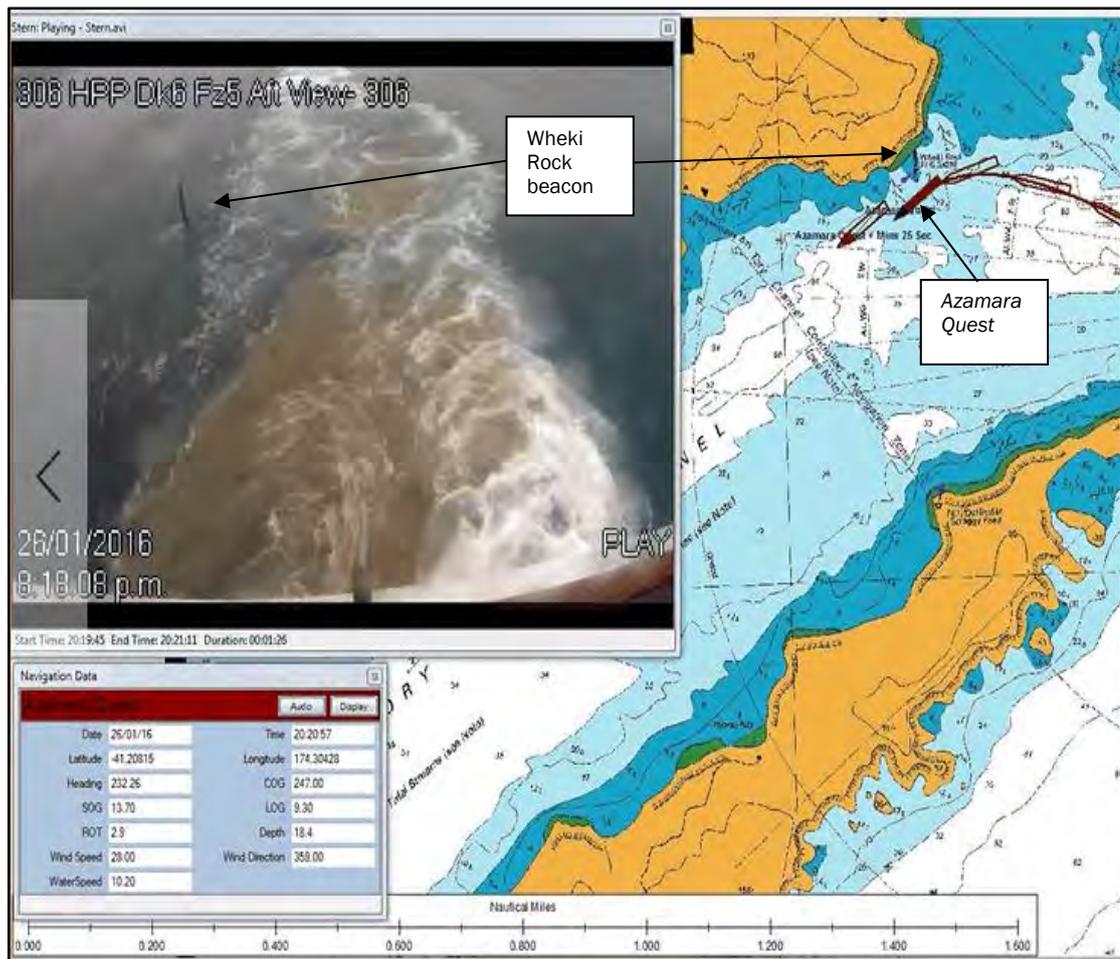
Figure 9  
CCTV<sup>15</sup> footage of the seabed coming to the surface when the Azamara Quest made contact with Wheki Rock

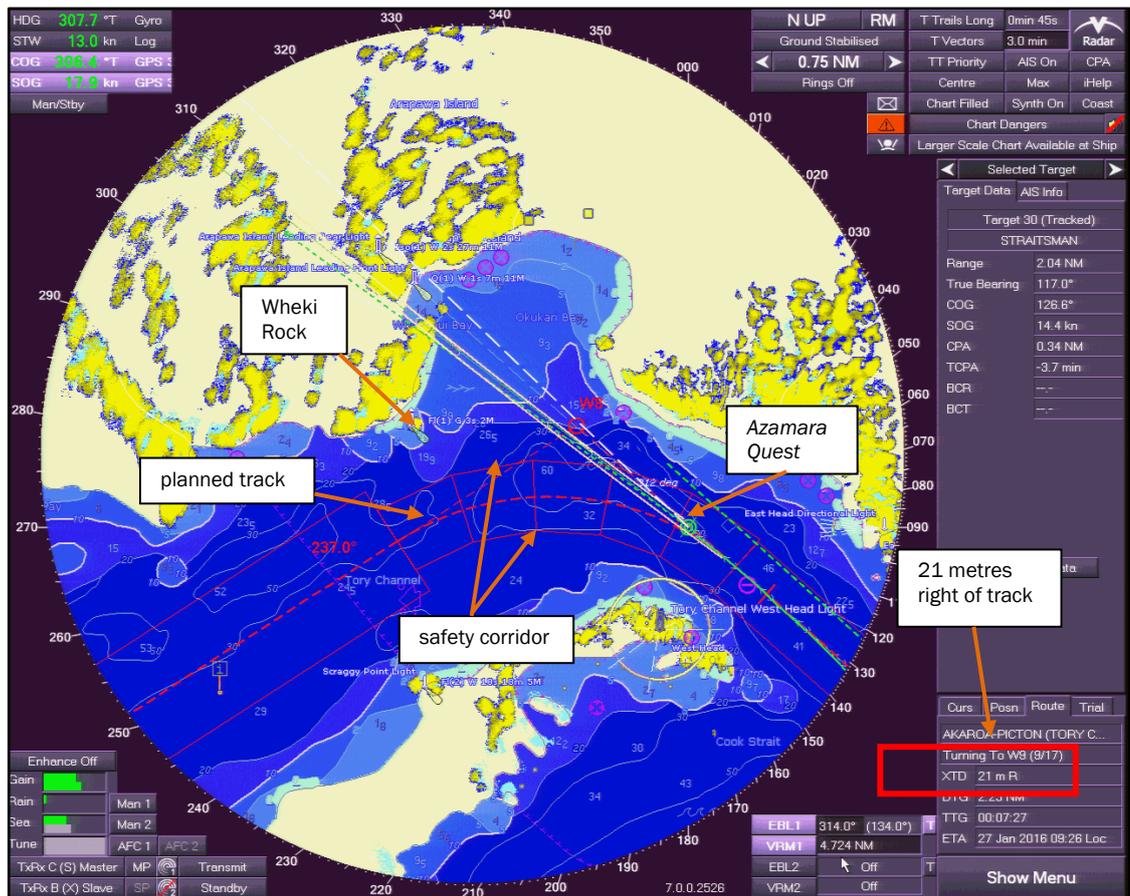
Figure 10

- 4.2.10. The master did not challenge the delay in starting the turn because that was what he was expecting based on his understanding of the pilot/master information exchange.
- 4.2.11. The pilot ordered three degrees of port rudder, expecting that it would start a “good” turn. However, at the time the ship’s heading was swinging slowly to starboard from a previous helm order and the ship was already 21 metres north of the intended track. At that point the ship’s speed over ground had increased to 17.9 knots (see Figure 10).

The Azamara Quest was 21 metres off track when the pilot ordered three degrees of port helm

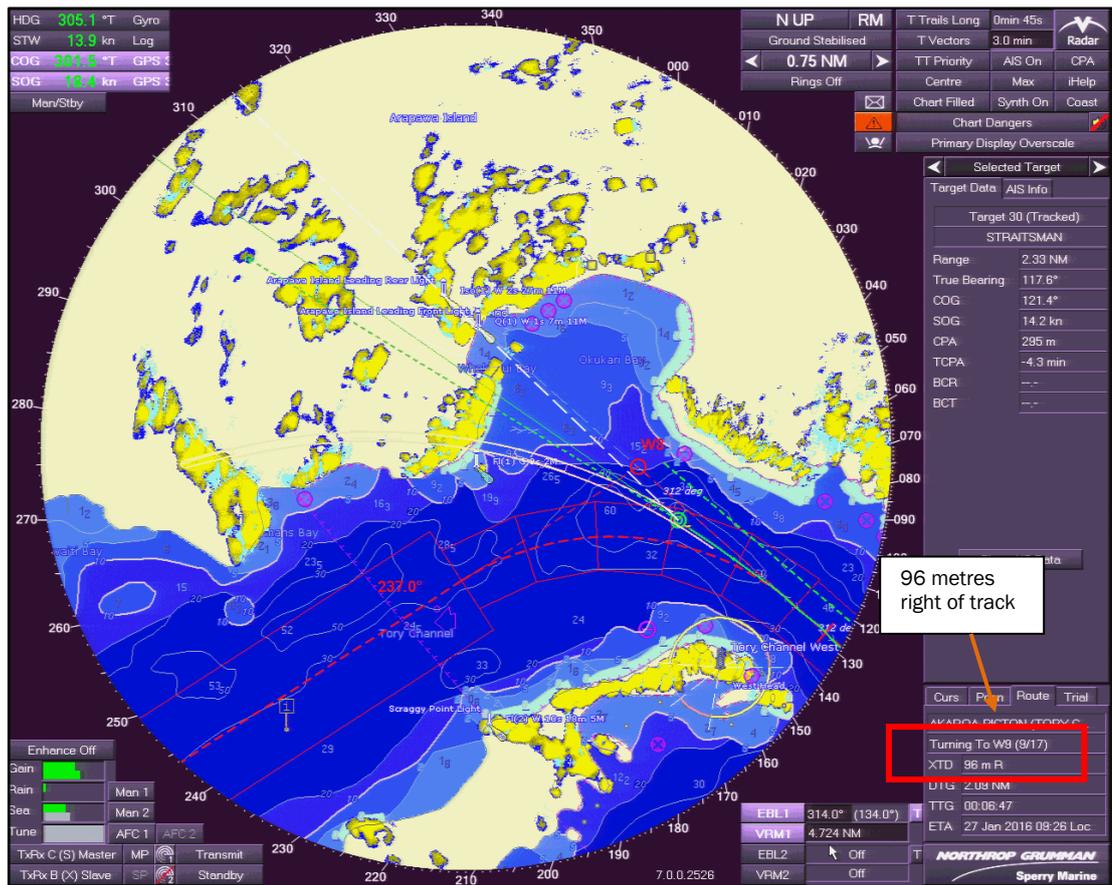
- 4.2.12. The pilot soon realised that the ship was not turning to port as expected, so he ordered 5 degrees of port rudder followed by 10 degrees of port rudder in quick succession. The ship was now about 96 metres right of the intended track (see Figure 11).

**Figure 11**  
**The *Azamara Quest* was 96 metres off track when the pilot ordered 10 degrees of helm**

- 4.2.13. The *Azamara Quest*'s electronic chart display and information system (ECDIS) (with a radar overlay) had a ship predictor feature that displayed on the screen the predicted path of the ship and where the ship would be at a predefined time. The future path and position of the ship was calculated based on the ship's current position, its speed over the ground and its rate of turn, and was displayed on the screen ahead of the ship (see the white curved line and ship shape in Figure 11 and 12).

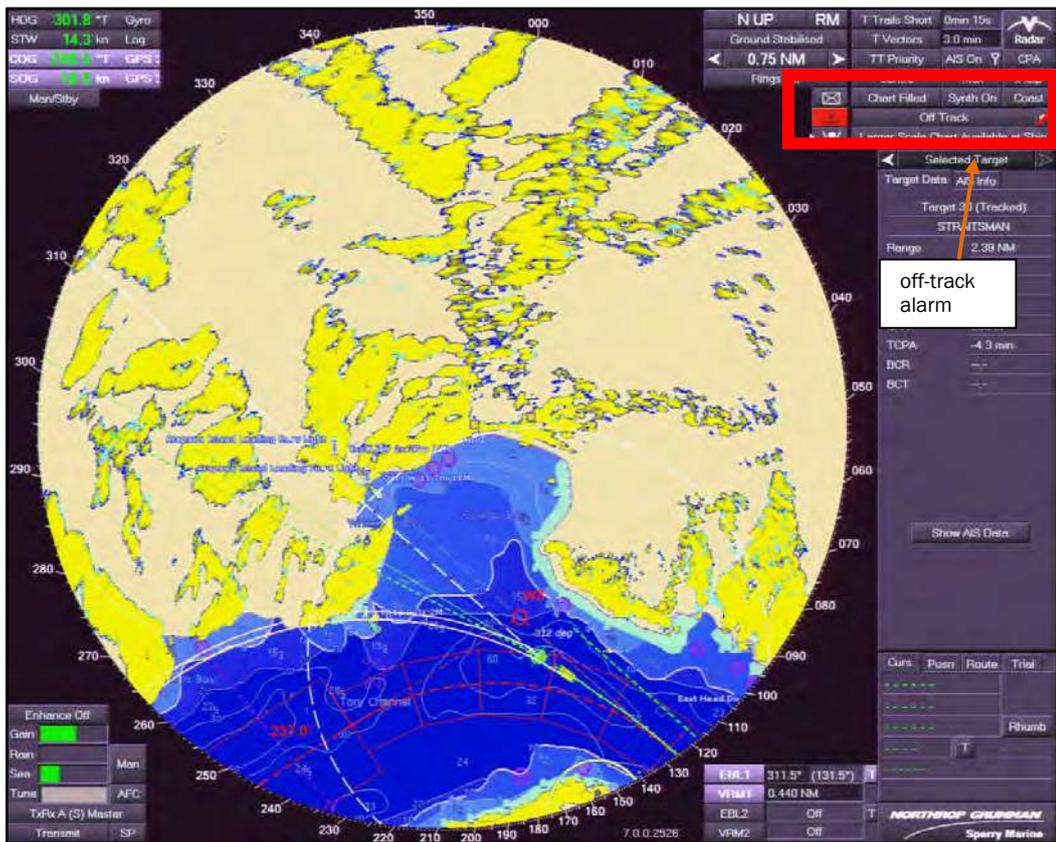
- 4.2.15. At about 0919 an off-track alarm<sup>16</sup> flashed on the ECDIS, but this information was not brought to the attention of the master or the pilot. The alarm was a signal that the ship had departed the predefined safety corridor either side of the planned track (see Figure 10). The alarm appeared only as a visual indicator on the radar screen because its audio had been muted prior to the ship entering Tory Channel (see Figure 12). Muting alarms on an ECDIS is not considered industry good practice.

Figure 12  
Off-track alarm triggered at about 0919

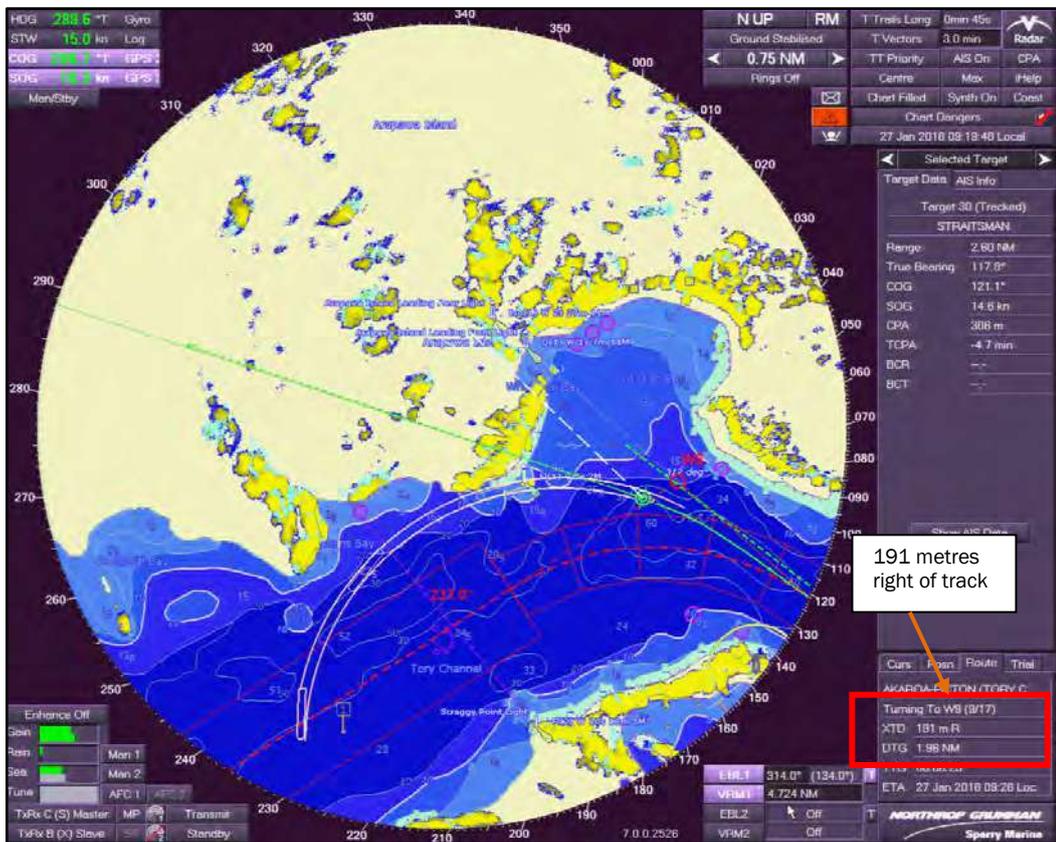
Figure 13  
The Azamara Quest was 191 metres off track when the pilot ordered 20 degrees of helm

- 4.2.16. When the rudder angle was increased to 10 degrees to port, the *Azamara Quest* was 191 metres off track and the predicted path of the ship showed that it was going to pass over Wheki Rock. However, it was another 42 seconds before the rudder was increased to 20 degrees, shortly before the ship struck Wheki Rock (see Figure 13).

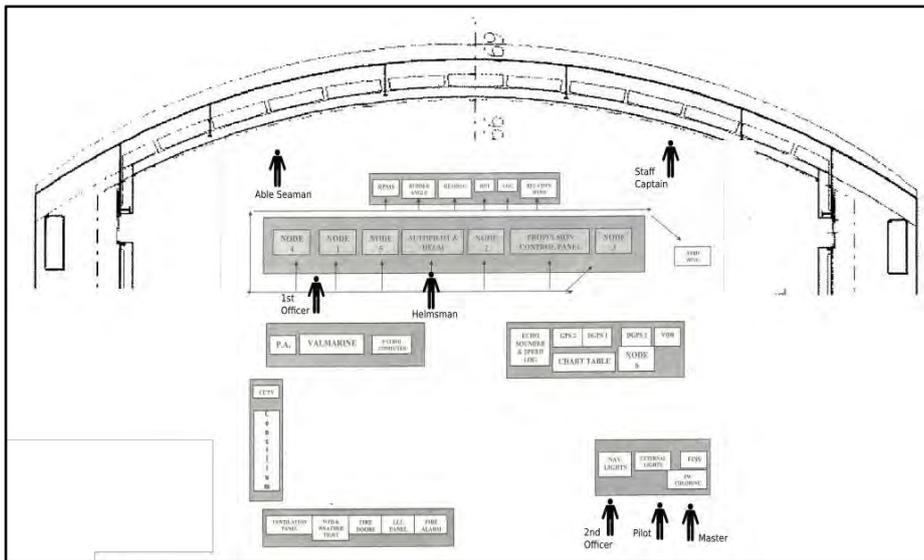
**Figure 14**  
The location of the bridge crew during the pilot/master information exchange

- 4.3.7. The standard of communication among the bridge team was a departure from good bridge resource management practice and also represented a missed opportunity to ensure that everyone was sharing the same mental model of how the ship would transit Tory Channel.
