**[Investigation Report No: 100E / 2018]**

**Very Serious Marine Casualty**

**Fatality due to fall into the sea while working over the ship's side from the Container Ship “MATAR N” on the 20<sup>th</sup> of July 2018**

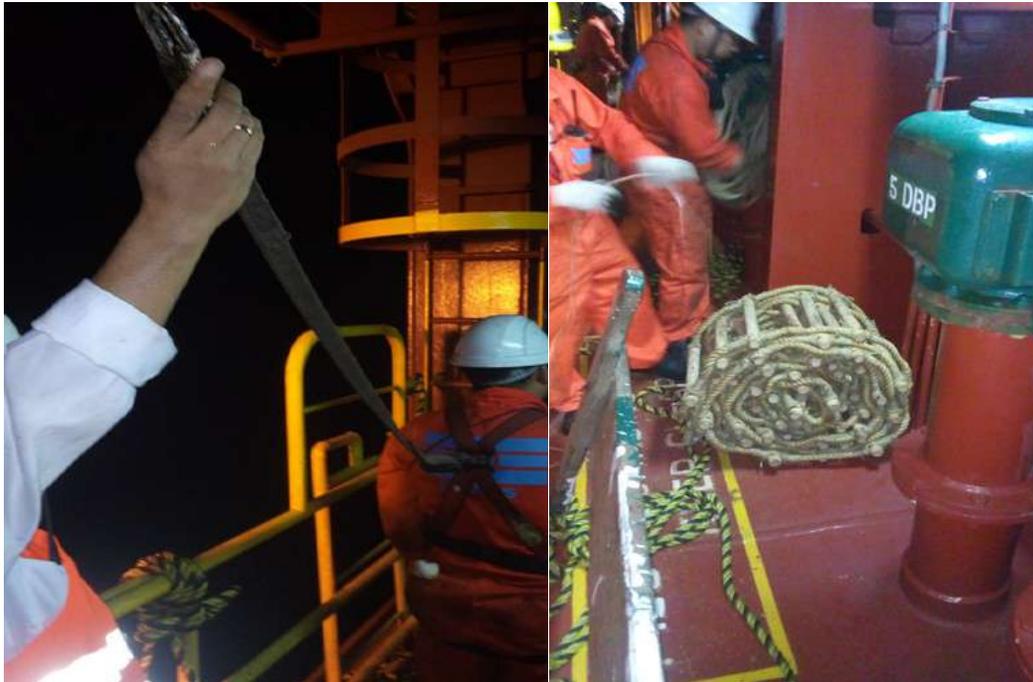
The Painting Stage's dimensions were measured by the Investigator. Painting Stage's Length was 2.00m, Breadth was 27cm and Thickness was 5cm. The transverse bearers of the painting stage, were 90cm. The breadth of the cradles (but not of the stages), according to the "ILO Code For Safe Working Practices", should be 40 cm. No reference for the stages dimensions is being made neither by the ILO Code nor by the "Cyprus Code of Safe Working Practices for Merchant Seamen". Also, the seaman who works is seated on the painting stage the most of the time. Therefore, it cannot be supported that the painting stage was not fit for purpose being only 27cm breadth.

Safety Line & Safety Harness

Jacobs Ladder and Painting Stage

No any certificates existed for the Safety Line, Safety Harness, Jacobs Ladder and Painting Stage. During the demonstration, the snap hooks of the safety line were operating properly. The Jacobs ladder and the painting staged seemed to be in good condition.
