REPORT

Marine 2019/03

REPORT ON MARINE ACCIDENT – AURORA EXPLORER, IMO NO. 9196723 ALLISION WITH QUAY AND PASSENGER INJURIES, BARENTSBURG, SVALBARD 15 JULY 2018

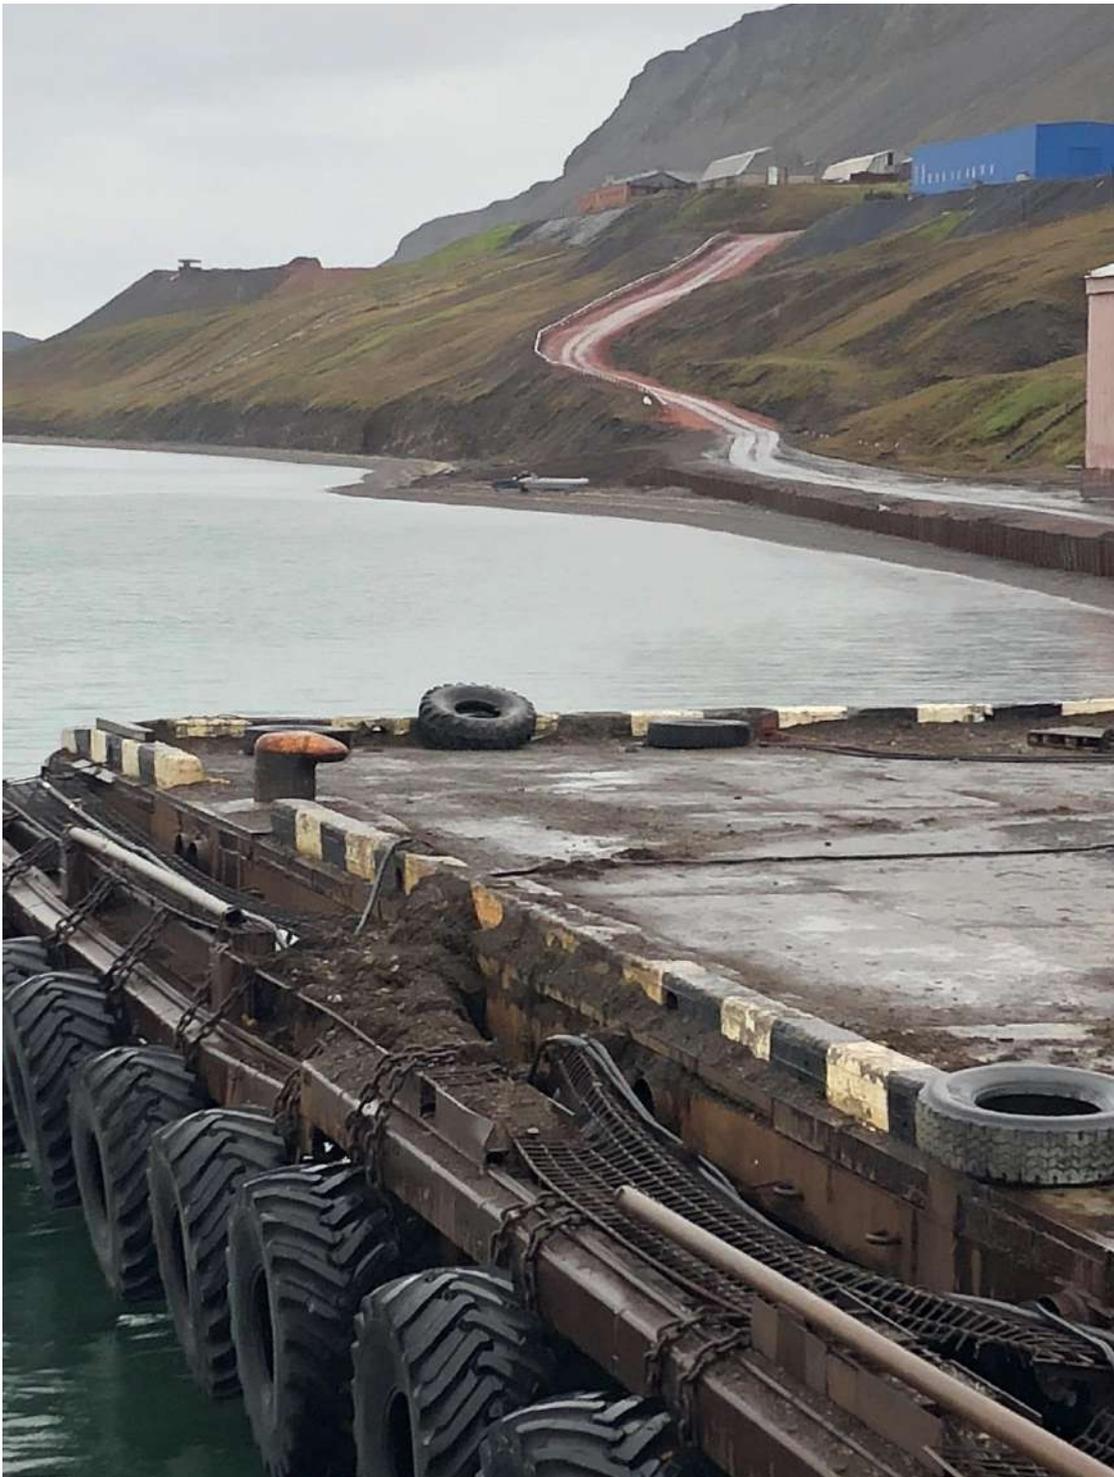
According to the master, speed was reduced to around 3 knots. Around 10-20 metres from the quay, the port engine suddenly increased power. The vessel swung uncontrollably to starboard, which led to the starboard foredeck colliding with the fenders (large rubber tyres) on the concrete quay.

*Figure 3: Quay and fender arrangement at the relevant quay in Barentsburg, Svalbard.
Photo: AIBN*

The submerged part of the starboard hull (the rapier) passed in under the quay. The collision led to passengers and crew being thrown forwards on the open deck and in the saloon below. The vessel sprang back from the fenders after impact, causing people to be thrown about again. The master disengaged both engines immediately after the collision. When he then re-engaged them in combinator mode, the engine, steering and manoeuvre handles functioned normally. *Aurora Explorer* was then moored with her starboard side against the quay. The collision caused injuries of varying severity to 37 passengers and

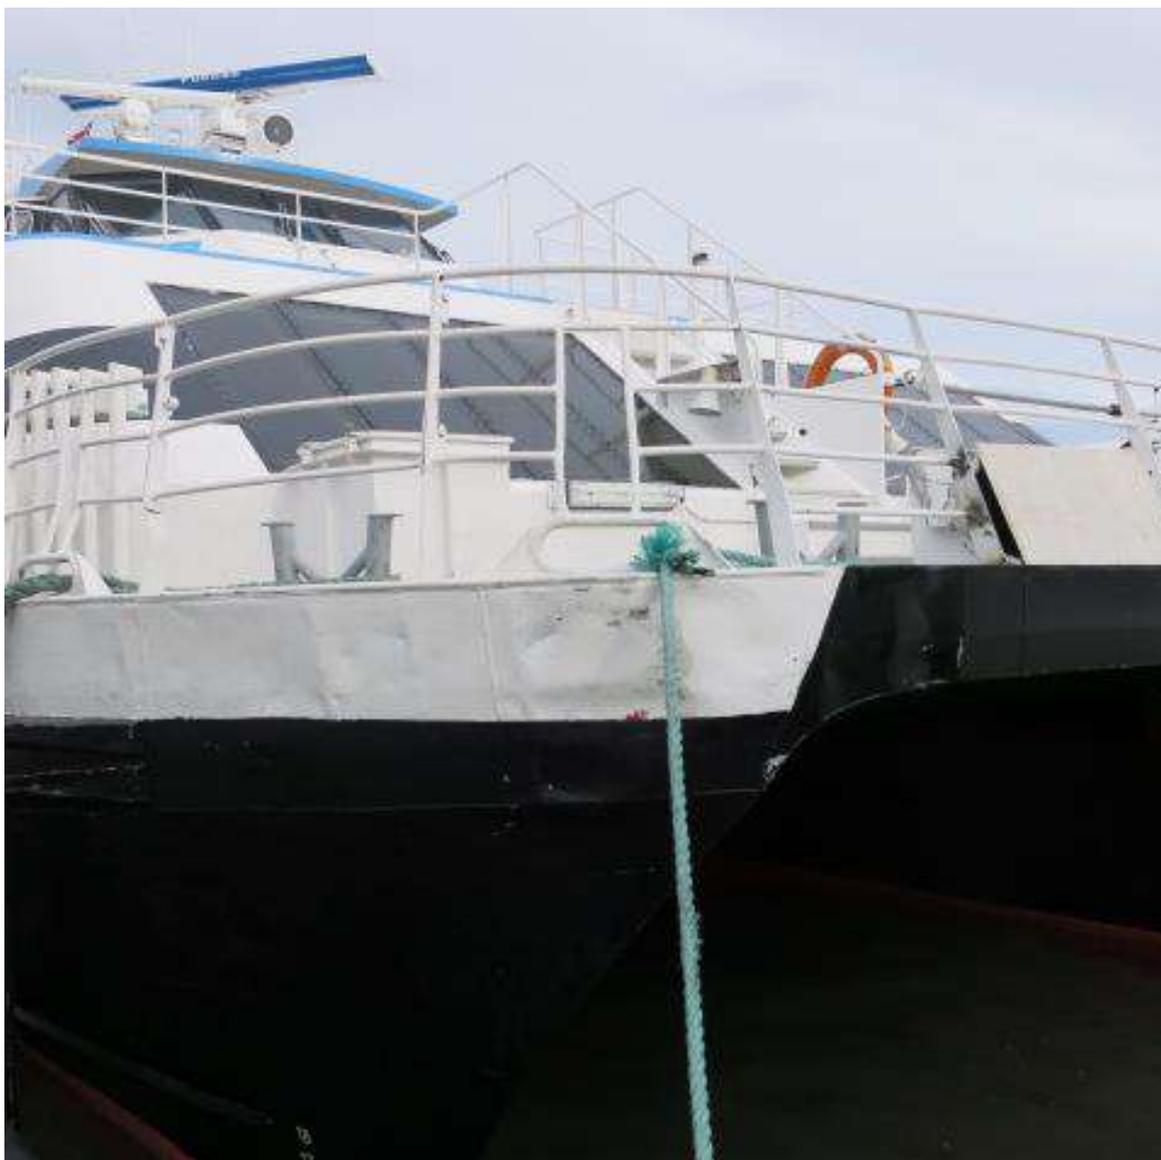
When the port engine increased power, the vessel swung to starboard and the starboard side of the hull took the force of the collision with the fender on the quay. The vessel suffered only minor damage above the waterline, with no water ingress. No emissions/pollution of the sea were recorded.

*Figure 4: Aurora Explorer at the quay in Longyearbyen after the collision. The collision with the quay in Barentsburg caused only minor damage to the starboard hull and searchlight.
Photo: AIBN*

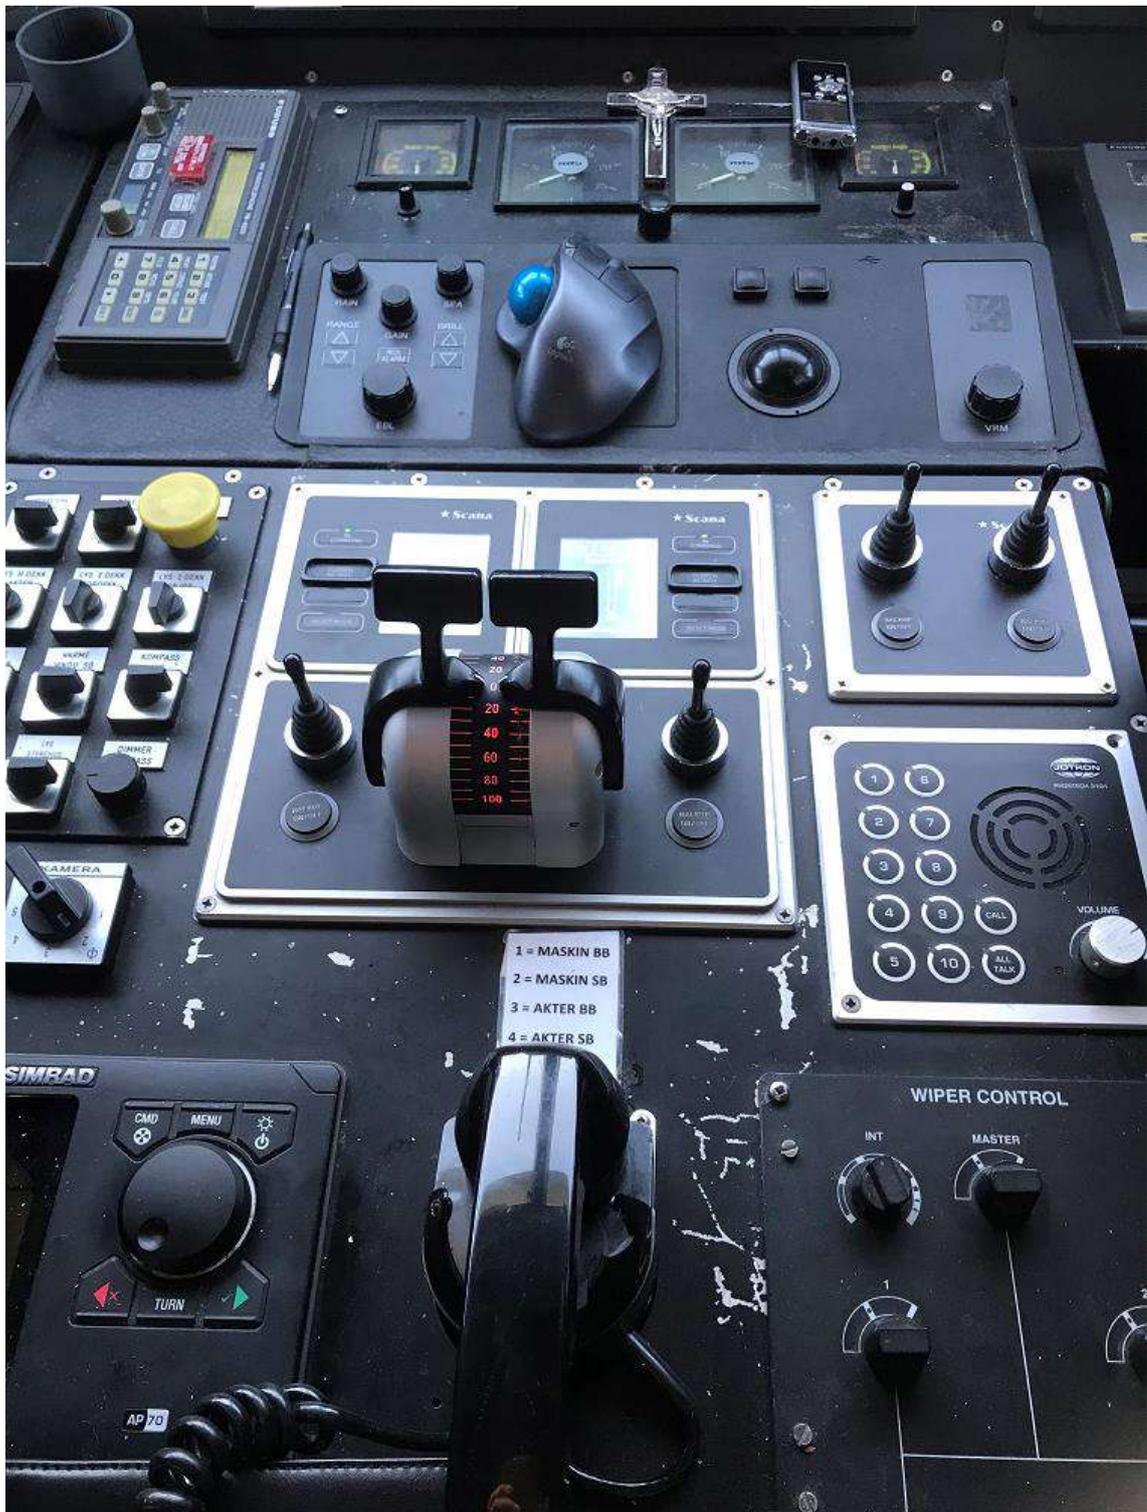
One theory, advanced by the master, was that the unexpected power increase might have arisen if he had involuntarily pressed the button for constant rpm on the port engine just before arrival at Barentsburg, thus causing rpm to increase unexpectedly.

Figure 5: The manoeuvre console on board Aurora Explorer. Photo: AIBN

unavailable. In Figure 5, which shows the manoeuvre console, joysticks can be seen on each side of the manoeuvre handles. If back-up mode was selected on one or both of the drive lines, pitch was controlled by the joystick, while rpm was controlled with the manoeuvre handle. Pitch ahead would increase if the joystick was pushed forward, and pitch astern would be increased if the joystick was moved backwards. Rpm/total output increased if the manoeuvre handle was moved forward. Rpm/total output would be at its lowest when the manoeuvre handle was at the null point and would increase again if the handle was then moved backwards.

The Norwegian Maritime Authority therefore introduced an extra cover, as an immediate precaution, to exclude the possibility of unintentional use.

The Norwegian Maritime Authority introduced an immediate precaution, where the buttons for constant rpm on the manoeuvre console are protected by an extra cover to exclude the possibility of error.
