# National Transportation Safety Board

## Marine Accident Brief

### Collision between Fishing Vessel *Polaris* and Tanker *Tofteviken*

<b>Accident type</b>	Collision	<b>No.</b>	DCA18FM023
<b>Vessel names</b>	<i>Tofteviken</i> and <i>Polaris</i>		
<b>Location</b>	Atlantic Ocean, about 30 miles south of Montauk, Long Island, New York 40°31.40' N, 071°57.78' W		
<b>Date</b>	May 12, 2018		
<b>Time</b>	1913 eastern daylight time (coordinated universal time – 4 hours)		
<b>Injuries</b>	None		
<b>Property damage</b>	\$716,047		
<b>Environmental damage</b>	None		
<b>Weather</b>	Visibility 10 miles, light breeze, seas 2–4 feet, air temperature 52°F, water temperature 51°F, sunset 1955		
<b>Waterway information</b>	North Atlantic Ocean. Navigational approach to New York Harbor.

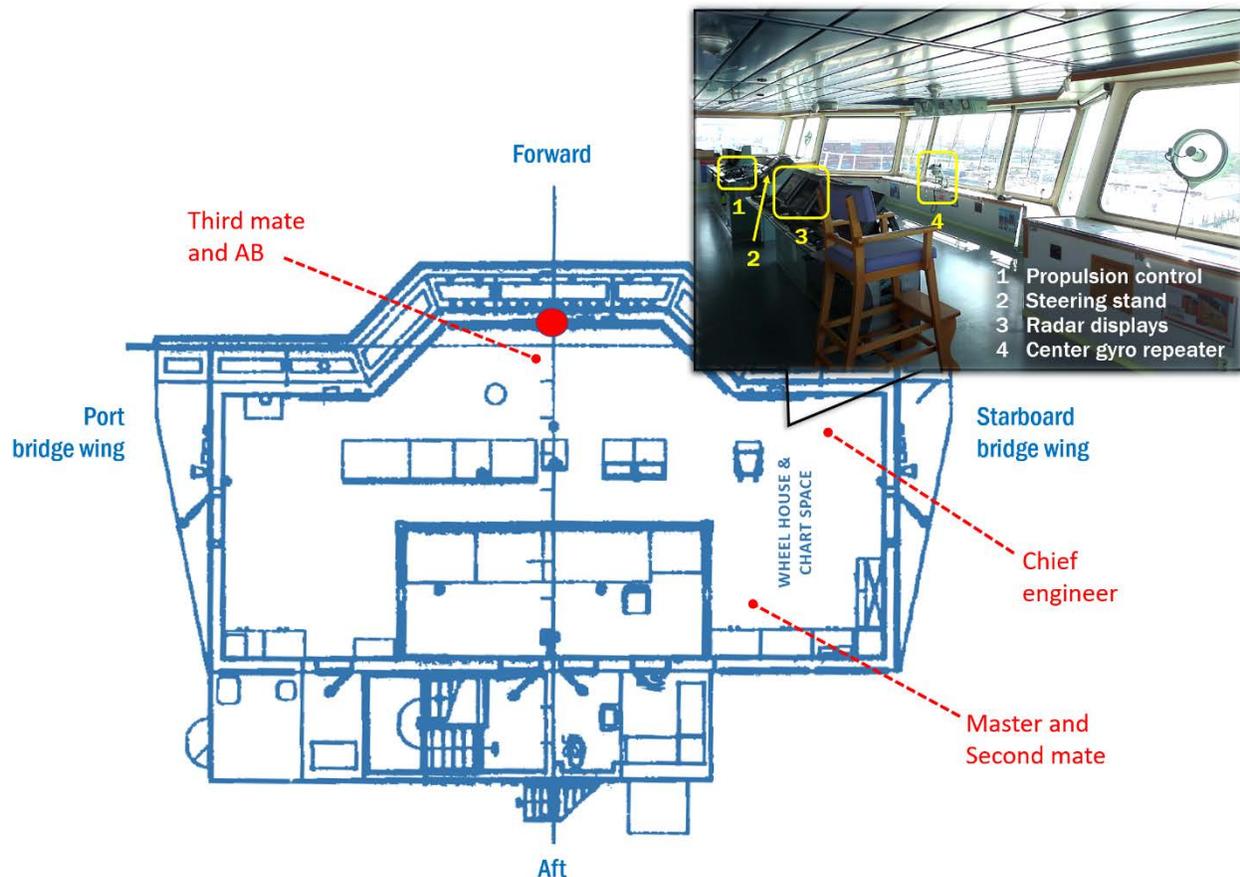
General arrangement of *Toftveiken* bridge and crewmembers' positions just before collision. Red circle indicates location of centerline compass repeater. Inset photo shows view from starboard side looking to port and forward.

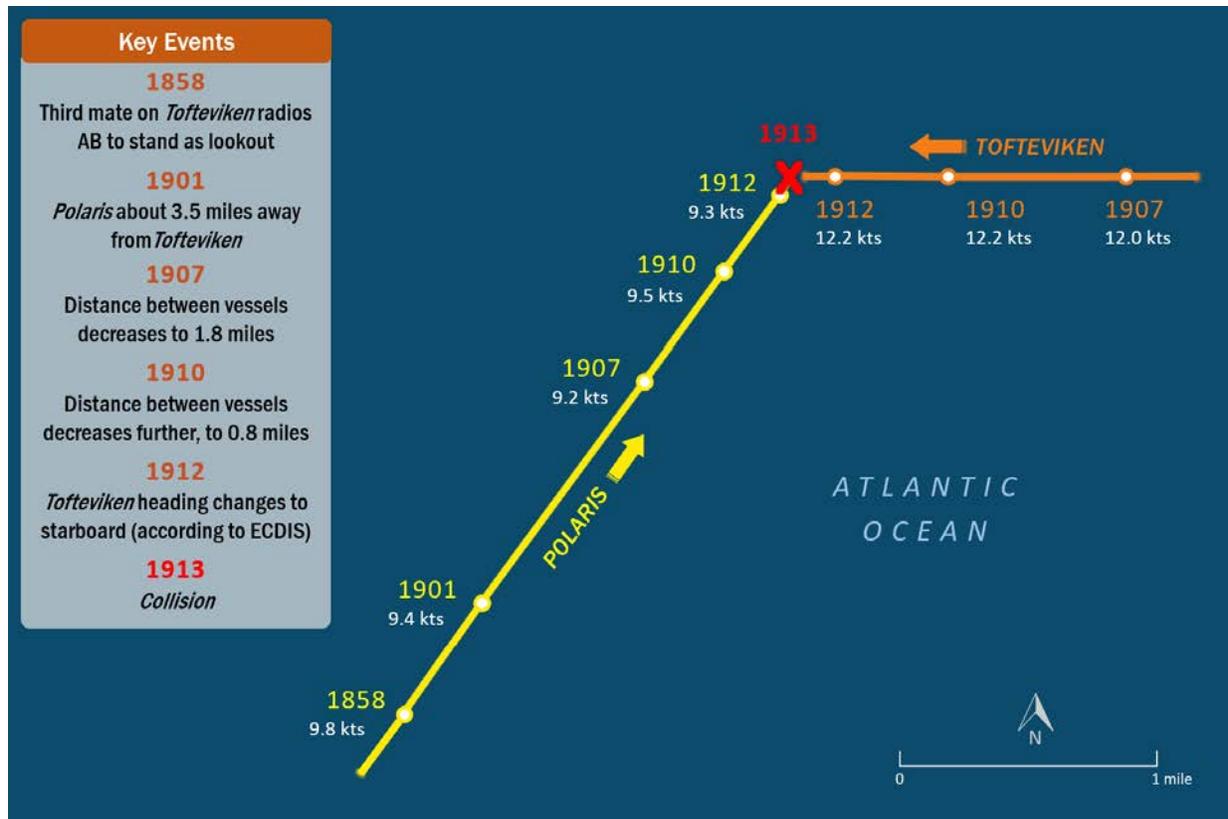
Tracklines of *Polaris* and *Tofteviken* leading up to collision, based on AIS data. (Background from Google Maps)

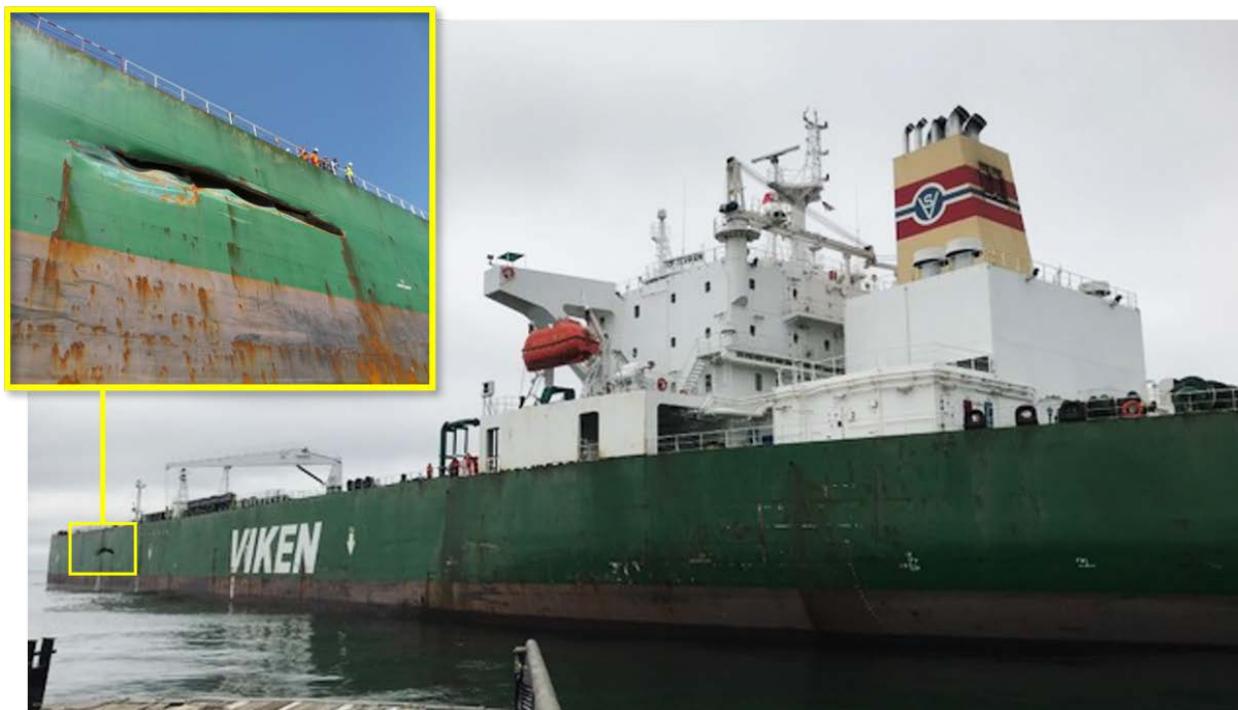
**Damage.** The *Tofteviken*'s port side shell plating sustained damage consisting primarily of a 40-foot-by-2-foot gash in the hull below the main deck into the port water ballast tank no. 3 (which was empty), along with multiple scrapes down the ship's side. There was no damage to any of the cargo tanks.

**Main damage area of hull of *Tofteviken*. (Photos by Coast Guard)**

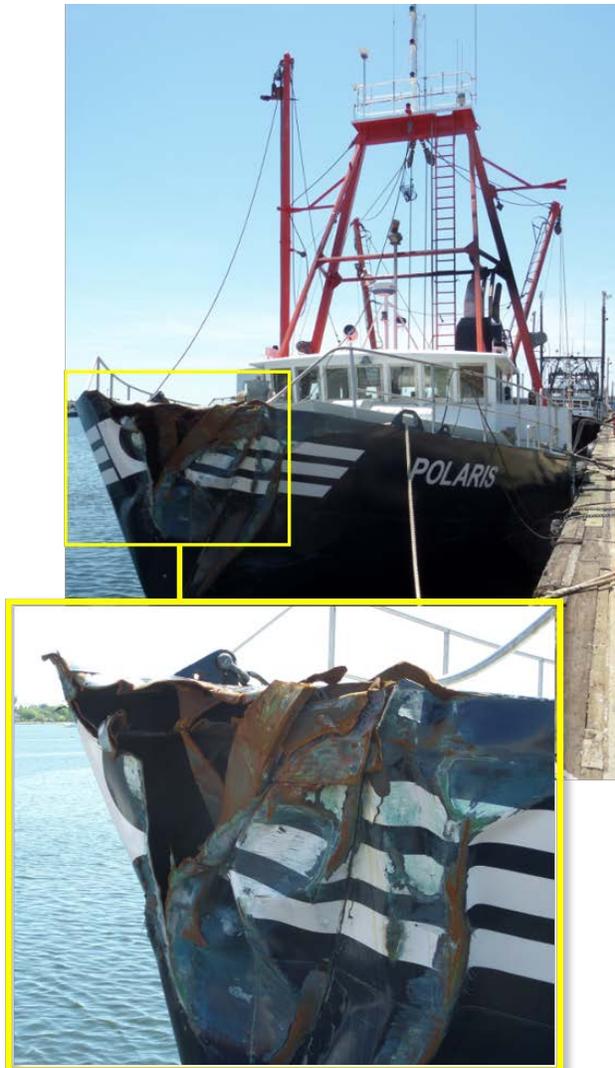
The *Polaris* sustained damage to its bow, port outrigger, and stern port gallows post used for hauling gear. Numerous scrapes and some dents extended down the port side from the bow to stern. The vessel's bow, constructed of welded steel and bolted onto a half-inch-thick backing plate, was torn and mangled.<sup>4</sup> The steel was 0.25-inch thick around the cone and 1.25-inch thick at the stem. Aft of the bolted-on bow, the main deck was fractured, buckled, and warped with the steel compressed. The portside outrigger was found bent toward the aft of the vessel and cracked at the base.

Area of greatest damage to hull of *Polaris*.
