Report on the investigation of the
grounding of the general cargo vessel

Priscilla

on Pentland Skerries, Pentland Firth, Scotland

on 18 July 2018

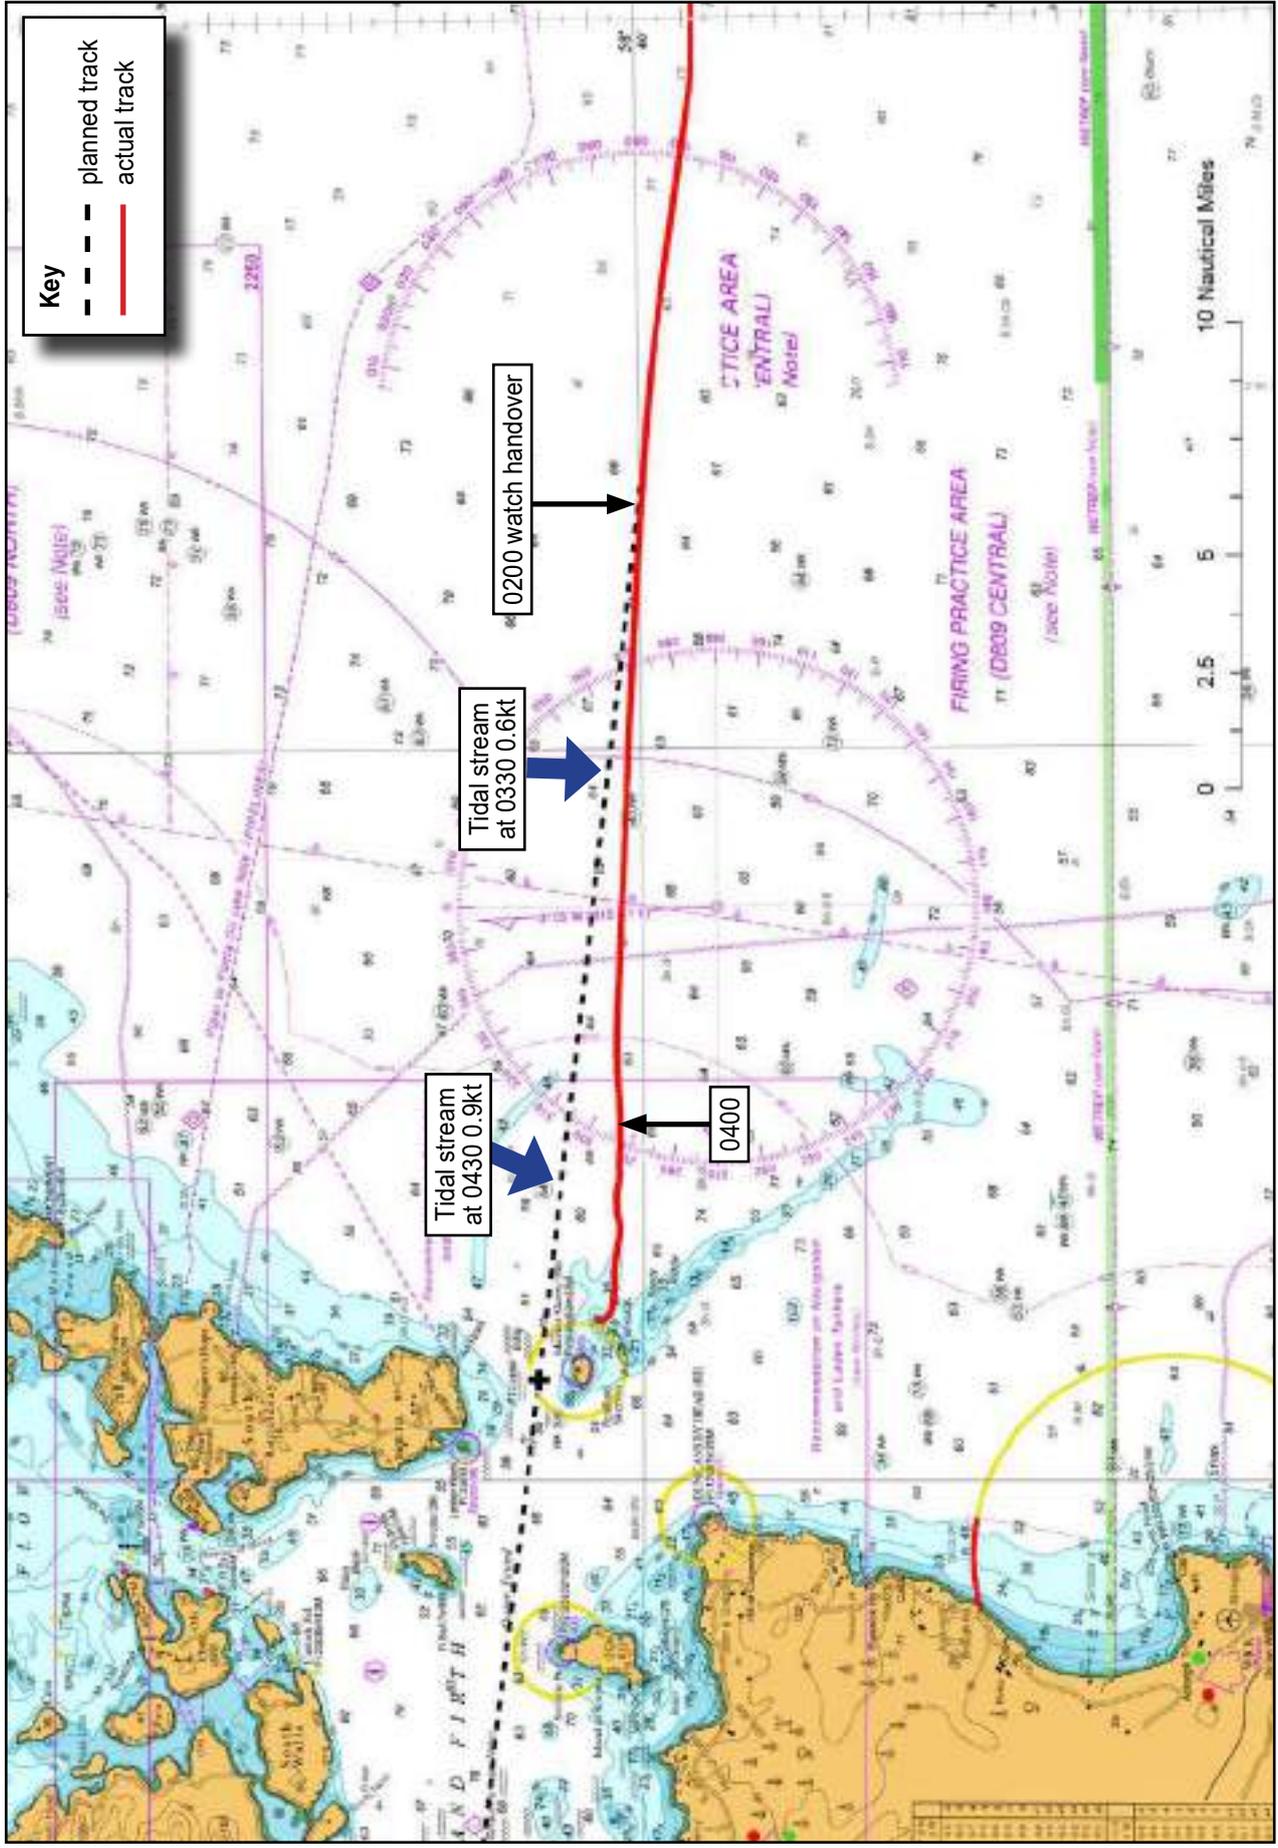
Figure 3: Chart showing Priscilla's planned and actual tracks prior to grounding

At about 0400, the maritime officer looked at the radar display on the port side of the bridge and realised that *Priscilla* was to port of the planned track (**Figure 3**). At the same time, he observed two small islands ahead of the vessel painting on the radar display and decided to proceed between them with a plan to alter course to starboard thereafter to regain the planned track.

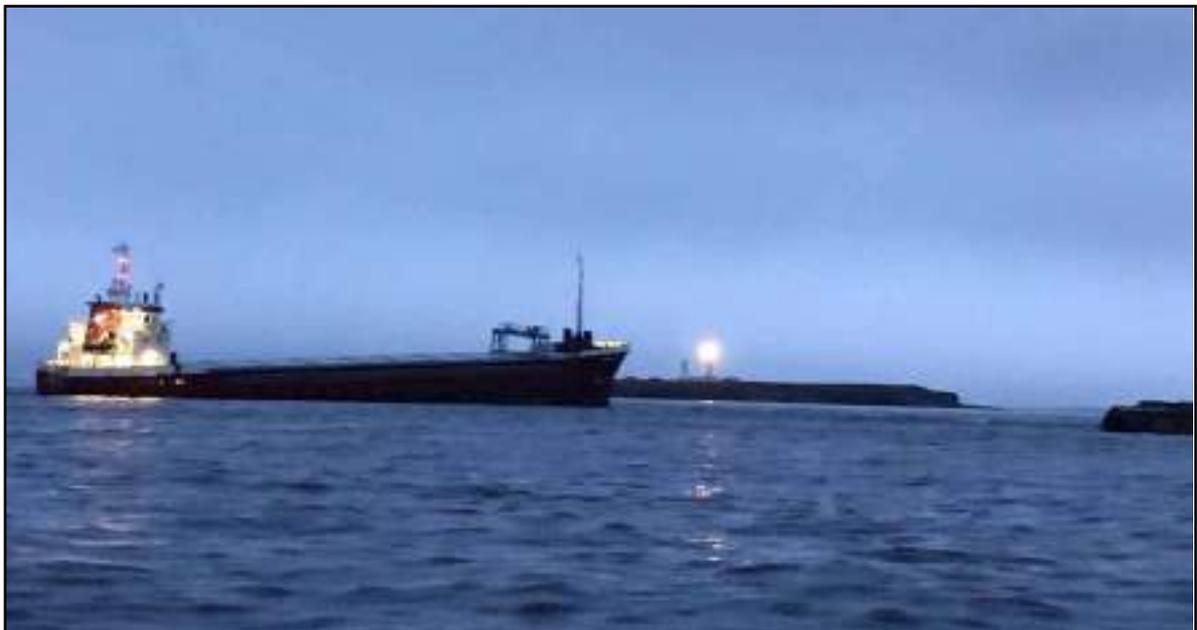
Figure 4: *Priscilla* aground with Pentland Skerries lighthouse visible in the background

During the VHF conversation with Orkney VTSO, *Priscilla's* OOW reduced the range scale on the port radar and added a chart overlay to the display. He then realised that his plan to pass between the two islands ahead was unsafe as there was a shallow reef between the islands. The OOW then selected hand-steering and put the rudder full to starboard in an attempt to steer away from the reef. At 0443, *Priscilla* grounded on Pentland Skerries at a speed of 7kts (**Figure 4**). Seconds prior to grounding, the ECDIS depth alarm sounded as *Priscilla* crossed over the 10 metre (m) depth contour.

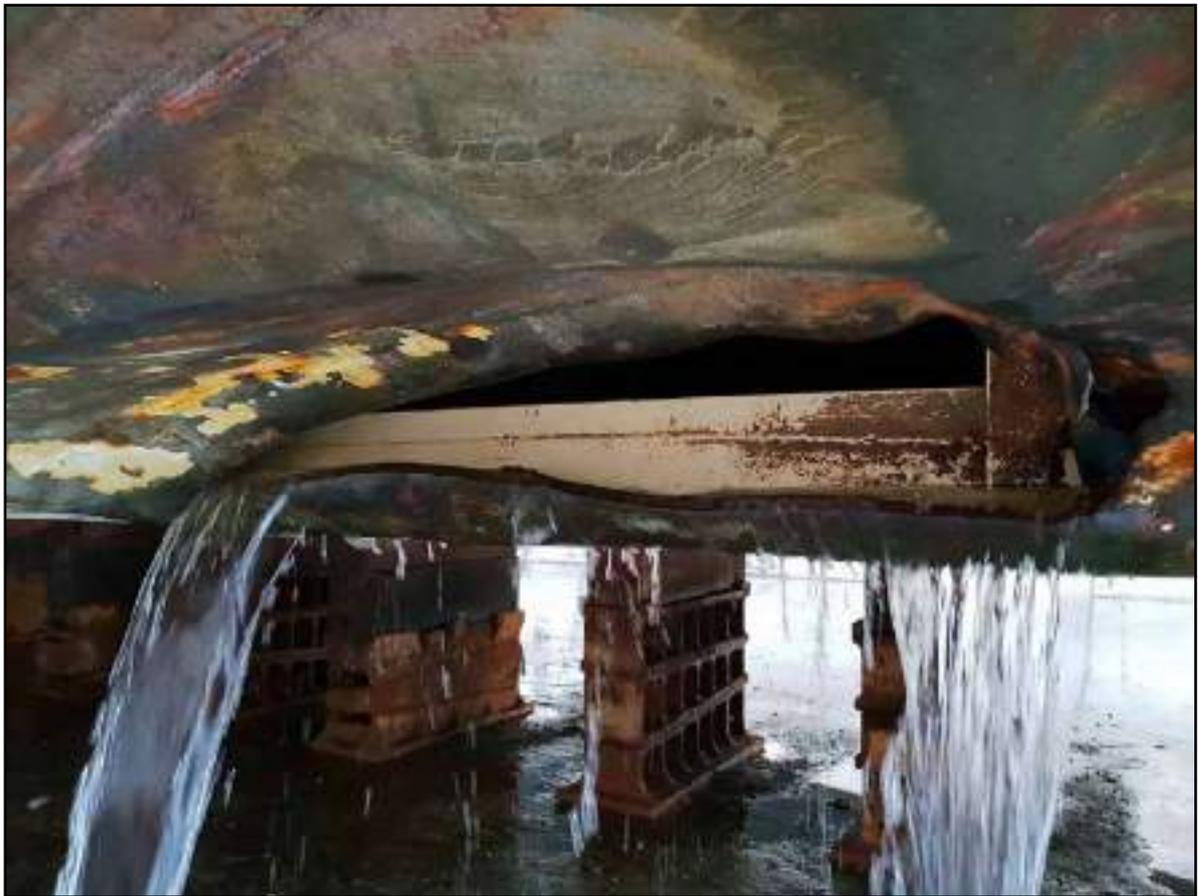
Figure 6: *Priscilla* - detail of hull damage

In the following days and at high water, two unsuccessful attempts were made to haul *Priscilla* off the rocks using tugs. On 20 July 2018, a salvage team arrived on board *Priscilla* and 3 days later, after a partial cargo discharge (**Figure 5**), the vessel was refloated and towed clear of Pentland Skerries. Following a diver inspection at Scapa Flow, *Priscilla* proceeded under its own power to Silloth to complete the cargo discharge. Thereafter, *Priscilla* proceeded to dry dock in Swansea, Wales where a full inspection revealed extensive structural damage throughout the forward section of the hull, including gouging and distortion to the shell plating (**Figure 6**).

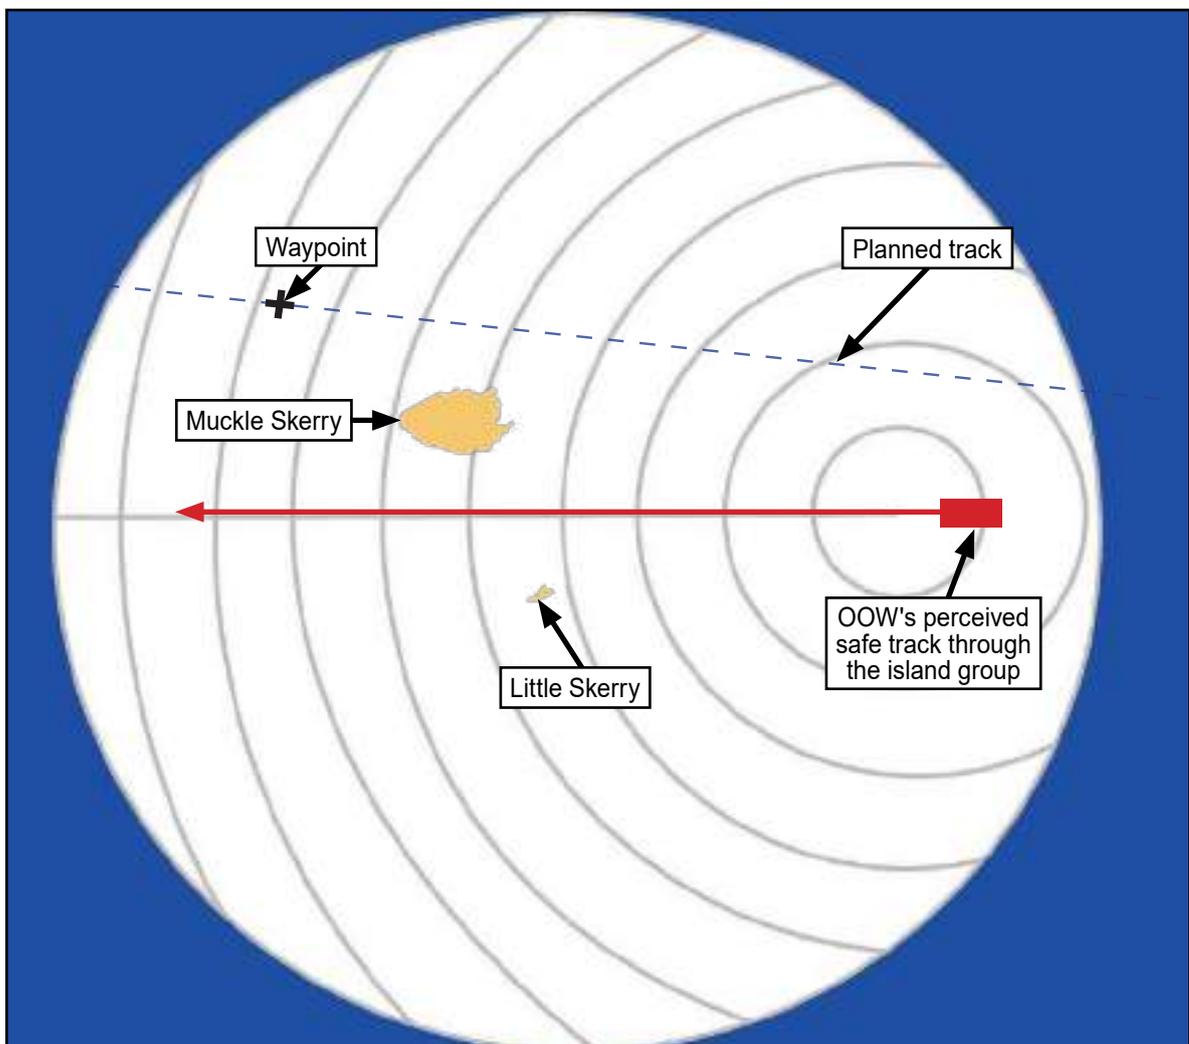
Figure 10: Reconstruction of the radar display to illustrate the OOW's perceived safe plan passing between the islands on radar

Therefore, and instead of immediately regaining the planned track, the OOW decided to steer between two islands that were painting on radar ahead. **Figure 10** is an illustration of a reconstructed radar display showing the OOW's intended passage between the islands. However, the OOW made no reference to the ECDIS display when making this decision, and the chart overlay function on the radar was not selected. This means that the decision to pass between the islands was based solely on radar data and not navigational information. As a result, the OOW was unaware that the islands ahead formed part of a shallow, dangerous reef and his revised plan was unsafe as it took *Priscilla* directly into this danger.

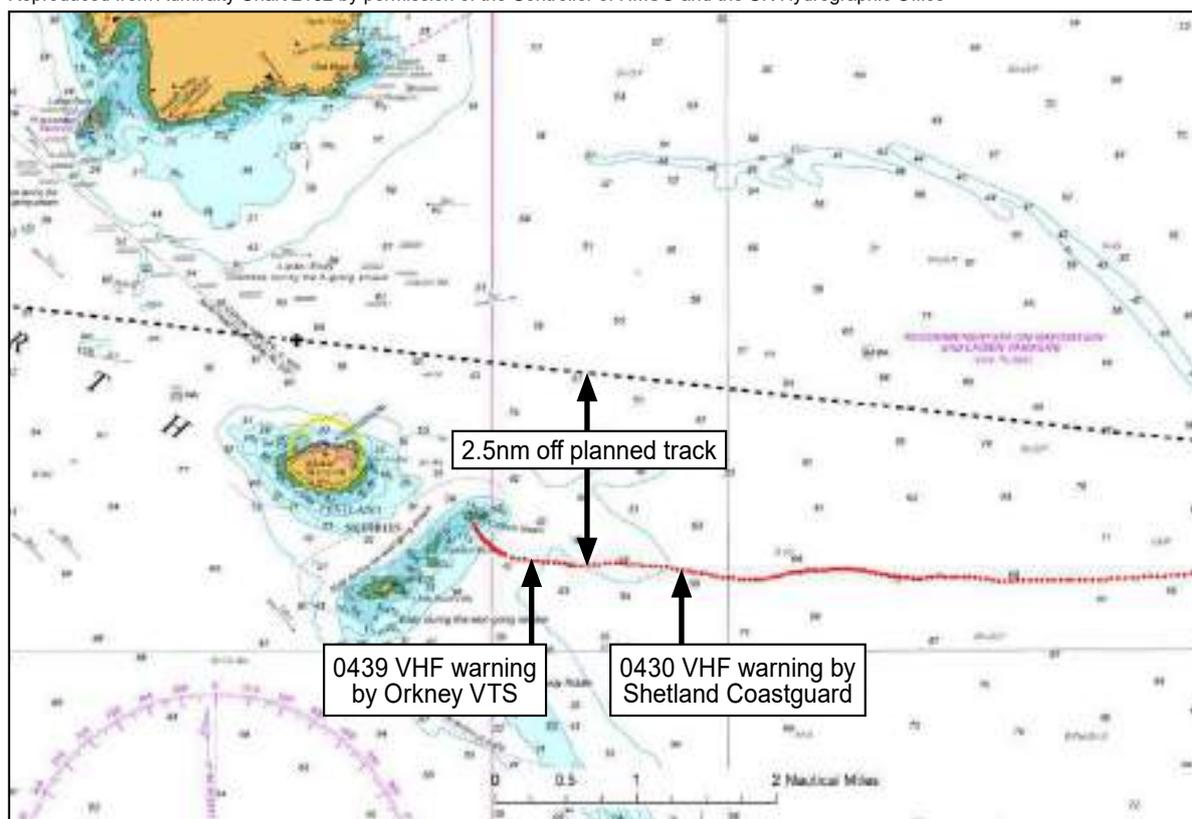
Figure 11: AIS track showing *Priscilla*'s position at the time of the VHF calls from Shetland Coastguard and Orkney VTS

At 0430 and with Pentland Skerries about 2nm ahead of the vessel (**Figure 11**), Shetland CGOC contacted *Priscilla* by VHF radio. The OOW answered the call, acknowledged the situation and stated that an alteration of course would be made. When the coastguard officer sought confirmation that avoiding action would be taken, the OOW stated “*we will see later*” (**Table 1**). This response was vague and did not offer a categorical statement that action to avoid danger would be taken. This action by the OOW indicates that he was confident of the plan to pass between the islands ahead.

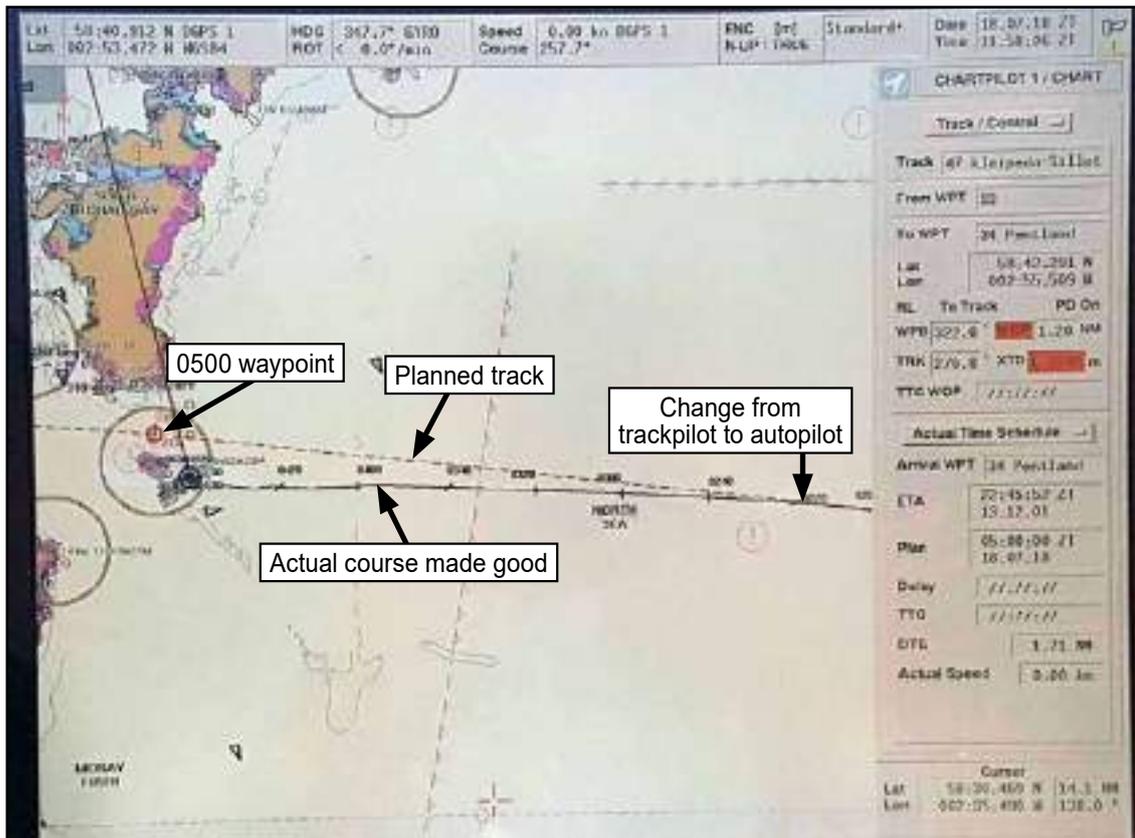
Figure 12: Screenshot of Priscilla's actual ECDIS showing the deviation from the planned track

When *Priscilla* was in Klaipeda, the chief officer completed the SMS voyage planning checklist, which then formed the passage plan. However, the SMS contained no guidance on the use of ECDIS for passage planning, and the chief officer did not consider the use of an ECDIS safety corridor or warning sector settings. Ideally, the safety corridor and warning sector values should be tailored to the navigational hazards that might be encountered in order to give sufficient warning. However, this did not happen, primarily due to the lack of onboard guidance. The absence of a safety corridor or a warning sector was evident from a screenshot of the ECDIS display taken after the accident (**Figure 12**).
