INTERIM REPORT 12 NOVEMBER 2019 ON THE INVESTIGATION INTO THE LOSS OF PROPULSION AND NEAR GROUNDING OF VIKING SKY, 23 MARCH 2019

Accident Investigation Board Norway
Postboks 213
2001 Lillestrøm
Norway
Phone: + 47 63 89 63 00
Fax: + 47 63 89 63 01
<http://www.aibn.no>
E-mail: post@aibn.no

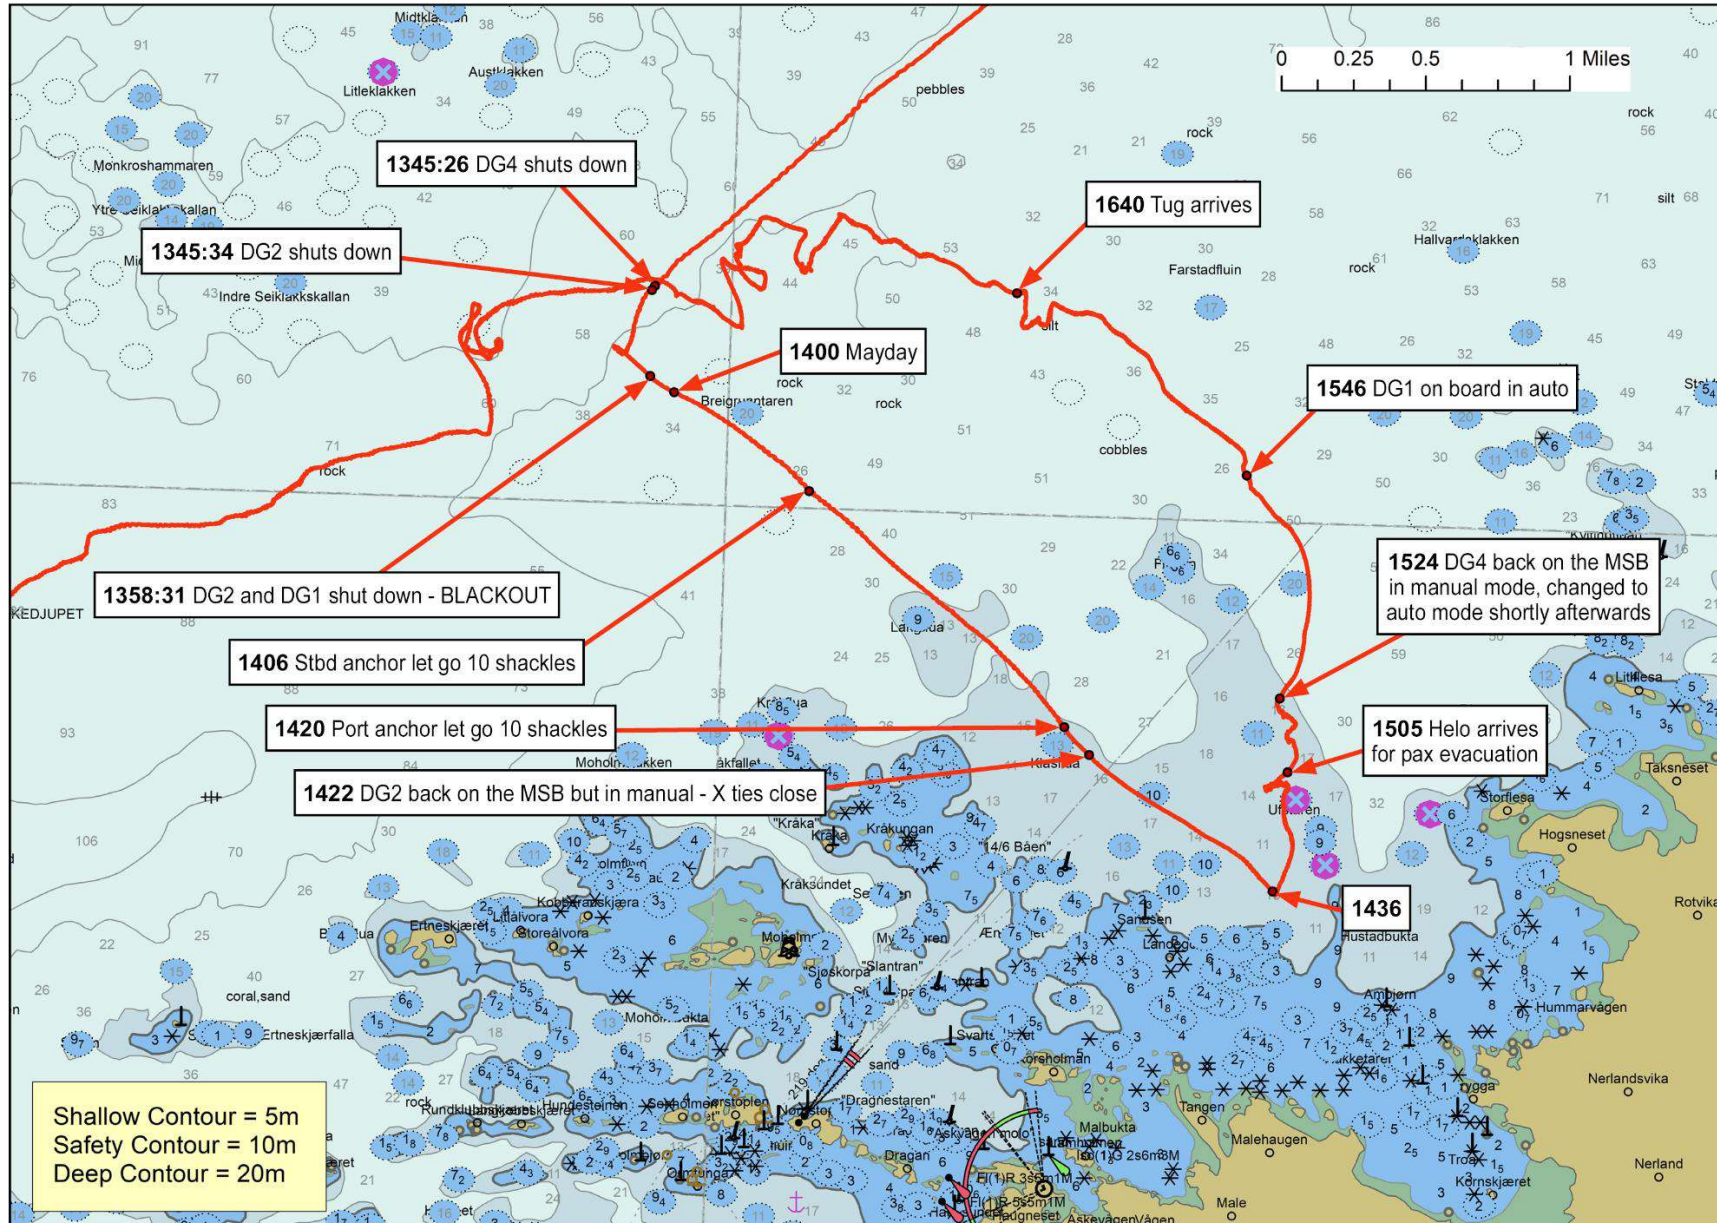
Figure 1: Sequence of events. Source: MAIB
