SAFETY INVESTIGATION REPORT

REPORT NO.: 20/2019

MV *Khosrov Bey* **Fatal fall down in the engine-room** **in position 41° 35.6' N 028° 44.0' E** **03 November 2018**

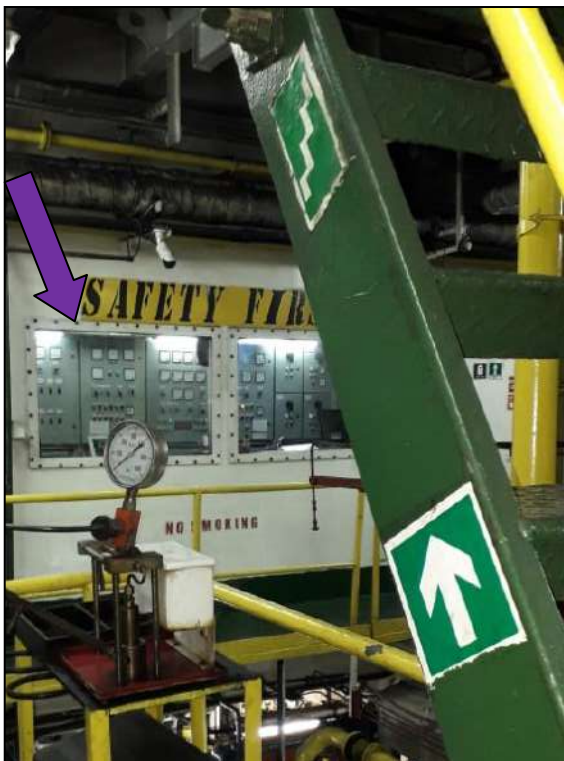
Figure 2: Engine control room window

By around 1200, the chief engineer, the third engineer, the electrical engineer, and one motorman, were all in the engine control room (ECR). In the meantime, the second engineer, who was on duty from 1200 till 1600, was making his way towards the engine-room. The electrical engineer, from the ECR's window (Figure 2), saw the second engineer descend the first few steps of the stairs (Figure 3) that led to the engine-room.

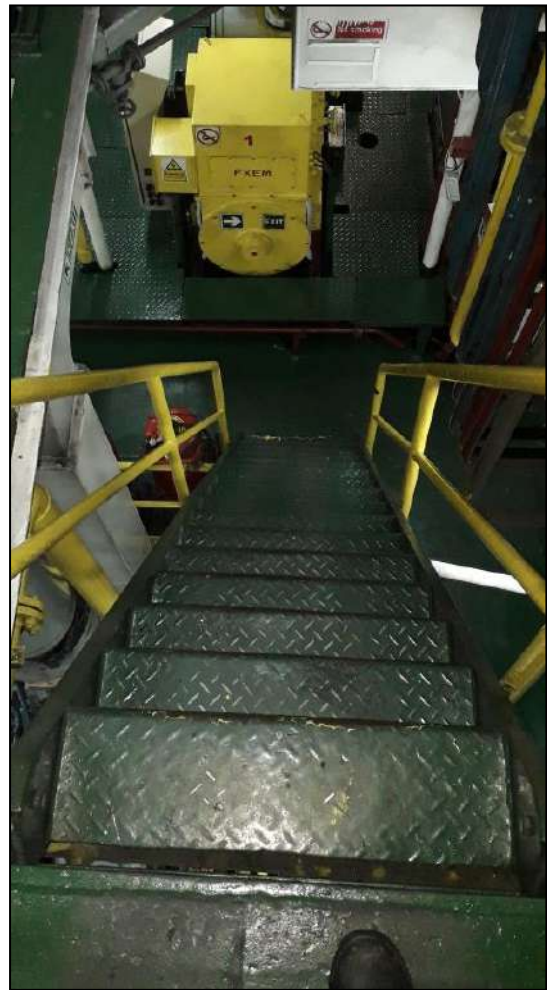
Figure 3: Stairs leading into the engine-room

The access to the first engine-room platform, (which is at level with the ECR), from the upper deck, is via a flight of stairs (Figure 4). These stairs are set at a 60° angle from the horizontal and comprise of sixteen steps, painted in green. Each step was reported to be uniformly placed, with a riser height of 22 cm and a depth tread of 20 cm.

At the time of occurrence, the crew reported that no defects in the structure or fittings were observed.

The stairs included a fixed handrail and a midrail at either side of the stairway, both painted in yellow. At the time of the occurrence, the stairs were reported as being clear of any obstructions and not being slippery. The stairs were adequately lit by artificial lighting throughout its entire length (Figure 5).

In addition to the above, the design of the staircase lacked contrasting step edges (nosings), which are highly effective against

missing a step and slipping⁴. It did not transpire to the safety investigation that the fitting of step edges is a mandatory requirement.

3. The fatally injured crew member may have missed a step on his way down to the engine-room;
4. There were no contrasting nosings on the step edges;
5. The fatally injured crew member was not observed to be holding the handrail;

10. The stairs were free from any defects or damages which might have contributed to the fall;
11. The stairs were adequately lit by artificial lighting at all stages of descent.

20/2019_R1 Mark nosings of stairs with a contrasting colour.

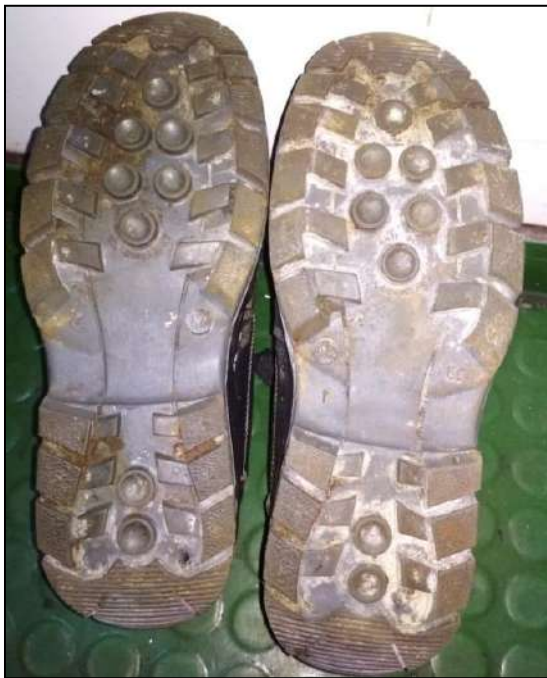
Figure 7: Grooves in the sole of the second engineer's safety boots

Close-up photos of the safety boots indicated that although evidently used, there was still adequate depth to the sole (Figure 7). The safety investigation could not attribute the fall to the condition of the safety boots.
