Grounding of the ro-ro freight ferry *Seatruck Performance* in Carlingford Lough, Northern Ireland 8 May 2019

SUMMARY

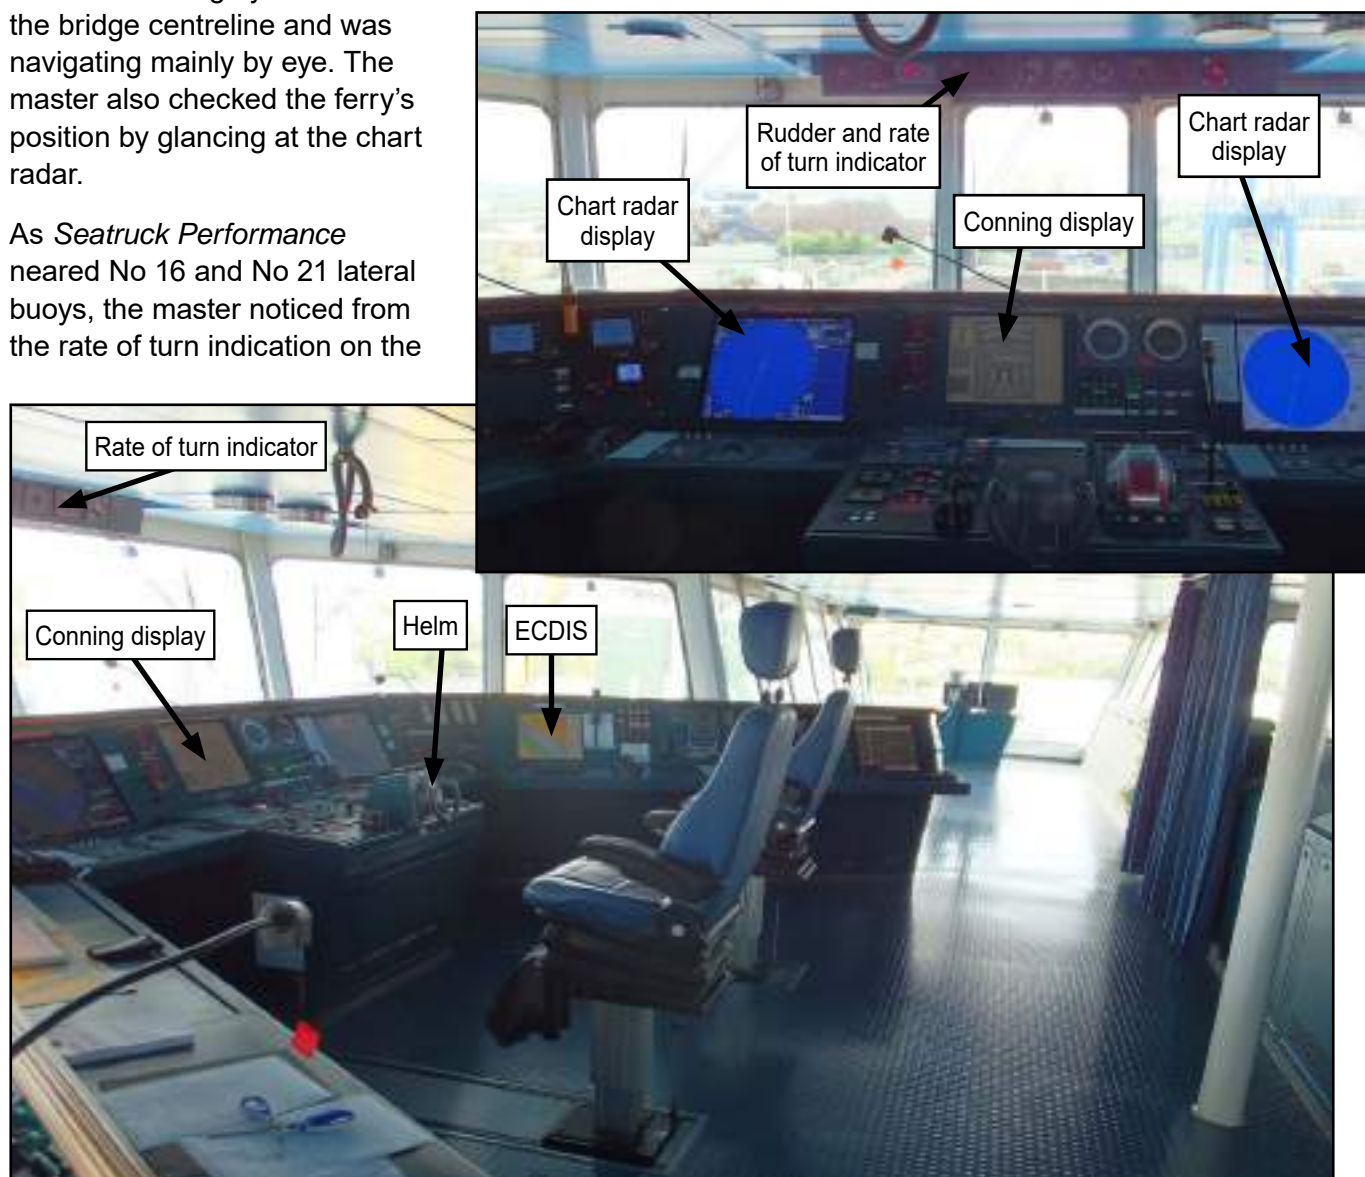
Figure 2: *Seatruck Performance* bridge (inset: Bridge looking forward)

Seatruck Performance was fitted with a modern cockpit style bridge (**Figure 2**) with a fully integrated Wärtsilä SAM Electronics 1100 series navigation system. The system included an ECDIS, a chart radar (radar with electronic navigational chart underlay) and a track pilot with 'hand', 'autopilot' (heading and course modes) and 'track follow' options.

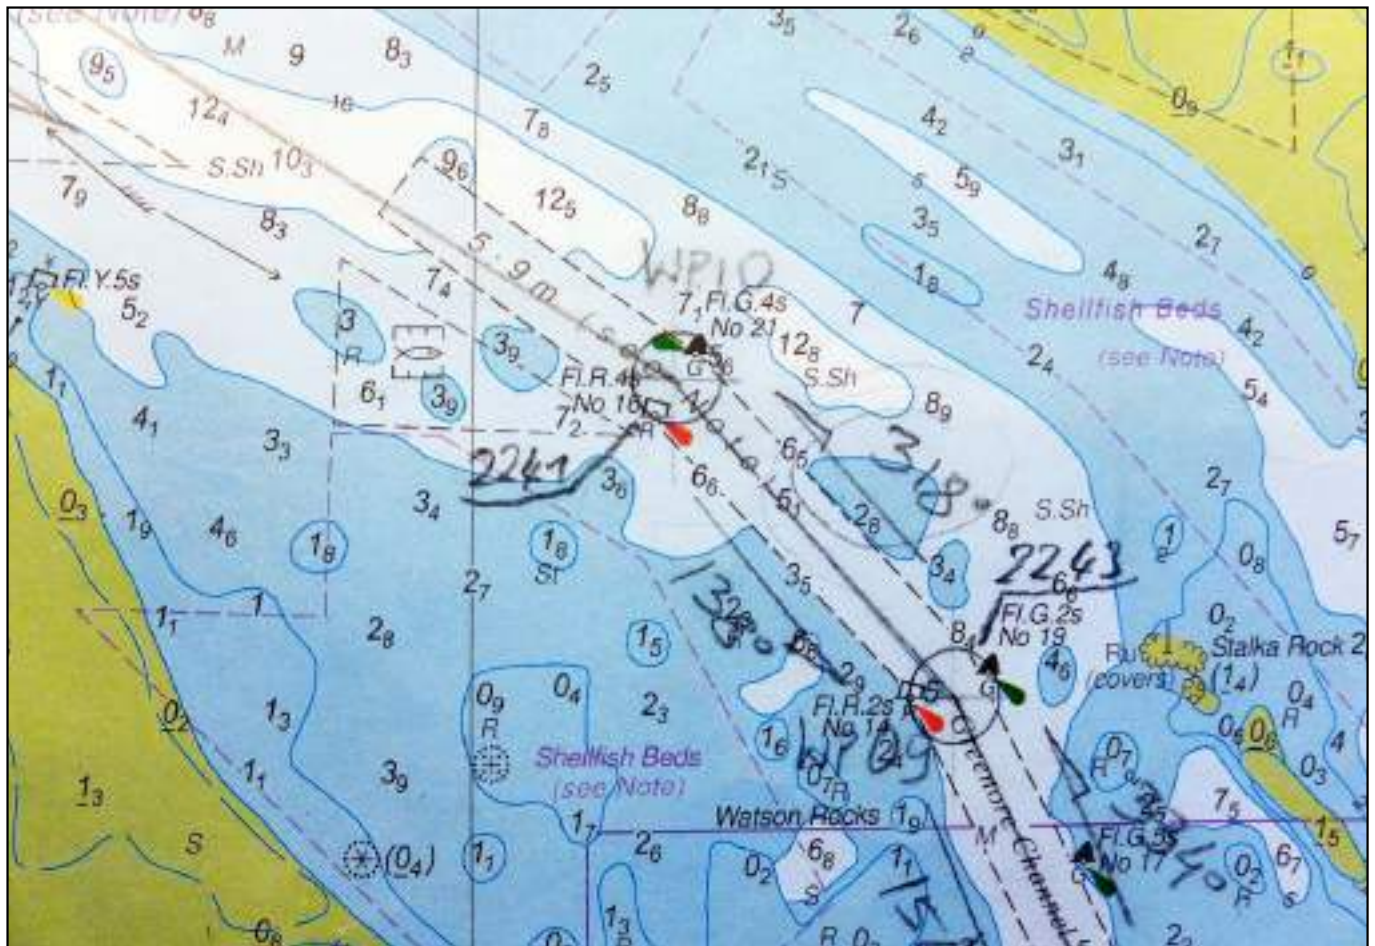
Figure 3: Planned track through the Greenore Channel

The Greenore Channel (**Figure 3**) was dredged to a depth of 5.9m and varied in width from 80m to 120m. It was marked by lateral buoys, which were lit, and no reports had been received to indicate they were out of their charted positions. The distance between No 16 and No 21 buoys was 120m. Passing in the channel was not permitted and there were no speed restrictions.

The reduced depths were located in the section of the channel between No 16 and No 14 buoys.

The passage plan required *Seatruck Performance* to alter from 121° to 138° when passing between No 16 and No 21 lateral buoys (**Figure 3**). The plan kept the ferry in the centre of the dredged channel as it headed to the next pair of lateral buoys. Although the planned alteration was only 17°, the width of the dredged channel between submerged granite banks to the east of No 16 and No 21 lateral buoys was only 120m, which afforded little margin for error.

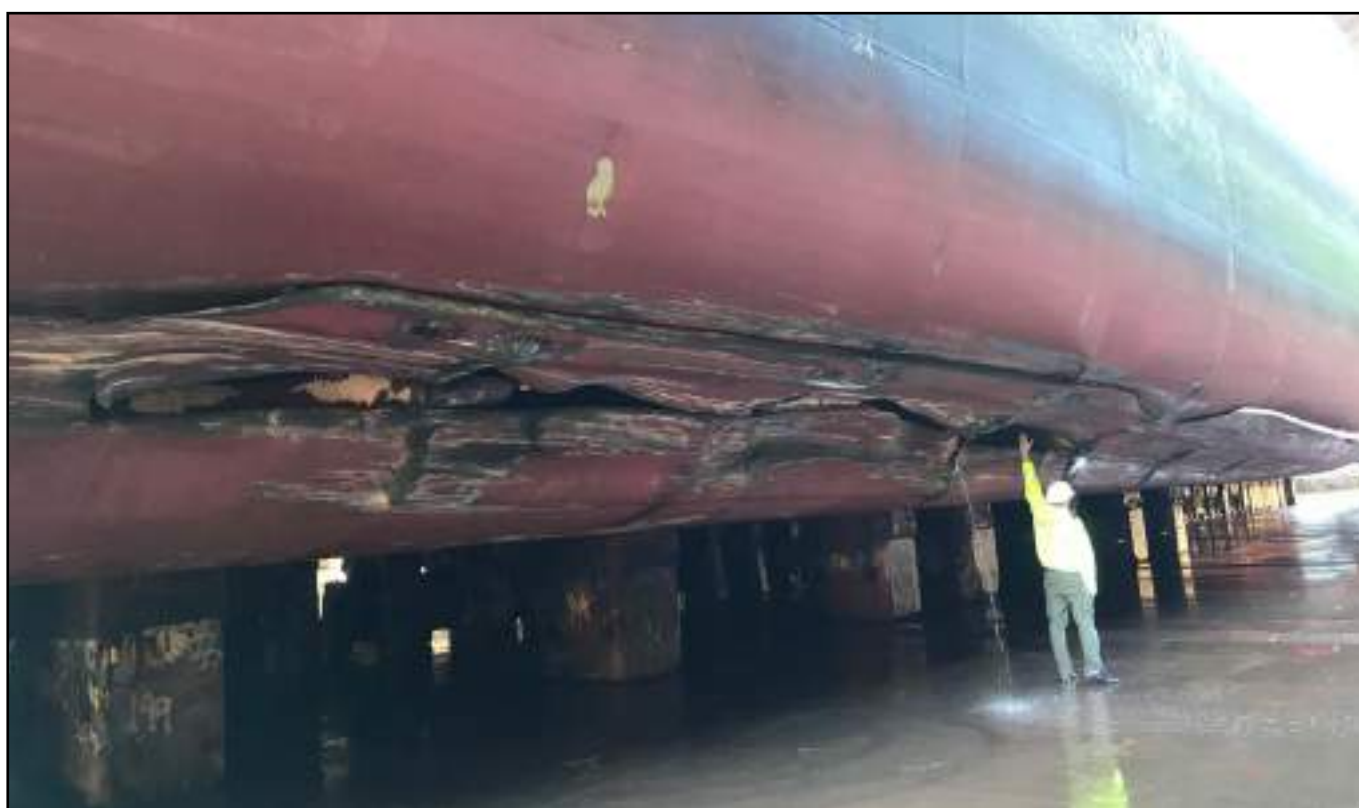
Figure 4: Damage to *Seatruck Performance* port side

An underwater inspection of *Seatruck Performance* on 9 May identified significant damage to the ferry's port side, including a 10m tear in way of No 4 void space and No 8 heeling tank, on the turn of the bilge (**Figure 4**). Both spaces were flooded to the waterline.

Following a single voyage dispensation by *Seatruck Performance*'s classification society, the ferry proceeded to a dry dock in Belfast, where it arrived on 11 May. Broken pieces of granite were found in the damaged tanks. *Seatruck Performance* was repaired and returned to service 3 weeks later.

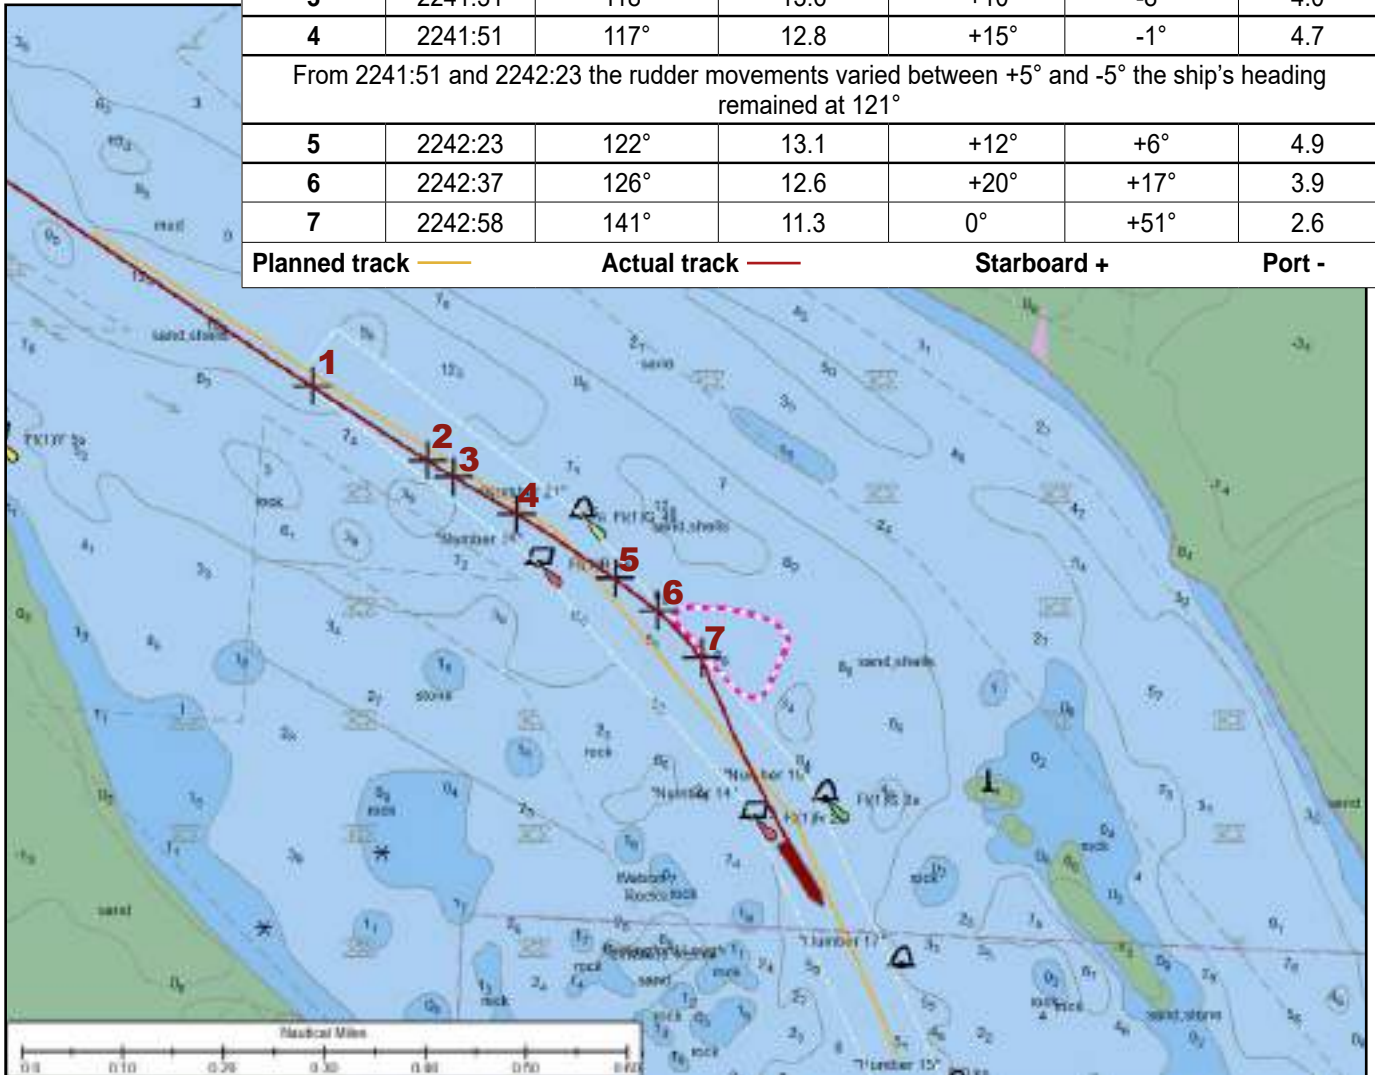
Figure 5: Reconstruction of *Seatruck Performance's* planned and actual track

Reconstruction of *Seatruck Performance's* track (**Figure 5**), which is based on voyage data recorder information, showed that when hand-steering was selected at 2241:22, the ferry was 20m to the south of the planned 121° track and was heading 119° at 14.1 knots. Over the next 30 seconds, the ferry's heading turned very slowly to port to a heading of 117°, until checked by the master's use of starboard helm. That *Seatruck Performance's* speed also decreased to 12.8 knots over the same period and the depth of water under the keel reduced from 7.6m to 4.7m, indicates that the ferry experienced 'bow-cushion'³ and other shallow water effects⁴ as it approached and passed the 3.9m shoal patch on the southern edge of the dredged channel.

Having arrested *Seatruck Performance's* slow turn to port with starboard helm, the master maintained the ferry's heading at about 121° between 2241:51 and 2242:23 by using between 5° of port and 5° starboard helm. During this period, the ferry passed between the No 16 and No 21 lateral buoys, beyond the intended course alteration, and was heading towards the north side of the dredged channel. Although the master then used increasing amounts of starboard helm to head between No 14 and No 19 lateral buoys, the turn was started too late. Consequently, *Seatruck Performance's* port side struck the submerged granite bank on the northern side of the dredged channel, which was indicated by a 2.8m spot depth.

Key	Time	Heading	Speed (kts)	Rudder (S+P-)	RoT (°/min) (S+P-)	Depth (m)
1	2240:48	120°	14.5	+ 2°	-2°	7.6
2	2241:22	119°	14.1	0°	-2°	5.1
3	2241:31	118°	13.6	+10°	-8°	4.0
4	2241:51	117°	12.8	+15°	-1°	4.7
From 2241:51 and 2242:23 the rudder movements varied between +5° and -5° the ship's heading remained at 121°						
5	2242:23	122°	13.1	+12°	+6°	4.9
6	2242:37	126°	12.6	+20°	+17°	3.9
7	2242:58	141°	11.3	0°	+51°	2.6
Planned track		Actual track		Starboard +		Port -
