SAFETY INVESTIGATION REPORT

REPORT NO.: 02/2020

MT SICHEM RUBY **Serious injury to crew member** **in position 41° 21.5' N 010° 11.0' W** **20 January 2019**

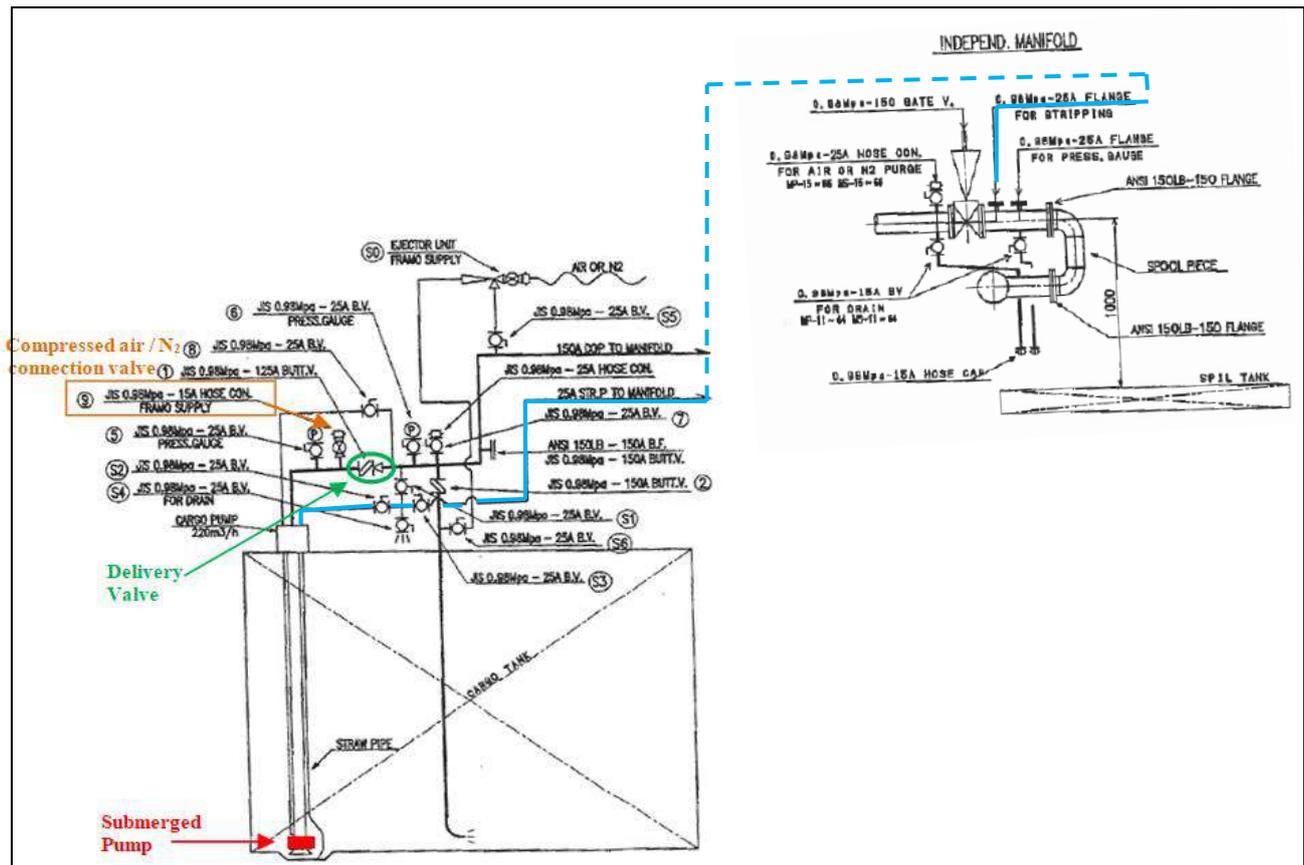
Figure 1: Piping arrangements for cargo tanks

According to the vessel's approved Procedures and Arrangements (P&A) Manual¹, the vessel had no special stripping line. A compressed air blowing system was provided on each cargo pump for stripping the cargo tank (Figure 1).

However, Figure 1 also shows pipelines of a 25 mm diameter, passing from the pump stack to the manifold, identified as '25A STR P TO MANFOLD' (highlighted in blue). Moreover, the P & A Manual also mentioned that a stripping system was available to strip the cargo tanks and lines, following unloading. Furthermore, the P & A Manual also indicated that the stripping system may also be used to drain the deck lines into the appropriate cargo tanks, upon completion of loading.

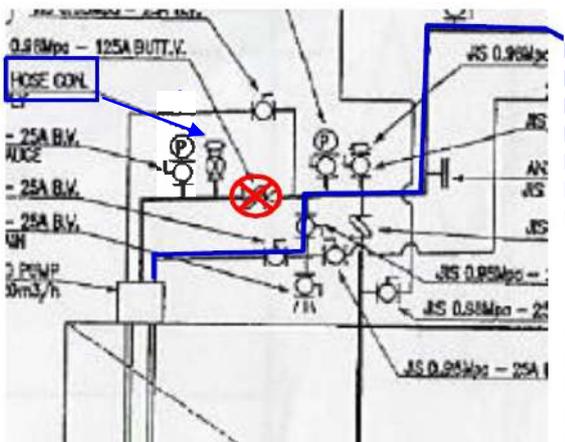
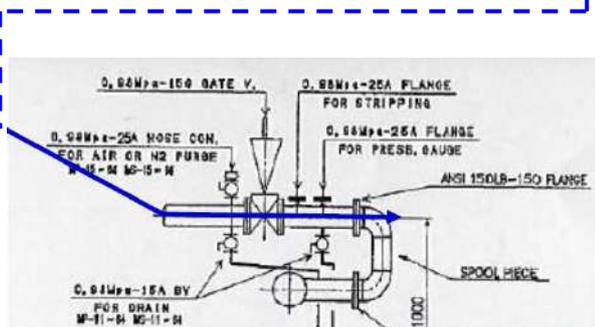
Figure 2: Pipeline diagram showing the method adopted on board of stripping cargo tanks and lines

The adopted method for stripping the cargo tanks and lines, by-passed a major part of the 25 mm stripping line and was as follows:

- Connect air or N₂ hose (depending of cargo) to the dedicated connection on discharge line above the Framo pump;
- Close the discharge valve

;
- Flush through the main cargo line directly to the manifold.

The stripping procedure that was reportedly being applied on board did not make use of the stripping line available on deck. Instead, compressed air / N₂ were being used to empty the pump and cargo line while bypassing the stripping line (Figure 2). This would explain why the Teflon blanks did not obstruct the stripping operations adopted on board.

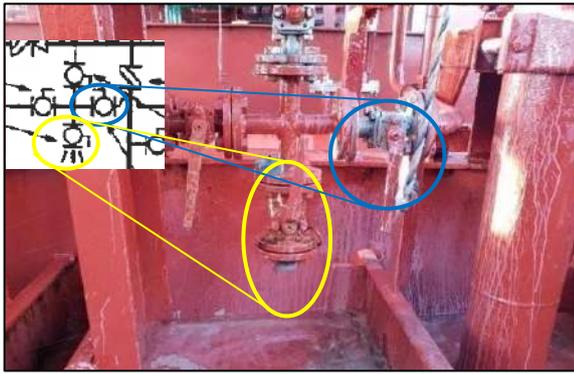
Figure 3: Position of the leaking valve (blue) & position of drain valve (yellow)

Later that afternoon, in preparation to overhaul a leaking valve on the stripping line of cargo tank no. 2 port, the pumpman opened the leaking valve and the drain valve (Figure 3), to confirm that the line was empty. Seeing no indication of any liquids inside the pipeline, the pumpman proceeded to dismantle the leaking valve from the stripping line of cargo tank no. 2 port.

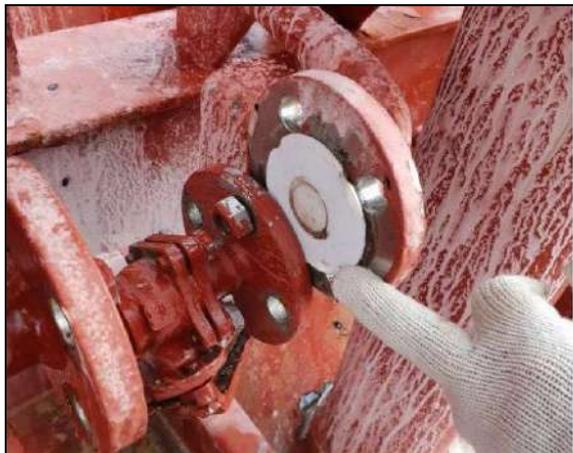
Figure 4: Teflon blank in way of the stripping line

After removing the leaking valve, the pumpman noticed a Teflon blank installed on the right flange (Figure 4).

1. Removal of all Teflon blanks from all pipelines and checks on sister vessel for any similar blanks;
2. Reinforcing of PPE campaign for routine maintenance jobs for the whole fleet;

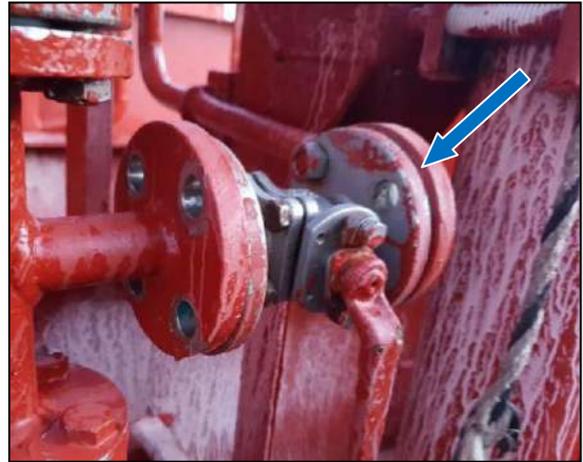
Figure 5: Right flange: location where sulphuric acid allegedly sprayed out from (blue arrow)

After removing the valve, the pumpman placed a reconditioned valve into position. Suddenly, sulphuric acid sprayed onto his face and body, as soon as he started tightening the first bolt on the right flange (Figure 5).

Sulphuric acid sprayed from between the Teflon blank and the pipeline flange which was to the pumpman's right side, while the pumpman was securing the first bolt on the reconditioned valve. It is the view of this safety investigation, that while tightening the bolt, the Teflon blank dislodged and gave way under the pressurised sulphuric acid, which remained trapped in the pipeline.

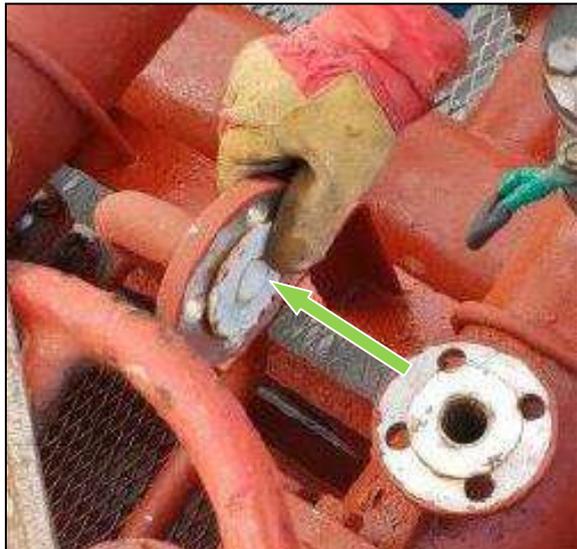
Figure 6: Cracked Teflon blank on the stripping line at the manifold's side

After the accident, the crew found that Teflon blanks had been placed on both ends of the stripping line on no. 2P. The blank that was nearest to the manifold was found cracked, allowing liquid to seep through (Figure 6).

The safety investigation could not establish the cause of the Teflon blank failure.

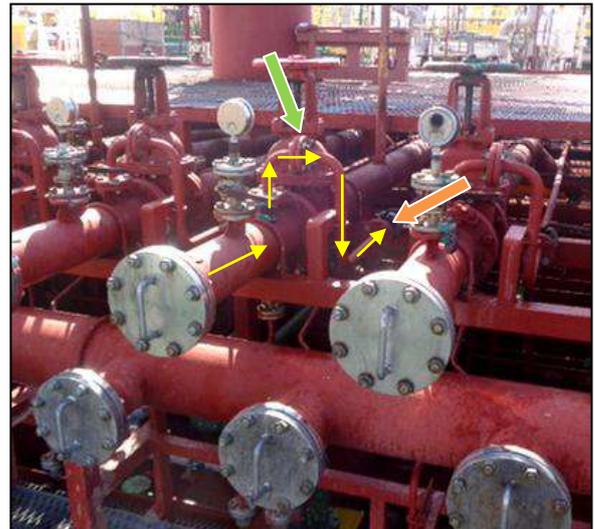
Figure 7: Location of the cracked Teflon blank, in between the flanges (green arrow) and location of the ball valve (orange arrow), on the stripping line

Following the stripping line piping, from the manifold side back to the cargo tank, it was observed that after the cracked Teflon blank, a ball valve was installed (Figure 7).

However, it was later reported that during deck line washing and draining, all the stripping line valves were kept open. This would have allowed sulphuric acid, which was accumulated in between the cracked Teflon blank and the ball valve, at the manifold, to pass through the rest of the stripping line unnoticed, until it reached the other Teflon blank.
