# Annual Digest 2019

Reports and Insight Articles

# Annual Digest of Reports and Insight Articles

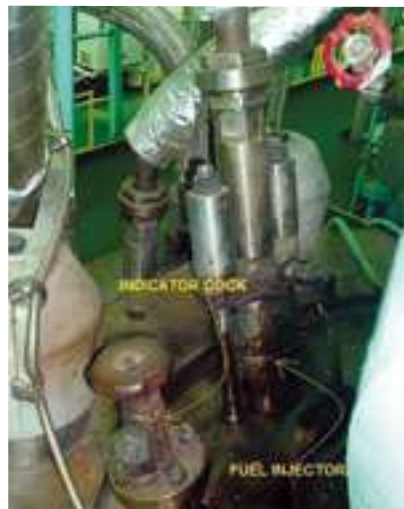
SOLAS Reg. II-2/15.2.10 states that “All surfaces with temperatures above 220° C which may be impinged as a result of a fuel system failure shall be properly insulated.”

**An unprotected indicator cock – non-compliant and a high-risk area for igniting a fire**

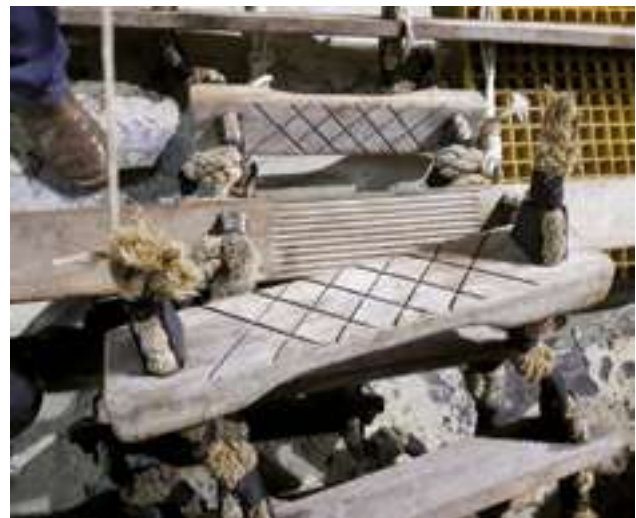
Reports being properly actioned so as to prevent a repetition might put an end to situations like the one illustrated below. In this scenario, the pilot actually placed his weight on the ladder and the ropes simply collapsed. Fortunately, this was whilst testing the ladder prior to disembarkation, but had this not been the case then the consequences might have been tragically different.

**Deathtrap – pilot placed his weight on this ladder prior to disembarking and both side ropes parted!!**

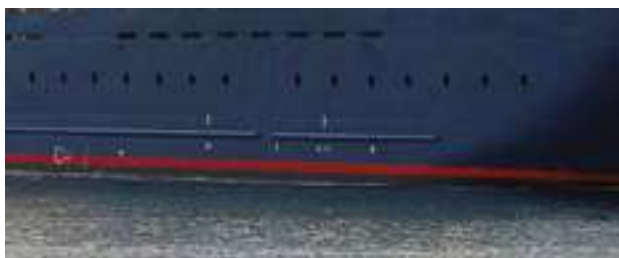
The gap in the ship's belting was estimated to be approximately 1 metre, significantly less than the requirements of IMO Resolution A1045(27) which states "Where rubbing bands or other constructional features might prevent the safe approach of a pilot boat, these should be cut back to provide at least 6 metres of unobstructed ship's side." See photo below. There are currently a series of new builds joining the fleet, and online images indicate they are all configured in the same way.

New build passenger vessel – and non-compliant

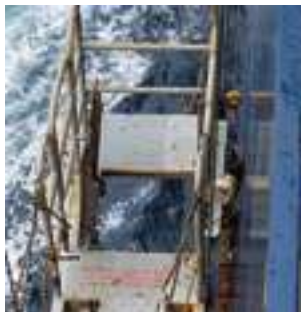
**Non-compliant combination boarding arrangement with the pilot ladder shackled to the underside of the accommodation ladder platform.**

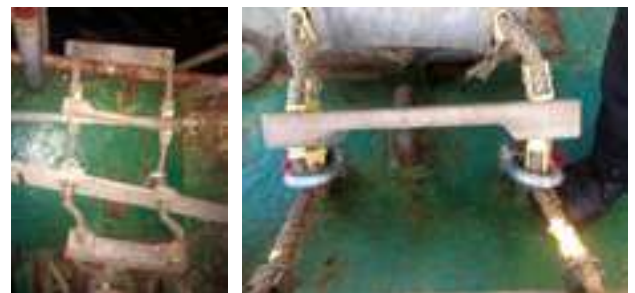
Figure 1 – Well-worn ladder with shackles impacting against the side chocks

In this example, the ladder had its weight effectively taken by the chocks. Whether they are plastic or wooden, chocks can be damaged if the shackles take the weight of the ladder directly against them. As it happens this example also resulted in the ladder being secured at the deck level in a manner which caused the steps to lie at an uneven angle. A cursory glance at the photo should be enough to tell you that this ladder is not fit for purpose and is (probably) not certified.

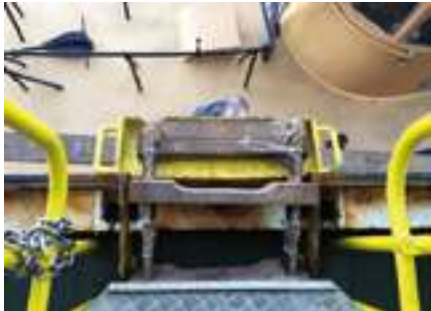
**Figure 2 – Ladder weight supported by a bracket which the step fits into**

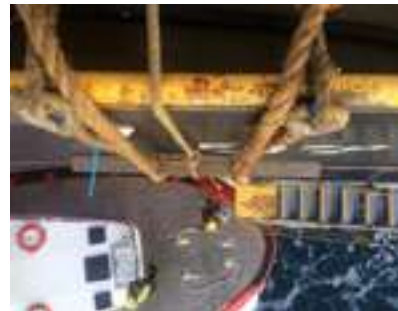
**Figure 5 – Ladder weight is actually supported by the whippings of the thimbles**

This picture shows side ropes terminating at thimbles below deck level. Lines through these thimbles run up to the deck where shackles are used to support the ropes. This was pointed out to the crew on deck, but they stated that a single line leading down to the top step was taking the weight! Definitely not compliant and a longer ladder is required so that side ropes can be secured directly on deck.

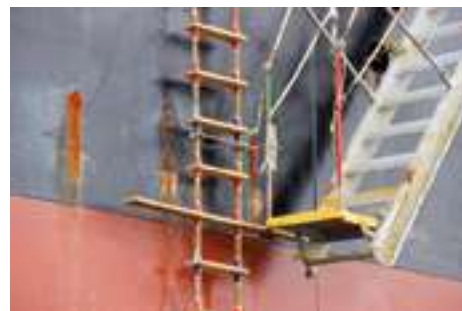
**Figure 6 – Ladder not attached to hull**

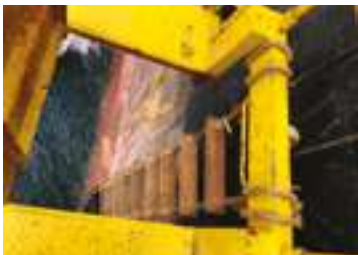
**Figure 7 – Ladder does not extend 1.5 metres above the trap door – how do you transit from ladder through the trap door?**

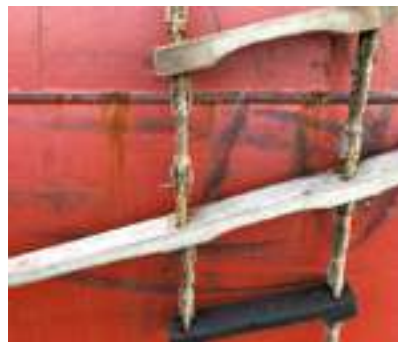
**Figure 10 – Pilot ladder steps not horizontal, chocks missing. Ladder needs replacing**

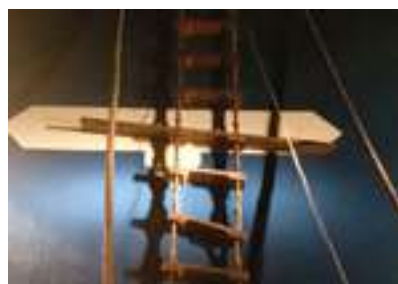
**Figure 11 – The step on this ladder gave way whilst the Pilot was disembarking**

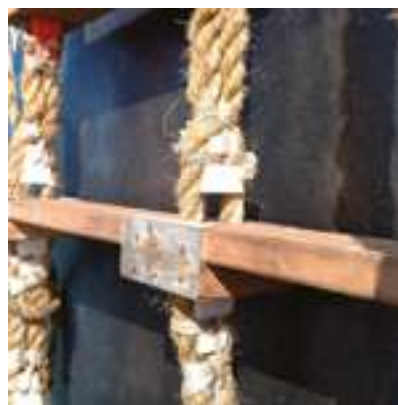
**Figure 12 – loose chocks – spreader replaced and not constructed of one piece of wood**

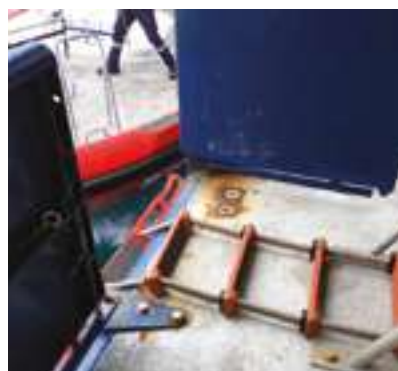
**Figure 13 – No stanchions provided to assist pilot boarding**

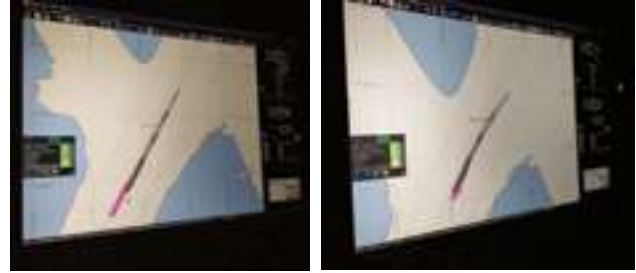
PPU showing GPS smoothing on the left with vessel "lagging" and smoothing removed on the right

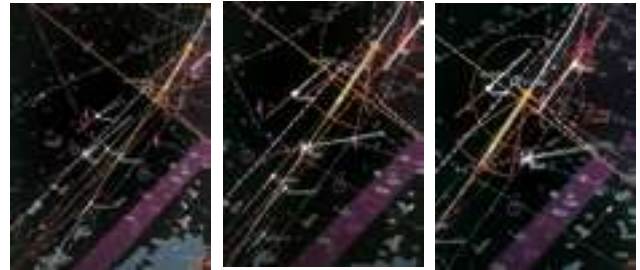
The contravening vessel was a 140m x 22m feeder container vessel and was a frequent trader on the Thames, Rotterdam and Kingston-upon-Hull route. It appeared to be taking a direct line between the Thames estuary and Rotterdam approaches. Such a course is contrary to the TSS and recommended routing.

Screen shots of the contravening vessel making no attempt to cross TSS lane at 90°

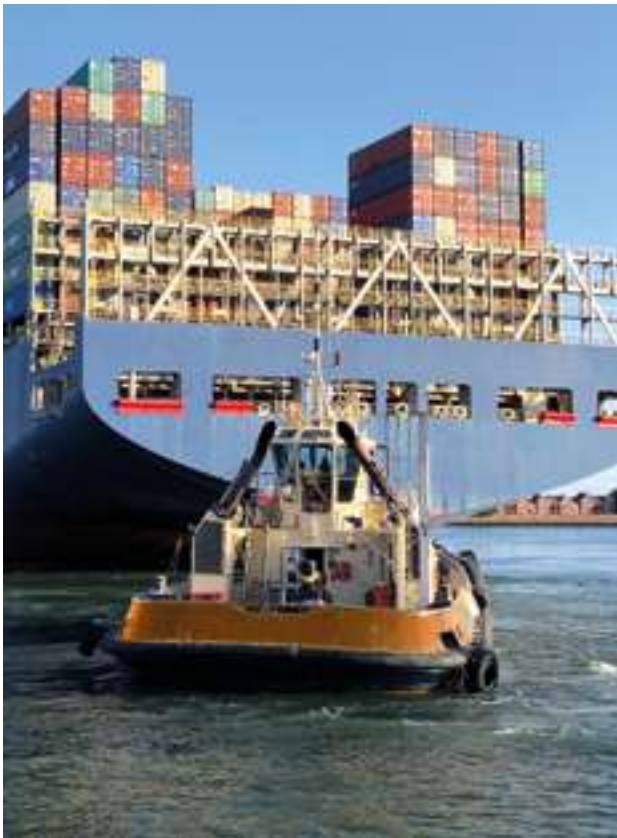
A tug towing with an open watertight door – highlighting the risk of flooding.

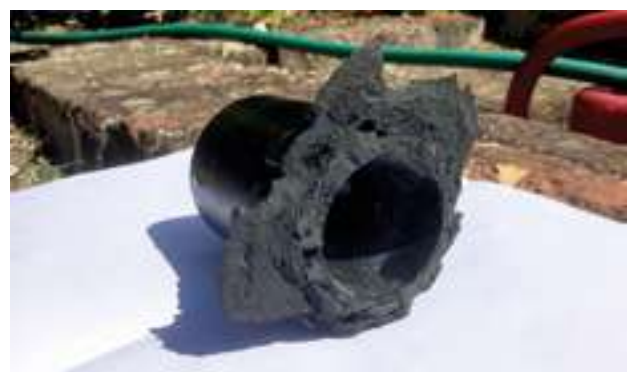
Since use of the main mast halyard for man overboard recovery is a recommended practice, a failure such as this could have been catastrophic. Further, we were informed that the winch has never been subject to heavy load or severe shock.

Photograph of failed casting.
