## SAFETY INVESTIGATION REPORT

REPORT NO.: 03/2020

### **MT GIOVANNI DP** **Inadvertent release of the FFLB** **and subsequent injuries to a crew member** **in position 30° 27.7' N 040° 53.6' W** **09 March 2019**

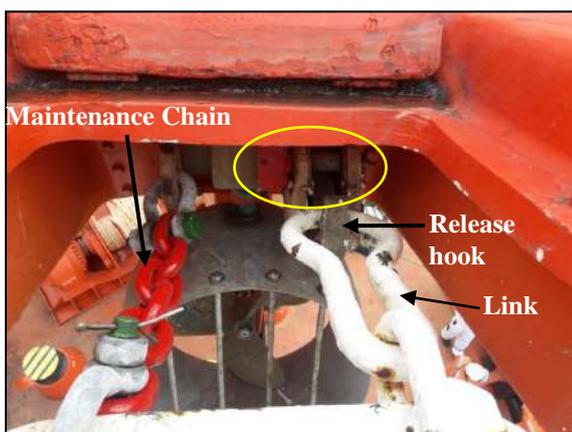
The FFLB's maintenance chain was installed and the hook's safety bolt was checked to be in place (Figure 1). All crew members entered inside the lifeboat, confirmed their seating positions, and instructions on the different methods of launching the FFLB were given by the chief officer. Thereafter, all persons left the FFLB except for the chief officer.

**Figure 1: Maintenance chain and Free-fall release hook (safety bolt circled in yellow)**

The immediate cause of the lifeboat's release into the water was the failure of the maintenance chain. A contributory cause to its release was the removal of the safety bolt from the maintenance position.

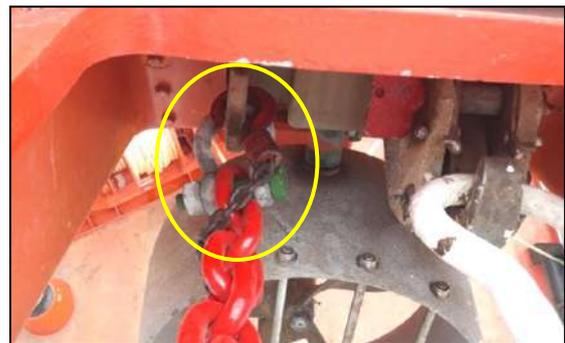
**Figure 2: Chain block assembly at the lifeboat's side. The other end of the chain block was attached to the stairs leading to the lifeboat's embarkation platform**

The installation of the chain block with a safe working load of two tons did not hold the lifeboat in position. The lifeboat weighed twice as much as the SWL of the chain block and the weight of the FFLB alone would have caused the chain block to exceed its tensile breaking strength.

Moreover, the chain block did not absorb the shock load applied, once the maintenance chain had failed. Chains do not absorb such loads and are not suitable to be used as fall preventer devices.<sup>6</sup>

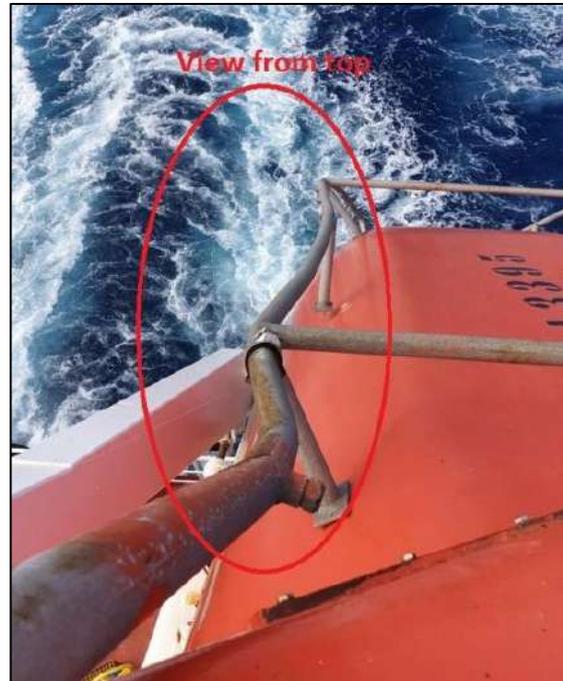
The FFLB sustained the following damages during retrieval:

- port side polyester fender;
- several cracks and scratches on the fibreglass material of the lifeboat;

- bottom slider flat-bars;
- guard rails and;
- aluminium sprinkler pipes and supports (Figure 3).

Figure 3: Damage to lifeboat's sprinkler system

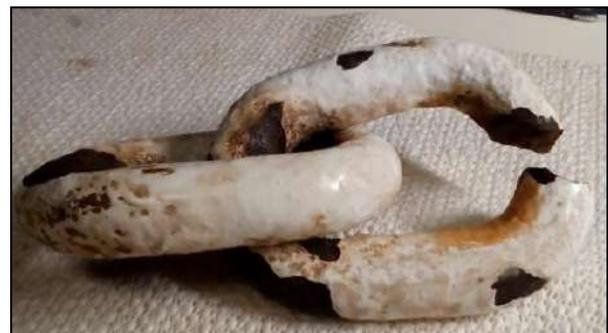
The immediate cause of the accident was the failure of the lifeboat maintenance chain.

Moreover, it was later confirmed that the maintenance chain, which was in position prior to the accident, had failed from the second link closest to the FFLB's stern (Figure 4).

Figure 4: Broken maintenance chain

During the course of the safety investigation, the Company identified several shortcomings, which had contributed to the accident. To prevent recurrence of this event, the Company updated its planned maintenance system, now requiring the maintenance chain to be replaced at five yearly intervals.

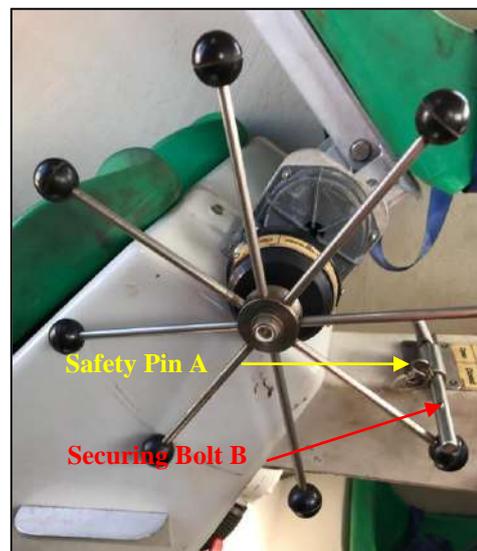
Figure 5: Hook release wheel with its securing in place

position during a ‘mock-training free-fall’. This would have prevented the free-fall release hook from releasing when operating the hook release wheel (Figure 5) from inside the boat.

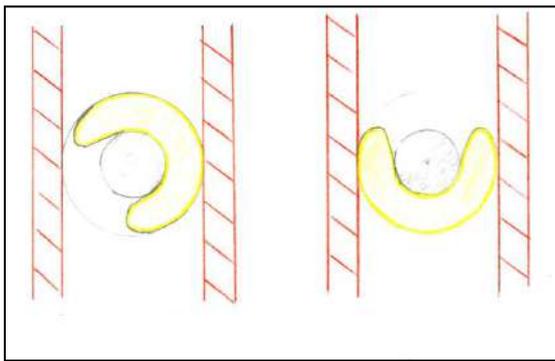
**Figure 6: Sketch showing the locker (yellow) in closed and open positions**

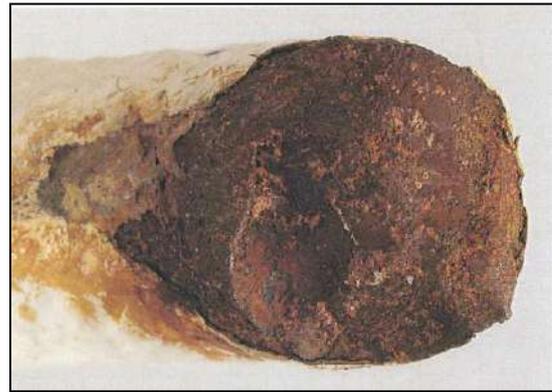
A portion of the maintenance chain (one broken link and one intact) was sent to a laboratory for metallurgical tests and to determine the possible cause of the fracture (Figures 8 and 9). As a basis, the test used a standard specification for grade 80 alloys; ASTM A391:2007.

The minimum tensile strength required from a grade 80 chain is  $800 \text{ Nmm}^{-2}$ . The tensile strength of a machined test piece taken from the broken chain link was measured to be  $1345 \text{ Nmm}^{-2}$ . The lab analysis showed that the tensile strength and hardness were very high for the grade of chain; which was probably the result of insufficient tempering after quenching<sup>8</sup>.

On a macroscopic scale, two cracks were found to have a brittle appearance, most probably originating from the inner radius of the chain. The causes of these cracks, although not completely confirmed, were deemed to be either from stress corrosion or a hydrogen assisted crack<sup>9</sup>.

The corrosion on the chain was deemed to be a partial cause of the failure as poor coating was noticed to have been applied on top of corroded steel. However, it was also acknowledged that the complete prevention of corrosion on such chains in a maritime environment is difficult to achieve.

Figure 8: Macrophoto of fracture side A, magnification approximately 3.3X

The metallurgical test therefore concluded that the high hardness of the chain was most probably the main cause of the fracture.

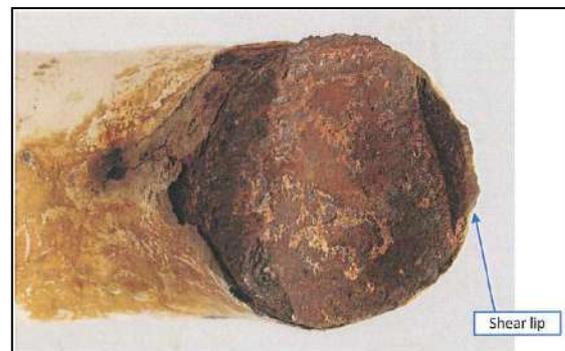
Figure 9: Macrophoto of fracture side B, magnification approximately 3.3X
