Collision between US Navy Destroyer *Fitzgerald* and
Philippine-Flag Container Ship *ACX Crystal*
Sagami Nada Bay off Izu Peninsula, Honshu Island,
Japan
July 17, 2017

Marine Accident Report

NTSB/MAR-20/02
PB2020-101007

National
Transportation
Safety Board

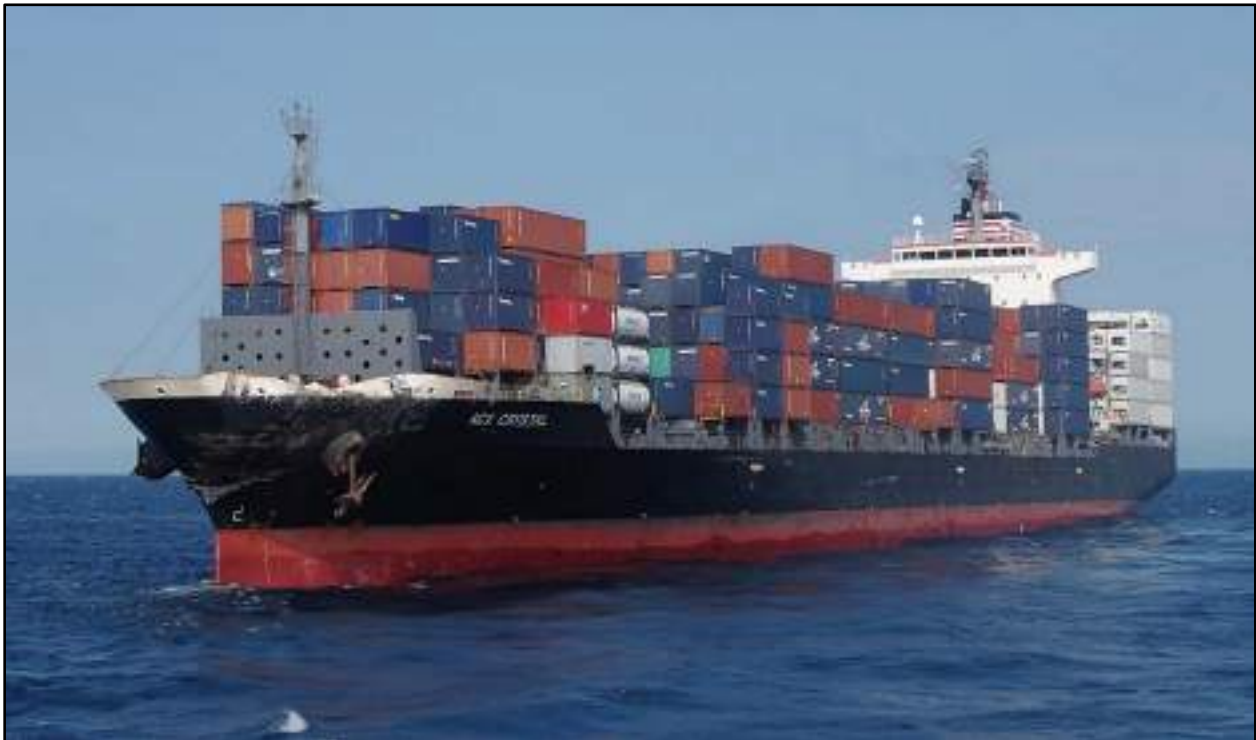
Figure 5. Container ship *ACX Crystal*, post collision. (Source: Sea Quest Management)

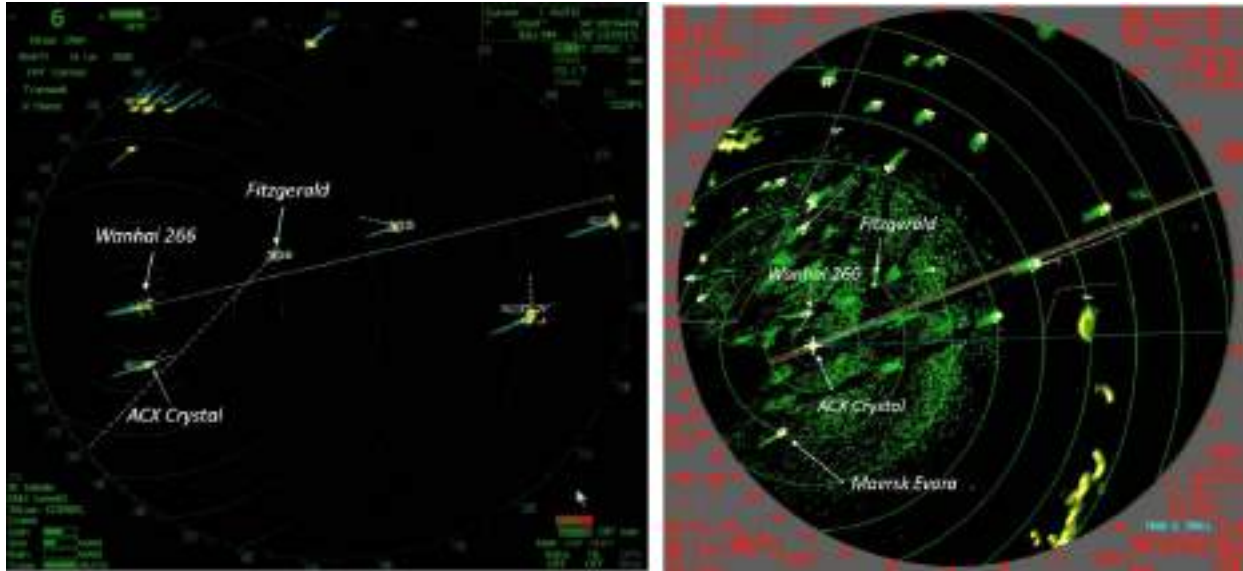
Figure 6. A comparison of radar screens from different vessels before the collision. Left, screen capture from the *Wan Hai 266* electronic navigation software, about 6 minutes before the collision. Right, screen capture from the *ACX Crystal* electronic navigation software (radar and ARPA), at the same time. (Vessel names have been added to screen images.)

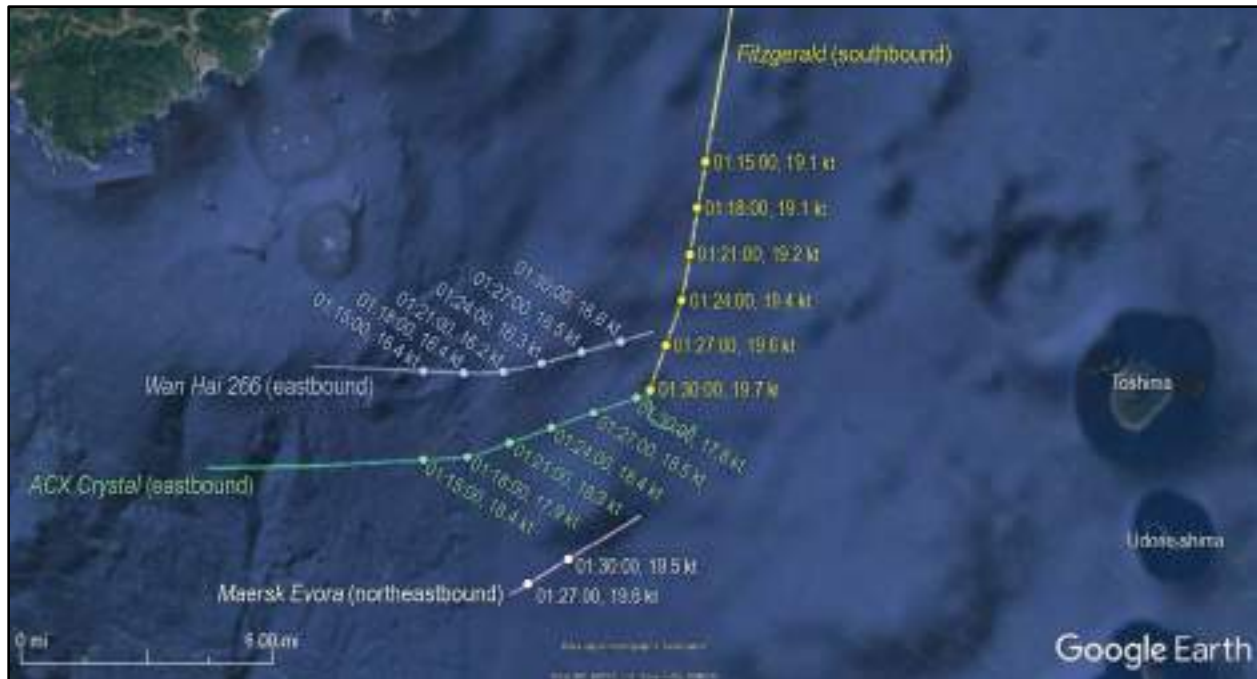
Figure 7. NTSB reconstruction of the paths of the *Fitzgerald*, *Wan Hai 266*, *ACX Crystal*, and *Maersk Evora*. (Background source: Google Earth)

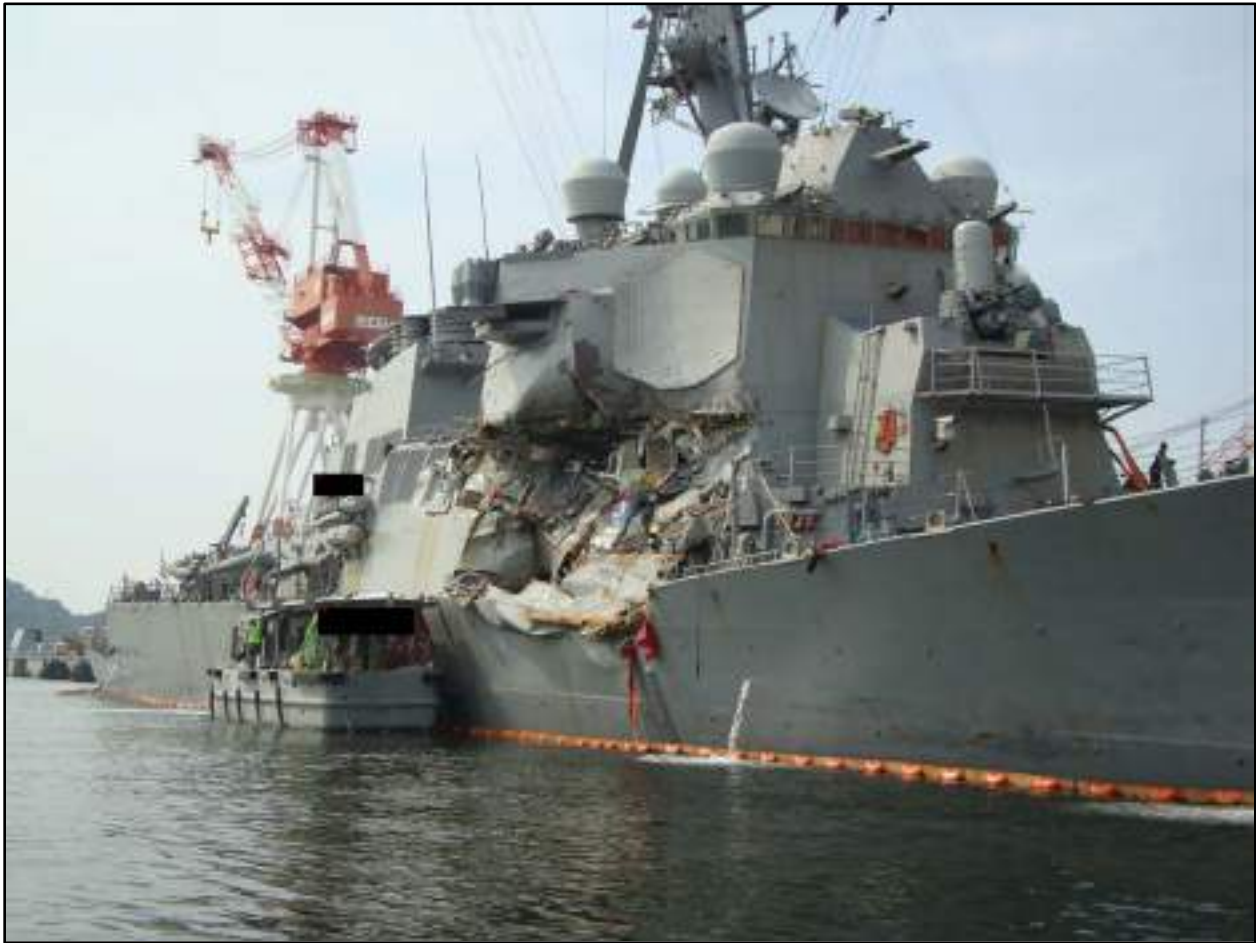
The *ACX Crystal*'s bow penetrated the *Fitzgerald*'s hull and superstructure, trapping numerous crewmembers aboard the destroyer, and the vessel took on a 7° starboard list. The *Fitzgerald*'s crew went to work to control the flooding, assist injured crew, and search for the missing. Seven crewmembers, trapped in their berthing compartment, perished. The destroyer sustained damage in excess of \$300 million.

Figure 8. Post collision damage to the *Fitzgerald*'s starboard side. (Source: US Navy)

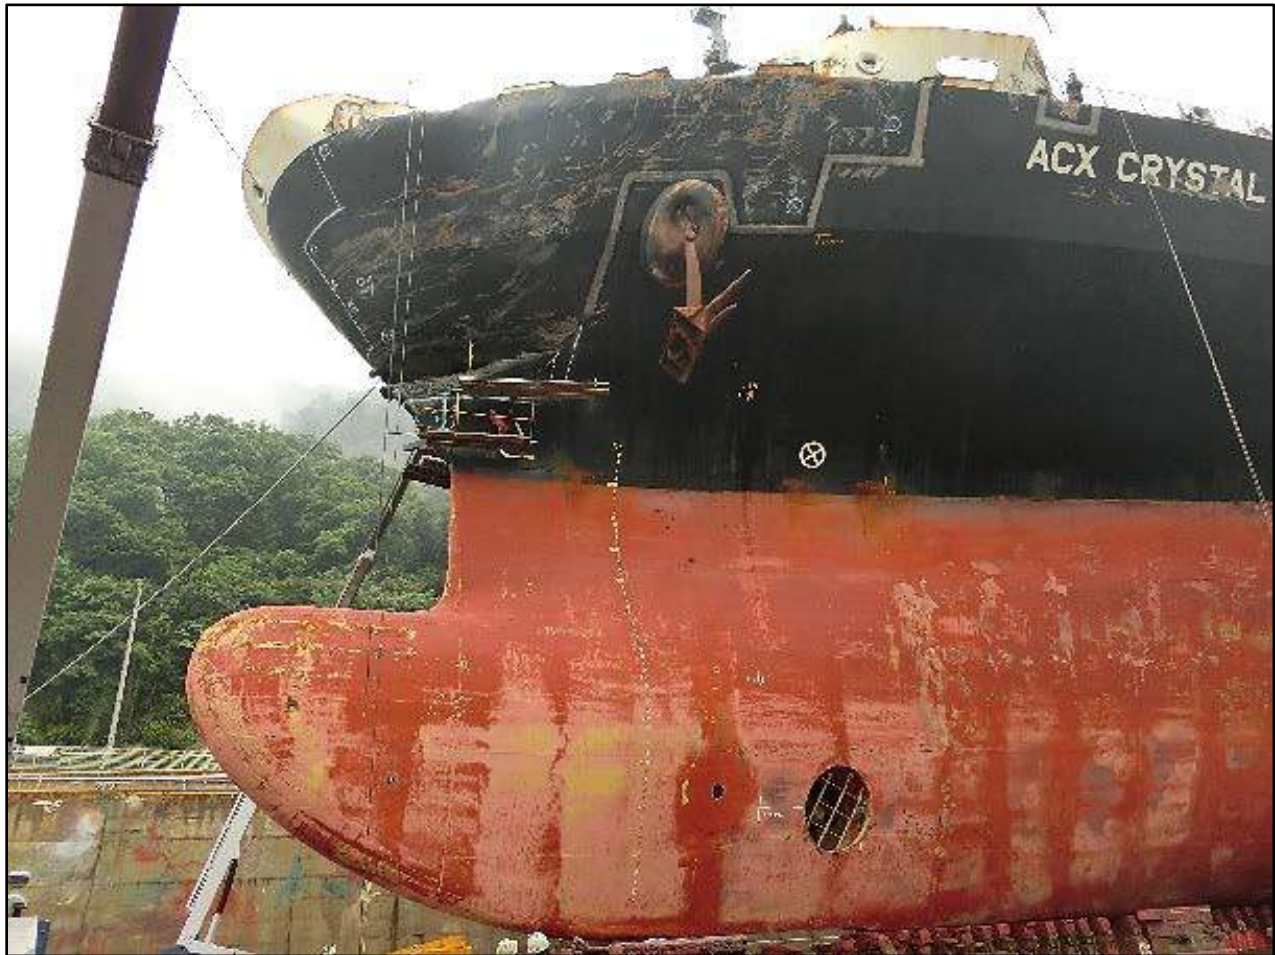
No one was injured on board the *ACX Crystal*, but the container ship sustained damage to its bow and forward compartments. The vessel's forepeak tank sustained a large gash, and a smaller gash was noted in the boatswain's stores compartment. Penetrations to the hull were above the waterline. The cost to repair the *ACX Crystal* was not reported to investigators.

Figure 9. Postaccident damage to the *ACX Crystal's* bow. (Source: Japan Transport Safety Board)

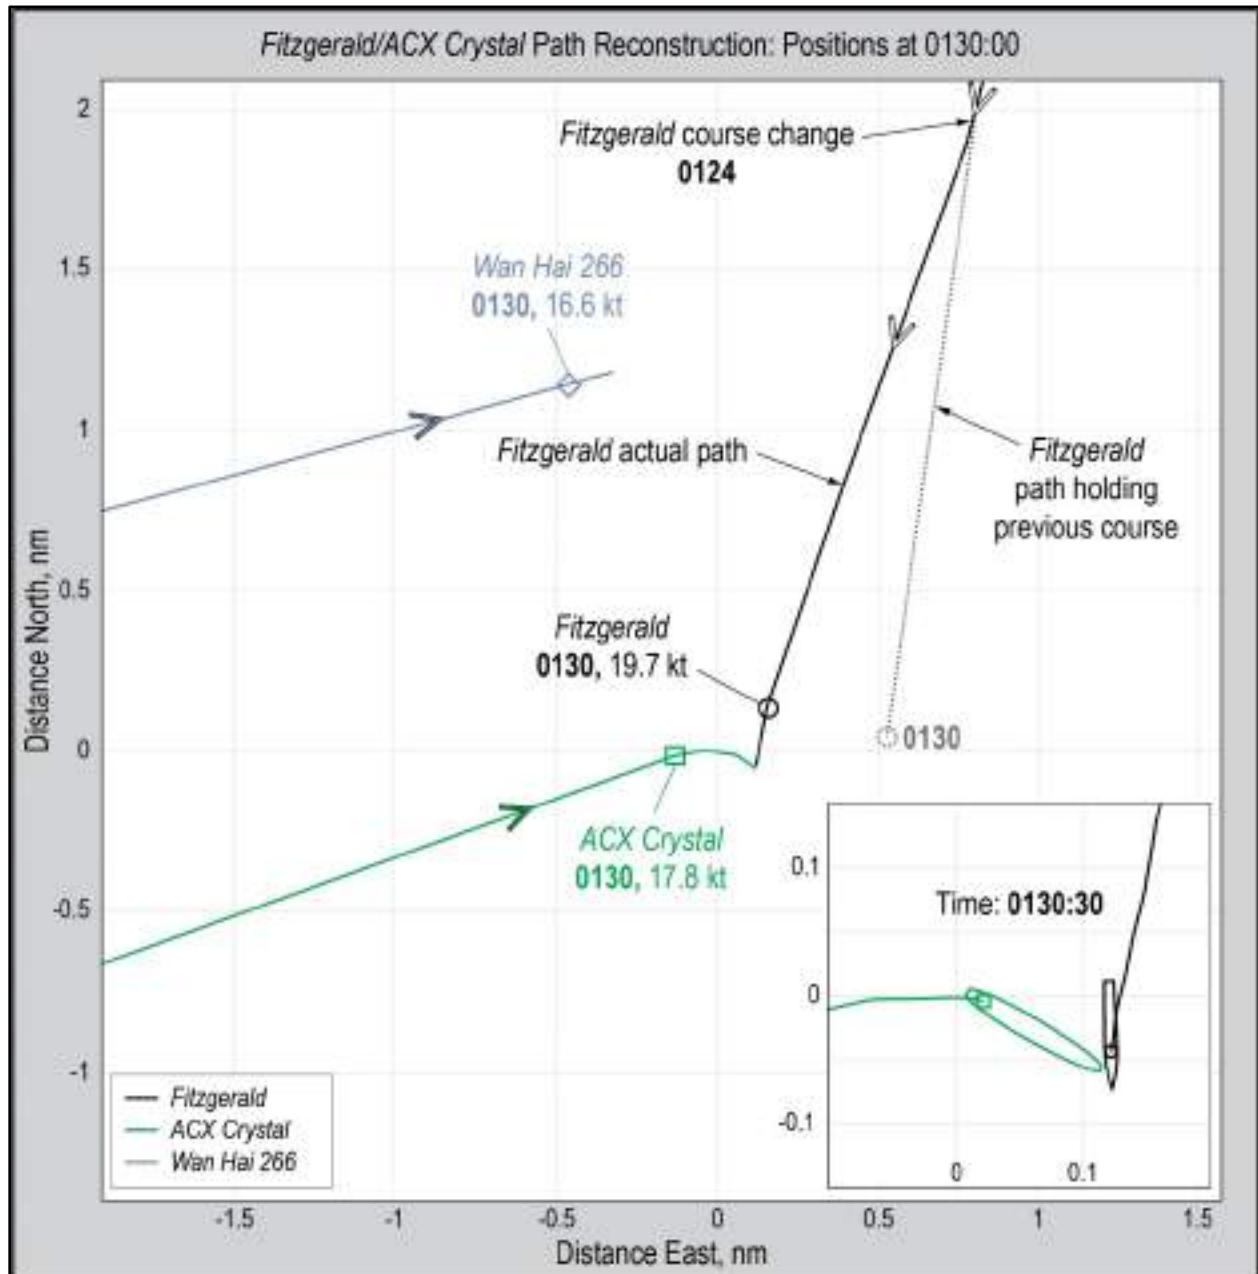
Figure 10. NTSB path reconstruction for *Fitzgerald* and *ACX Crystal*, from data compiled from NTSB Vehicle Performance Study.

The *Fitzgerald*'s deck log shows that a course change was ordered at 0122, and the vessel came right from 190° to 200°. They had steadied on the new course by 0124. This course change proved to be a critical error, and investigators were unable to determine the reason for it. The NTSB conducted a Vehicle Performance Study using GPS data as well as course and speed data for the *Fitzgerald*, *ACX Crystal* and *Wan Hai 266*, to recreate the tracks of the vessels leading up to the accident. The study found that if the *Fitzgerald* had not made the course change from 190° to 200° 8 minutes before the collision, the destroyer would have passed ahead of the *ACX Crystal* with a CPA of about 1,000 yards, or about 0.5 nautical mile. Therefore, the NTSB concludes that the
