# STONE I

Marine accident report on loss of control

4 JANUARY 2020

**MARINE ACCIDENT REPORT ON LOSS OF  
CONTROL ON STONE I ON 4 JANUARY 2020**

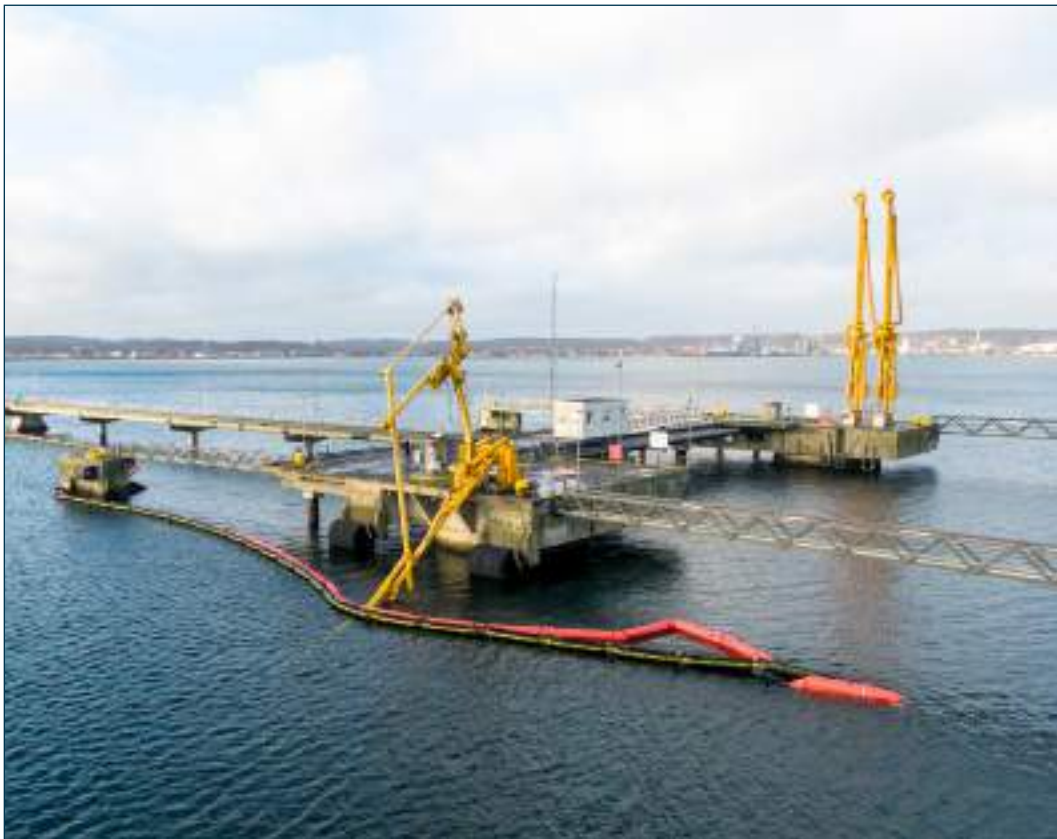
Figure 2: Ensted Oil Terminal after the accident  
Source: DMAIB

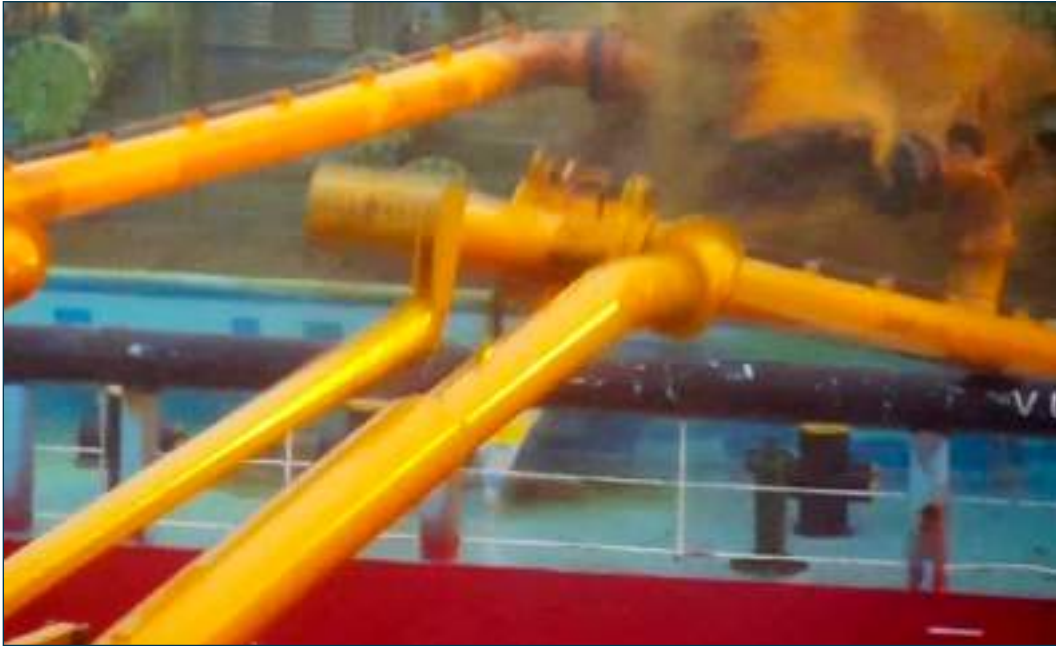
Simultaneously, at 0930, the master received information from the deck crew that one of the aft spring lines had parted. An AB who was standby at the manifold rushed to the forward mooring station together with the 2nd officer. Another AB went to the aft mooring station to assess the situation, but he soon realised that he was not able to safely approach the mooring winches, as the mooring ropes payed out uncontrollably, and the brake bands developed heavy smoke. Both loading arms from the jetty broke off the ship's manifold and vacuum gas oil gushed onto the ship and into the water (figure 3 and 4, next page).

*Figure 3: CCTV footage of loading arms breaking off and oil gushing out.  
Source: Inter Terminals Denmark EOT Aps*

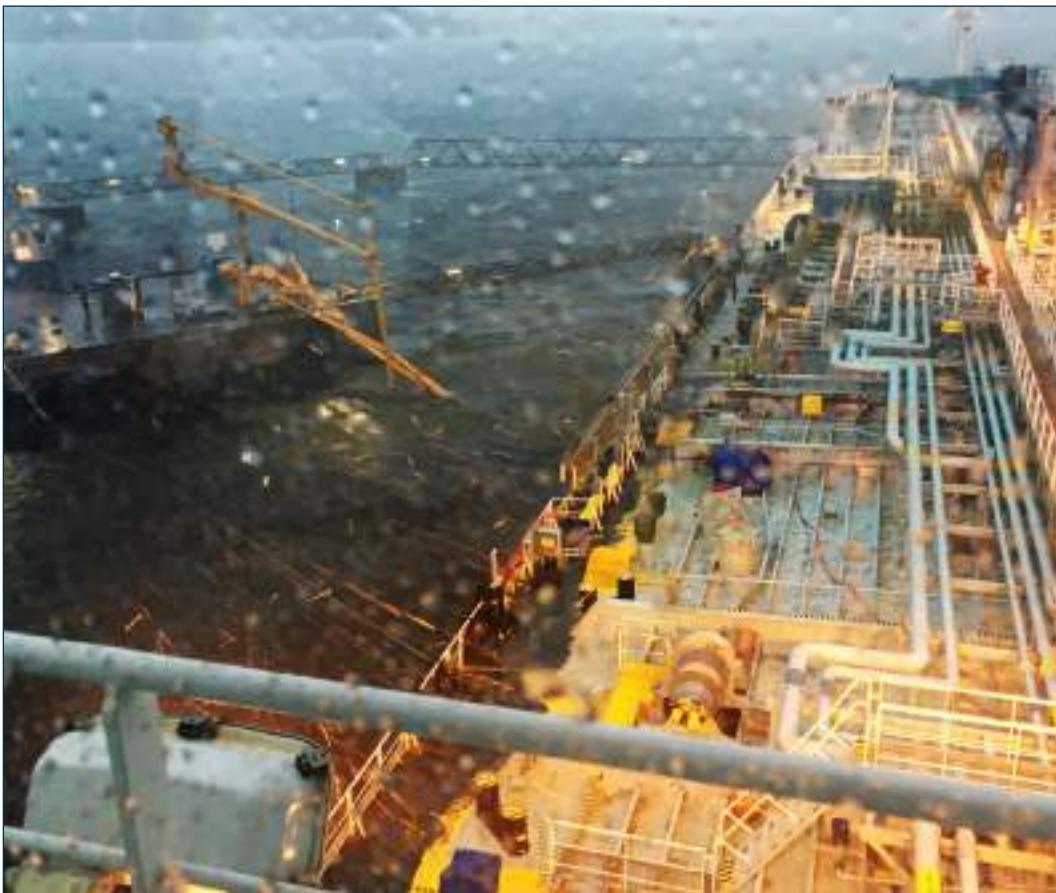
*Figure 4: Master's view from bridge at 0930.  
Source: Private photo*

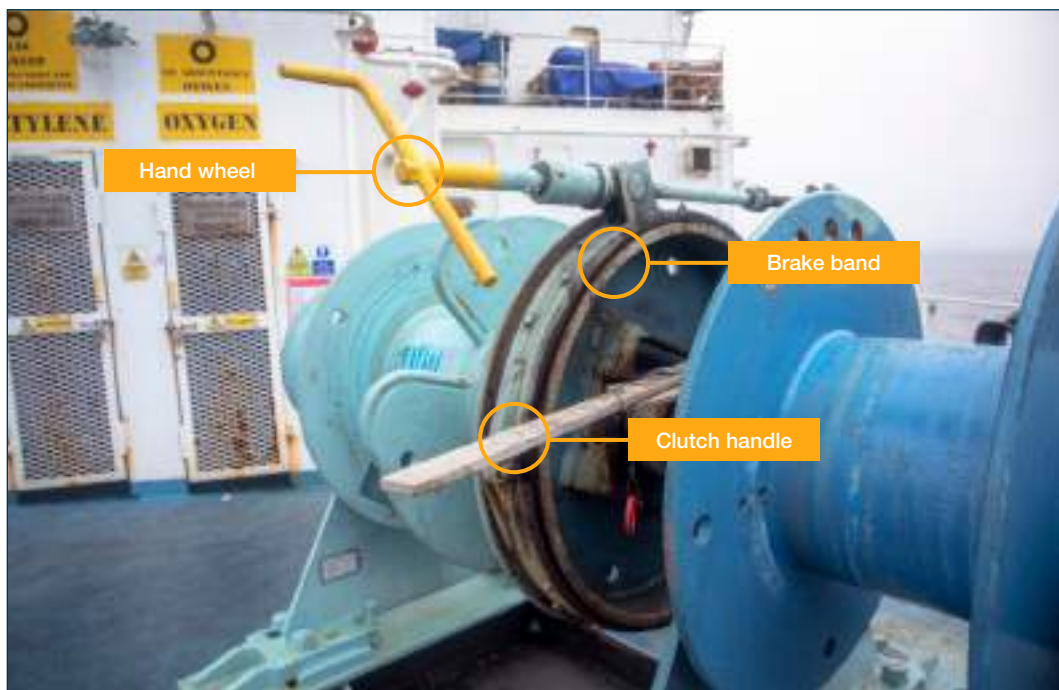
Figure 7: Hand wheel, brand brake and clutch on mooring winch.  
Source: DMAIB

The condition of the brake bands was instrumental for the brakes to work as intended. During the investigation, the mooring winches on STONE I were examined by DMAIB. They were not found to be in a state that impaired their functionality. Brake holding capacity tests were performed annually to ensure the correct functioning of the brakes. Prior to the accident a break holding capacity test was conducted in May 2019, which showed that the brakes were found to function as specified. After the accident in January 2020 and in February 2020, while the ship was dry-docked, break holding capacity tests were carried out again. Both tests showed that the brakes were in good working order. As the brakes were found to be in functional order, it can be concluded that the winch brakes did not pay out due to malfunctioning brakes.

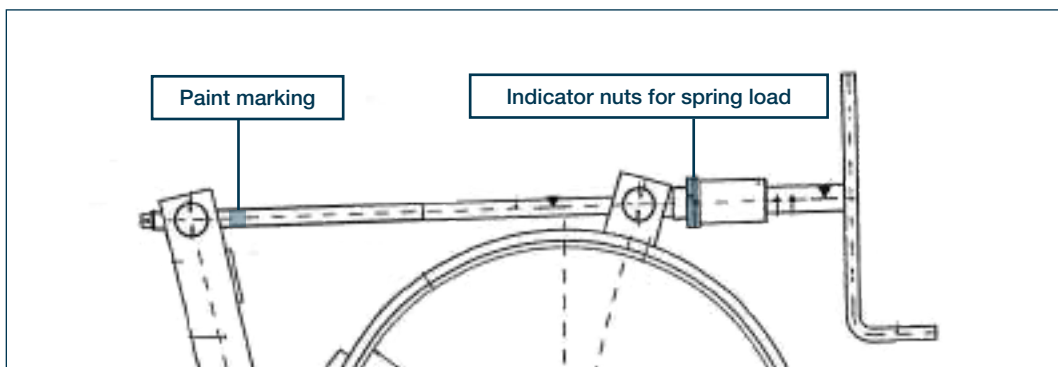
Figure 9: Visual indicators on the winch brake  
Source: Zenith Gemi Isletmeciligi AS / DMAIB

During the investigation on the ship, it was not certain whether the winches had been adjusted during or after the accident. Therefore, it was not possible to determine on site if the winch brakes had been fully applied before the accident. Statements from witnesses affirmed that the brakes on the aft deck winches made a screeching sound and developed smoke, caused by friction between brake band and brake drum, when the ship drifted away from the jetty. This indicated that the brakes were tightened prior to the drifting of the ship; however, it did not verify whether the brakes had been fully or only partially applied.

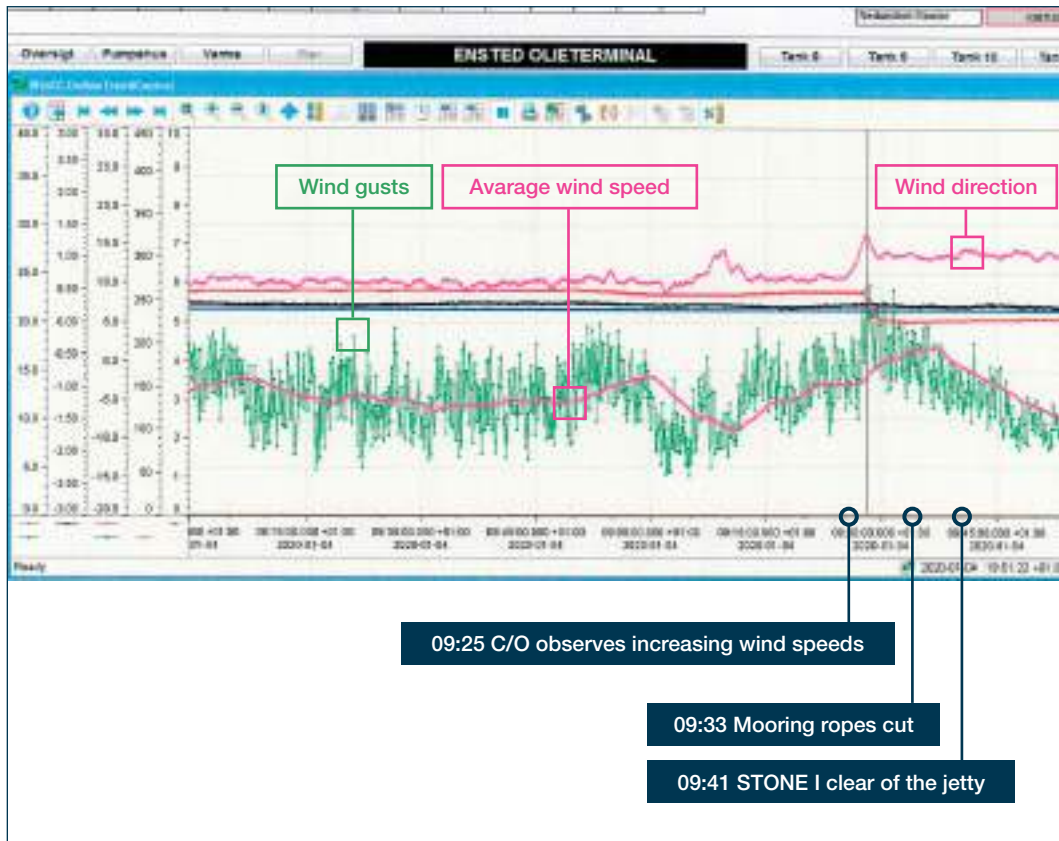
Figure 11: Screenshot from Inter Terminals' trend control panel  
 Source: Inter Terminals Denmark EOT Aps/DMAIB

On figure 11 next page, a record of wind direction and speed from Ensted Oil Terminal is presented. It shows wind measurements and trend data for the average wind speed for the period 0800-1000 on 4 January 2020. STONE I's mooring winches started to pay out at 0929. In the period of 0927 to 0940, the wind data shows a sudden increase in wind speed up to 25 m/s and a change of wind direction from 270° to 325 °. This wind speed was higher than the forecast predicted. However, the average wind speed did not at any time during the time period exceed the terminal's wind criteria for loading.

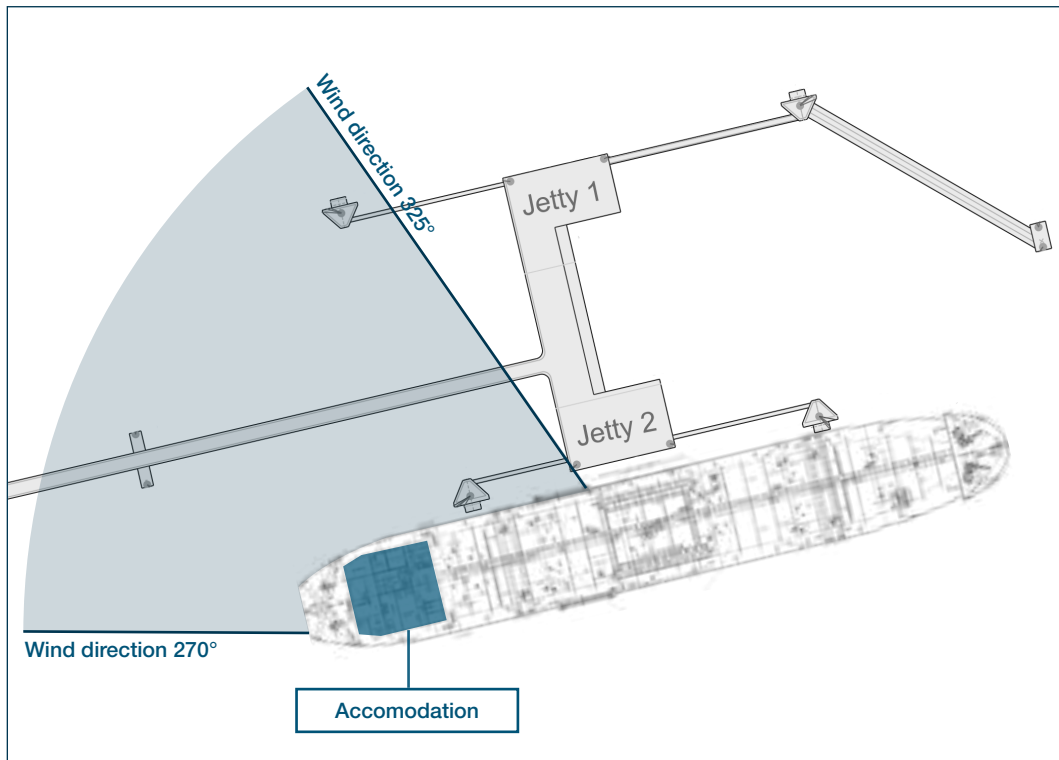
Figure 12: Wind forces acting on the ship during the accident  
 Source: Inter Terminals Denmark EOT / Zenith Gemi Isletmeciligi AS / DMAIB

During the accident STONE I was berthed port side alongside, heading 080°, and the wind came from a WNW direction. The wind hence acted on the ship's aft on port side, where the ship's accommodation was located (figure 12, next page). The wind direction and location of the accommodation exposed the aft part of the ship to a higher lateral force than on the forward, which caused a higher the load on the aft moorings than on the forward.

The owner of the terminal contracted FORCE Technology to calculate at what wind force the winch brakes would release. The report prepared by FORCE concluded that the ship should not suffer from collapse of the winch holding capacity for wind speeds below 31 m/s for any wind direction. This finding implies that the winches had not been correctly applied or malfunctioned. However, the report contained several uncertainties. E.g. the pretension of the moorings and the mooring ropes vertical angles were not included in the calculation. These are significant factors for determining the load on the winches.

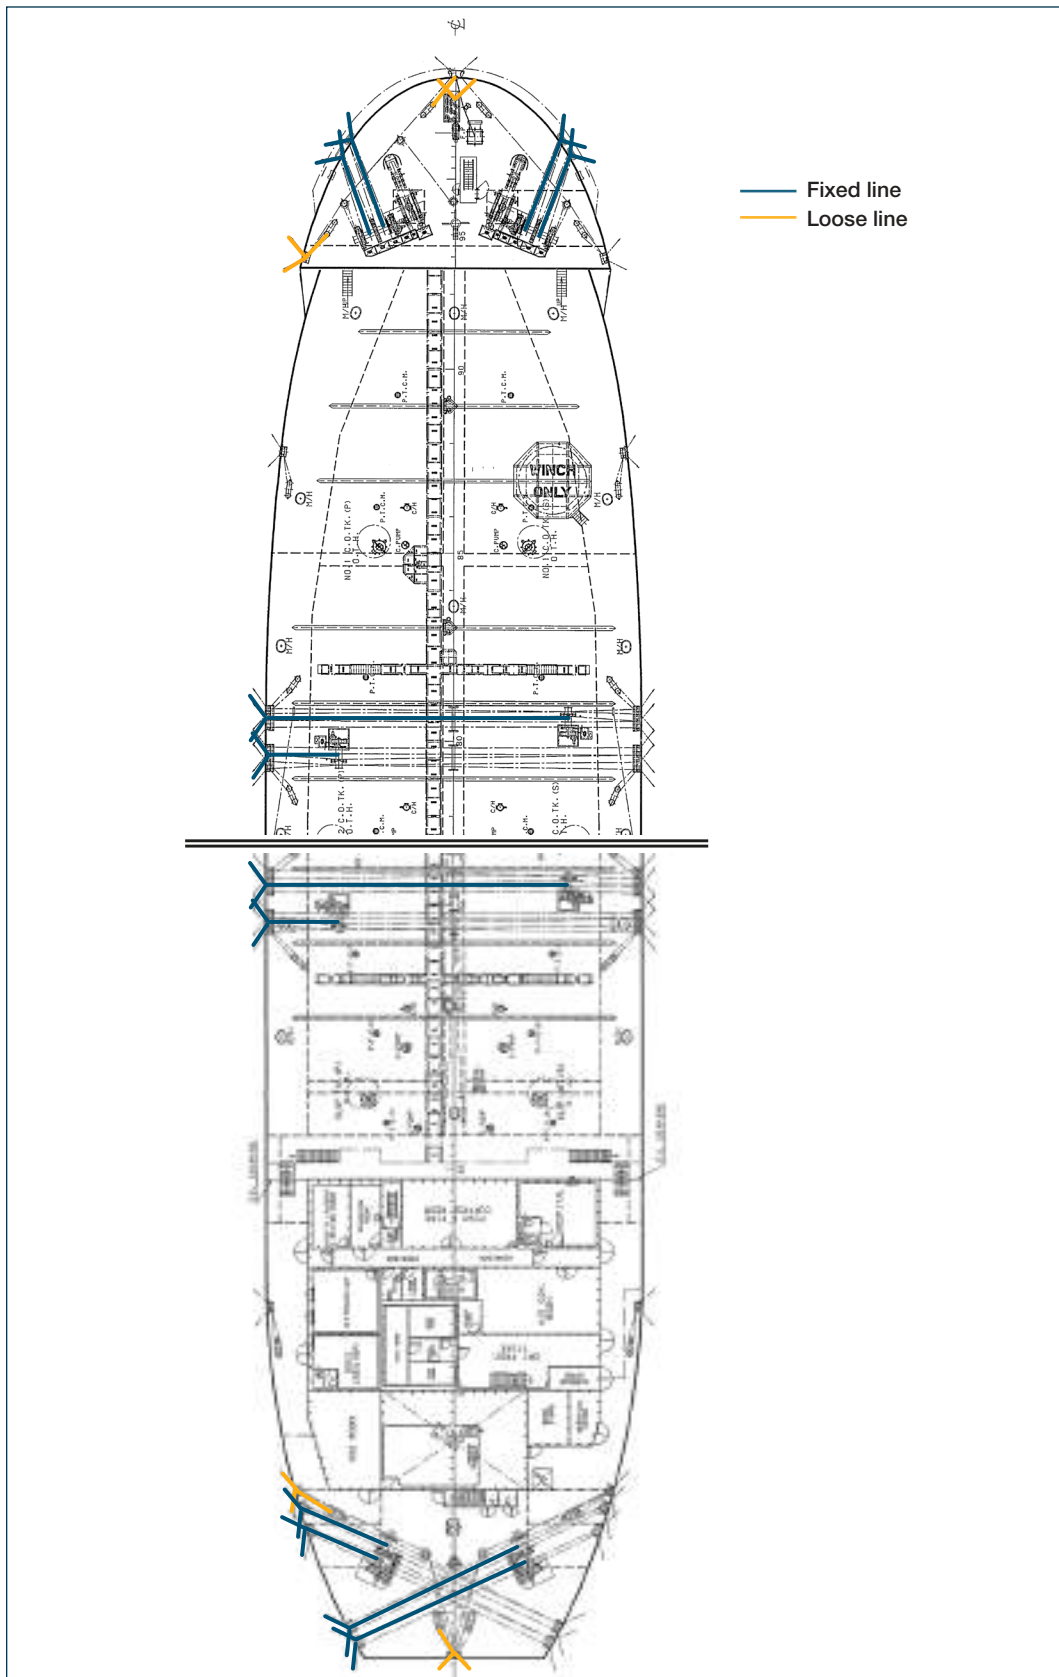
Figure 18: Possible ways of directing mooring lines on STONE I when berthed on port side.  
Source: Zenith Gemi Isletmeciligi AS / DMAIB

The illustration below shows the possible ways of directing mooring lines on STONE I, when the ship was portside alongside. It is noted that on the aft mooring station the mooring layout did not allow for mooring lines to be directed from the winches to the berth via the transom (figure 18).

- The aft mooring station did not allow for mooring lines to be directed from the winches to the berth via the transom.
- The mooring management plan recognised that an optimal mooring pattern was not always achievable.
- In the event of deteriorating weather or sea conditions, the mooring management plan stated that the master should not hesitate to put out extra moorings, if he considered this to be necessary.

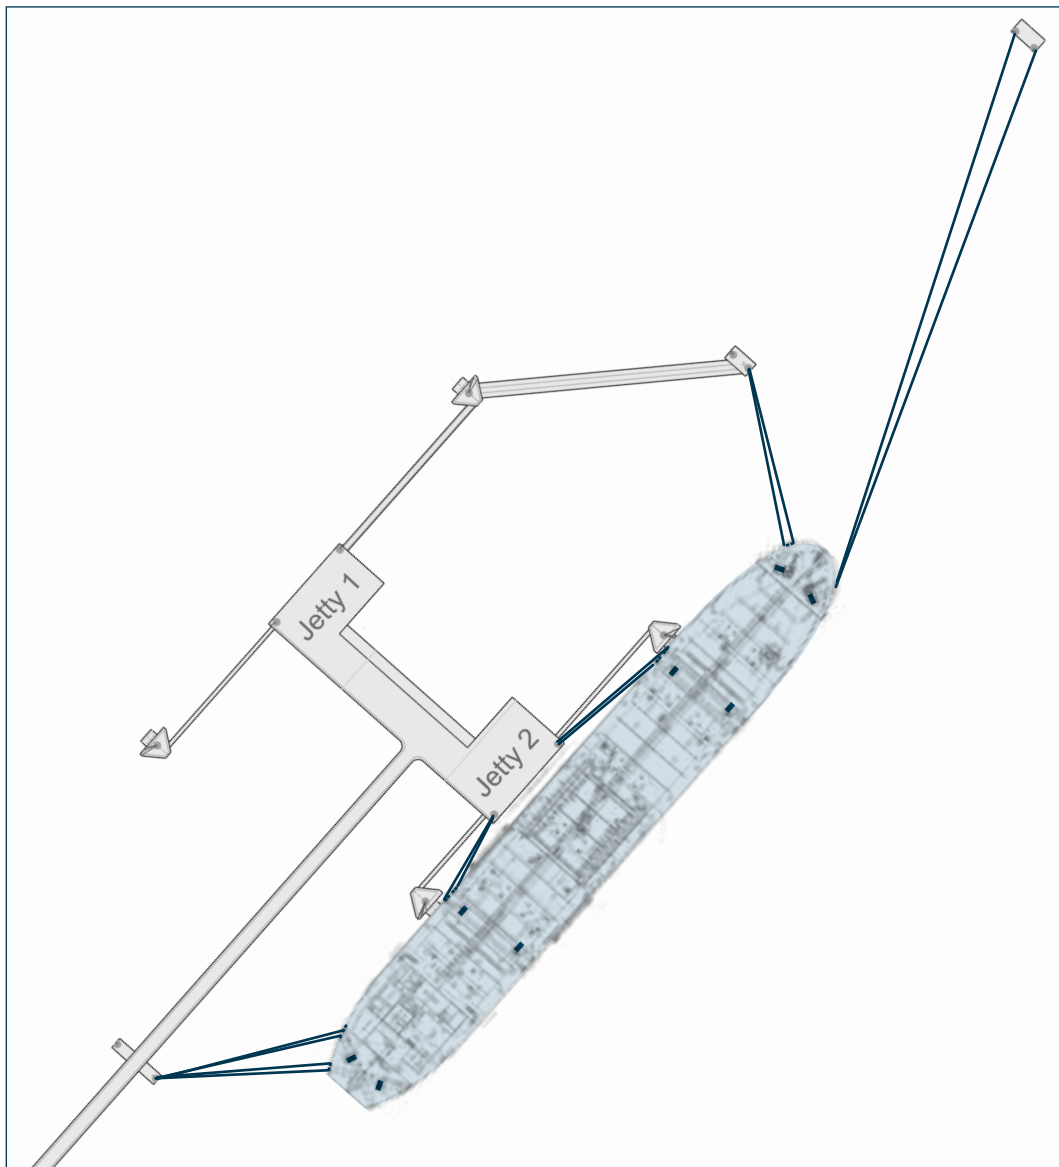
Figure 22: STONE I moored at Ensted Oil Terminal  
 Source: STONE I

The agreed mooring configuration was similar to the typical mooring pattern in the ship's mooring management plan. However, during berthing, the master was informed that the jetty's bollards and hooks were not aligned to direct the breast lines in an optimal angle. The master assessed the situation and decided to accept the mooring configuration as this seemed to be the only feasible option. STONE I was thus moored with four lines on the forecandle, four lines on the main deck and four lines on the aft (figure 22).

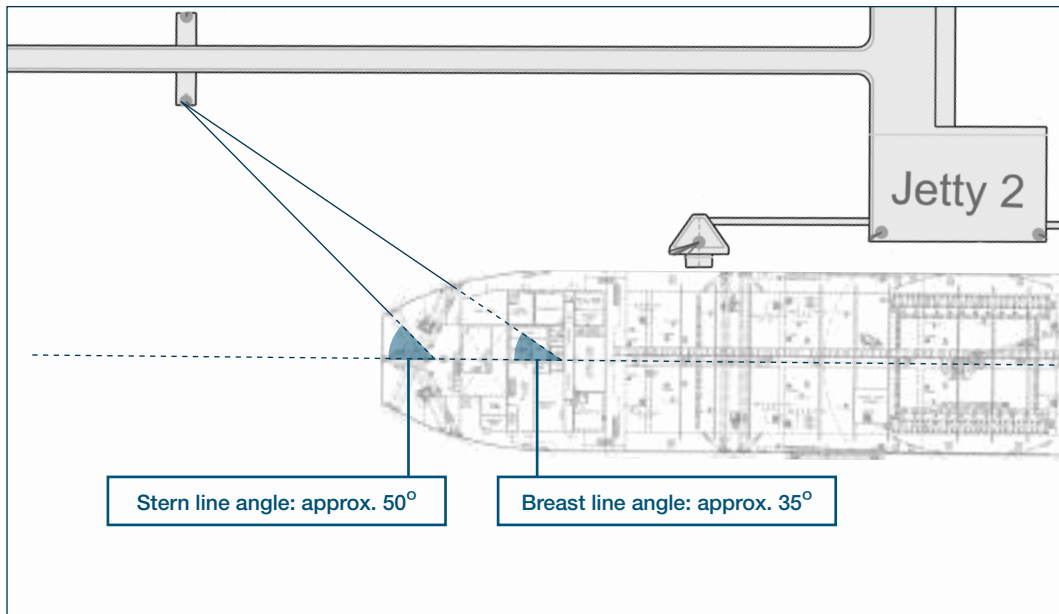
Figure 23: STONE I moored at Ensted Oil Terminal  
Source: STONE I

An examination of the actual mooring configuration on STONE I at Ensted showed that it differed from the mooring configuration, which the master had initially planned, from the mooring pattern described in the ship's mooring management plan and from Ensted Oil Terminals' mooring plan. The main difference was that the intended breast lines on the aft deck had an angle of approx. 35° instead of the ideal 90°. In comparison, the stern lines had an angle of 50 approx., and was hence leading in a more perpendicular direction than the breast lines (figure 23).

- On the aft part of STONE I, the mooring configuration on the day of the accident differed significantly from the planned.

The actual mooring pattern and the direction of the mooring lines from the aft deck had the effect that the aft moorings had significantly reduced transverse restrain capacity. This resulted in an increased load on the aft mooring winches. When the wind force suddenly increased, the wind direction and location of the accommodation exposed the aft part of the ship to a higher lateral force than on the forward. This added an increased load on the aft mooring winches.
