# Loss of containers overboard involving *APL England*

46 NM south-east of Sydney, New South Wales, on 24 May 2020

**ATSB Transport Safety Report**

351-MO-2020-002

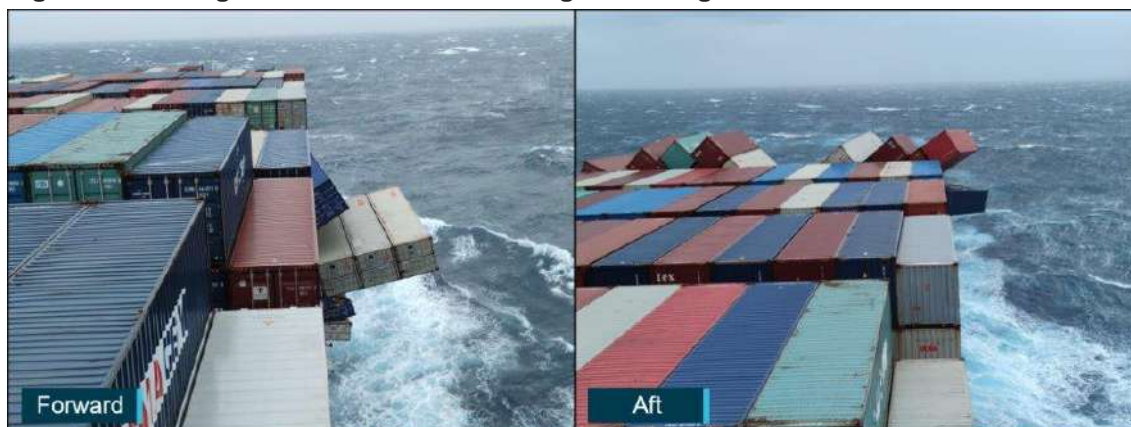
As the skies lightened (sunrise was at 0647), the chief officer noticed fallen stacks of containers aft (bay 62) (Figure 3). The master notified the company of the incident. Upon returning to the bridge about 10 minutes later, the master was notified by the chief officer of the damage and loss of containers forward (bay 30).

**Figure 3: Looking forward and aft from navigation bridge at about 0700**

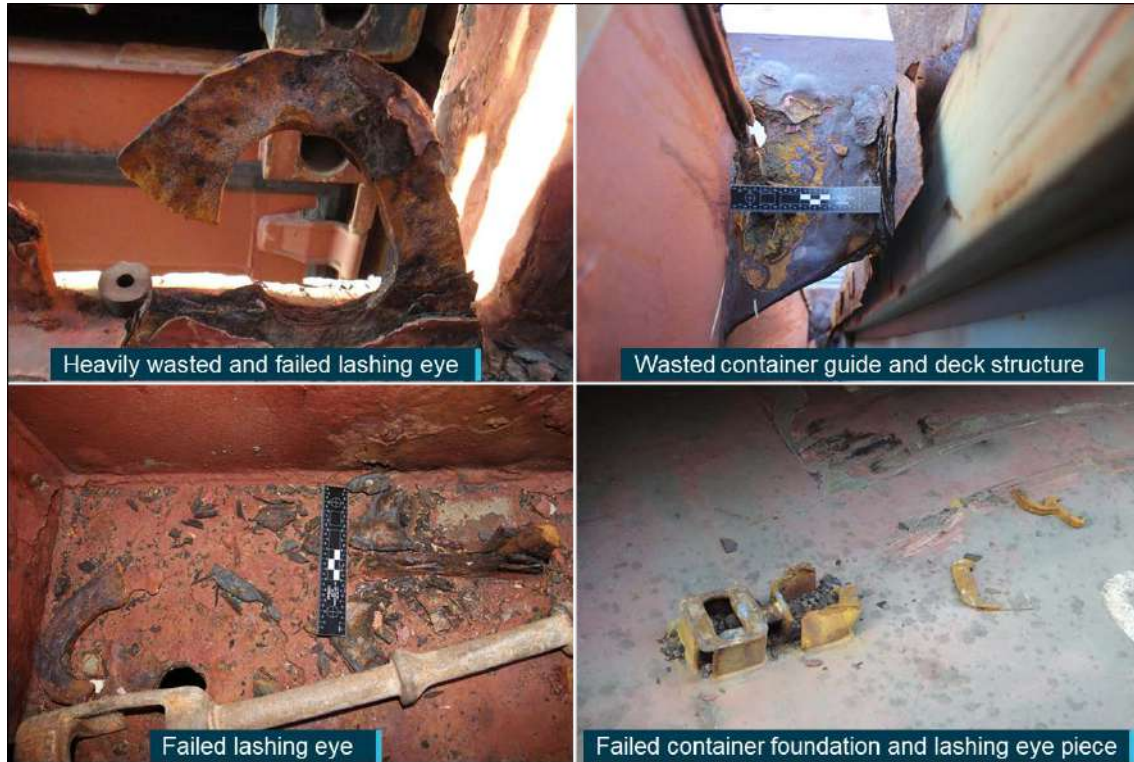
The ATSB onsite investigation examined securing arrangements and lashing equipment in use on the ship. The lashing equipment appeared in generally good condition. However, many of the ship fittings (lashing eyes, lashing bridges and deck structures) were not found in good condition, as evidenced by the examples shown in Figure 4.

**Figure 4: Examples of condition of cargo securings and ship structure**

The ATSB inspection of the bay 62 (aft) arrangement and damage revealed similar structural and securing conditions as shown in Figure 4. However, in addition to this, examination of the stowage arrangement showed that the security of the stow above the container cell guides used in bay 62 was affected by the use of high cube (2.9m (9'6") high) as opposed to standard height (2.6 m (8'6")) containers.

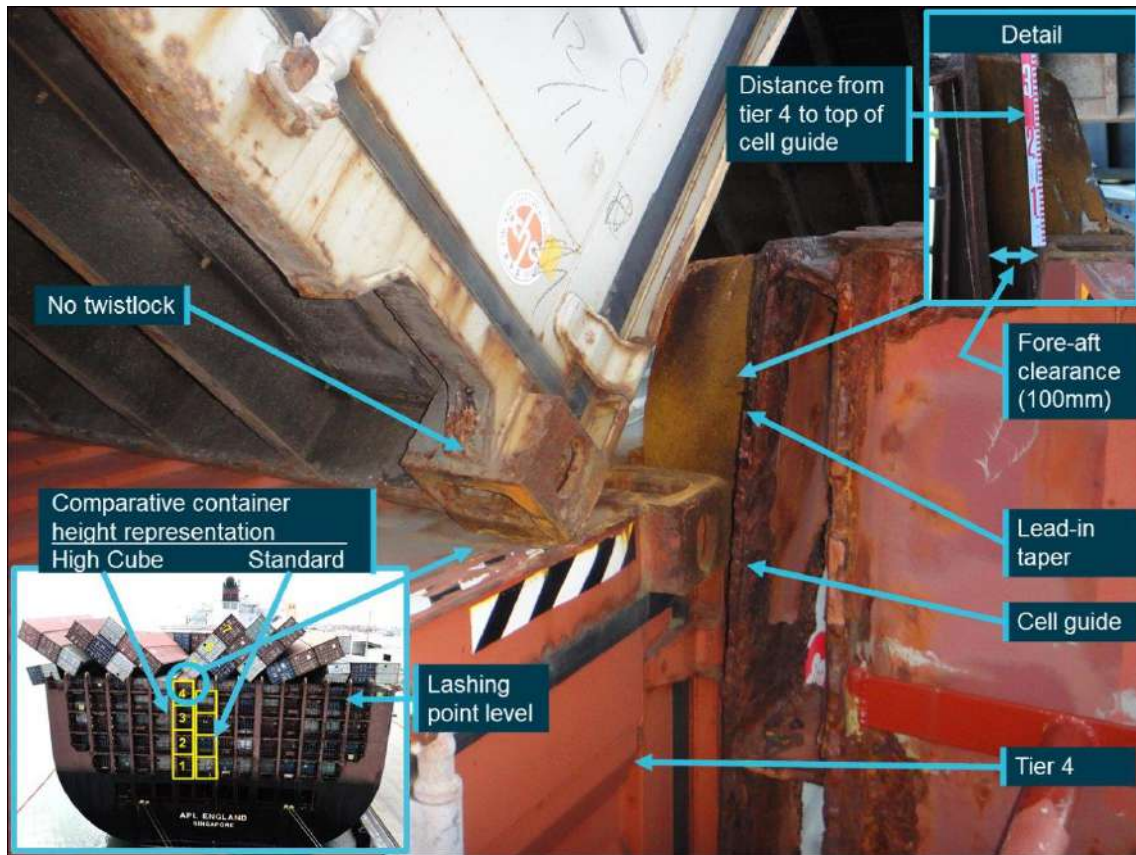
In this arrangement, when loading standard height containers, the top of tier 4 was about 1,550 mm (5'1") below the top of the cell guides. However, high cube containers are 300 mm (1') higher than the standard height container. Therefore, when loading high cube containers into bay 62, the top of tier 4 was 1.2 m (4') higher than when loading standard height containers. In these circumstances, the bottom of tier 5 containers would be about 300 mm below the top of the cell guides, and within the tapered (fore-aft) lead-in section of the guide (Figure 5).

For the voyage to Australia, bay 62 was loaded with predominantly high cube containers to 7 tiers. The loading computer lashing and forces checks did not show any conflicts for this arrangement.

Figure 5: Bay 62 container stowage versus cell guide arrangement
