MARINE SAFETY INVESTIGATION REPORT

Safety investigation into the engine-room fire on board the
Maltese registered ro-ro cargo vessel

EUROCARGO TRIESTE

following departure from the port of Livorno
on 21 November 2019

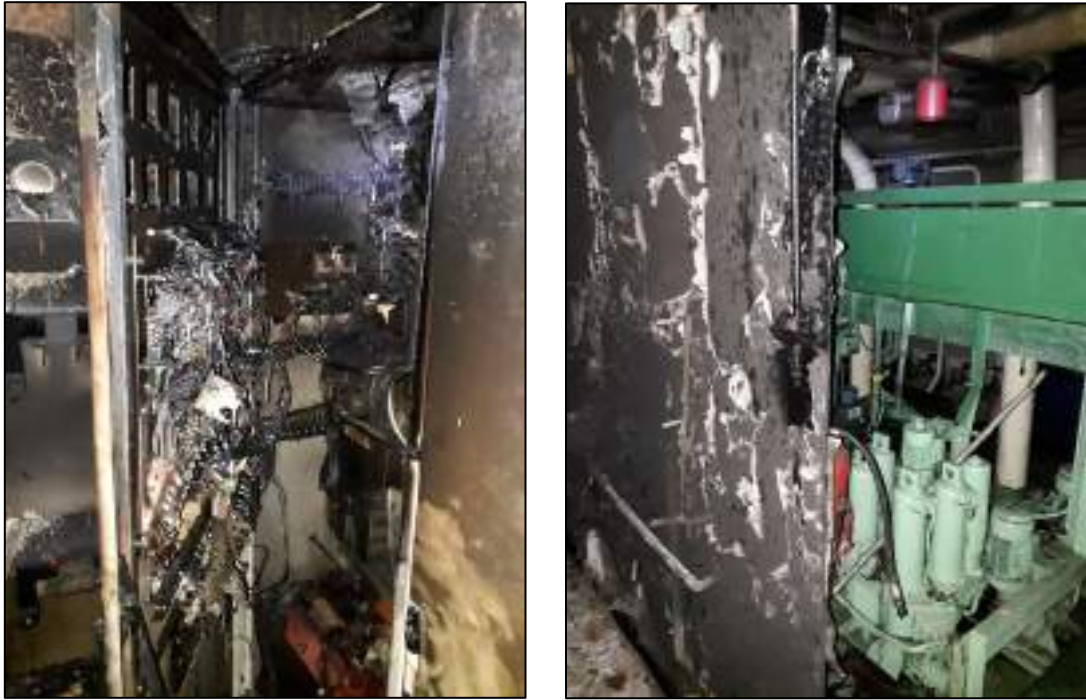
The starboard propulsion system's damage could only be determined by a complete overhaul of its units and the turbocharger. The port propulsion engine appeared to have been unaffected. An electrical control sub-station unit, located immediately forward of the ECR's windows, was completely destroyed (Figure 7).

Figure 7: Burnt out electrical / control panel forward of the ECR and modules room bulkhead

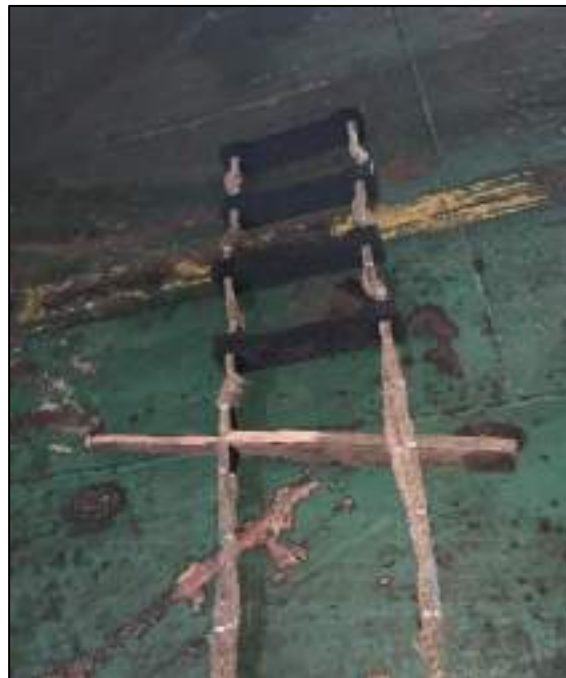
The port side pilot ladder was found damaged, namely: its lowermost spreader was broken (Figure 8).

Figure 8: Damaged port side pilot ladder

The paint scratches on the port side shell plating of the vessel, in the vicinity of the area where the port side pilot ladder was rigged up, seemed to indicate that the damages to the pilot ladder and the paint scratches were caused by the fire-fighting tugs, whilst they were engaged in boundary cooling, and/or the boats used to transfer the pilots. It should be noted that the pilot ladder was reported as damaged when the

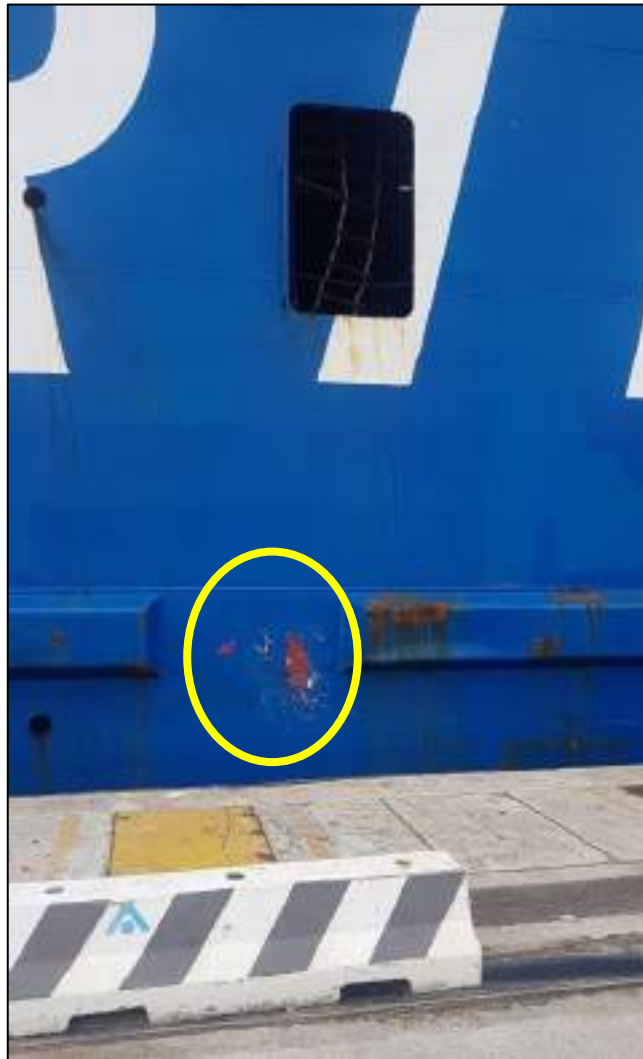
Furthermore, paint scratches were observed on the port shell plating of the vessel, around the area where the pilot ladder was rigged up (Figure 9).

Figure 9: Paint scratches on the vessel's hull (circled in yellow)

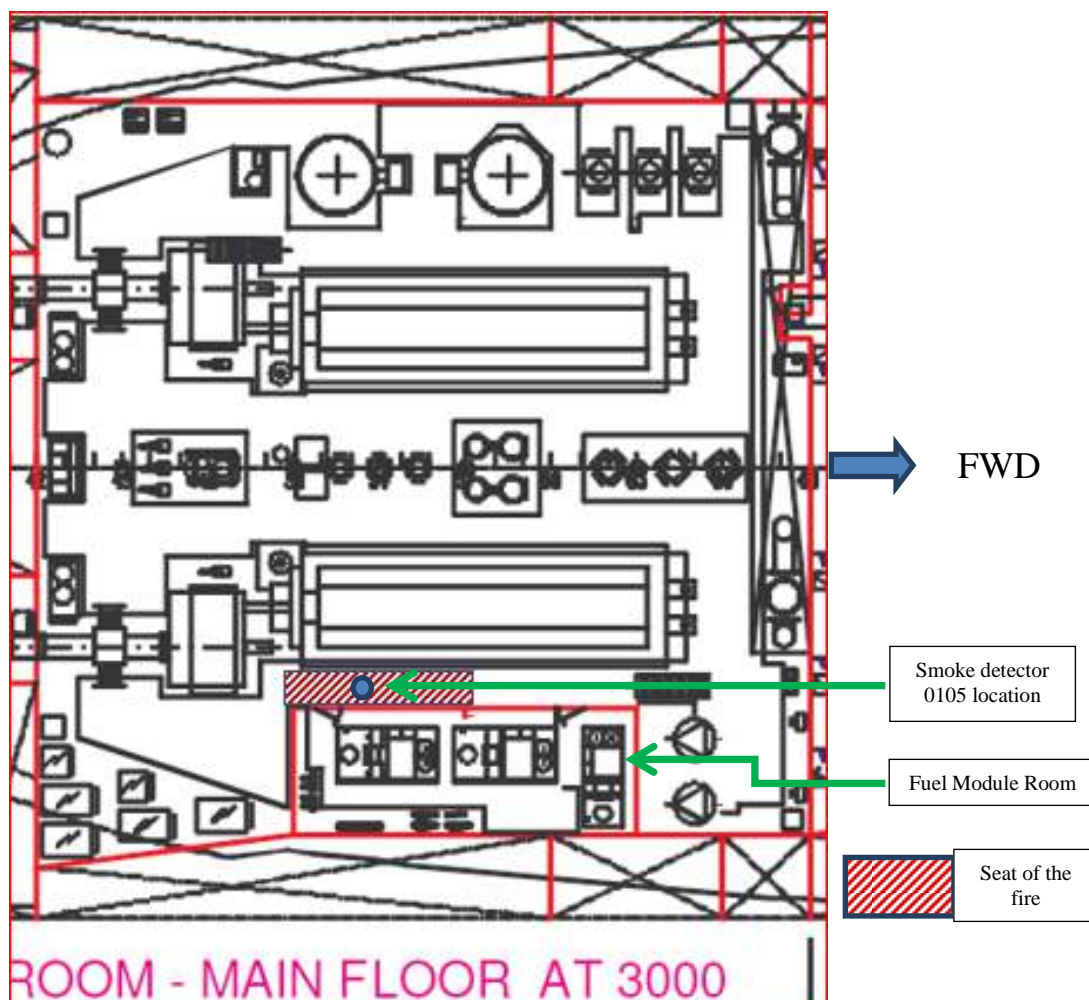
According to the fire alarm system's printer data, smoke detector 0105 (Figure 10) located on the starboard side of the starboard engine, above the main deck level, was the first smoke detector in the machinery space that was activated by the fire.

Figure 10: Seat of the fire on the main floor

The location of the seat of the fire⁷ was just outside the fuel oil modules room, on the main floor, in front of its aft access door (Figures 10 and 11). All fuel supply equipment to the engines such as pumps, heaters, fuel filters and gauges are in the modules room. Signs of heat and smoke damages were observed in the modules room, as well as in the separator room, indicating that these rooms were partly affected by flames, even though the seat of the fire was not within any of these rooms. This led the safety investigation to believe that at least one of the access doors to each of these rooms were open during the fire.

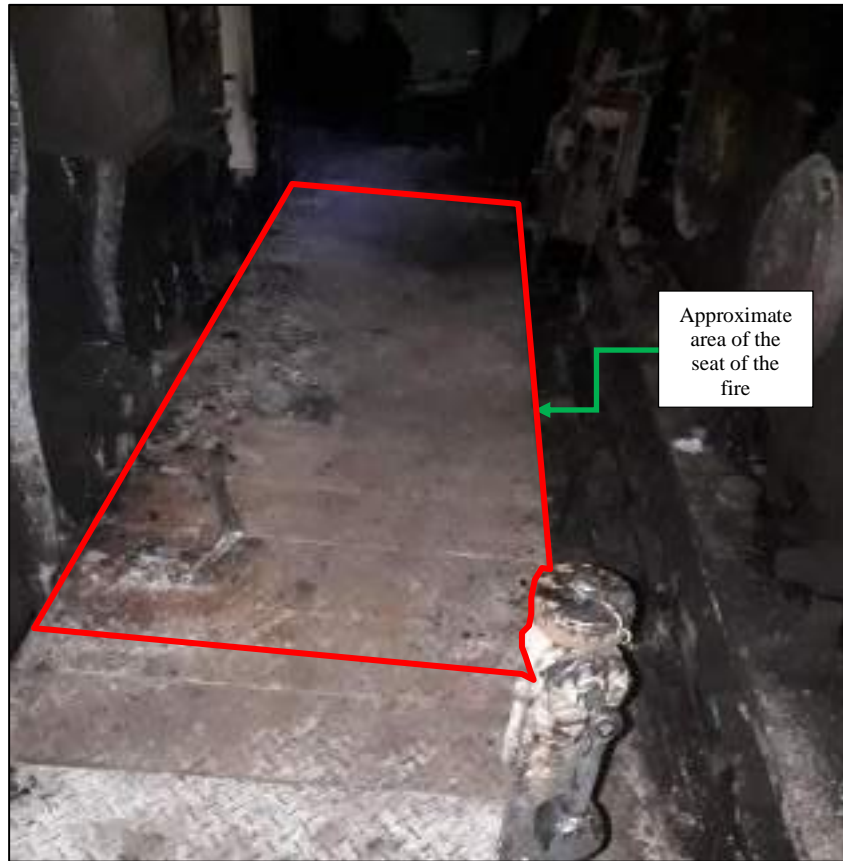
Figure 11: Seat of the fire on the main floor in the propulsion room

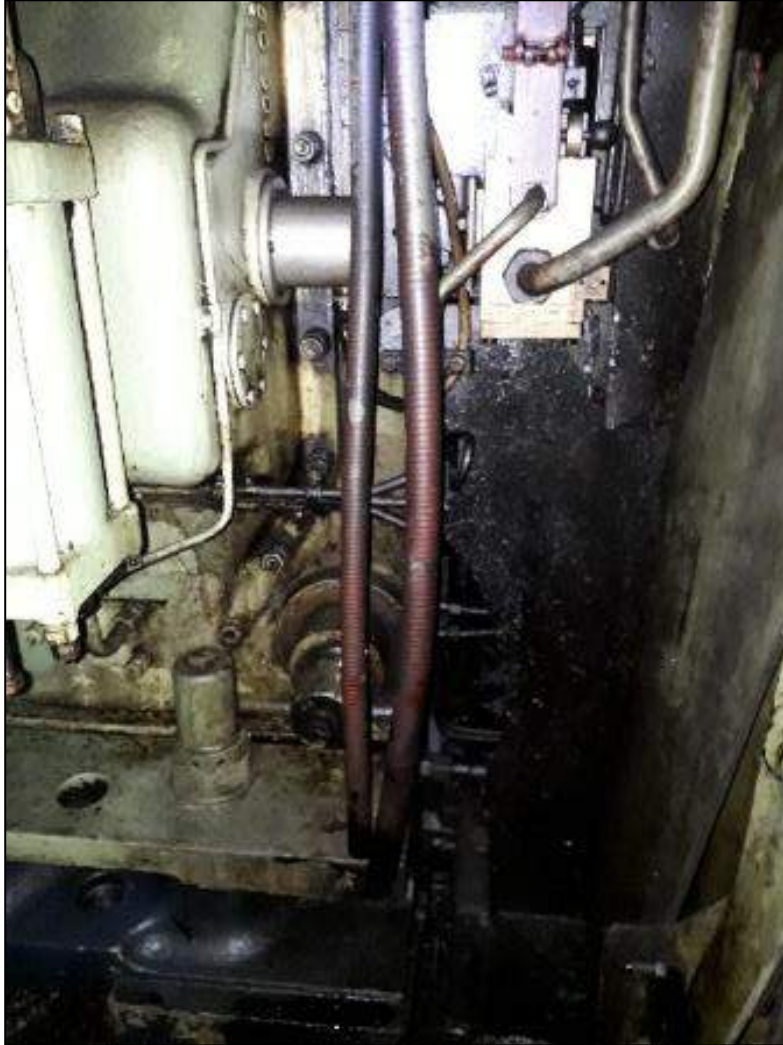
The safety investigation did not rule out that the fire spread due to the presence of combustible materials at and around the starboard propulsion engine, and in the bilges. The electrical cables at the aft of the starboard propulsion engine under the plates and in the bilges were found covered by PVC braided pipes, most probably to protect them from the oily water in the bilges. Some PVC braided pipes were used to direct leaked oil and fuel from the engine into the bilges or collection containers. A similar arrangement was used on the port side engine (Figure 12).

Figure 12: PVC braided pipes used to direct leaking oil from the port engine

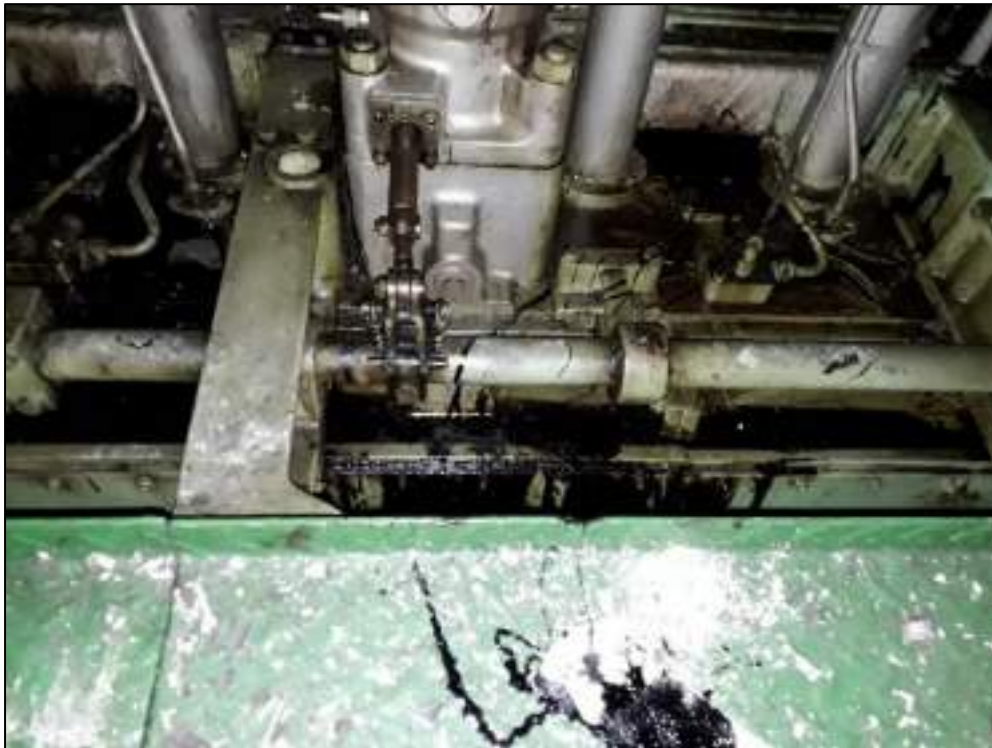
It was highly likely that the use of plastic materials, braided PVC and the leaked oil on and around the starboard propulsion engine (Figure 13) exasperated the situation and allowed the fire to develop further; in particular, a hanging plastic container which had been used on the aft/port side of the starboard engine, to collect the leaked fuel oil from the engine's fuel oil pumps.

Figure 13: Propulsion engine's fuel pumps tray showing leaked fuel

- .2 Combustible materials in the form of leaked fuel, leaked oil, braided PVC pipes (to direct the leaks), plastic containers to collect drained oils, oil in the bilges and the vicinity contributed to the propagation of the fire.

21/2020_R1 Provide guidance in the vessel's SMS on good housekeeping practices with reference to monitoring of oil leaks.

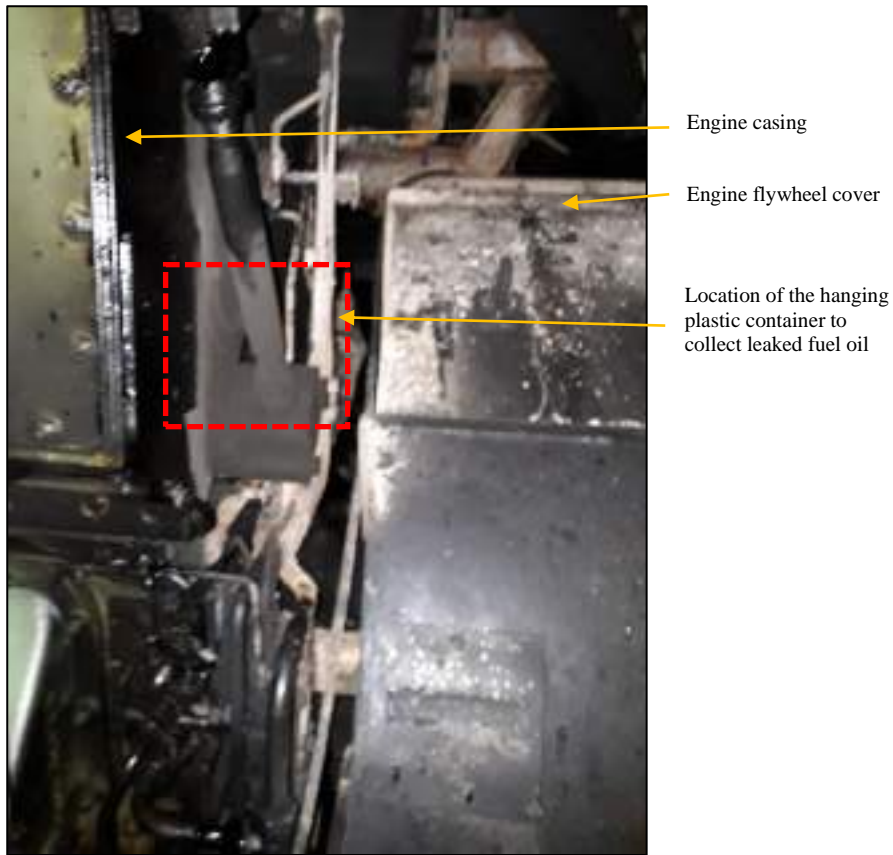
The safety investigation was also made aware of at least one plastic container, which was used to collect the starboard engine's fuel pumps' leaking fuel oil. This container, which is very common in many engine-rooms, was hanging on the aft/port side of the engine. It was clear that it had caught fire, as the bottom of the charred container was found in the bilge exactly below its original position.

Figure 14: Position of the plastic container for collecting leaked oil

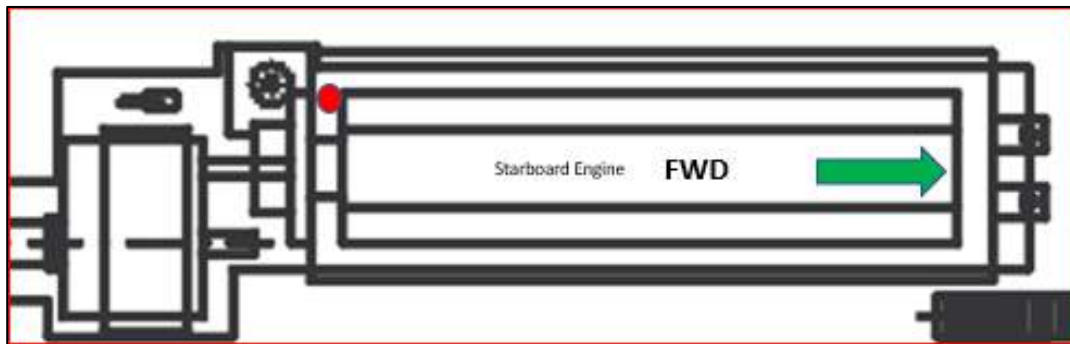
Figure 15: Red circle indicates the position of the plastic container in relation with the engine

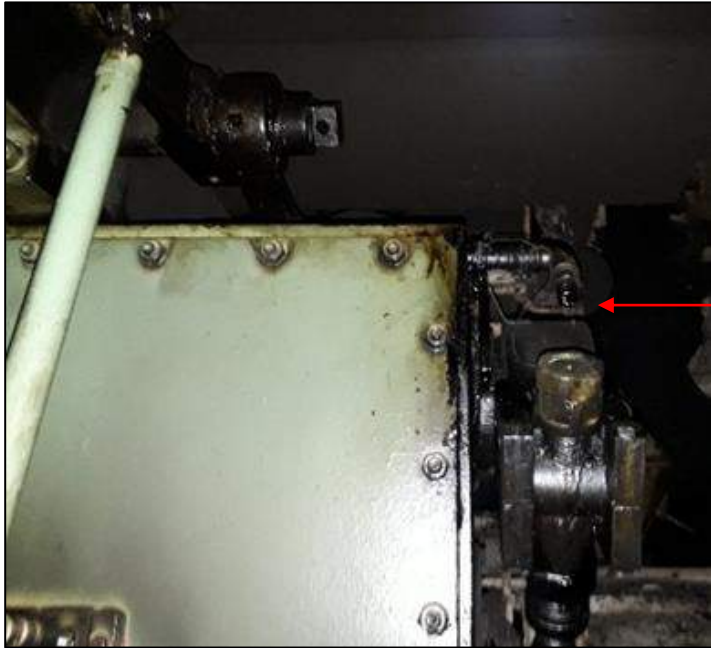
Although the seat of the fire was on the starboard side of the engine, the direction of the supply air flow (forward to aft) to the engine may have directed the flames towards the plastic container that contained the leaking oil from the main engine. The leaking oil was directed into the plastic container through a braided PVC pipe (Figure 16).

Fuel drainpipe.
The connected PVC pipe
had burnt and fallen during
the fire.

Figure 16: Starboard engine's leaked fuel drain position
