**REPUBLIC OF CYPRUS
MARINE ACCIDENT AND INCIDENT
INVESTIGATION COMMITTEE**

Investigation Report No 201A/2018

Very Serious Marine Casualty

**Fire, Explosion and Stranding of the Oil / Chemical Tanker
“ATHLOS” on 29/12/2018 off the Southern Coast of Cyprus**

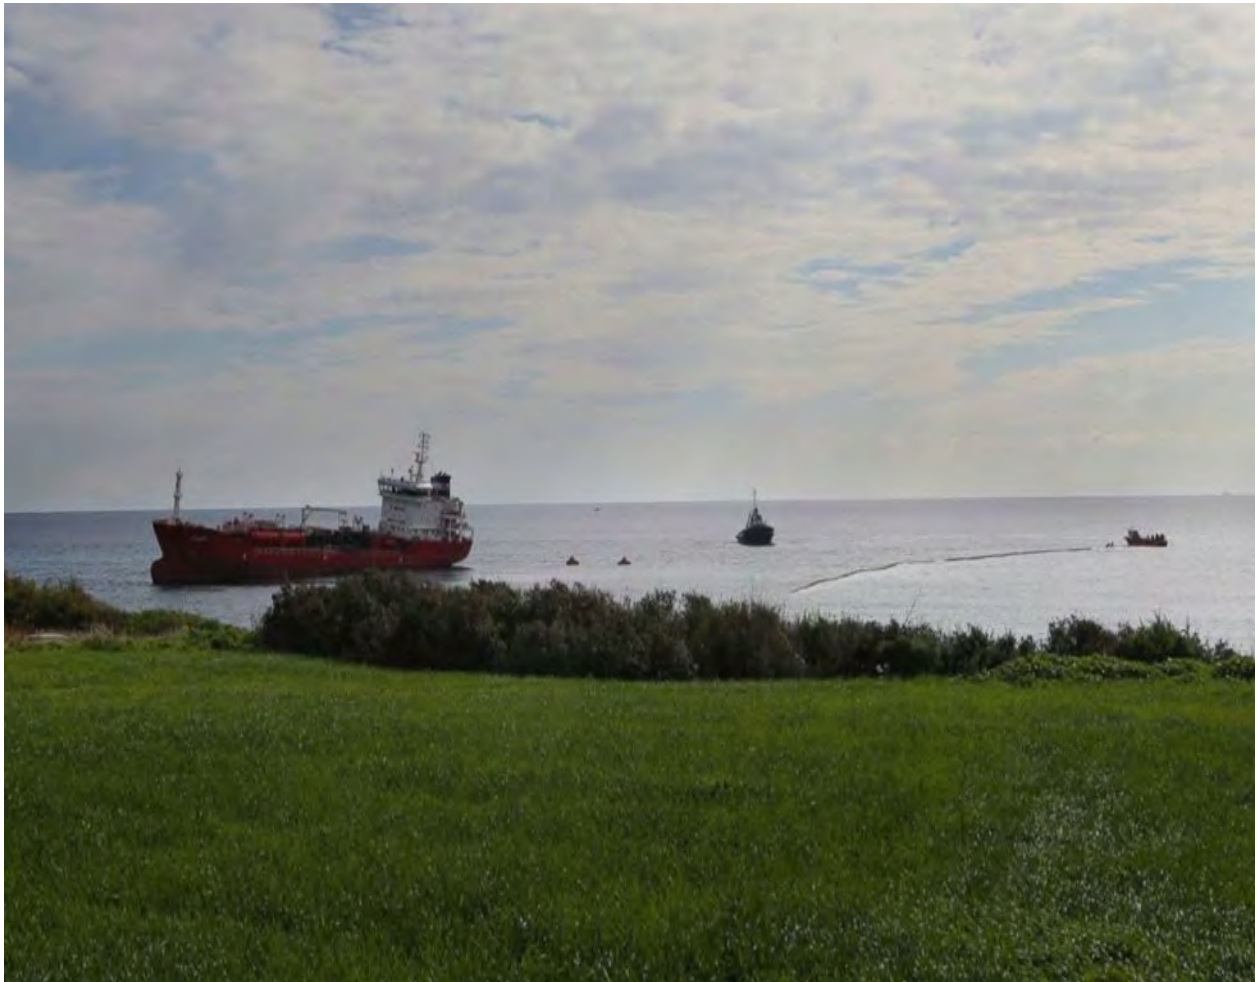
Vessel stranded 200m from shore, with 5 degrees list to port. Two Life-Rafts were thrown into the sea. An Oil-Collection Boom and a Tug-Boat standing by to contain potential pollution.

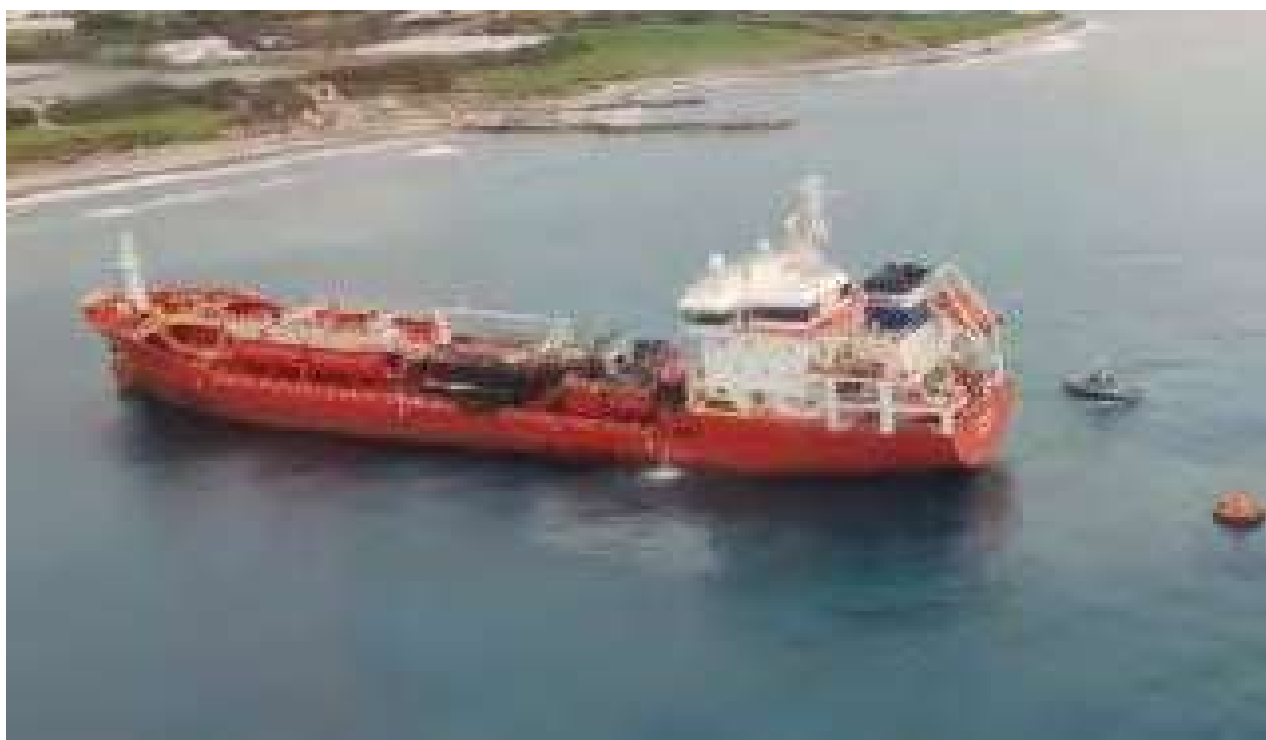
“ATHLOS” stranded 200m from the shore, with 5 degrees list to port.

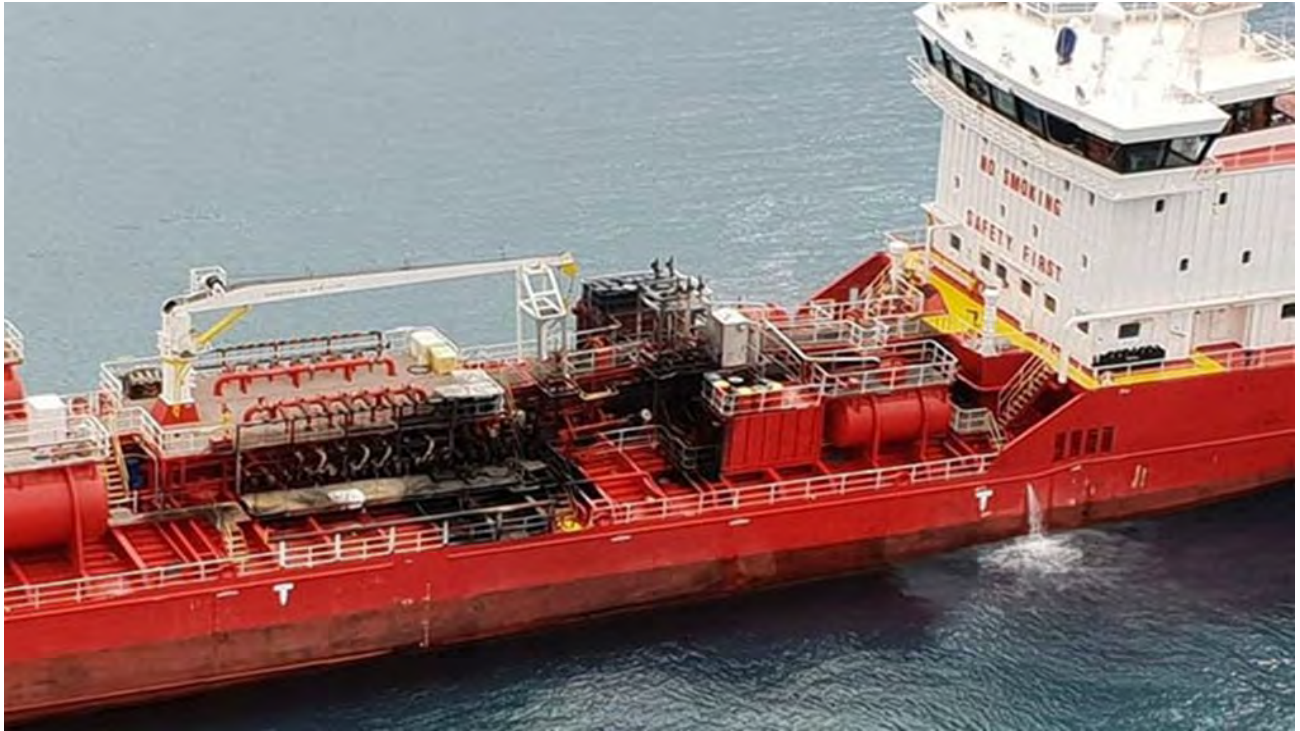
Hull Occasional Survey (Afloat and In-Water-Survey by Approved Divers), was carried out by Classification Society Bureau Veritas (BV), for the issue of a Certificate of Survey for a voyage in ballast to a repair facility at Limassol.

-Cargo oil tank No. 5 port/stbd side and adjacent Tanks 4 and 6 were damaged with corrugated bulkheads to have been severely damaged/partly collapsed.

-Main deck plating, in way of cargo holds 4- 6 port and stbd was severely damaged with holes and openings in various positions. Pippings, deck fittings and equipment also deformed and damaged. Main deck plating and transverse frames in way of tanks 5 and 6 stbd visibly buckled upwards.

-Deck longitudinals and transverse beams in way of Cargo oil tanks 4-5-6 port and stbd, were damaged, bend, partly detached and deformed, in various positions throughout the affected cargo tank top plating.

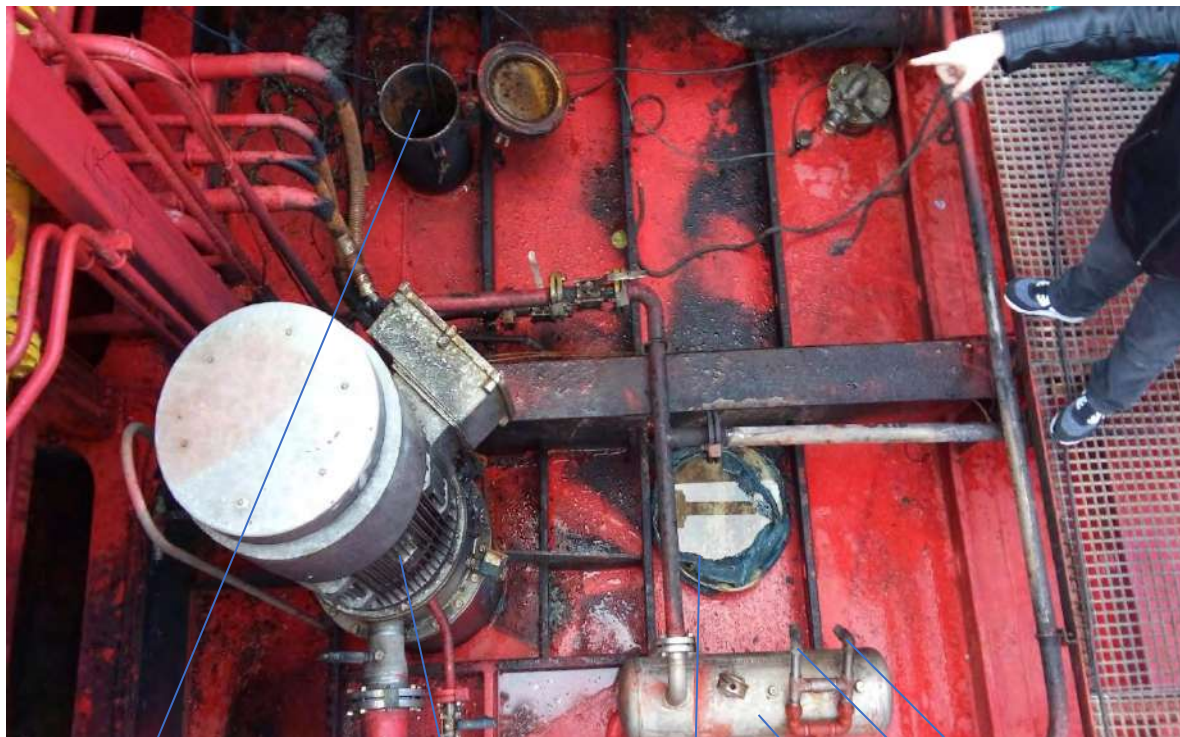
Sounding /Sighting Port

Cargo Pump

1)There is evidence that the initial fire was developed in the plastic bucket. It is unlikely that the adjacent cargo pump, provided the ignition source for the fire. The fire broke out, due to an accumulation of air /gas in the plastic bucket or from static electricity generated by the suspension of electrical continuity of the Ejector's de-aeration pipes.

2)The plastic bucket could not be grounded and presented another source of static electricity. When petrol is mixed with water /moisture which may existed in the plastic bucket, a static charge may have been generated between them.

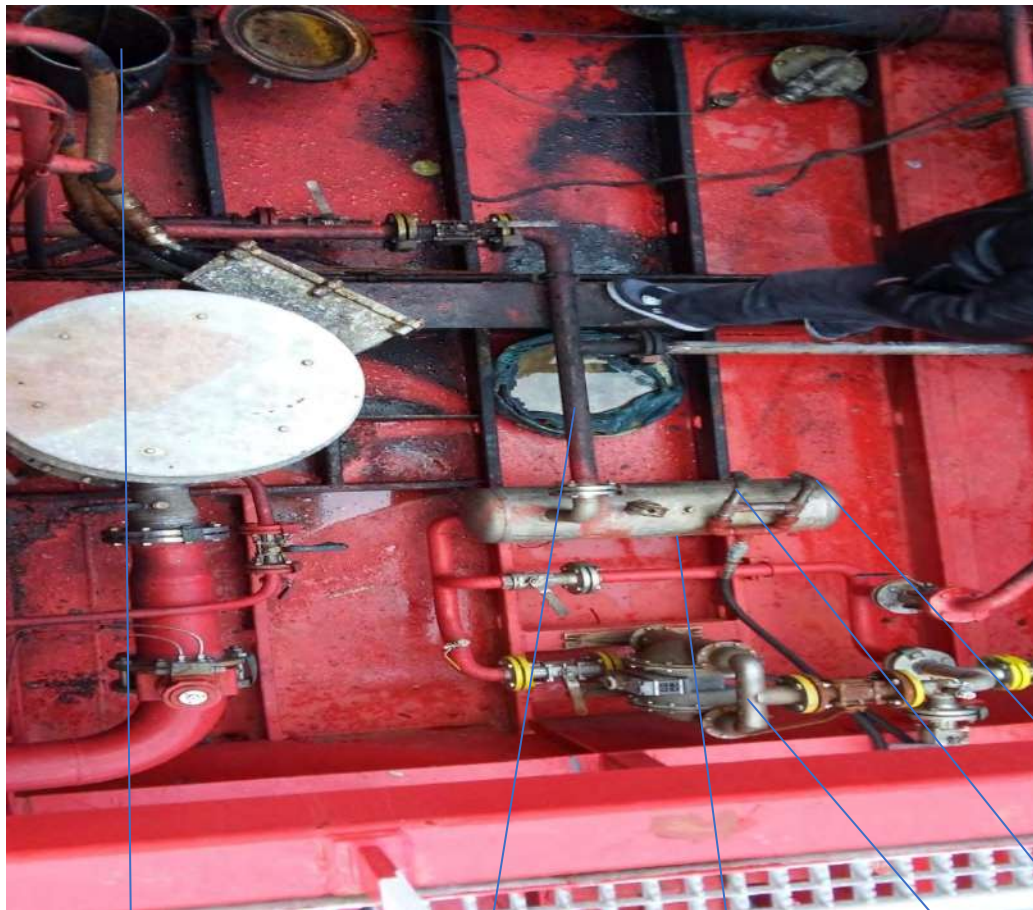
The inappropriate arrangement for the de-aeration of the Vacuum Ejector and the placement of inappropriate equipment (plastic bucket), in a hazardous environment, in the presence of hydrocarbons, of a tanker's cargo area was a contributing factor to the accident.

Sounding /Sighting Port Pipes

Plastic Bucket

Wilden Pump

De-Aeration
