SAFER SEAS DIGEST

2019

Lessons Learned *from* Marine
Accident Investigations

NTSB | National
Transportation
Safety Board

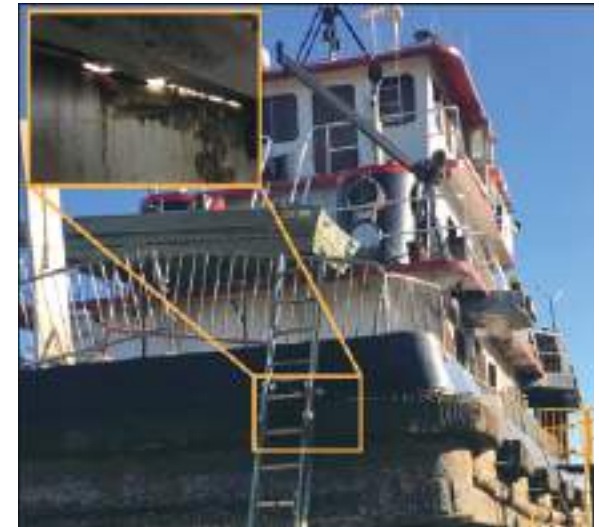
Prior to the sinking, the *Miss Roslyn* was in drydock in June 2017 for maintenance and repairs to the hull. However, on November 16, a marine surveyor found two wastage holes and a fractured weld seam at the main deck to the starboard steering void, which therefore was not watertight. The captain stated that he was assisting in making up a tow, which required him to push against the tow at a 90-degree angle to the bank for 2.5 to 3 hours. This action, in combination with the current, likely would have lowered and intermittently submerged the wastage and fracture holes on the starboard stern quarter (which were normally just above the waterline) and allowed continuous water ingress to the starboard steering void for about 3 hours. As the *Miss Roslyn* got under way to head back for crew change, the aft steering void would have been partially flooded, which likely caused the observed starboard list. Once the hull flooded, the vessel sank lower, increasing the rate of flooding through the holes to the starboard steering void, thus increasing the starboard heel and submerging the starboard bulwark and then the stern deck. Eventually, the port flanking void flooded, resulting

The severe wastage found throughout the vessel in the postaccident survey indicates that the *Miss Roslyn* was poorly maintained, so holes in and fractures to the hull and deck went undetected and ultimately led to flooding. An effective maintenance program would have prevented the holes from forming and made identification of hull fractures easier to see and flag for repair, or helped to determine when the vessel had outlived its useful service life.

The probable cause of the capsizing of the *Miss Roslyn* was the company's lack of effective hull inspection and maintenance program, which resulted in flooding into a steering void through multiple wastage holes in the hull.

Figure 10. The orange outline approximate location of a large hole along the seam between the *Miss Roslyn*'s starboard steering void and aft main deck; the hole is shown in the inset image.

To protect vessels and the environment, it is good marine practice for owners to conduct regular oversight and maintenance of hulls, including between drydock periods. Regardless of inspection requirements, owners are obligated to ensure vessels are properly maintained, equipped, and operated in a safe condition. Issues with watertight integrity and wastage need to be addressed by permanent means.

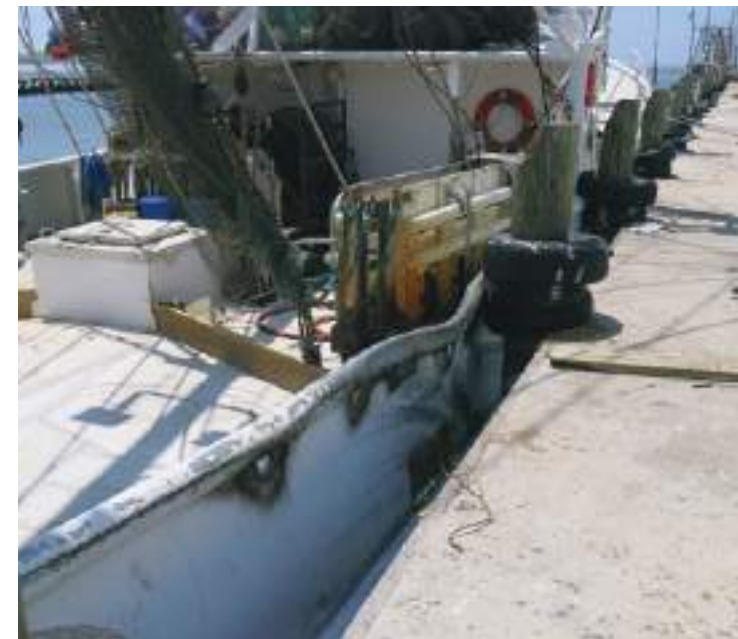
Figure 24. The starboard (damaged) side of *Lady Toni*.

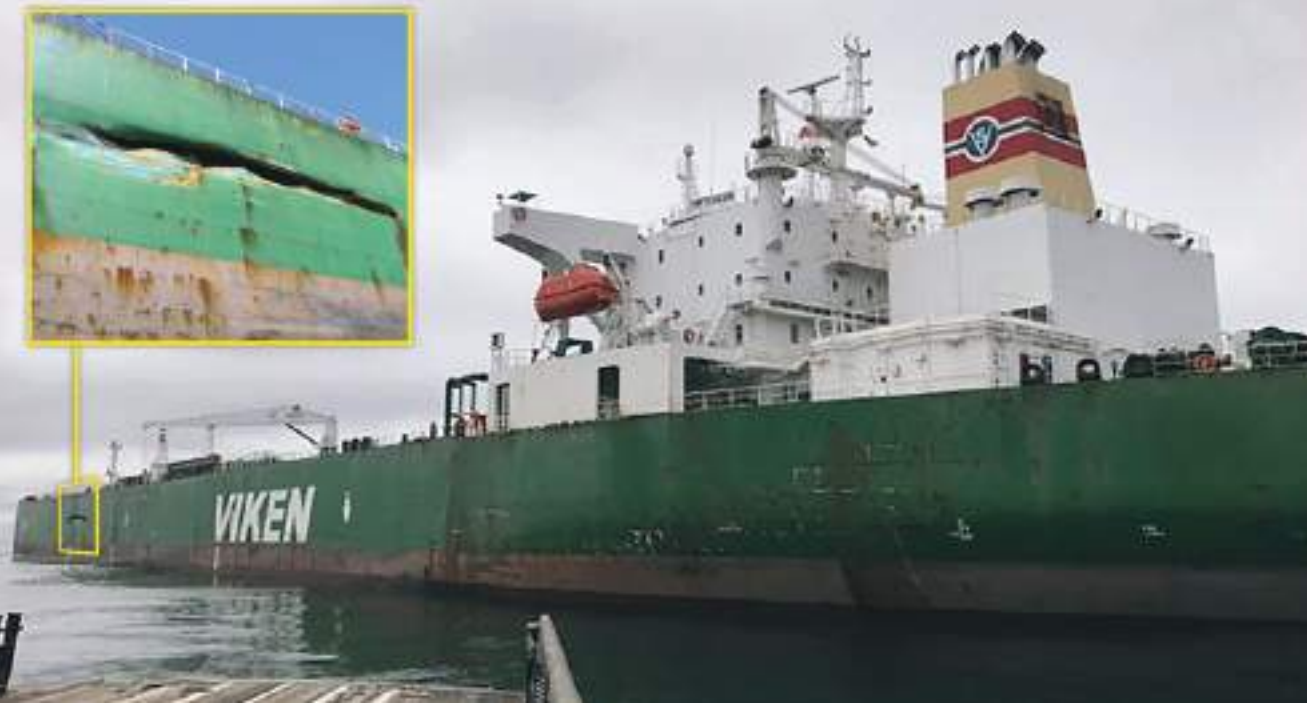
Figure 29. Main damage area of hull of *Tofteviken*.

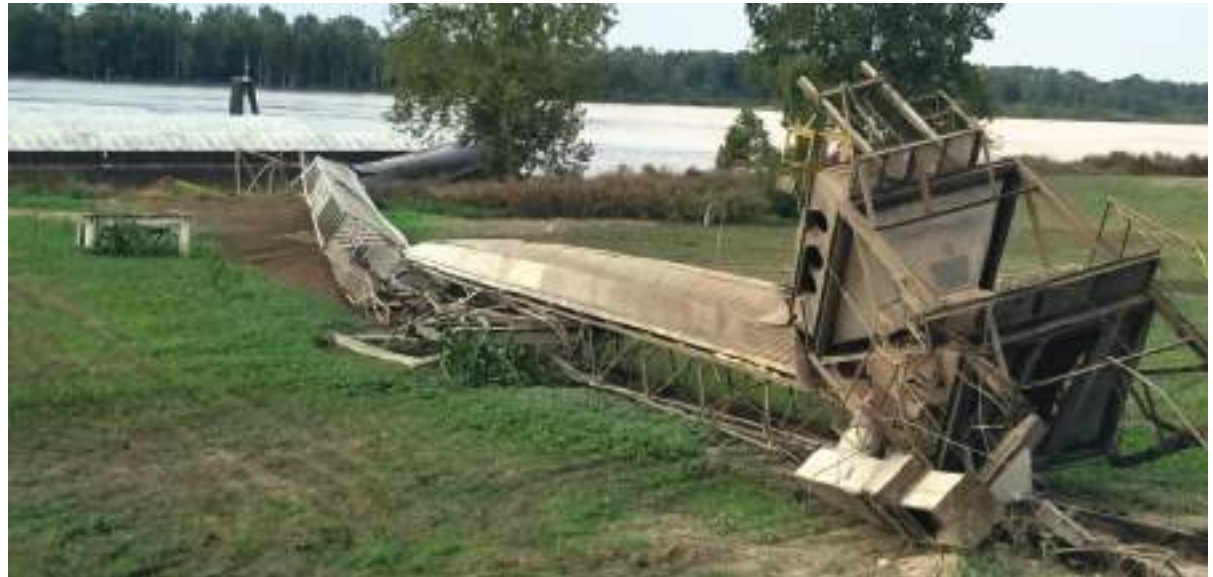
Figure 45. Damaged conveyor as seen from the bank looking toward the river.

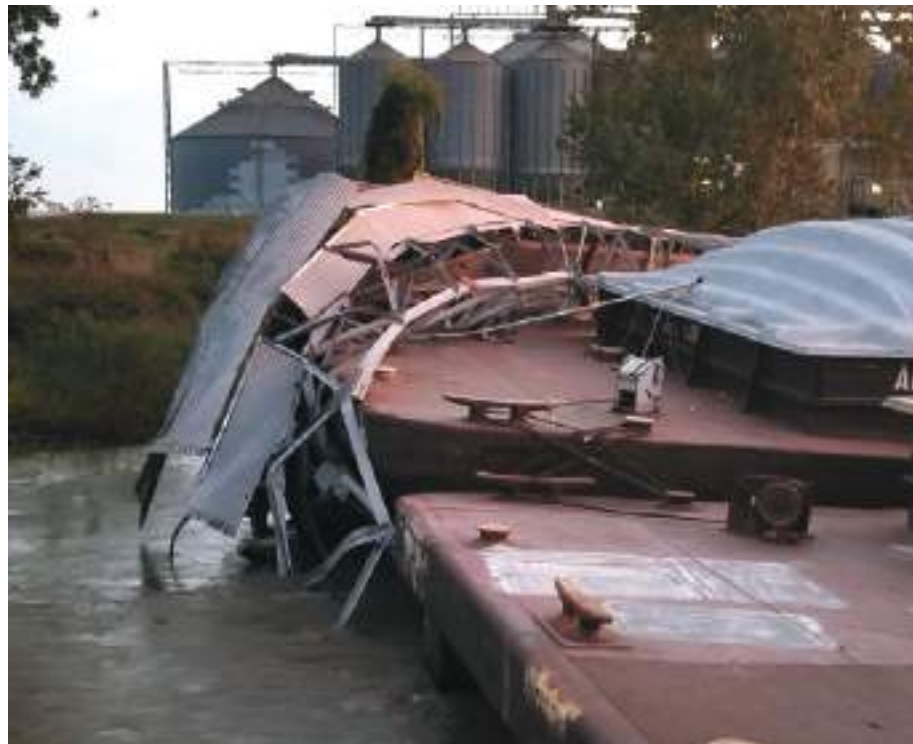
Figure 46. Damaged conveyor and catwalk laying across the forward deck of barge ART 44160. The Farmers Grain Terminal can be seen in the background.

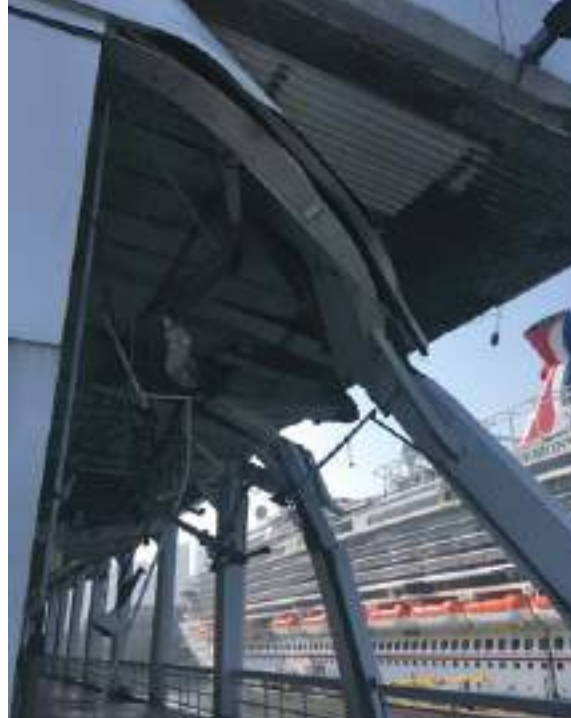
Figure 56. Structural damage to Pier 90's parking garage.

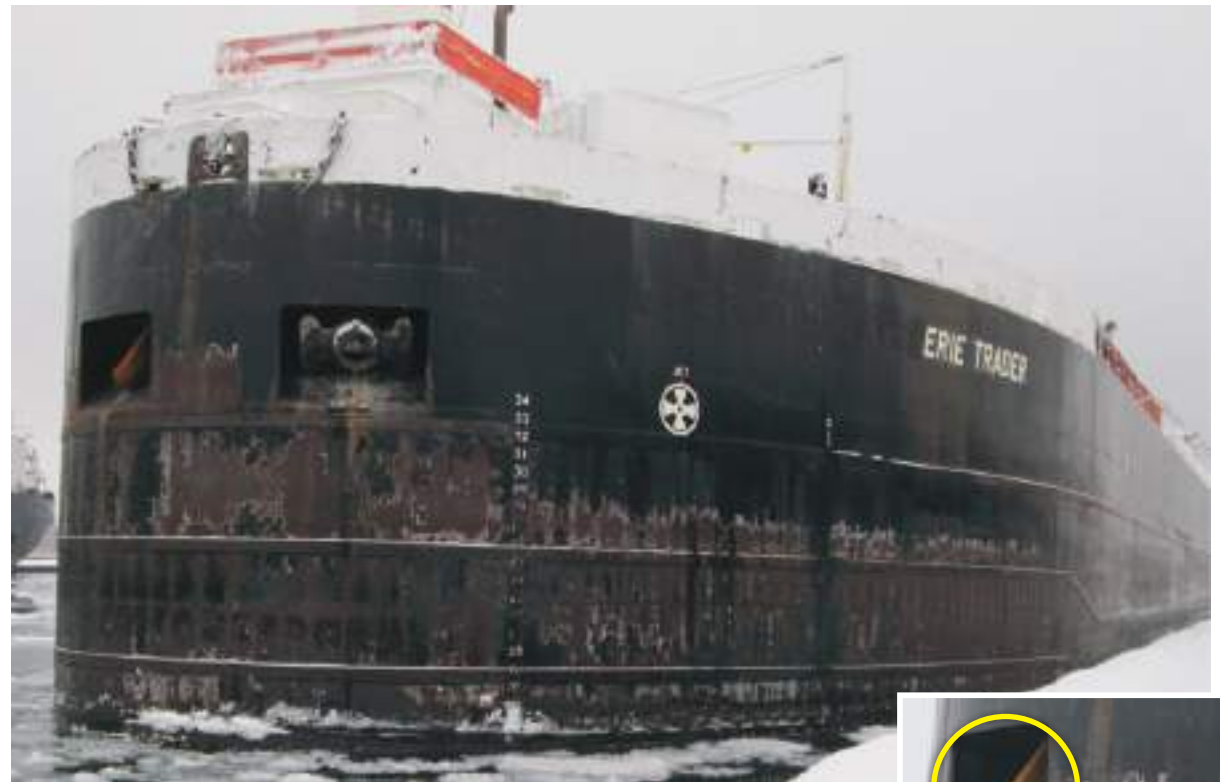
Figure 60. The bow of barge *Erie Trader* after the accident. At right: the remnant shank of the starboard anchor in the anchor pocket is highlighted. SOURCE: COAST GUARD

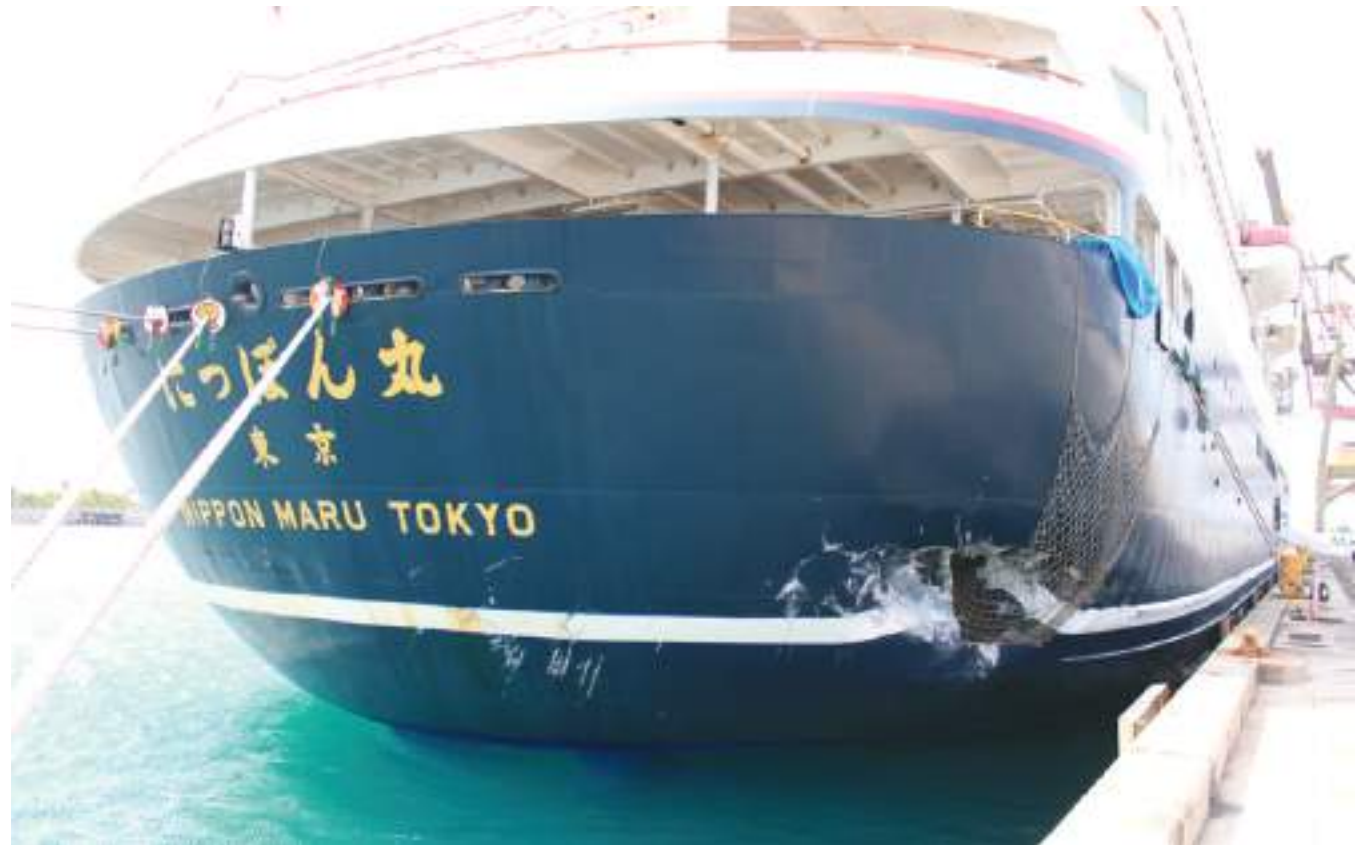
Figure 62. Starboard side of the stern of the *Nippon Maru* shows the damage to the ship.

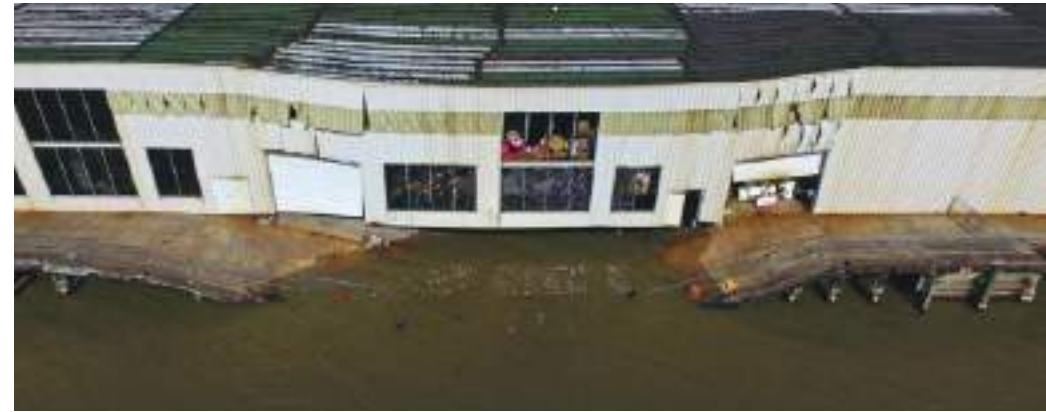
Figure 71. Damage to the Mardi Gras World warehouse and wharf. SOURCE: COAST GUARD

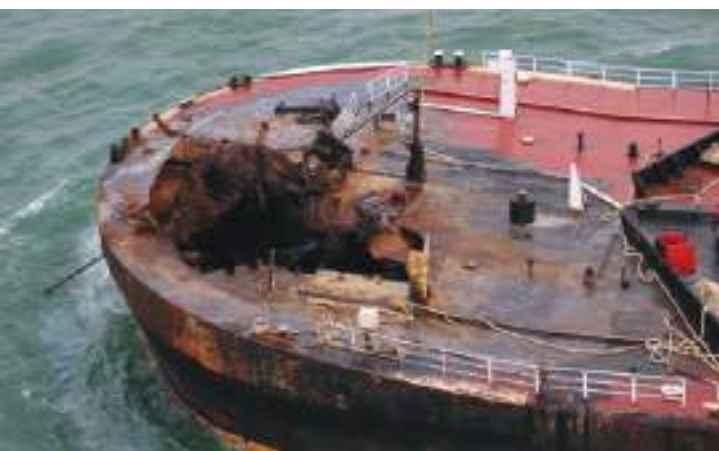
Figure 74. Explosion and fire damage to port bow of **B. No. 255**. SOURCE: COAST GUARD

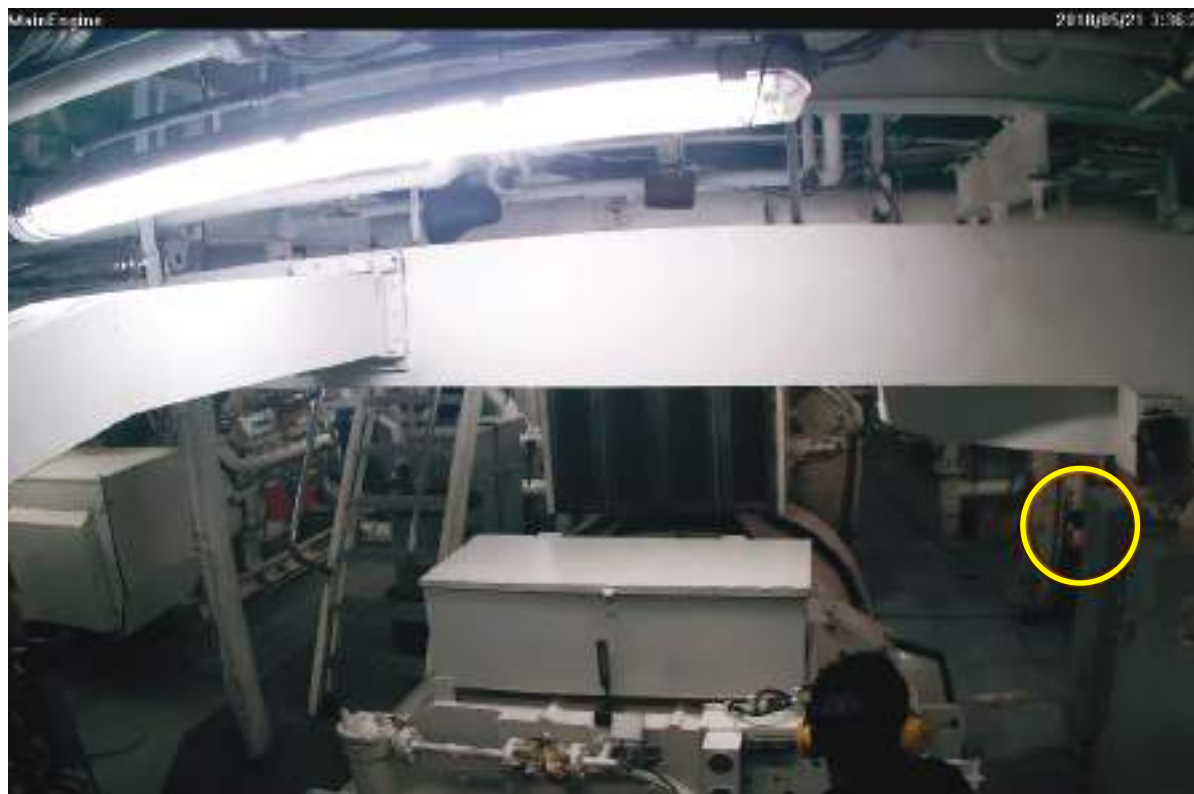
Figure 79. Screenshot from the closed-circuit television camera in the lower engine room, looking forward. The initial fire began in the area overlaid by a yellow circle (starboard side). SOURCE: COAST GUARD

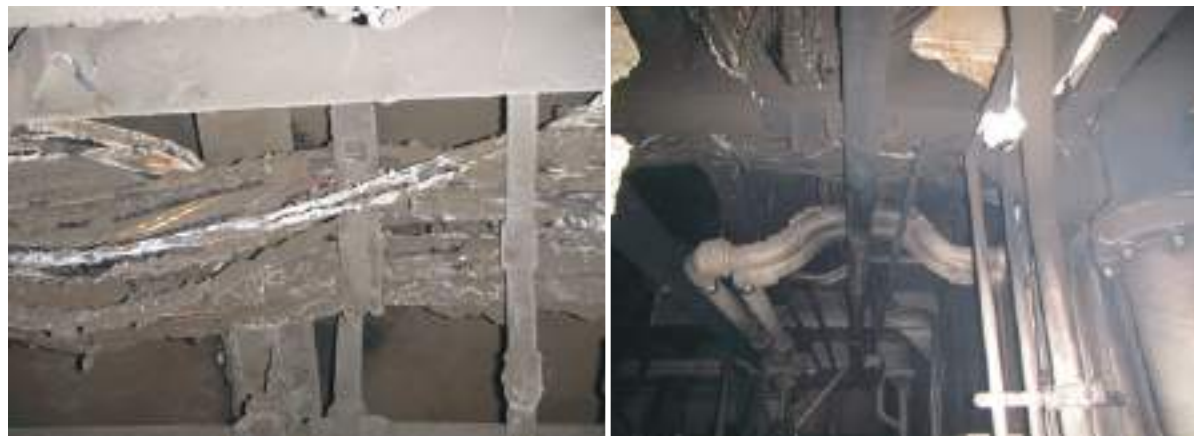
Figure 80. Left: Electrical cabling above generator no. 2. Right: Smoke and heat damage in the overhead of the starboard forward corner of the lower engine room. SOURCE: COAST GUARD

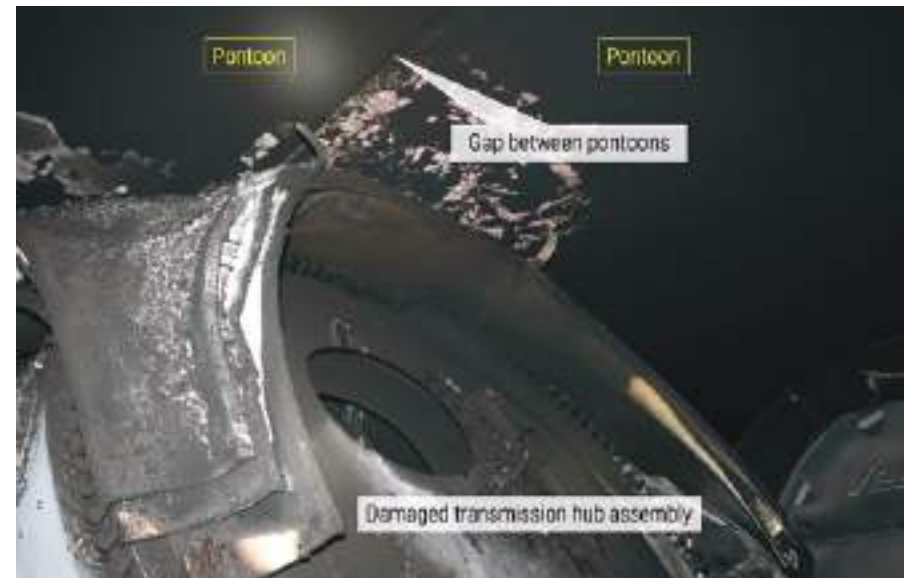
Figure 84. Fire damage to transmission hub in cargo hold no. 3 aboard *Chipolbrok Moon* directly below gap between pontoons. SOURCE: HOUSTON FIRE MARSHAL

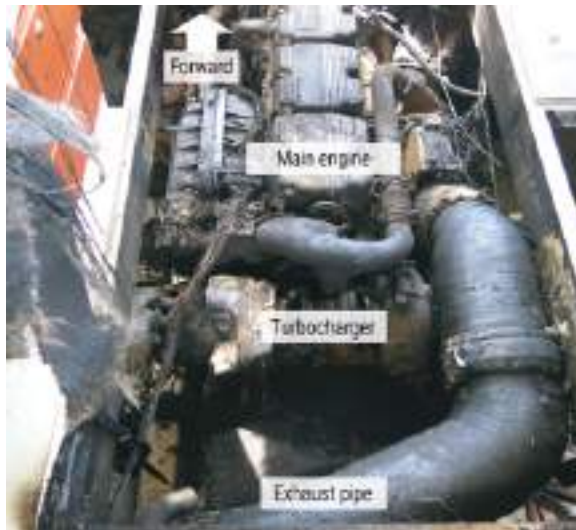
Figure 91. Damage to the engine as seen from above. Right: Damaged exhaust tubing after removal from engine room.

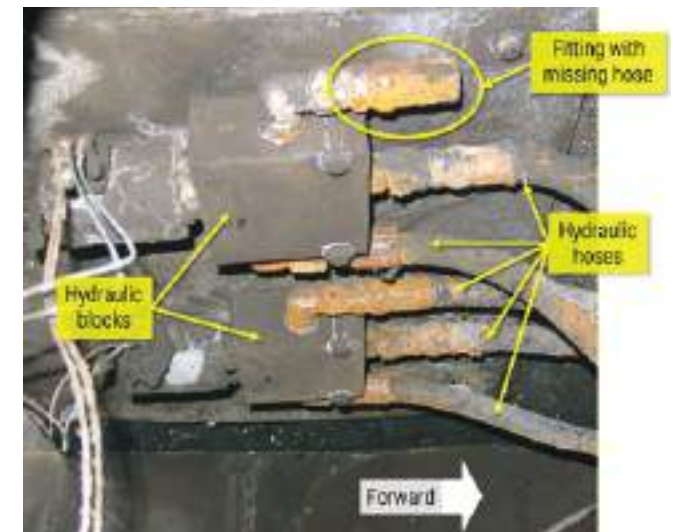
Figure 92. Hydraulic block with parted hose fitting, circled in yellow.

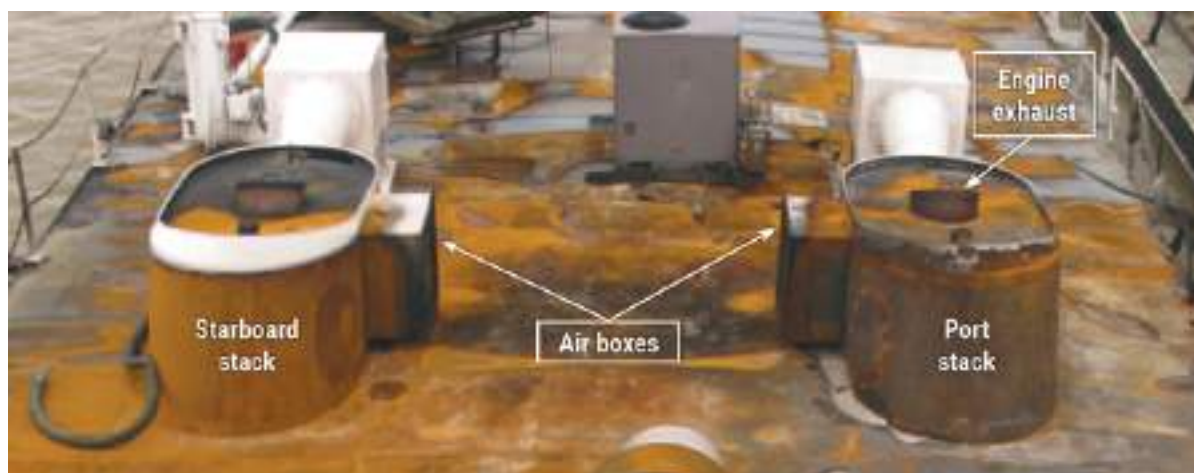
Figure 109. Looking aft at stacks and air boxes post-fire.

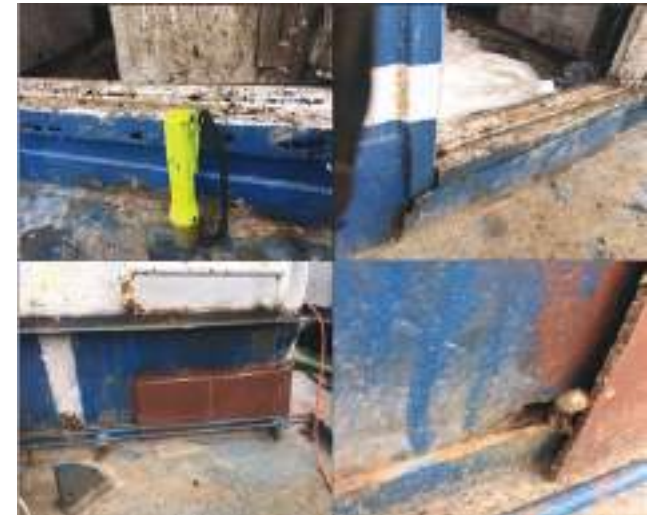
Figure 131. Wastage and doubler plates as found on *Ms Nancy C* deckhouse. Top left: doubler plate over wastage below starboard engine room entrance. Top right: doubler plate over wastage below port engine room entrance. Bottom left: doubler plates over wastage on starboard aft deckhouse. Bottom right: close-up of starboard aft doubler plate showing gap between plate and wastage area.

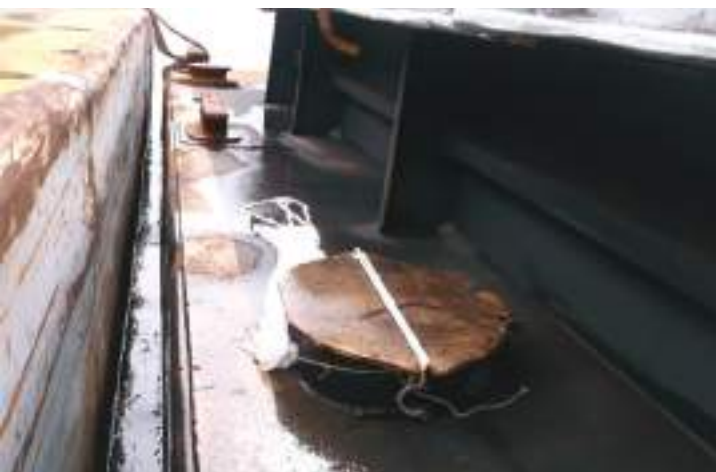
Figure 135. Postaccident views of a manhole cover on the *PTC 625* is in poor condition, with missing dogs, and strapped down with line.

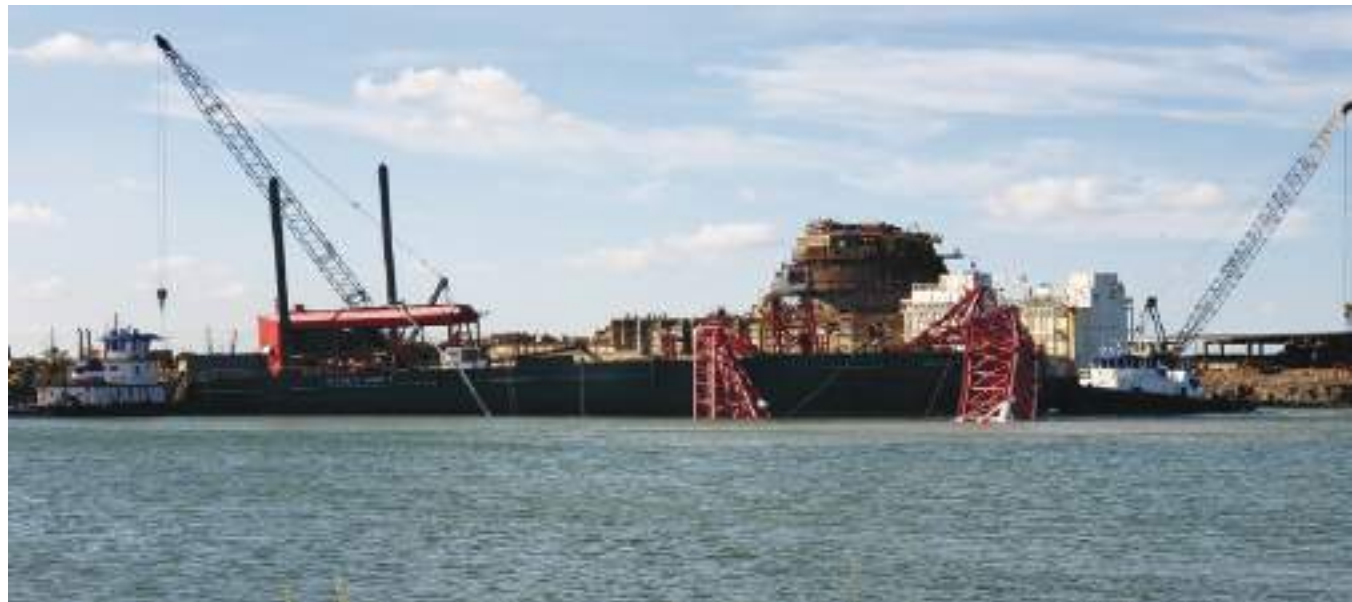
Figure 153. Collapsed crane boom on *Atlantic Giant II*. In background are *TOPS DB1* and *BOABARGE 29*.

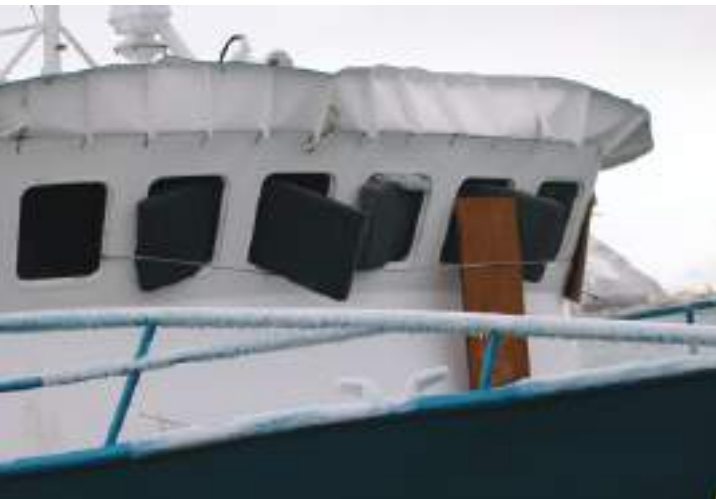
Figure 157. Wheelhouse damage and missing windows on the *Progress*.
