SAFETY INVESTIGATION REPORT

REPORT NO.: 01/2021

MV STARA PLANINA **Two manoverboards** **in position 66° 05.0' N 005° 26.3' E,** **02 January 2020**

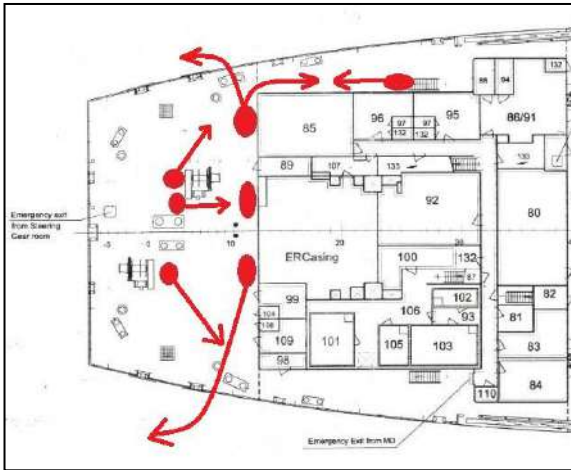
At around 1000, on 02 January 2020, the second engineer observed loose mooring ropes around the poop deck, with some dangling over the vessel's guard rails (Figure 2). He immediately notified the third officer, who was keeping a navigational watch on the bridge, via telephone.

Figure 2: Poop deck. Red dots indicate the stowed position of the mooring ropes. The arrows indicate the direction that the mooring ropes were scattered

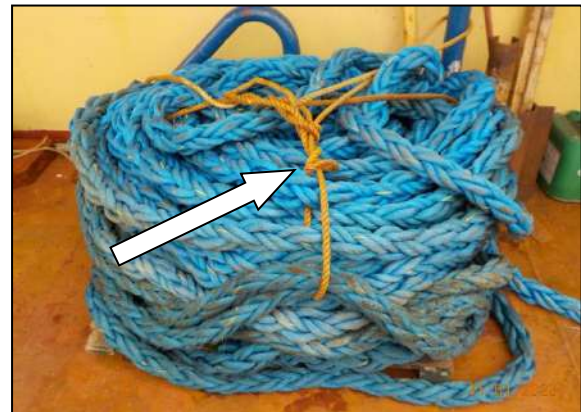
Figure 3: One of the mooring ropes on the poop deck, secured on a pallet and an adjacent fitting

The mooring ropes were secured on pallets, using two smaller ropes, and crossed and wound around a fixed structure. It was noted that the smaller ropes did not secure the mooring rope in its entirety, but only the topmost coils (Figure 3).

This procedure may have sufficed in fair weather conditions, when the movements of the vessel would have been limited. However, considering the rolling and pitching movements of the vessel in inclement weather, coupled with the wash of the waves over the poop deck from time to time, may have led to the bottom coils of the mooring ropes to slip out of the securing and scatter around the deck.

It appeared that the approach applied to secure the aft mooring ropes, did not suffice to prevent the mooring ropes from scattering around the poop deck and over the rails in the encountered adverse weather conditions.

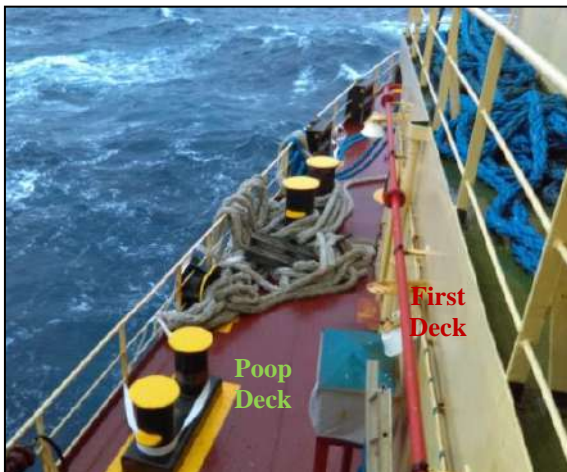
At around 1100, two ABs and the deck trainee arrived on the first deck to assist. The operation moved to the starboard side and, at one point, the deck trainee was seen on the poop deck assisting the chief officer. As the crew could not untangle two of the mooring ropes on the starboard side, the crew members secured them to the guard rails of the poop and first decks (Figure 4).

Figure 4: Situation on starboard side, two ropes secured to the railings of the poop deck, while the end of one of the ropes was hauled onto the first deck

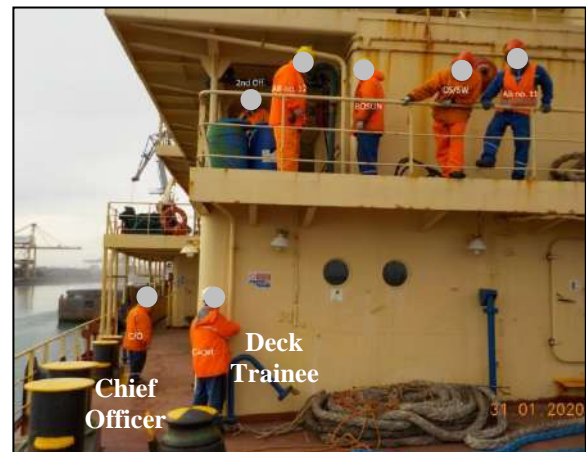
The crew reported that at this moment, a large wave suddenly washed over the poop deck from starboard to port sides. Unexpectedly, a second larger wave washed on board from the same direction and within seconds of the first one. Both the chief officer and the deck trainee were swept overboard. Figure 5 shows the position of the crew members at the time of the accident.

Figure 5: Simulation of the crew's location when the waves washed over the poop deck

Two consecutive, unexpected large waves (the second one reportedly larger than the first), washed over the poop deck where the chief officer and the deck trainee were located. Reportedly, both crew members were not secured to the vessel, given that the securing operation of the mooring ropes had been completed.

The safety investigation hypothesized that a sudden roll of the vessel was possibly induced by the waves. Furthermore, the force of the wave itself may have been too strong for the chief officer and the deck trainee to react, leading to their fall overboard.

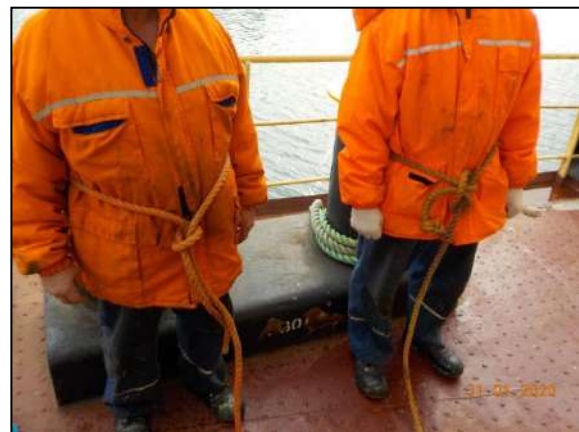
and the deck trainee had ropes tied around their waists (Figure 6). Most of the crew members could not confirm whether the other end of their rope was secured to the vessel during the recovery of the mooring ropes. One of the crew members stated that the rope was not secured to any part of the vessel, as the other end was noticed lying free on deck. Another crew member stated that the chief officer and the deck trainee were tied together with the same rope.

However, all crew members confirmed that when the two large waves washed over the poop deck, both the chief officer and the deck trainee were not secured to any part of the vessel⁶

Figure 6: Simulation of how the rope was tied around the chief officer's and deck trainee's waists

The crew used ropes around their waists. Although the plan to secure oneself had been put in practice, this did not provide the necessary protection to the two crew members. A fall of a crew member from a height, while being secured with a rope, would result in internal/external injuries in the abdominal region and back. A safety harness is designed to prevent such injuries¹³.
