SAFETY INVESTIGATION REPORT

REPORT NO.: 03/2021

MT VALTAMED **Fatality in the pump room** **at Ceyhan OPL Anchorage, Turkey,** **in position 36° 20.6' N 035° 09.66' E** **03 February 2020**

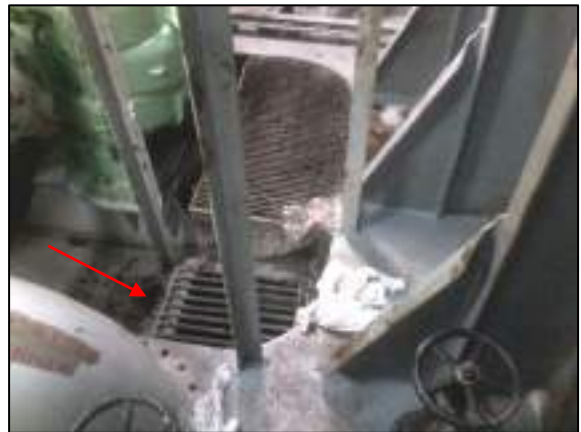
Figure 6a: Access manhole for starboard side bilge alarm sensor (red arrow)

The starboard side sensor was located within a more confined area. This area was surrounded by the pump room's bottom floor above, the keel below, and strengthening structural members, in the form of steel plates with lightening holes which allowed access through them, on its sides (Figure 2).

To access the starboard sensor, crew members had to go down below the lowest gratings (Figures 5), access a manhole (Figures 6a and 6b) of about 2.0 m depth and

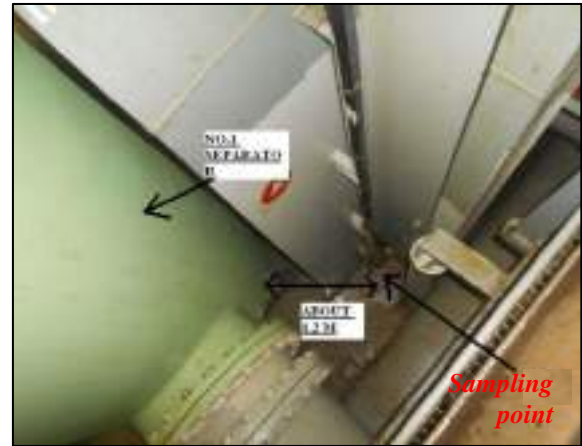
Figure 10: Location of LEL and H₂S sampling point

The H₂S sampling point was located 4.5 m to the port side of the access manhole to the starboard side bilge alarm sensor.

4. The pump man was found by a rescue team in the pump room's starboard bilge space, without vital signs, after he did not respond to repeated calls from the CCR.
5. The pump man was conducting tests on the pump room's bilge alarms when the accident occurred.
6. The pump room's fixed gas detection system alarms did not activate at any point in time surrounding the accident.
7. It is likely that the effectiveness of the system was compromised by the distance (4.5 m) between the starboard bilge alarm sensor and the nearest sampling suction point.

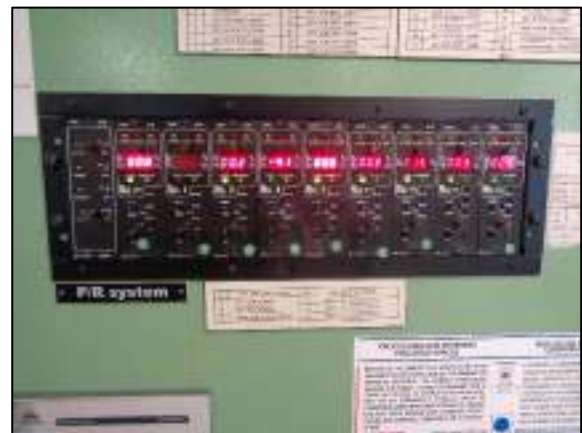
Figure 11: Display panel of the fixed gas detections system

This system was last maintained for checks and calibration by a shore service provider on 27 September 2019. During the calibration procedure, it was observed that the hydrocarbon samples extracted from above the lowest gratings and the pump room bottom, on the port side could not be set to match the contents of the calibration gas used. The same was noticed for the H₂S

samples extracted from the pump room bottom on the starboard side. Furthermore, a smell of the calibration gas was detected, indicating a possible leak in the system. The attending service technicians had recommended retrofitting a new system since the one on board was considered obsolete.

The safety investigation was unable to determine whether there were multiple reasons for the gas not being detected. To this effect, it was not possible to confirm whether the issues noted during the checks and calibration of the pump room's fixed gas detection system could have contributed to the inactivation of the system alarm.

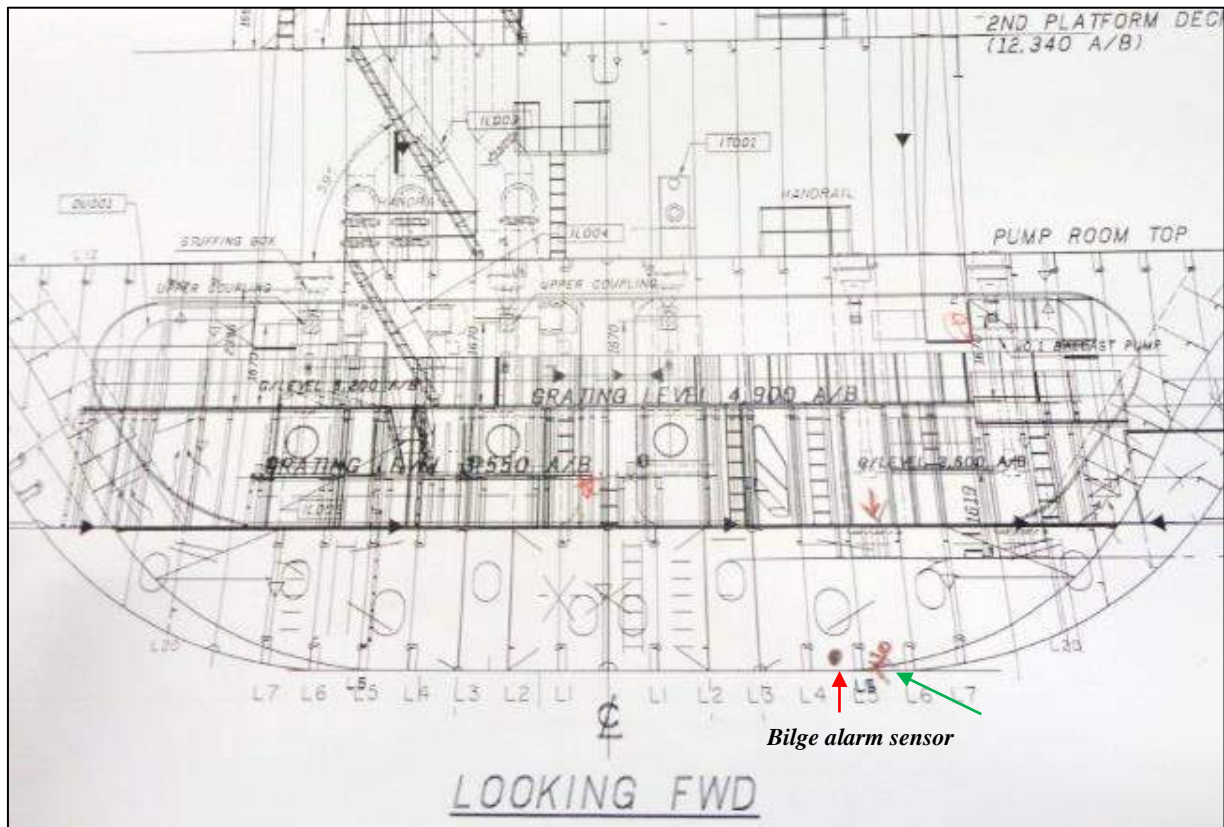
Figure 14: Location where the fatally injured pump man was found (green arrow)

On looking closer, they saw that the pump man lying in the bilge (Figure 14) with his helmet off. They also observed a small amount of oily water in the bilge.

Reportedly, post-accident atmosphere checks of the bilge area where the pump man was found, returned H₂S readings between 2 ppm and 20 ppm, although H₂S levels read zero just above the space. These checks were conducted by the Company after the vessel berthed. No other gases, besides 20.9% of O₂, were detected during these checks.

during the warming-up of the steam-driven stripping pump, resulted in accumulation of a small quantity of oily water in the starboard bilge space. It is possible that this oily water may have caused the pump man to slip, struck his head and fall unconscious while attempting to exit the space.

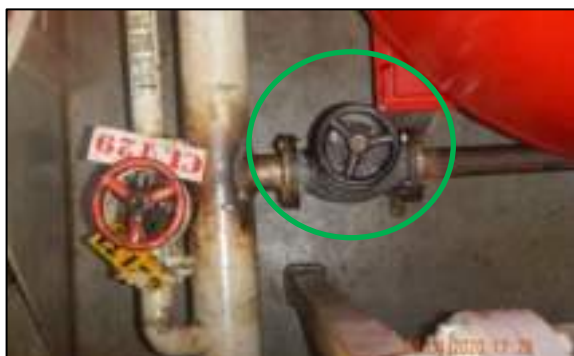
Figure 15: Suction valve (circled in green) of the starboard bilge of the pump room

Following the accident, further investigations revealed a small quantity (approximately 4.0 cm in depth) of an oily-water mixture in the vicinity of the starboard bilge alarm sensor. The source of the oil component of the mixture, was observed to have been a small leak in the suction valve of the bilge space (Figure 15).

The leak was found after Company personnel conducted a pressure test on this valve, while trying to investigate the source of the leak. The water reportedly originated from drain valves of the steam-driven stripping pump, which were drained during the warming-up of the pump at the time of cargo unloading operations.

5. All valves on the stripping pump suction line and the suction valves of the pump room bilges were overhauled and pressure tested.
6. The arrangement for stripping the AUS drain tank was modified to eliminate the risk of accidental contamination of the bilge spaces by cargo residue and vapours (Figures 19 and 20).

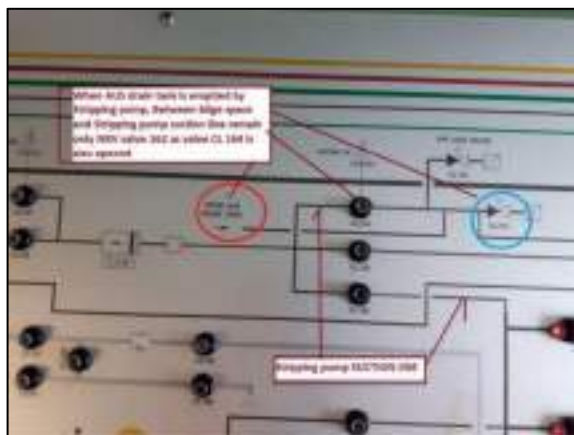
Figure 16: Location of the pump room's starboard bilge suction valve (circled in blue)

This valve was of the non-return type and was connected to the line used for stripping off the contents of the automatic unloading system's (AUS)⁵ drain tank (Figure 16).
