SAFETY INVESTIGATION REPORT

REPORT NO.: 07/2021

MV CROATIA
Cargo explosion
in position 03° 38.7' N 105° 37.7' E
23 February 2020

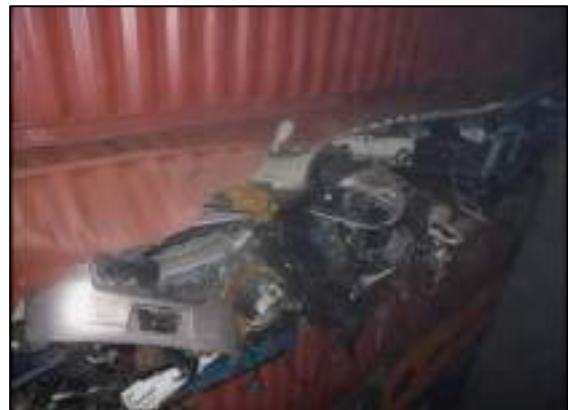
Once inside the cargo hold, the fire-fighting team found that one container had explosion damages (Figure 2), but no active fire was raging. Debris from the container was seen lying in various locations of the cargo hold (Figure 3). The fire-fighting team also reported that five other containers were partially damaged and that some of the vessel's fittings had been affected.

Figure 2: The exploded container in the cargo hold

Evidence submitted to the MSIU revealed that the container stowed in position 500612 had sustained substantial internal overpressure and one of its side walls and the door-leaves had been blown off. Reportedly, the container was loaded with used auto parts.

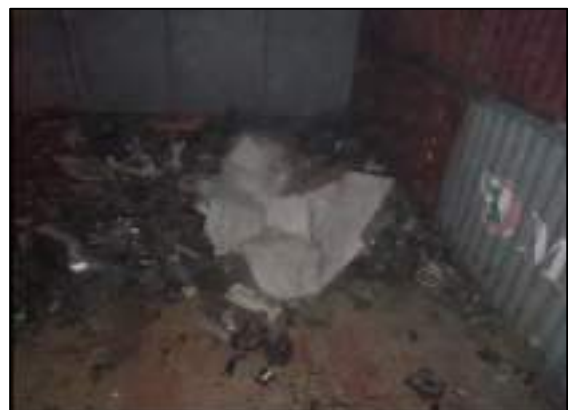
Figure 3: Container and Cargo debris on tank top

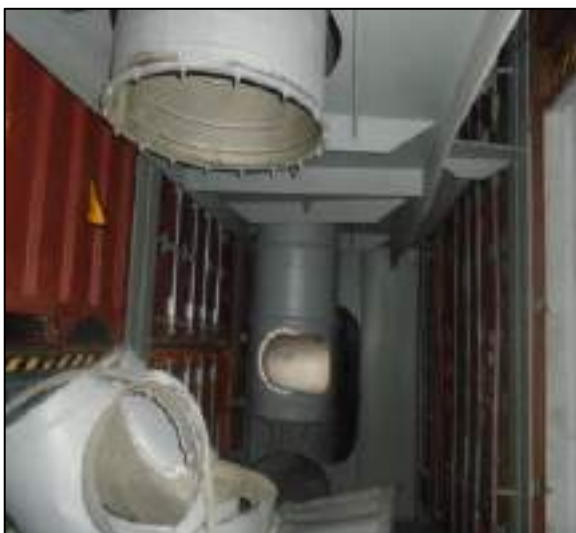
- ventilation ducts nos. 1, 2 and 3 on port side were found distorted and damaged (Figure 4);
- the safety railing on deck platform no. 2 was noted to be bent for about 2 m in length;
- the steel walkway on no. 2 deck platform was found distorted (Figure 5); and
- the safety steel wire no. 2 deck platform was found parted for approximately 2 m in length.

Figure 4: Mechanical ventilation duct damaged

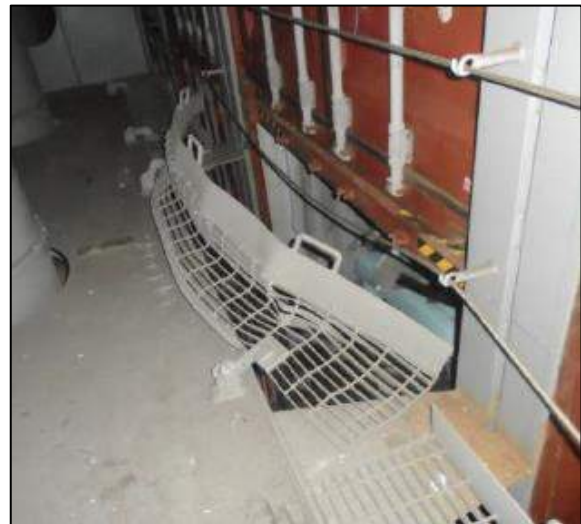
Figure 5: Distortion of steel walkway platform

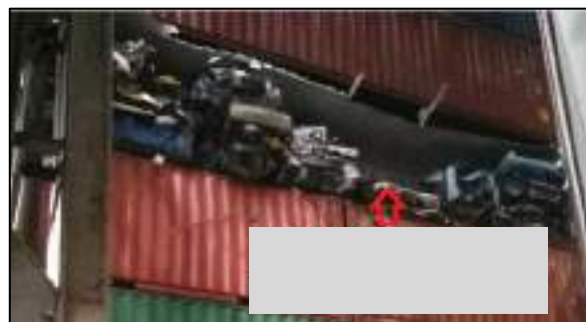
The container inside which the explosion had happened was in position Bay 50, Row 06, Tier 12 (500612) (Figure 6). As a result of the explosion, the entire right panel and the access door were ripped off, exposing the cargo contents (Figure 7).

Figure 7: Exposed cargo contents

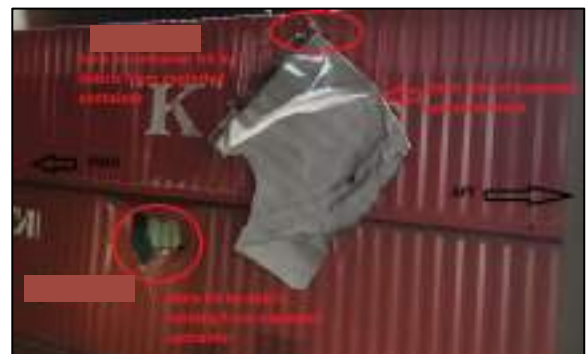
1. 500616 – right panel dented and torn at around corrugated no 8 – 11;
2. 510610 – right panel bulged, and roof dented;
3. 490610 – right panel bulged, and roof dented;
4. 500516 – left panel dented and torn (Figure 7);
5. 500514 – left panel dented and torn/hole;
6. 500812 – right door dent, locking bar damaged, right panel dented and left panel bulged; and
7. 490810 – right panel slightly dented.

Figure 7: Damages sustained to containers in positions 500516 and 500514

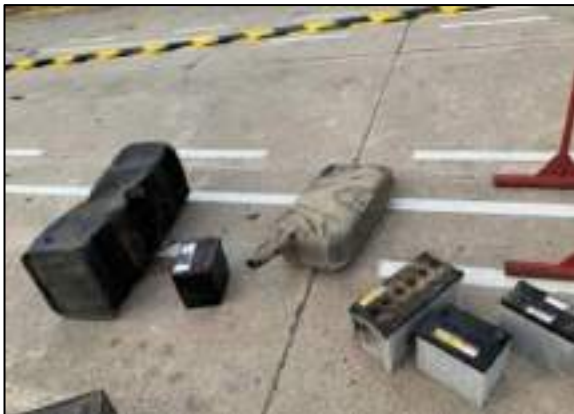
On 09 March, a re-working of the exploded container's contents into another intact container was carried out. The inspection report on the container's contents, revealed the presence of a partially filled fuel tank, car batteries, a cigarette lighter and several flares (Figures 8 and 9).

Figure 8: Fuel tanks and batteries

An examination of the ejected debris revealed the presence of at least eight automotive metal fuel tanks, four of which had a ballooned appearance, consistent with the effects of internal over pressurization. The information available to the safety investigation revealed that gas measurements of the internal atmosphere of several of these fuel tanks, indicated the presence of flammable vapours within the explosive range.

It was not excluded that fuel may have leaked from one or more of the tanks, which gradually led to an explosive atmosphere within the container. Although no old / damaged batteries were sighted in the container, it was not excluded that an intermittent electrical spark, could have been the likely source of ignition.

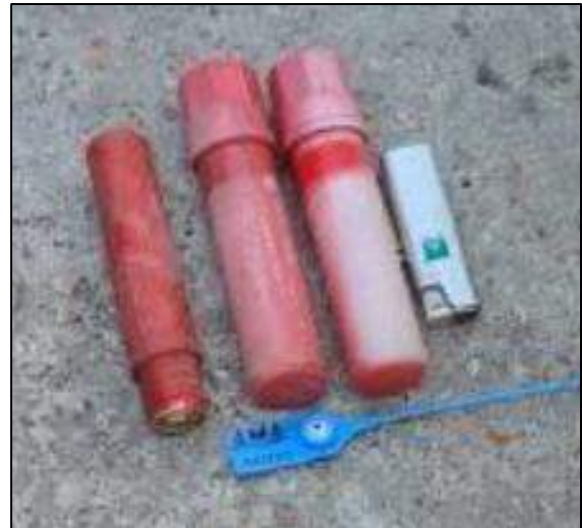
Figure 9: Flares and cigarette lighter

The safety investigation neither came across specific details on the flares and the cigarette lighter, nor the reason why these were stored inside the container. However, flares are

considered as pyrotechnics⁹ and would have to be classified under the appropriate hazard division of Class 1¹⁰ of the IMDG Code.
