MARINE SAFETY INVESTIGATION REPORT

Safety investigation into the serious occupational accident on board the
Maltese registered heavy lift /pipelay vessel

PIONEERING SPIRIT

MARINE SAFETY INVESTIGATION REPORT NO. 02/2021

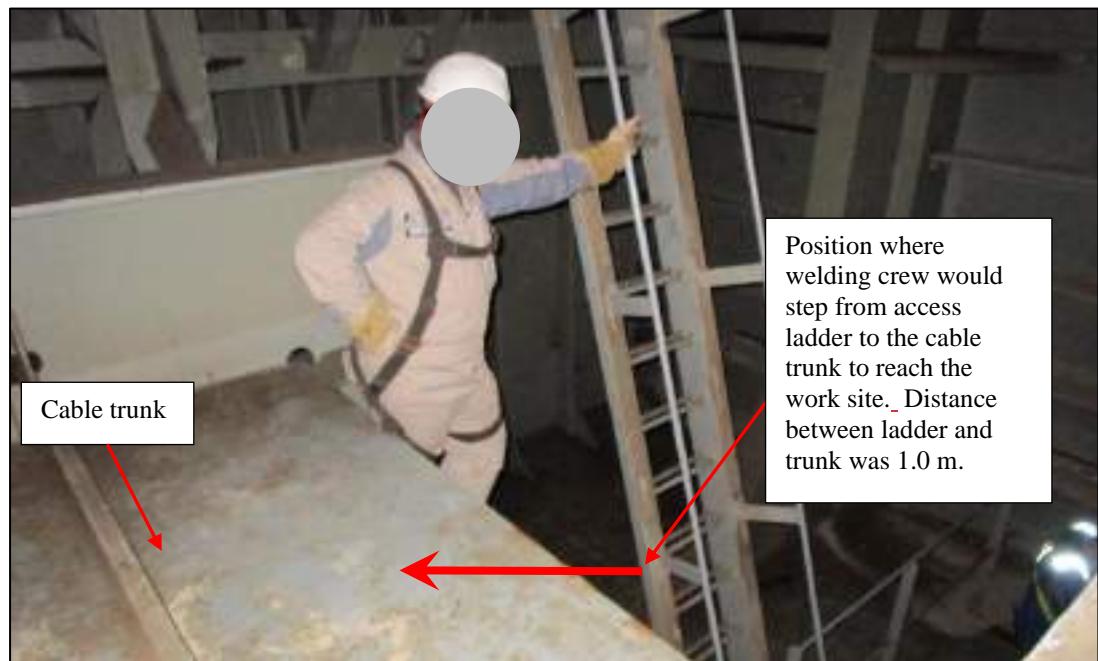
Figure 10: Access ladder passing cable trunk

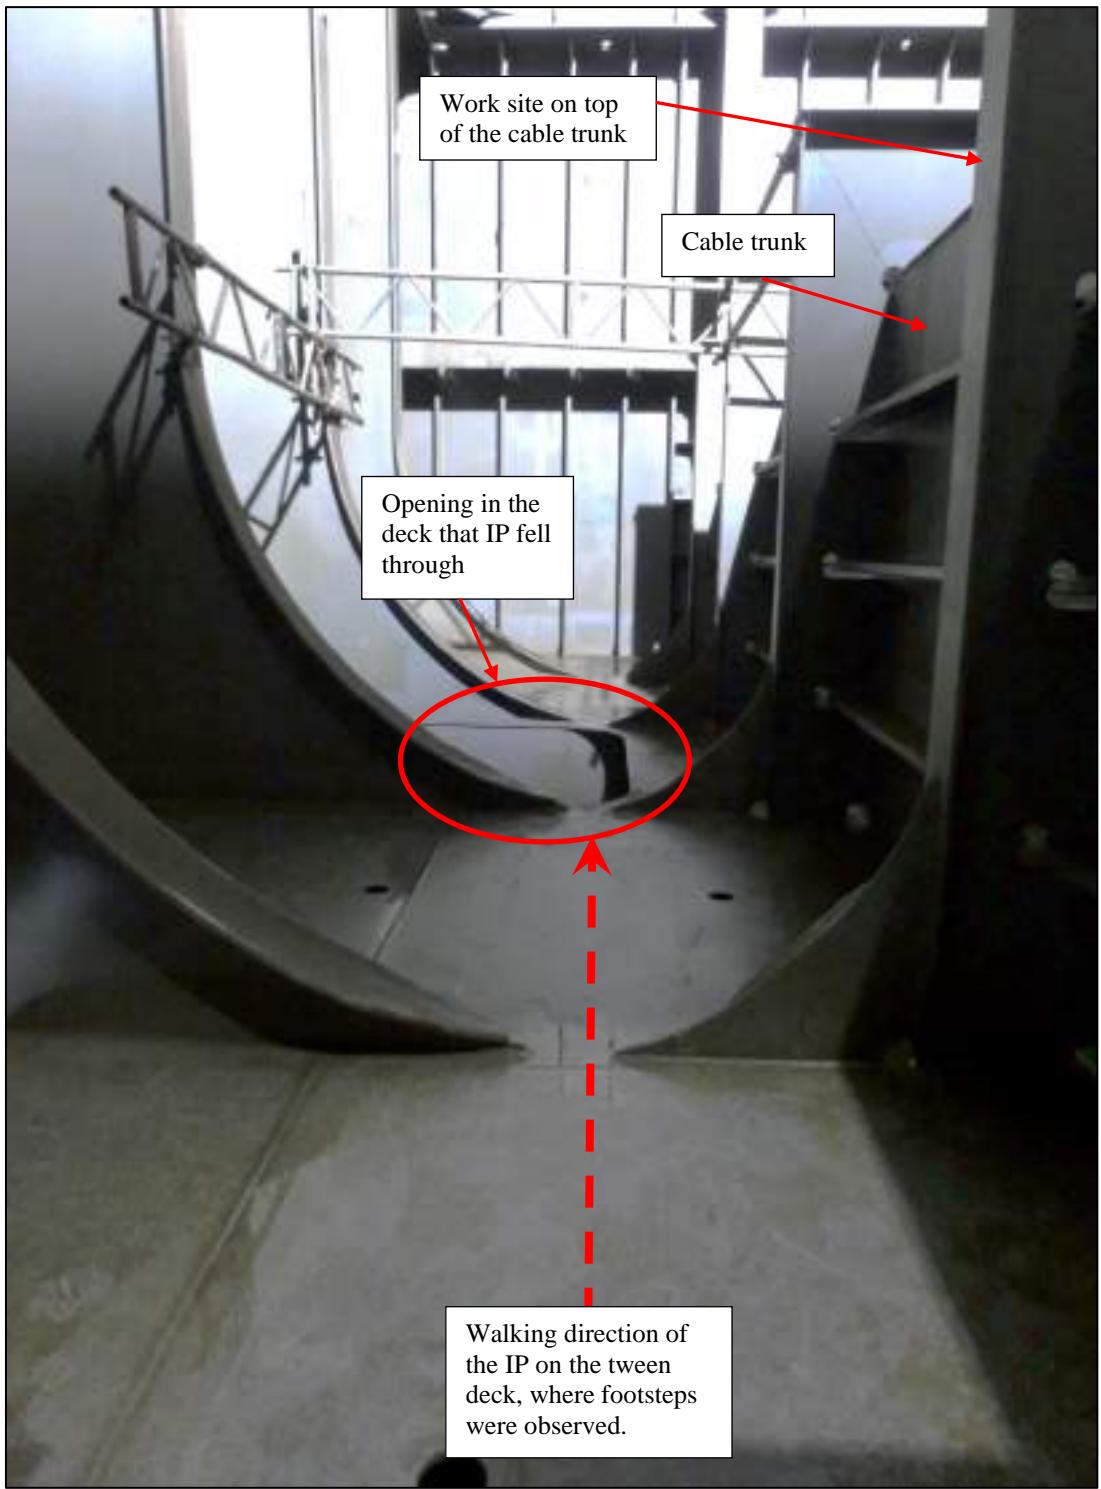
The opening in the deck through which the IP fell, was located about halfway from the guard railed passageway to the aft bulk head of the tank (Figure 12). Neither permanent nor temporary barriers had been fitted specifically around the opening in the deck.

Figure 12: Access ladder passing cable trunk. Lighting conditions are similar to those at the time of the accident

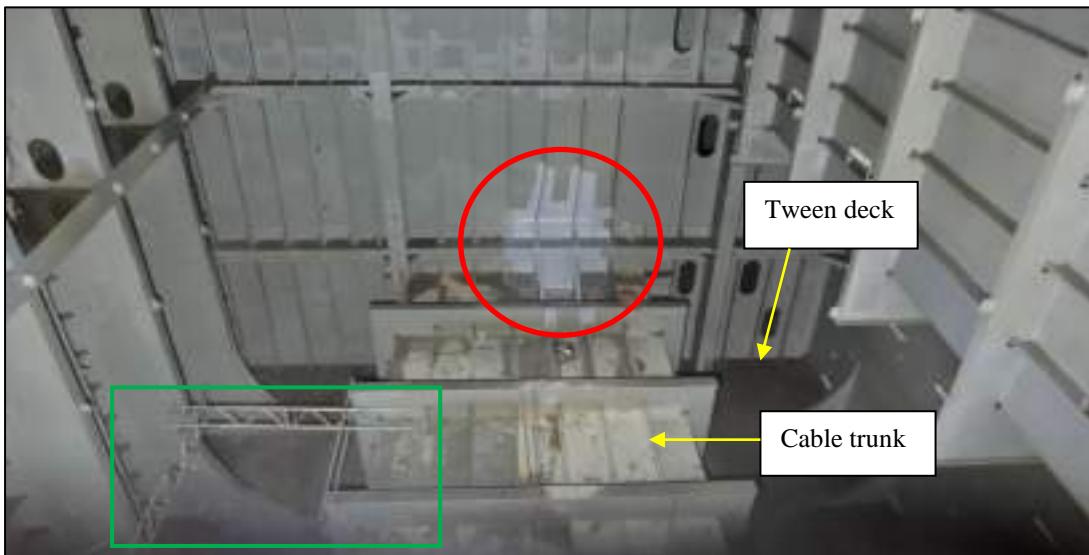
The welding job was to be carried out at the aft bulkhead on top of a large cable trunk, located on the tween deck of the tank structure (Figure 5), which the welder⁶ had stepped on to, from the access ladder. When the IP started lowering the hoses from the welding machine, the welder grabbed and dragged them to the work site. At this time, the two crew members that were inside the tank had visual contact with each other. After that, the welder observed the IP making his way down the second access ladder, and then he turned around, and started to mark where the stiffeners had to be welded on to the sheave-block assembly reinforcement.

Figure 5: View inside of the WBT. Position where stiffeners were to be welded on, marked in red. Scaffolding (marked in green) was rigged during the recovery of the IP

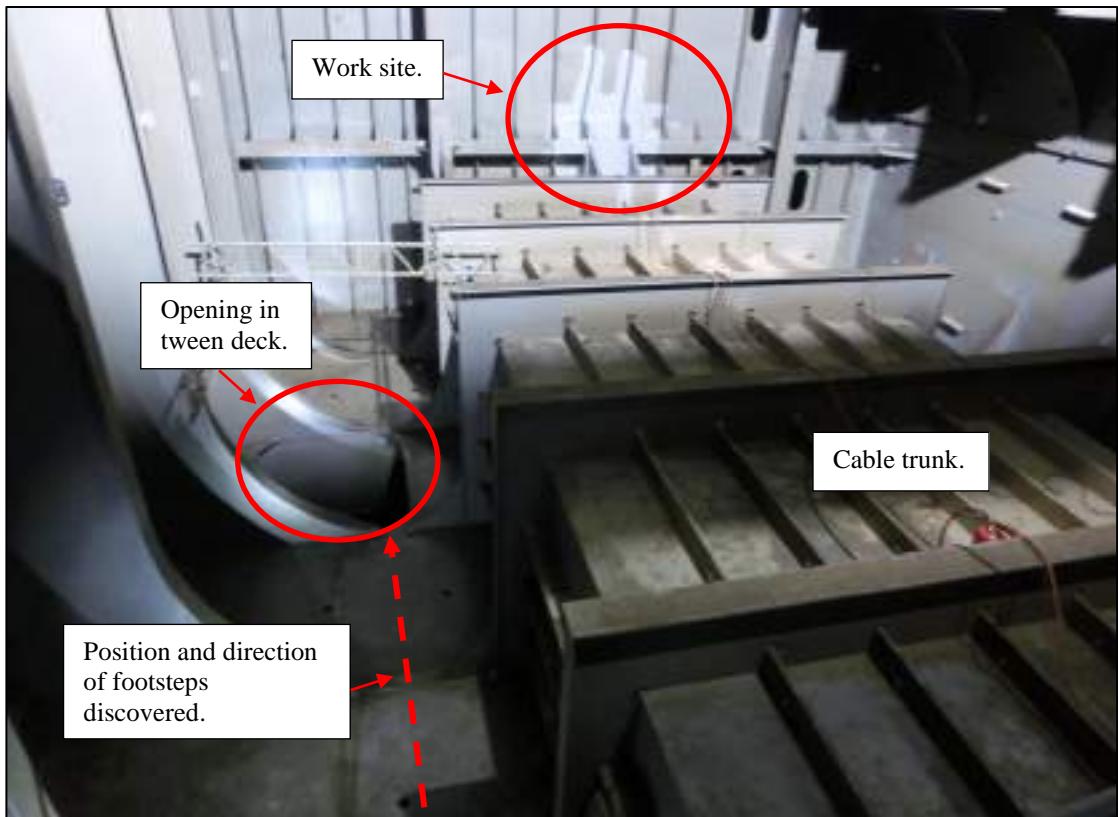
At around 1330, on his way down the ladder, the first welder helper shouted for the IP but received no response. He shouted to the welder that the IP was nowhere to be found on the tween deck below the trunk. When the first welder helper made a turn at the bottom of the access ladder, he observed fresh shoe prints on the otherwise untouched sludge coating on the tank tween deck going aft from the tank access pathway, which was bounded by hand railings. The shoe prints led along the side of the trunk in the direction of the work site (Figure 6).

Figure 6: Most probable route taken by the IP

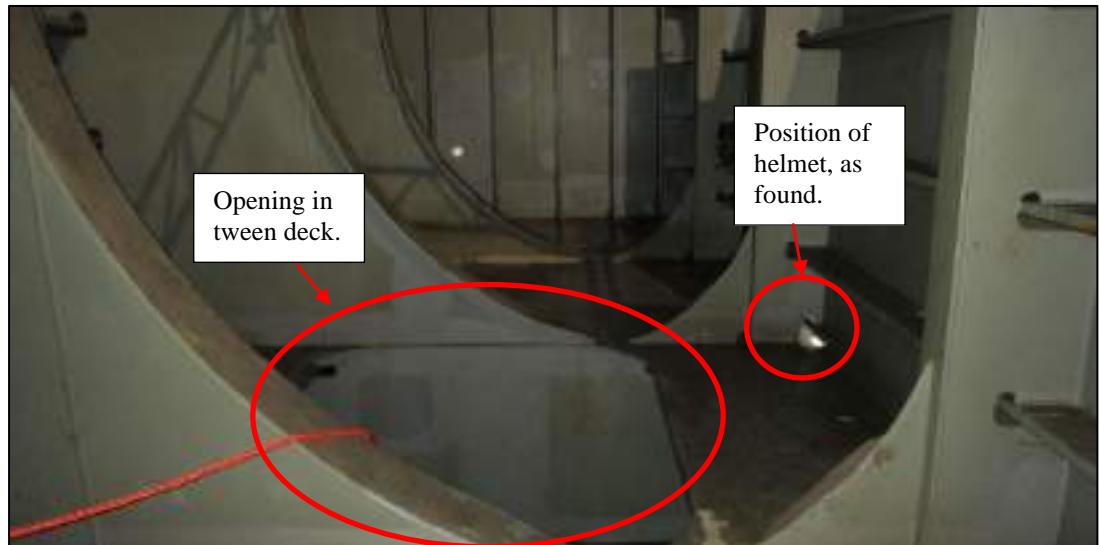
There, the first welder helper discovered a hard hat lying on the deck with the head torch still lit just next to a large opening in the deck leading to the lower level of the WBT (Figure 7).

Figure 7: Accident site

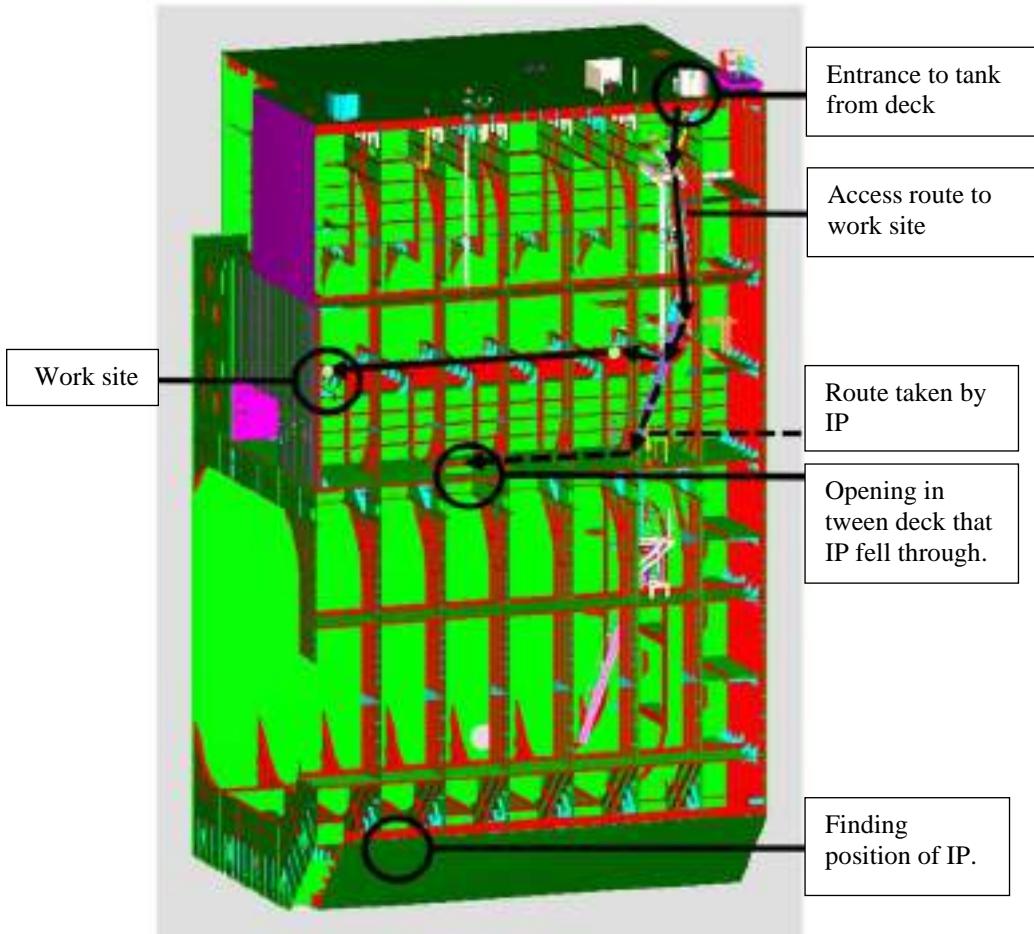
- the IP was looking up in the direction of the work site while walking ahead, failing to see the opening;
- the bag he was carrying may have obstructed the opening on the tween deck; or
- the IP noticed the opening ahead of him but, while circumnavigating it, slipped and fell through the opening.

Through these hypothesis, the safety investigation also considered the possibility that the IP was uncomfortable with crossing the one metre gap in between the access ladder and the cable trunk.

Figure 15: 3D model of water WBT no. 1006, as viewed from starboard side - walking routes marked

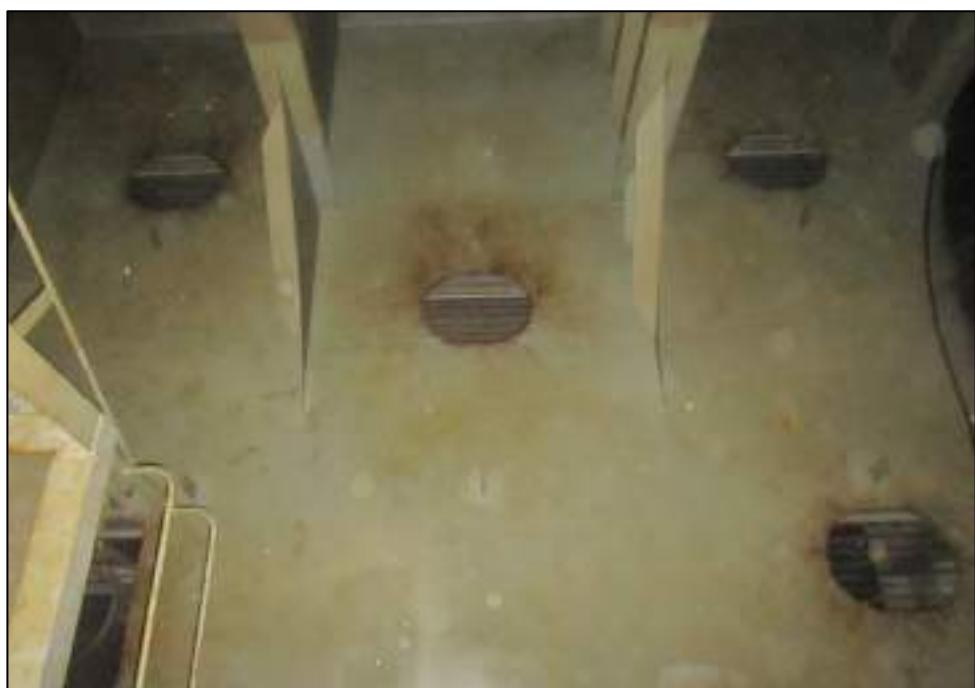
It was later revealed that some WBTs fitted on board *Pioneering Spirit* had bars across the tween deck openings to prevent someone from going through. These openings were noted to be of smaller diameters than the ones fitted in the WBT (Figure 16). It was not known why these bars had not been installed on all tween deck openings of all tanks present on board.

Figure 16: Protected openings on tween decks of other water ballast tanks

This safety investigation believes that absence of material barriers around the tween deck opening inside of WBT no. 1006, was contributory to this occurrence.
