Report on the investigation of the grounding
and recovery of the container feeder vessel

Thea II

Svitzer Josephine

on 15 December 2018

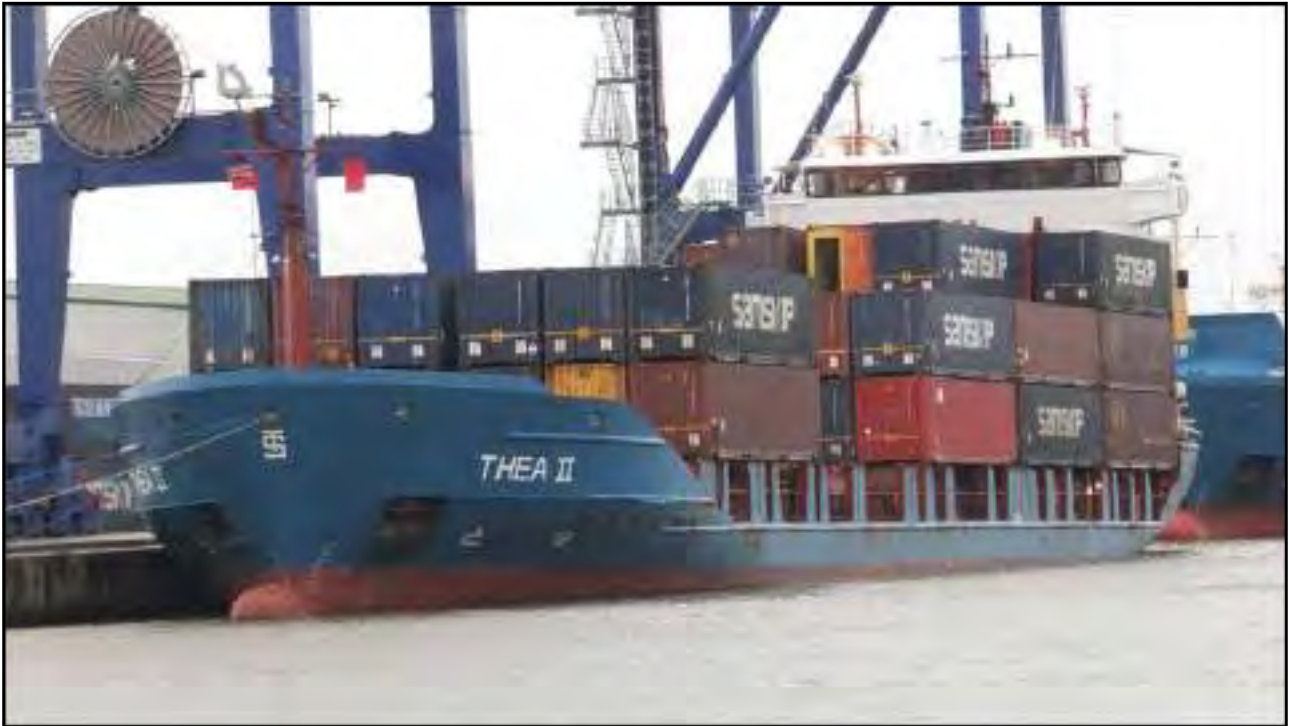
Figure 1: *Thea II*, post-grounding, alongside in Hull

- The rudder and steering gear were damaged, but operational.
- The vessel's hull was intact, but the hull bottom paintwork was damaged.
- There was minor damage to the propeller blades.
- Two quarter deck ventilation pipes had been broken by the tug's towline.

Thea II was out of service for 6 weeks for repair. The vessel resumed its charter in February 2019.

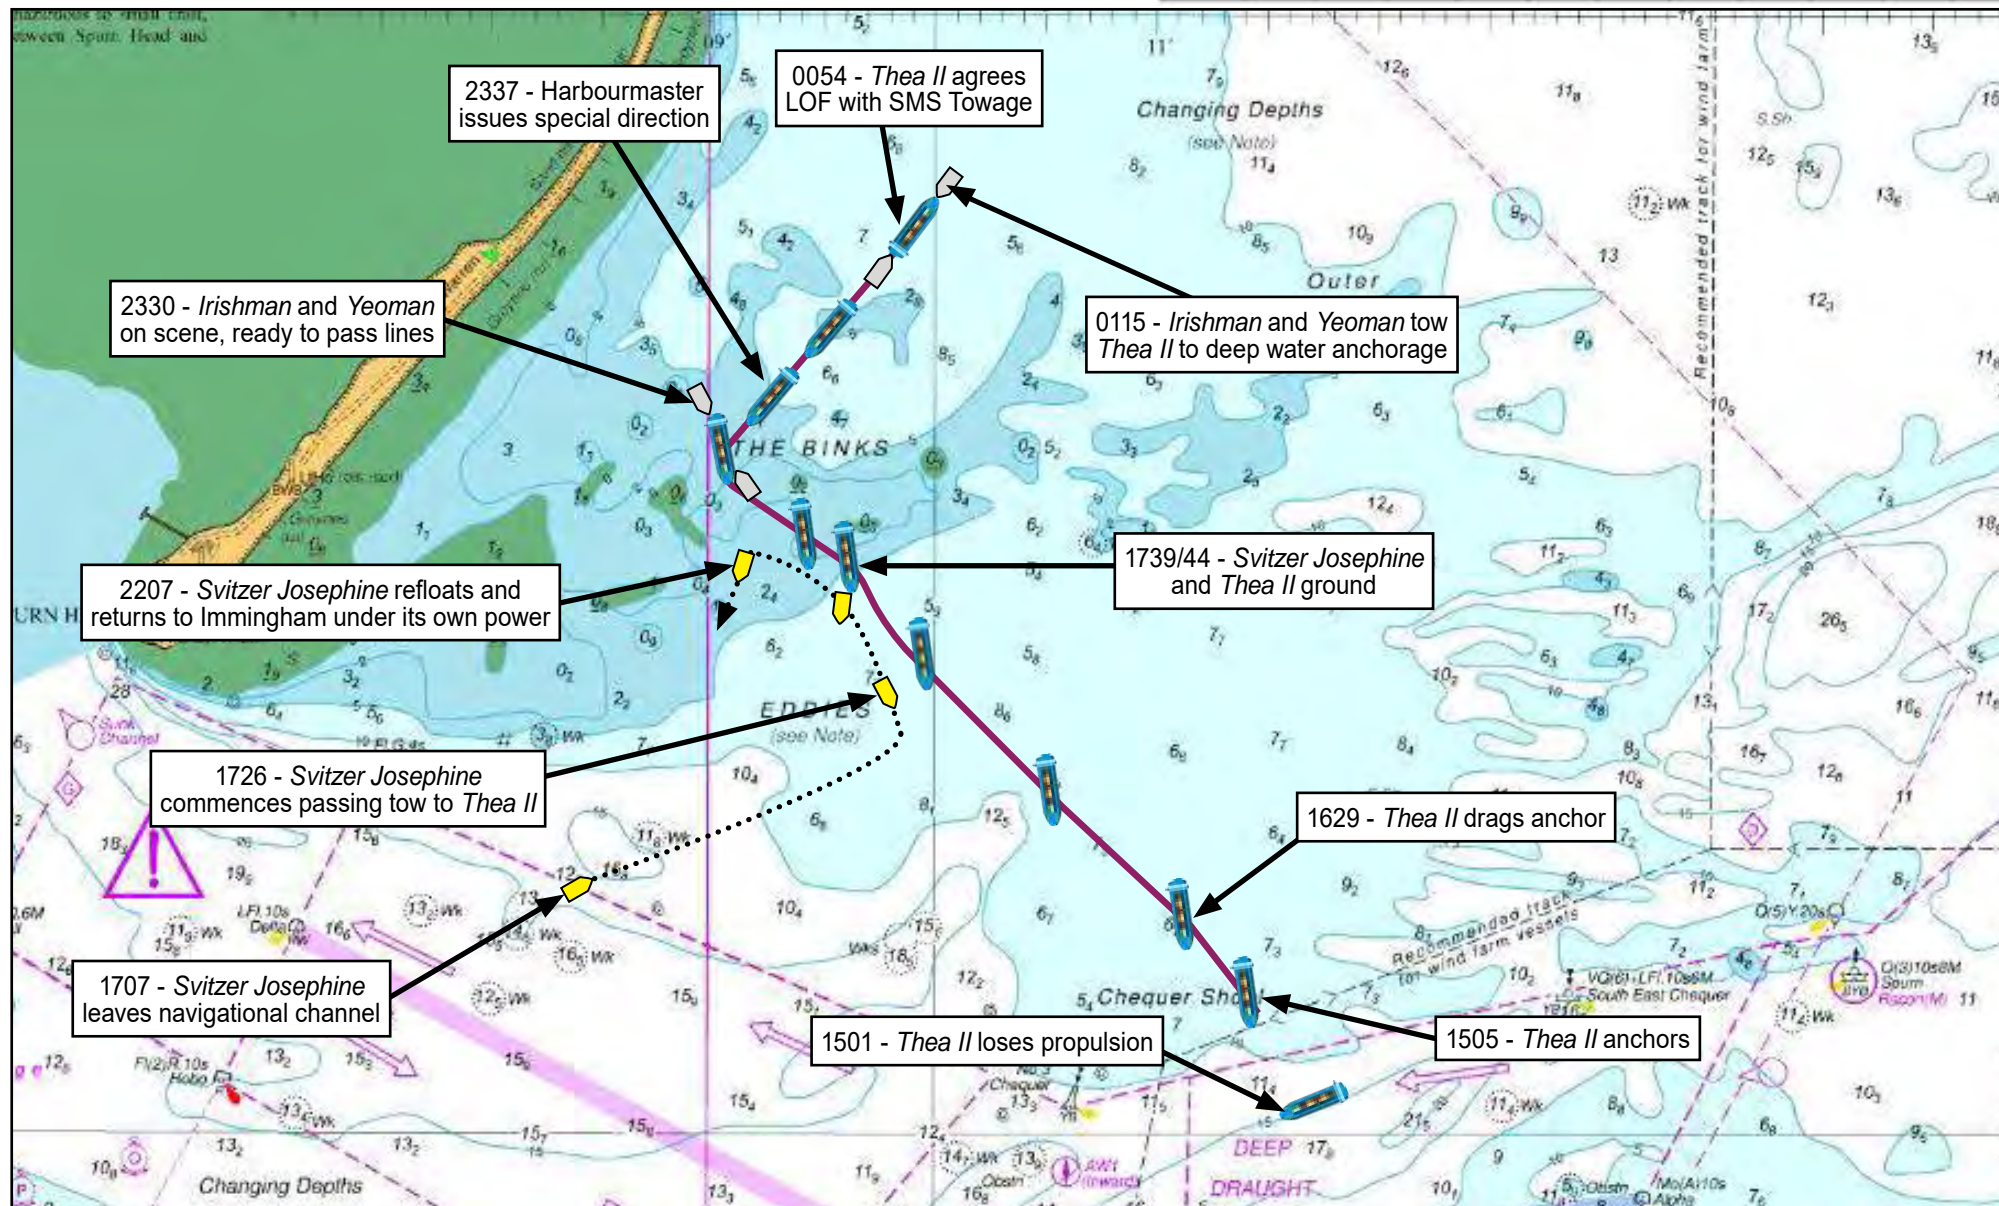
At 1633, just before low water Spurn Head², the VTSO observed *Thea II* drifting north-west at 1.7kts (knots) (**Figure 3**). He called the vessel and enquired if *Thea II* was dragging its anchor. The master confirmed that this was the case and reported that he was deploying a further shackle of anchor cable. However, this did not stop the vessel's drift.

Figure 3: Overview of the accident track from 1501 on 15 December until 0115 on 16 December

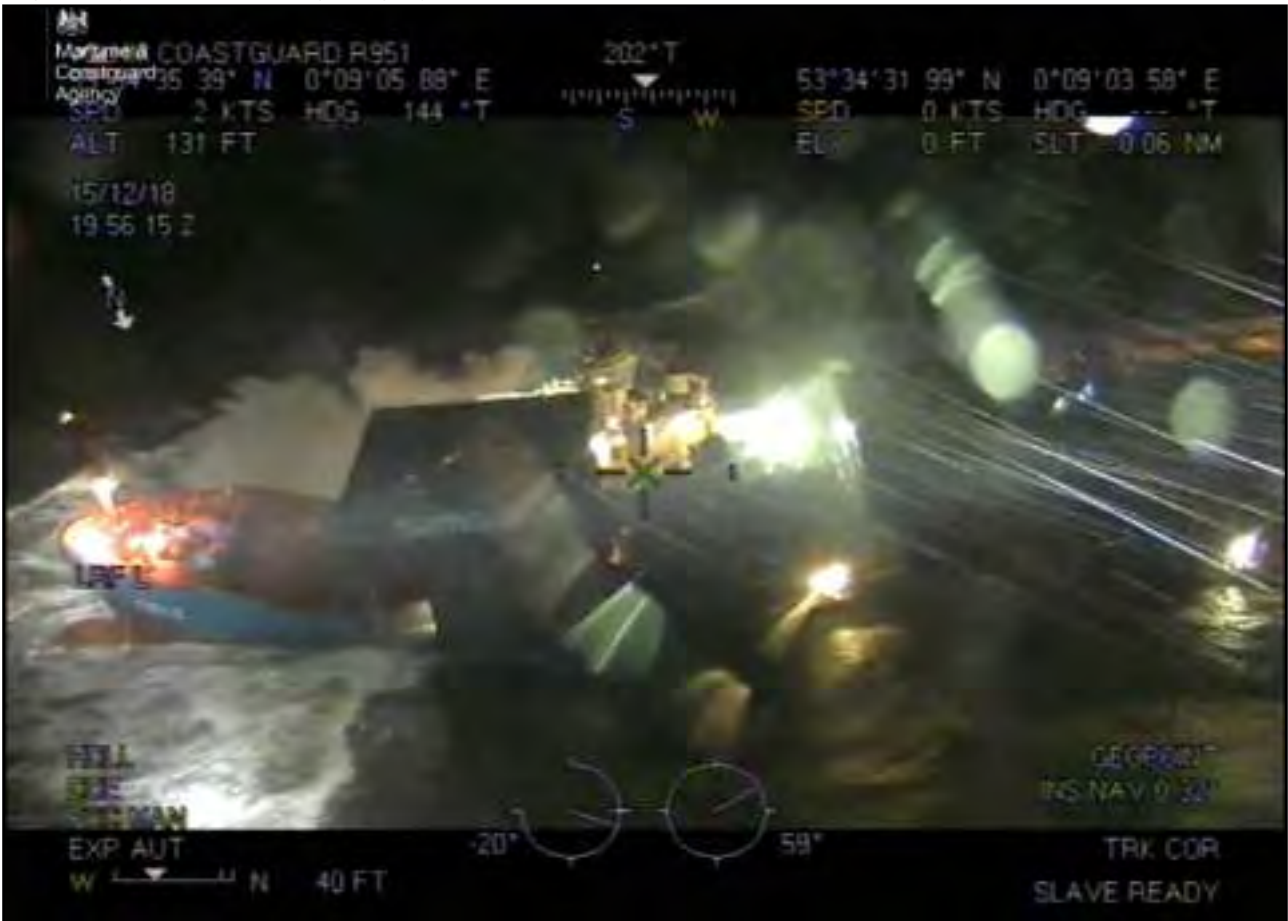
Figure 4: *Thea II* and *Svitzer Josephine* viewed from the search and rescue helicopter, aground on the Binks Shoal

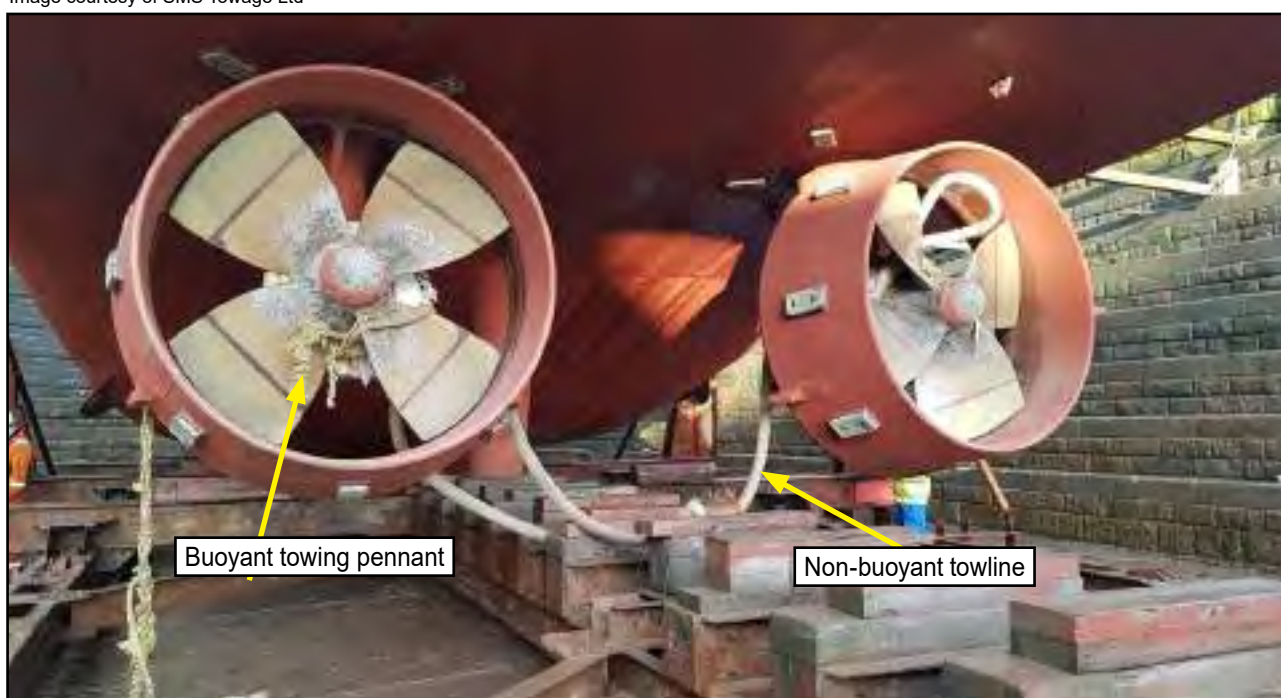
assumed that its propellers had been fouled by fishing gear. However, when *Yeoman* was in dry dock it was discovered that the port and starboard azimuth units had been fouled by a towline (**Figure 7**). The following damage was also discovered:

- The internal engine room mountings were out of tolerance.
- The starboard bilge keel and starboard side of the hull were damaged.

Post-accident inspection of the rope recovered from *Yeoman's* azimuth units suggests that it was an 80mm, 3-strand 'Strongline' polyester, Langhorst towing hawser, attached to a 15m yellow/orange towing pennant. This was similar to *Svitzer Josephine's* towline, which had been discarded by *Thea II's* crew.

Figure 7: *Yeoman's* propellers fouled by *Svitzer Josephine's* towline

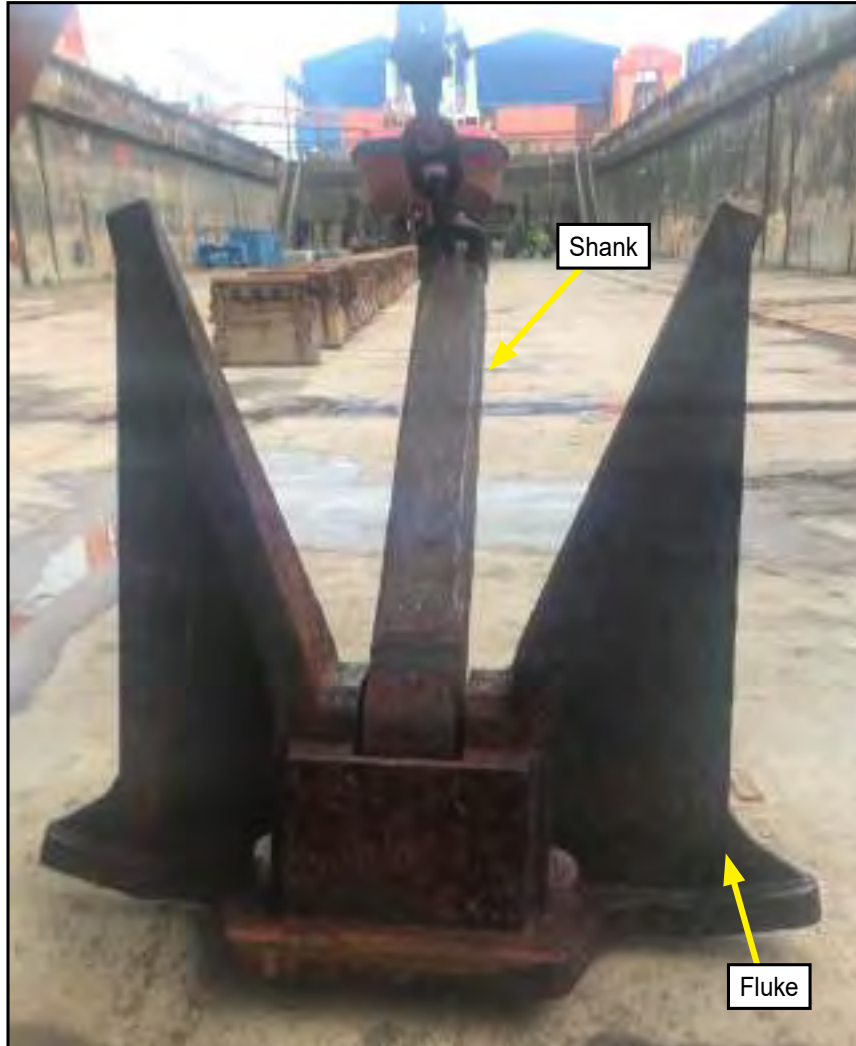
Thea II's anchor arrangements comprised a forecastle windlass and two 1998kg, high holding power, D'Hone anchors (**Figure 8**). The port anchor was attached to 12 shackles and the starboard anchor to 9 shackles of 40mm hardened steel cable.

Figure 8: *Thea II*'s D'Hone, high holding power anchor

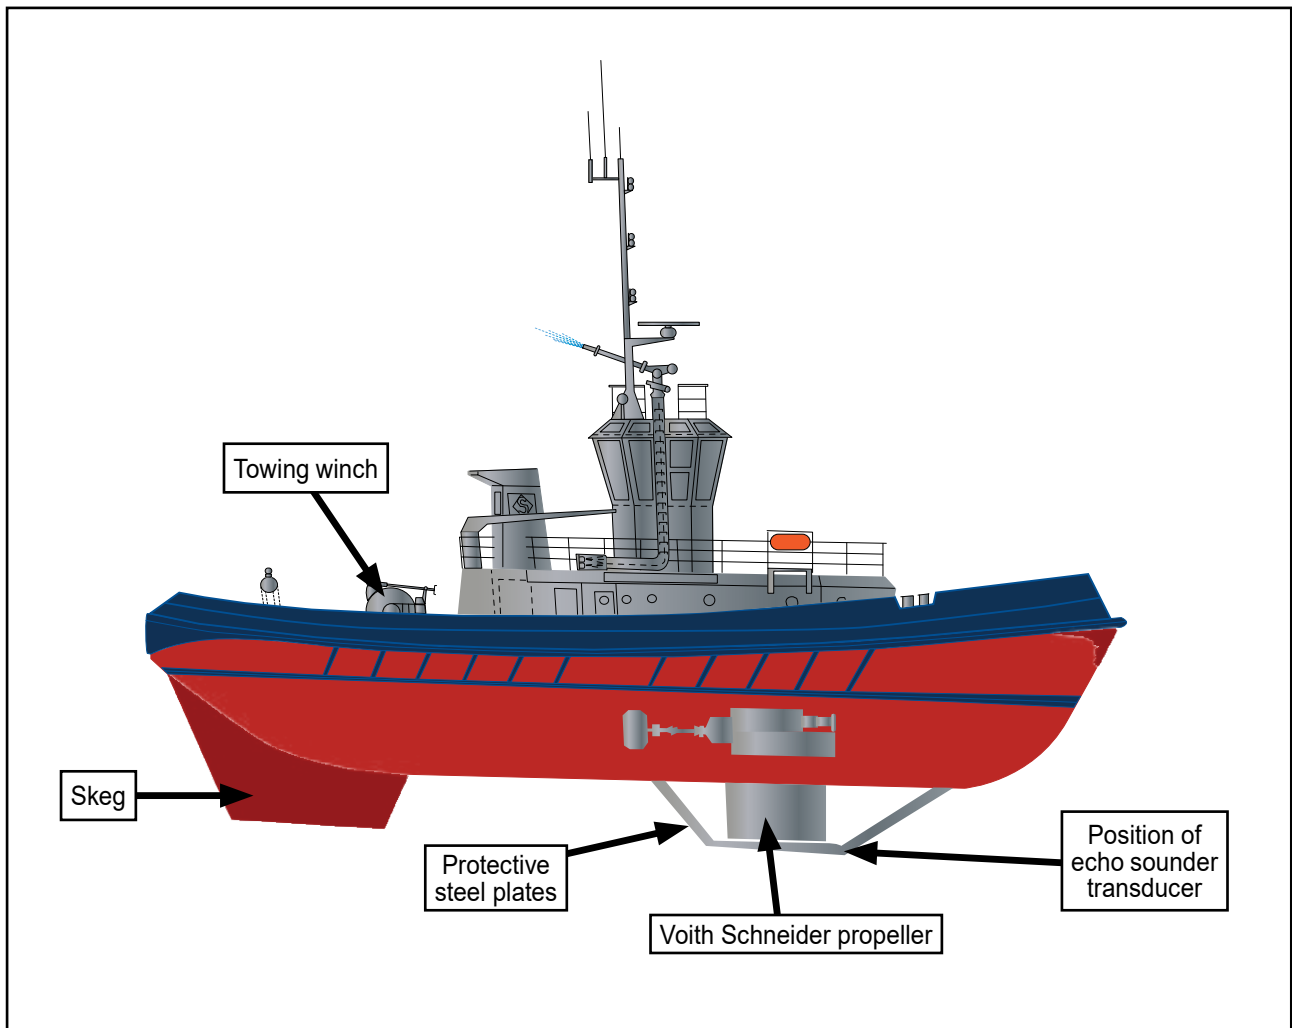
Post-accident in-water survey of *Svitzer Josephine* revealed that the void space containing the starboard engine room vent fan had flooded. This had shorted the fan motor and probably triggered the fire alarm. The starboard weather deck door had also vibrated open during the grounding, causing water damage to the tug's accommodation and recreational spaces. Initially it was thought that the tug's hull and Voith Schneider propellers (VSP) were undamaged. However, during the dry-docking of the vessel in June 2019, extensive cracking was identified along the skeg and adjoining keel plating, which had not been detected during the in-water survey.

Svitzer Josephine's echo sounder transducer was fitted in front of its VSPs. The echo sounder's minimum depth alarm was set at 1m. However, the position of its transducer, like many tugs, meant that it was prone to false alarm due to VSP wash and, on the day of the accident, the echo sounder's audible warning alarm had been silenced.

Figure 9: *Svitzer Josephine's* underwater arrangements

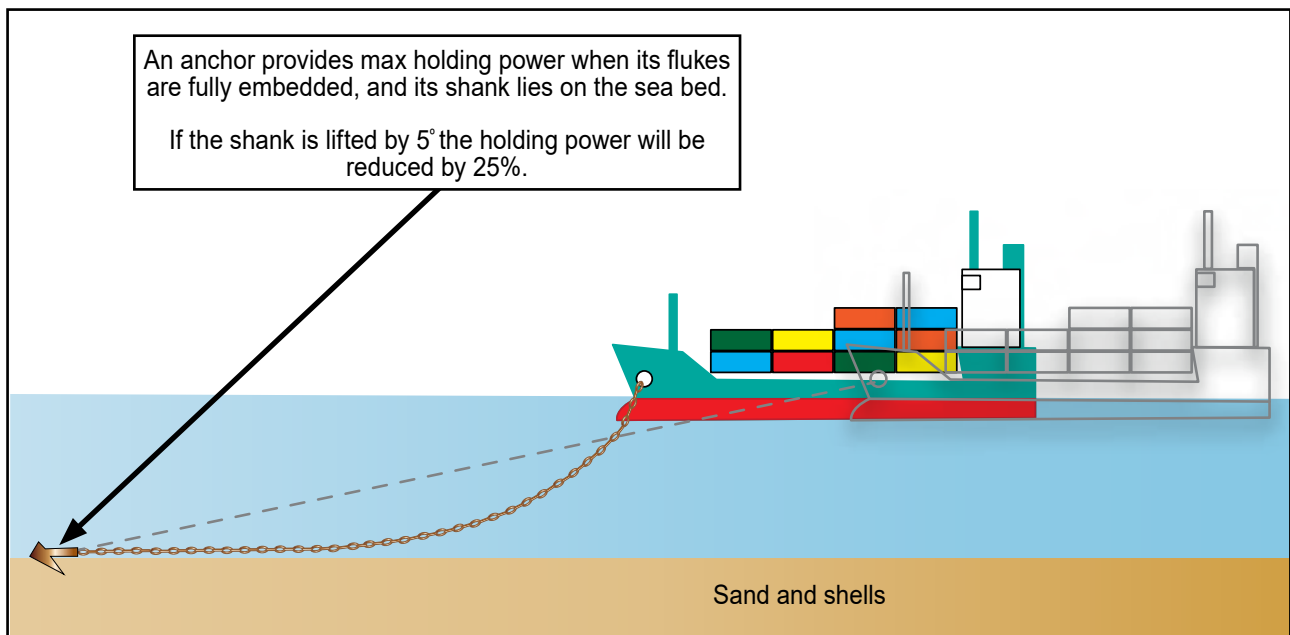
Using a charted depth of 12m these guidelines indicate that *Thea II*'s master should have deployed between 2.6 and 5.2 shackles of cable. When *Thea II* initially anchored, 5 shackles of cable were deployed, which was increased to 6 shackles once the vessel started to drag its anchor.

These guidelines recommend that in bad weather additional anchor cable be deployed. Furthermore, in strong winds, high-sided vessels like *Thea II*, with containers stowed on deck, can be prone to yaw either side of their anchor cable. At the extremity of each yaw, the vessel would snatch at the cable, placing it under

Figure 12: Scope of deployed anchor

considerable load and increasing the risk of the anchor breaking free and dragging. *Thea II* was yawing approximately 35° either side of its cable immediately prior to dragging its anchor.
