# **SAFETY DIGEST**

**Lessons from Marine  
Accident Reports  
1/2021**

**SAFETY DIGEST**  
**Lessons from Marine Accident Reports**  
**No 1/2021**

April 2021

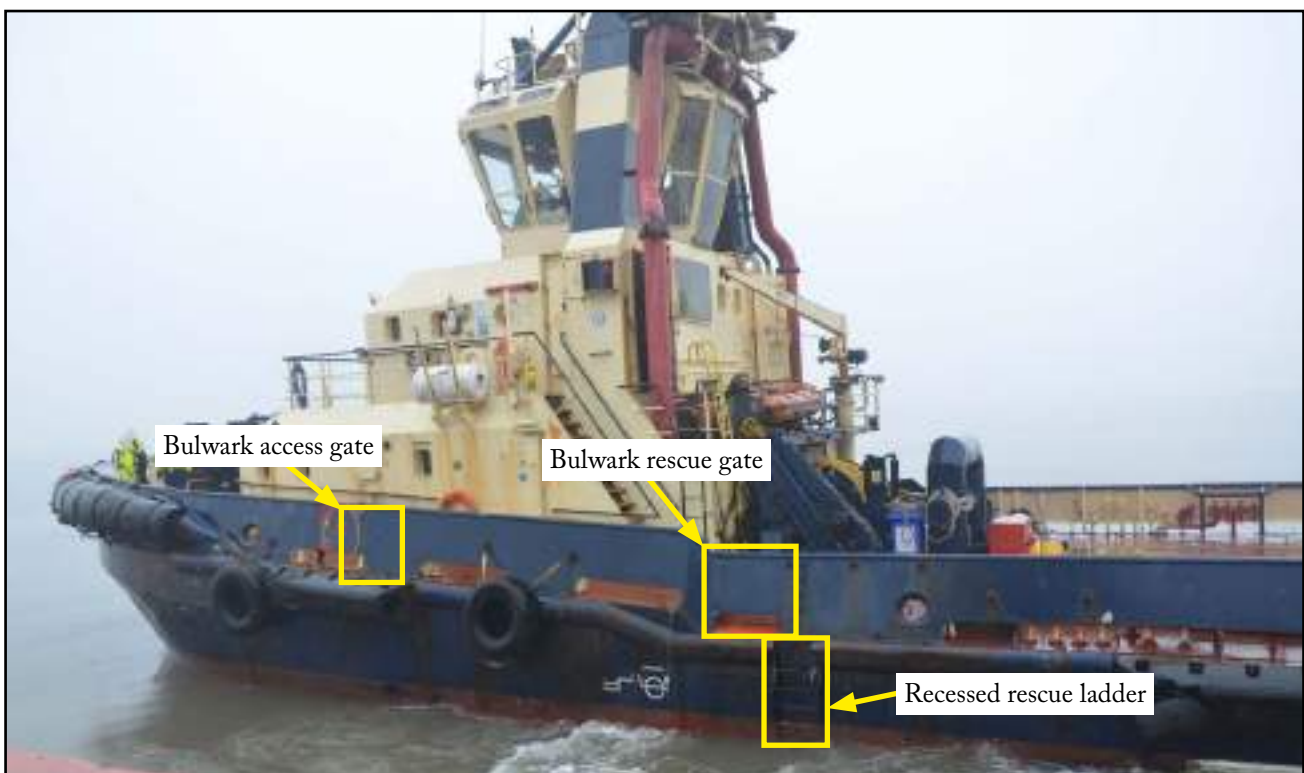
Figure 1: Tug and its access doors

It was subsequently found that it had become a standard practice to use the quay's fenders to step on and off tugs, and that the terminal had facilitated this by painting them with non-slip paint.

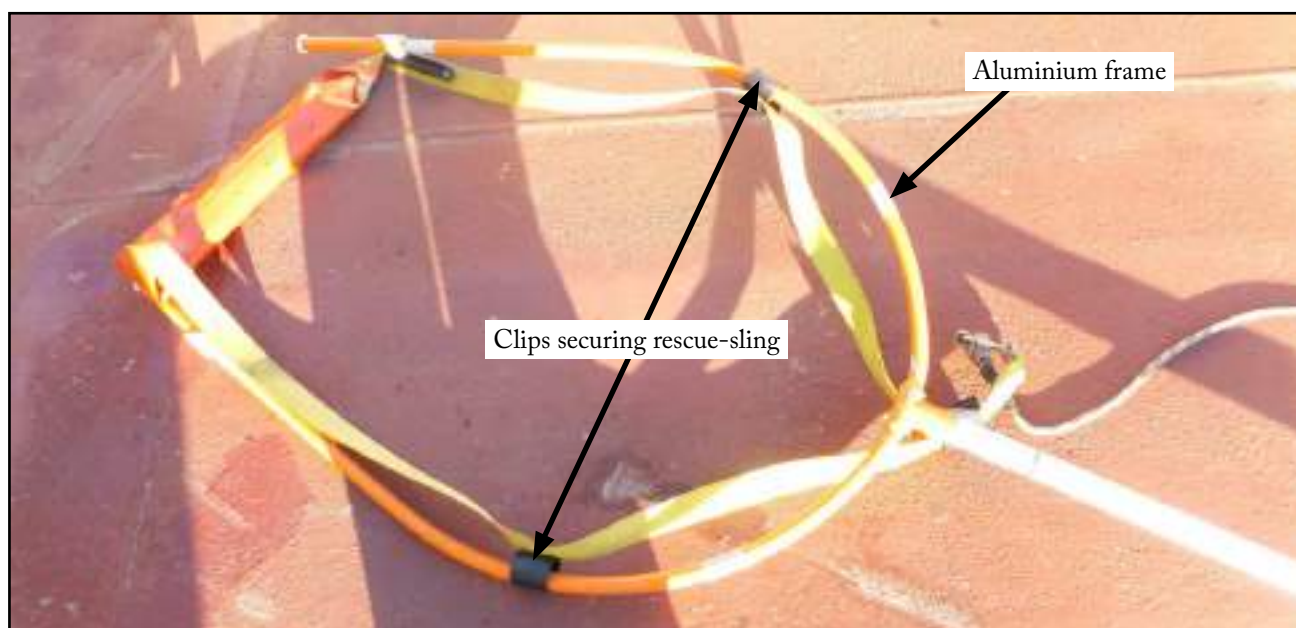
Figure 2: Man overboard rescue device with detachable strop

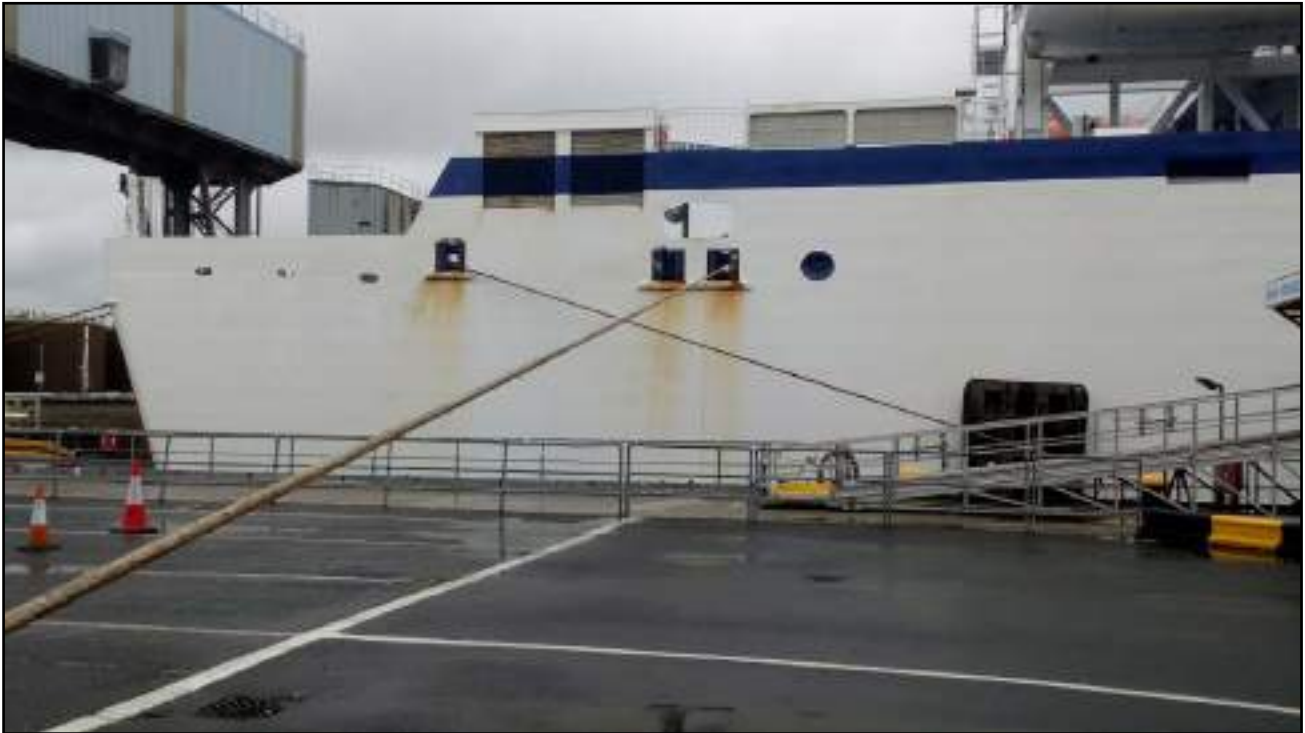
Figure 1: Breast, spring and stern lines

1. Self-tensioning winches are designed to work at a constant tension, and will heave in if tension is less than set and pay out if tension is greater. They are designed to keep a ship alongside in varying tidal or draught conditions. Here, in response to a sudden increase in wind speed, and a corresponding increase in forces on the ship and tension in the line, they payed out, operating as designed. If using winches in the self-tension mode, expected conditions for the period alongside must be carefully assessed, and if there is a chance that limits will be exceeded then use of higher tension settings, or holding on the brake with manual monitoring as the tidal height varied, could be considered.

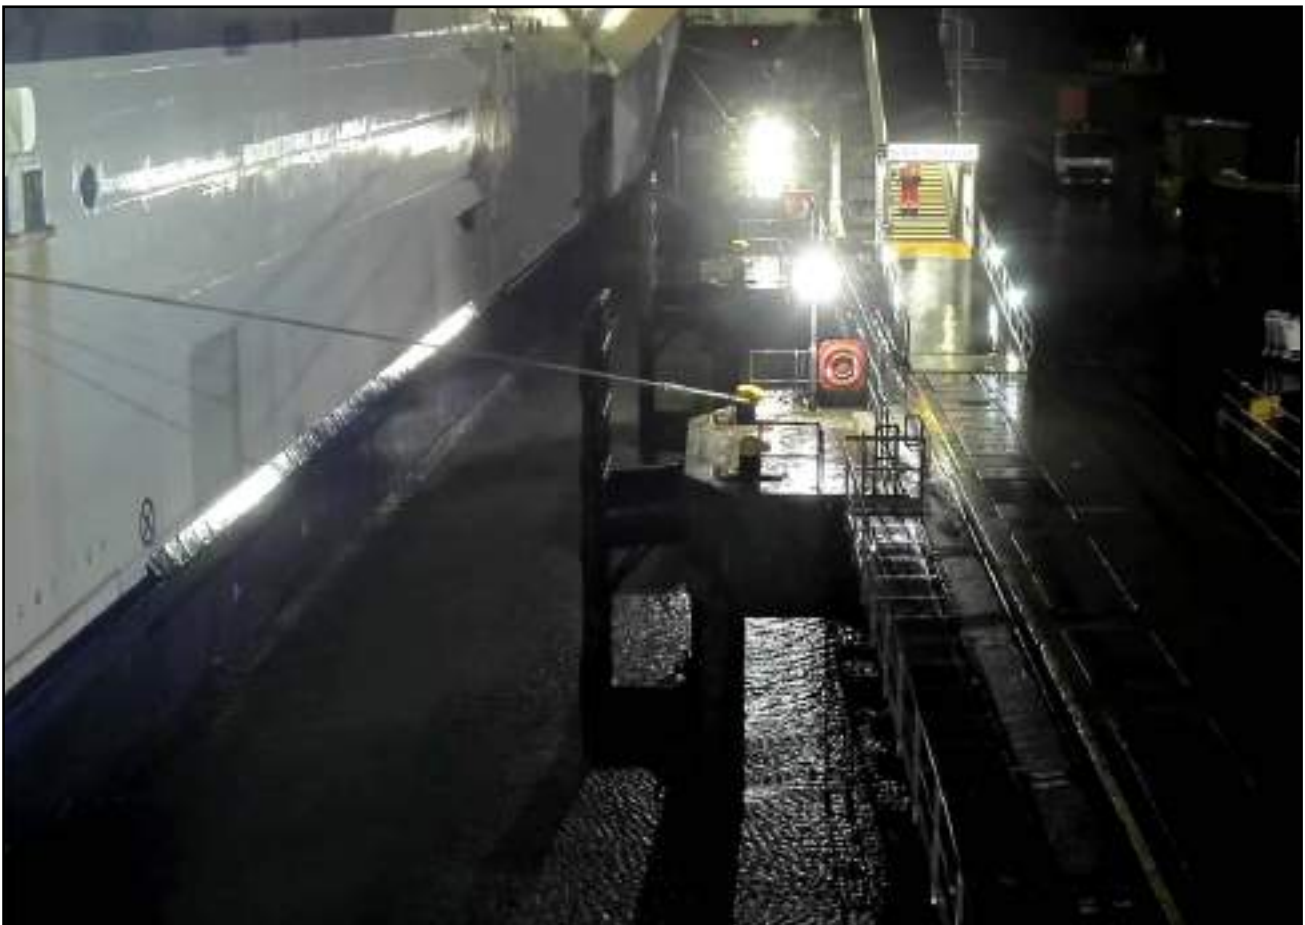
Figure 2: Spring paying out and gangway falling into water

3. The sliding gangway section had a minor defect that meant two doors had to be tied to the ship while the gangway was in place. As the ship moved away from the jetty, these ties prevented the gangway operator from disengaging the gangway and led to it falling into the water. Some seemingly minor defects can have major consequences – think carefully before putting off maintenance.

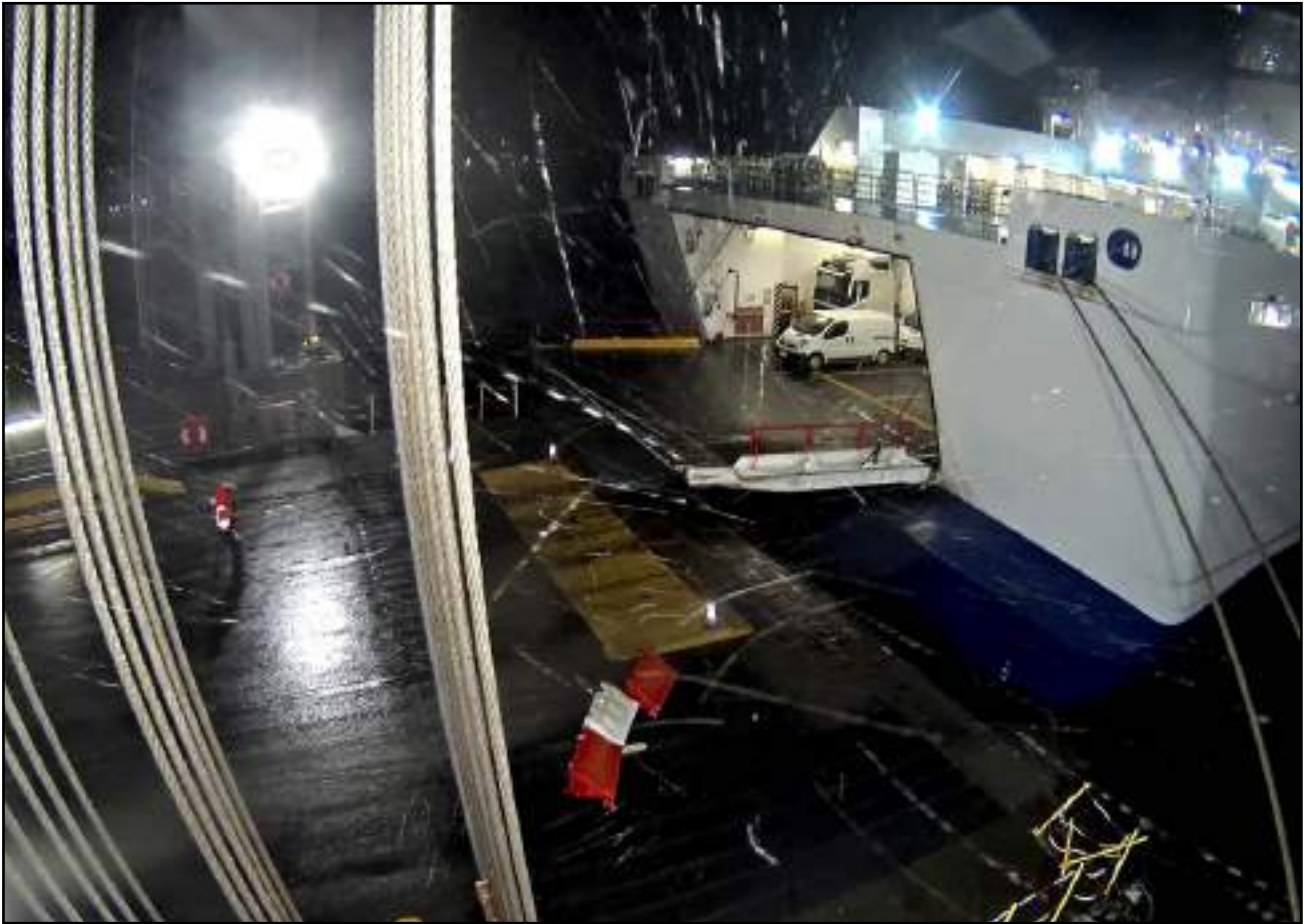
Figure 3: View of stern of ship being blown across linkspan

2. While winds at the time of the decision to remove the breast line were within the pre-agreed limits, some forecasts indicated that winds could increase up to force 8 and had mentioned the possibility of squally showers. If considering reducing the security of a ship alongside, then the most up to date forecasts must be sought. If conditions are marginal, mooring lines should be removed only if other mitigations are in place.

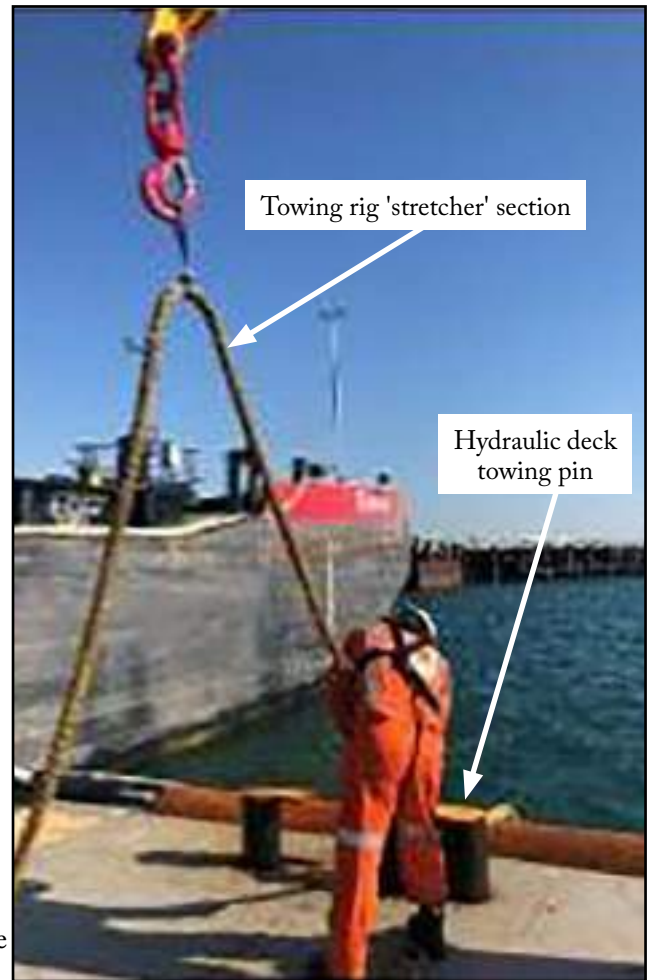
Figure 1: Reconstruction of the suspended rope stretcher being held above the deck

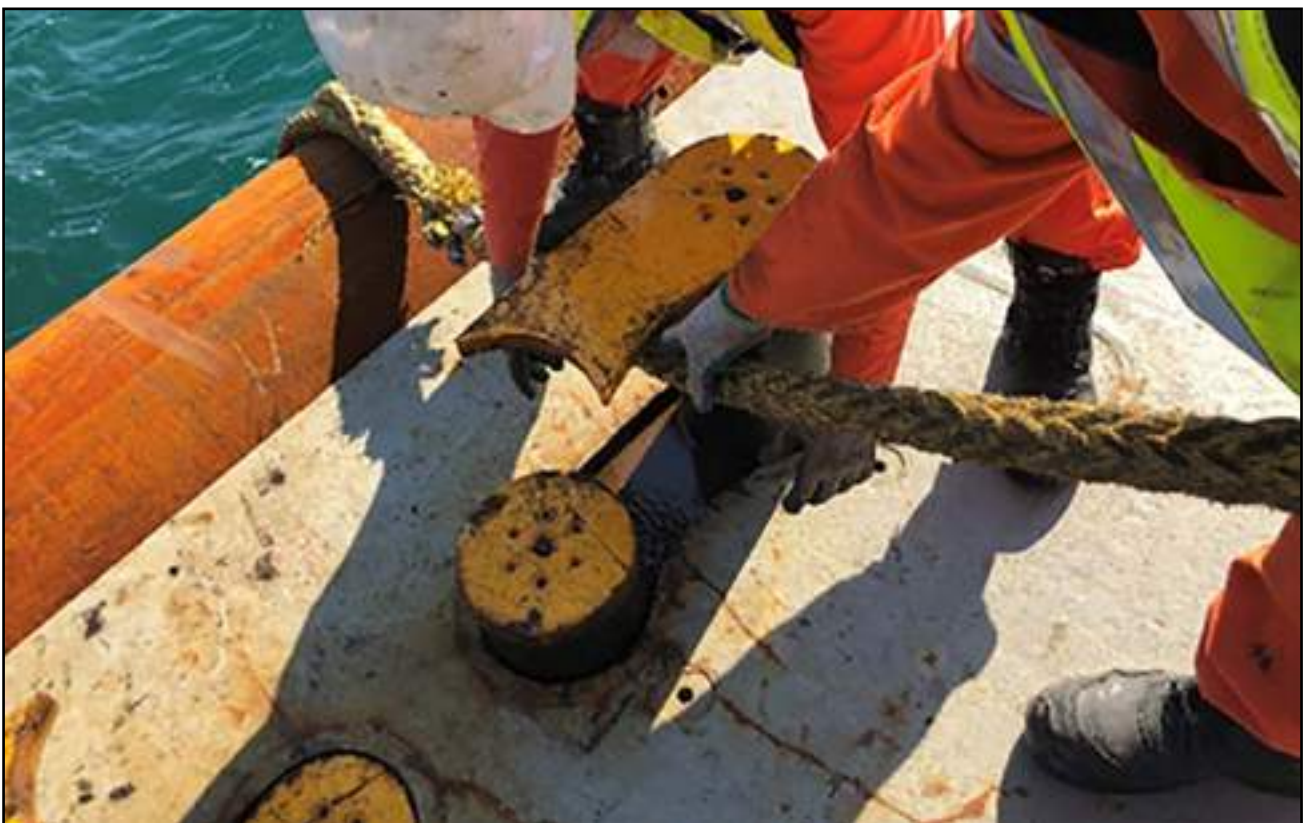
As the stretcher was being manhandled into place, it rapidly and unexpectedly came under tension, crushing the hand of one of the crewmen under the top plate of the hydraulic deck pin (Figure 2). The crewman suffered a serious hand injury requiring hospital treatment.

Figure 2: Reconstruction of the two crewman working on deck illustrating how the hand injury occurred

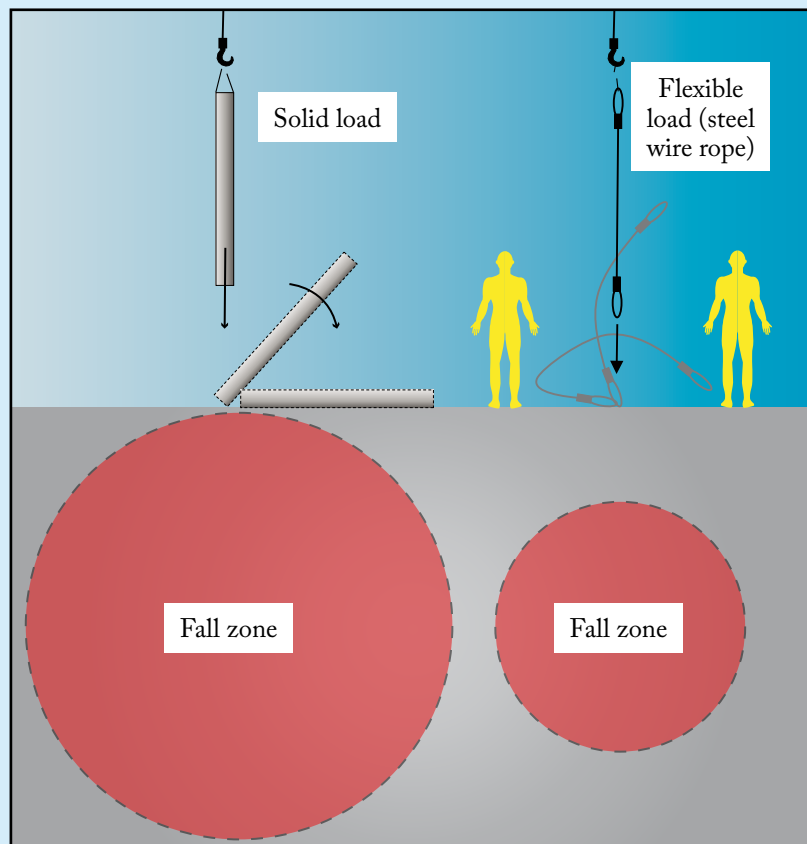
Figure 1: Illustration of the danger zone under a suspended load

1. During lifting operations, it is vital that crew avoid the hazardous fall zone under the suspended load. This is not just the area directly under the suspended load; it extends to the entire area where it is reasonably foreseeable that a load could fall (Figure 1).
2. All lifting operations should have a safe plan, ideally a task specific risk assessment and method statement. In this accident, the ABs were struck because they were standing in the fall zone, which had not been assessed as a dangerous area. At safety briefs or toolbox

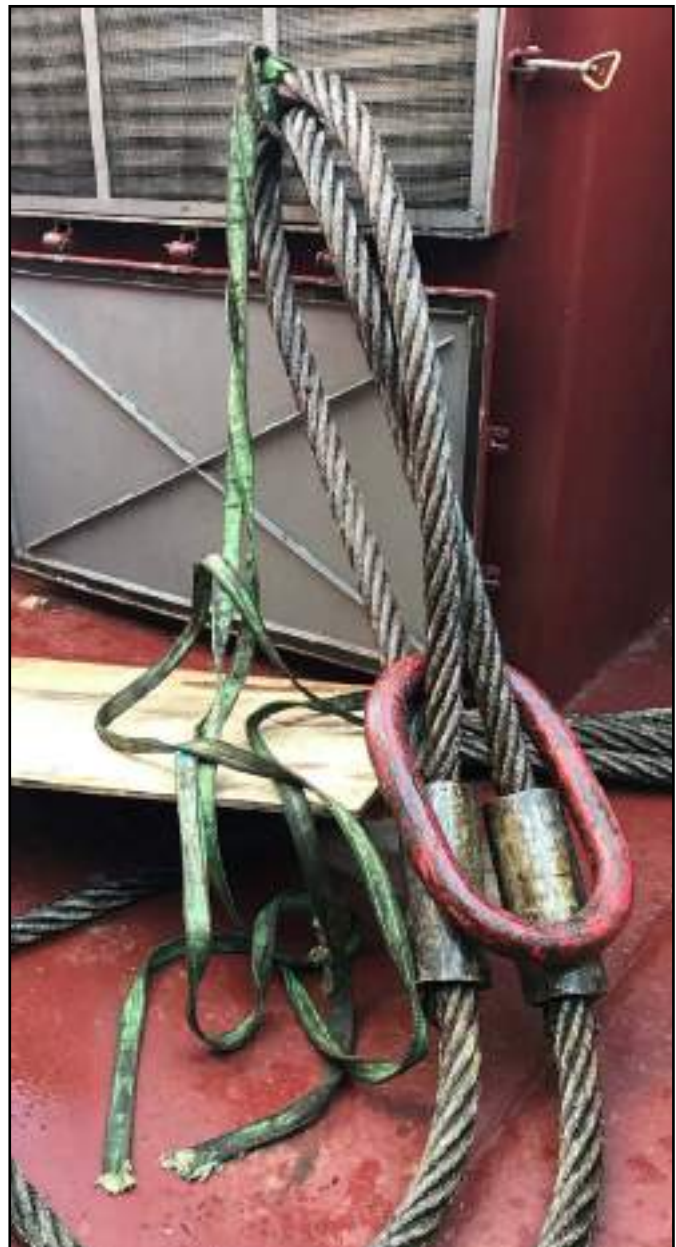
4. All fixed and loose lifting gear should be regularly inspected and documented. The purpose of inspections is to check that the gear is being maintained in a satisfactory condition for safety-related operational use. After the accident, it was discovered that the fibre sling in use was in a poor condition (Figure 2) and had not been recorded in the vessel's lifting gear log. Although the breaking load of the sling was sufficient to hoist the lifting gear, it should have been disposed of due to its poor condition.

Figure 2: The broken fibre sling, still attached to the lifting gear, after the accident

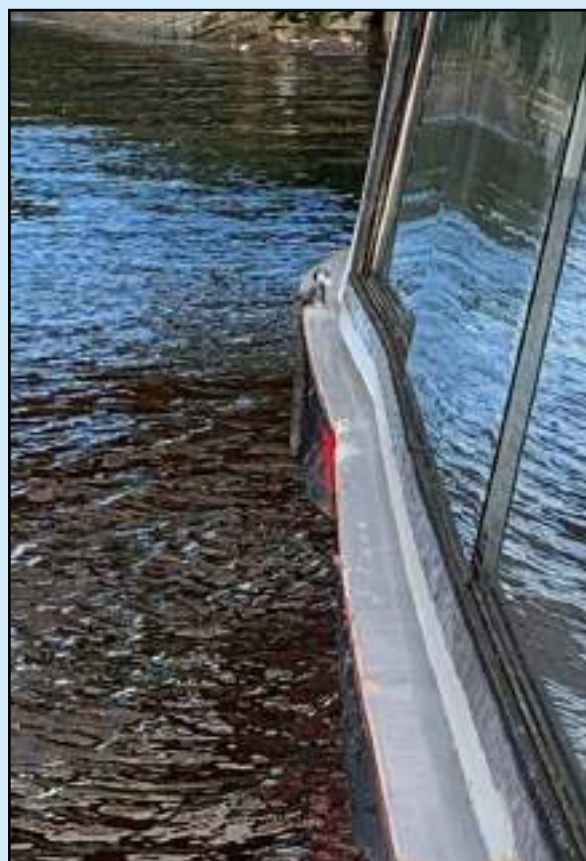
As the vessel's heading was being reversed close to the bridge, it was swept sideways towards one of the bridge's pillars by the combined effect of the strong stream and wind. The vessel's port side made heavy contact with the bridge, resulting in a dent on the fendering (see figure). Some passengers fell over and glasses were damaged in an internal bar area, however there was no injury.

Figure: Damage to the passenger vessel's port side after the contact with the bridge

1. Irrespective of a vessel's size or purpose, every journey, however repetitive, needs a passage plan. In this case, the strong breeze and peak flow of the river made for very difficult conditions for manoeuvring the passenger vessel close to the bridge. The master was familiar with the area and conditions, so the additional risks could probably have been recognised and avoided. Since the incident, the vessel's operator has issued guidance to its ferry masters to turn around downstream of the bridge during peak river flow or windy conditions.
2. There were a small number of passengers on board compared to the vessel's normal maximum capacity; this meant the risk of passenger injury was also reduced. If there is any risk to passengers, the public address system should be used to make sure everyone is sitting down or holding on prior to an impact of this nature.

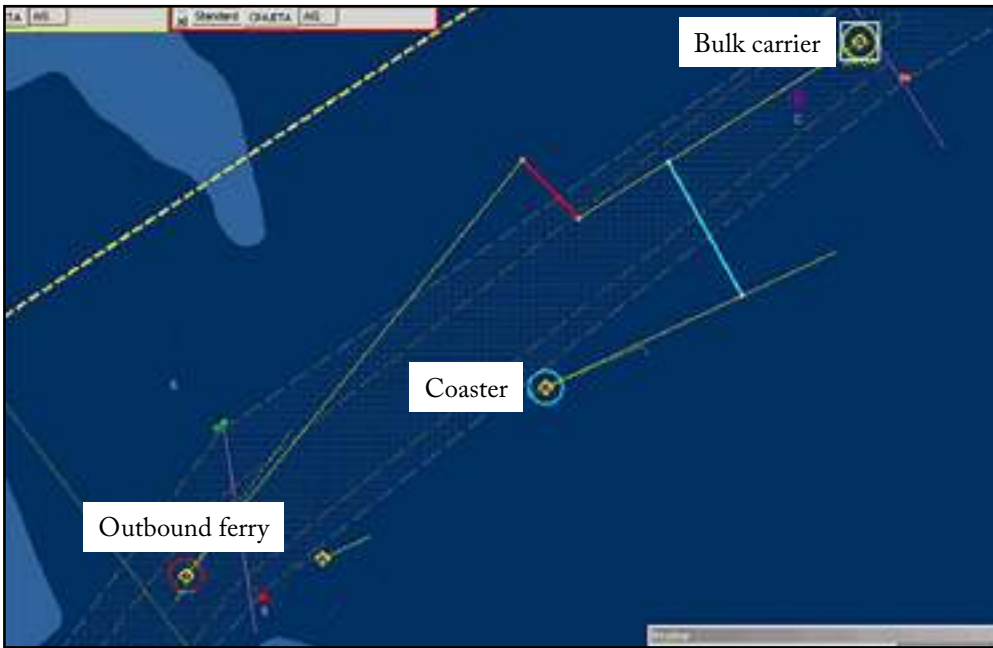
Figure 1: The coaster leaving the buoyed channel early

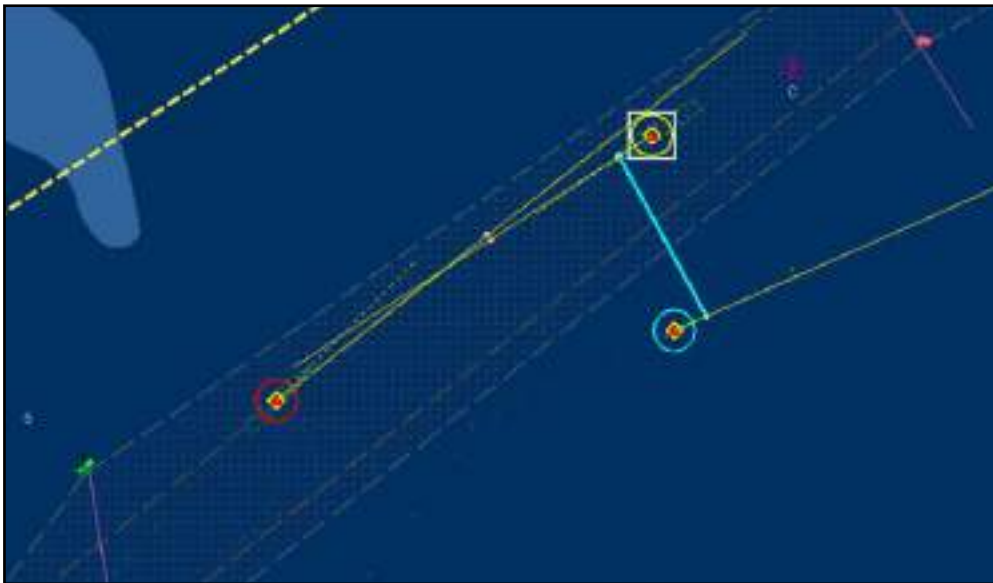
Soon afterwards the pilot on the inbound bulk carrier raised his concerns with VTS that the ferry's position appeared to be to the north of the channel and was likely to cause a risk of collision (Figure 2).

Figure 2: The bulk carrier pilot raises his concerns

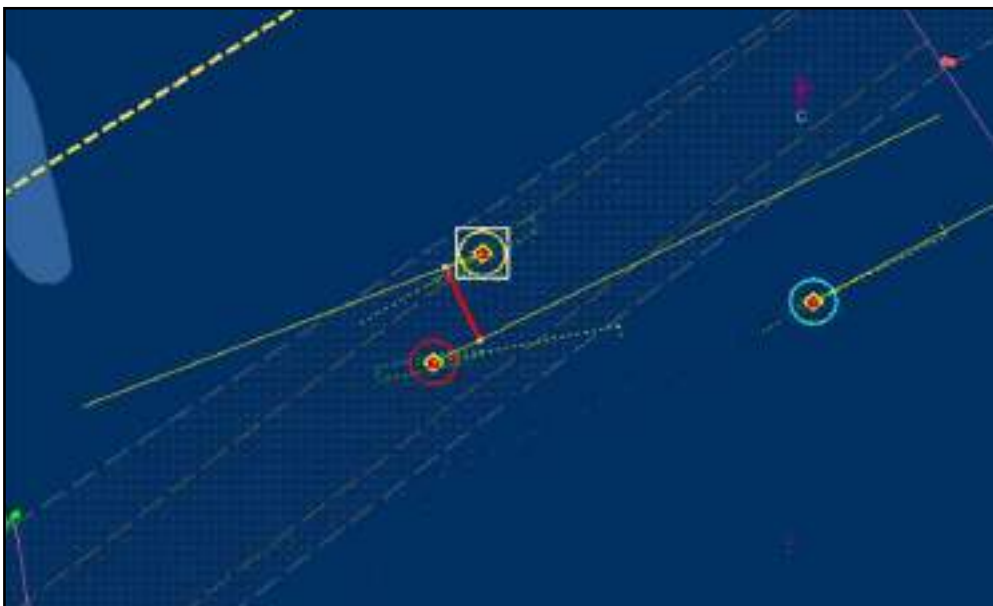
Figure 3: Passing at 1 cable

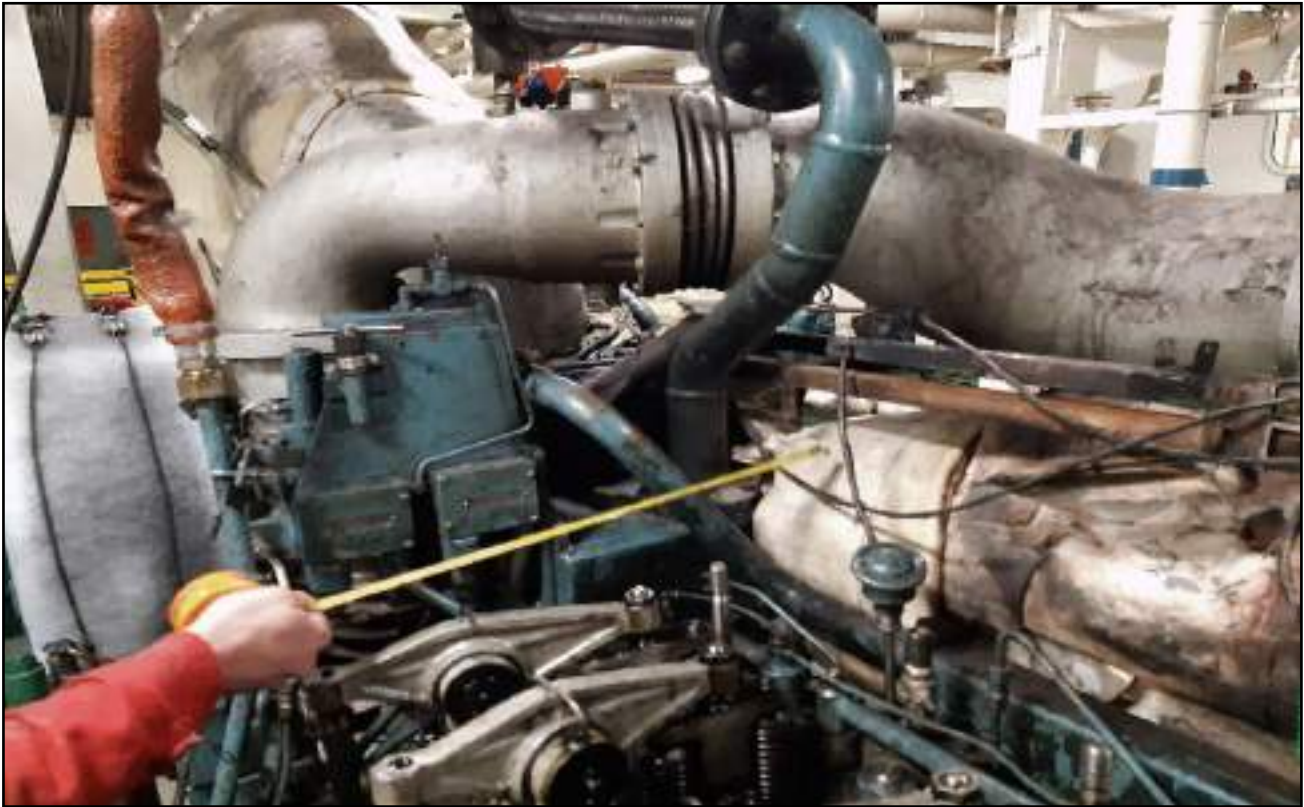
The company investigation later identified that during maintenance work on the main engine cooling system a pipe had been removed to allow a leak to be repaired by replacing a seal. This was not a planned task, and no risk assessment or method statement had been produced. When the pipe was removed, around 5 litres of water had drained from the top of the crank case breather box, and some oil residue inadvertently washed into the lagging. Main engine runs conducted alongside after the repair had not produced sufficient heat to ignite the oils. However, when the main engine was run under load at sea, the increased temperature produced was enough to cause a fire.

Figure: Location of lagging that ignited indicated

1. Whenever maintenance work is carried out around or near potential sources of heat, a risk assessment must be conducted to ensure unexpected results are considered. The working and adjacent areas should be protected from contamination – even if you expect only water to be present. If water can wash oils into places that can then become hot when machinery is running, a source of ignition can be created. In this case the crew were alert and the fire was small. This may not always be the case.
2. Even after AFFF is used, sufficient heat will cause flammable material to reignite once it gets hot enough. The crew involved in this incident were monitoring the site carefully and quickly extinguished the second fire. However, the only real solution would have been to remove the flammable material from the source of heat, which was subsequently done by removing and replacing the lagging.

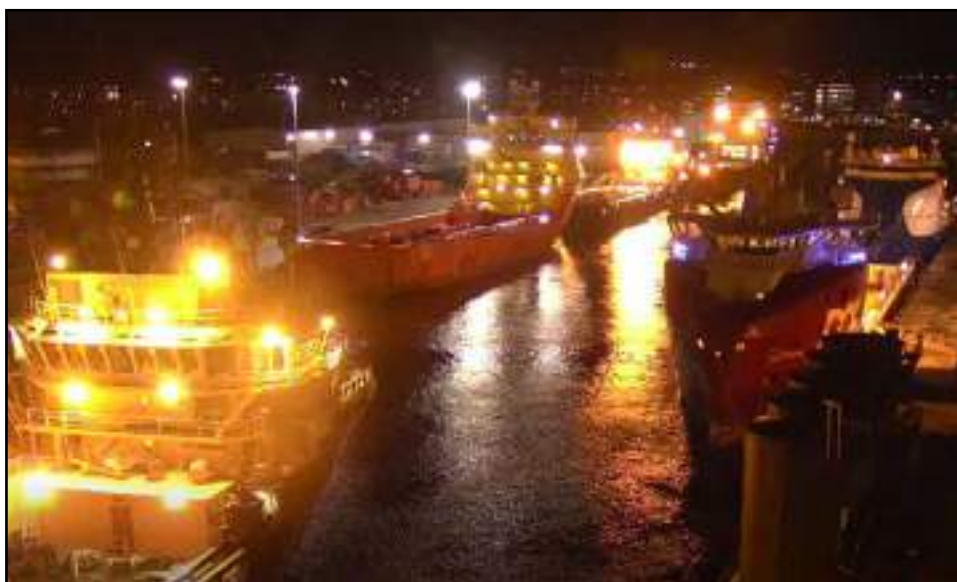
Figure 1: The support vessel approaching the berth (port side alongside)

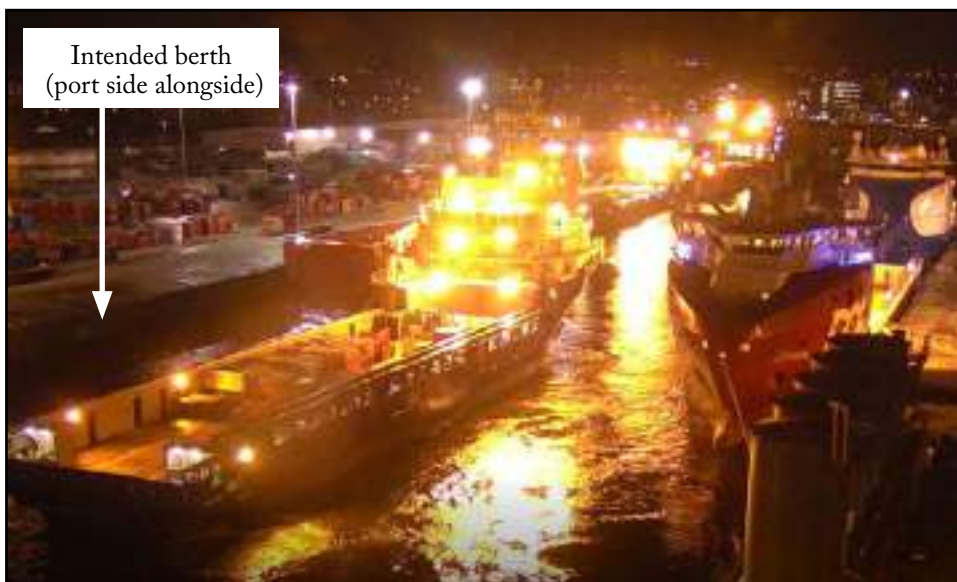
Figure 2: The support vessel overshoots the berth

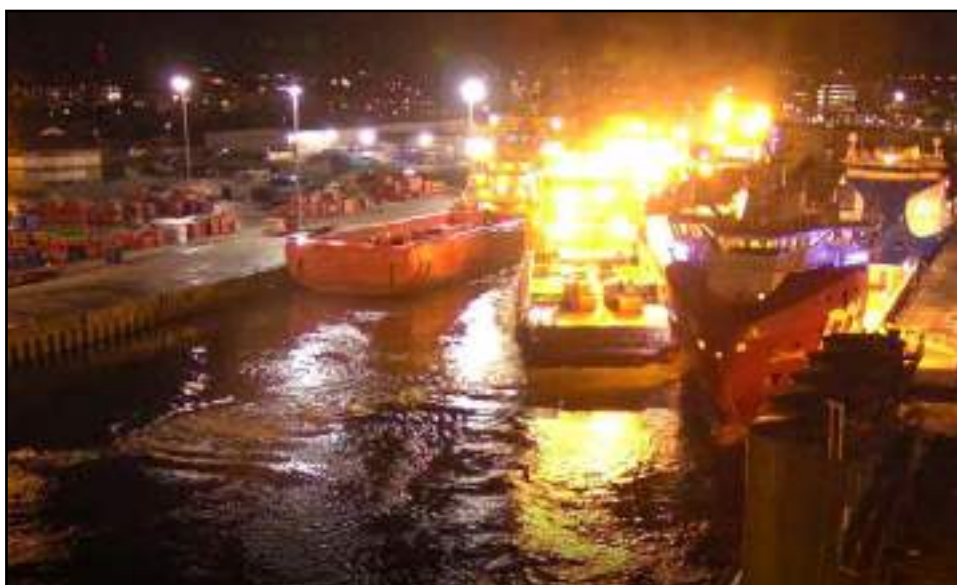
Figure 3: Loss of control and sheer to port, with contact made with berthed vessels

1. Pilotage and ship-handing in harbour requires the highest standards of planning and execution. This manoeuvre had been conducted before by the crew and pilot, who were all familiar with the vessel and the harbour. However, the situation deteriorated rapidly when control of the vessel was lost during transfer of conning positions. This changeover occurred at a

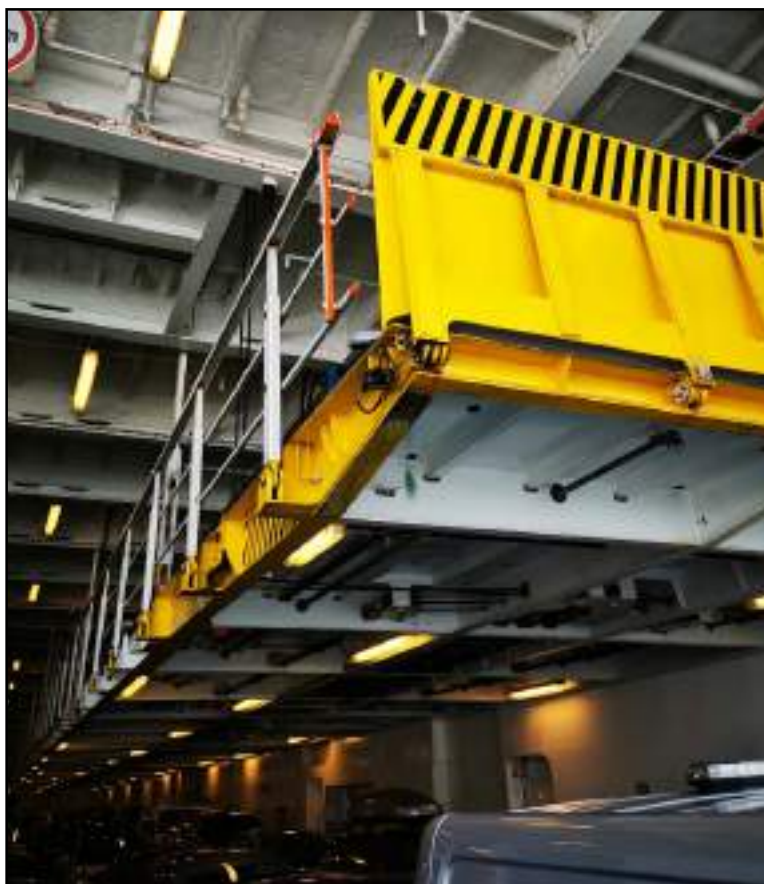
Figure 1: The loaded mezzanine decks in the raised position with the vehicle ramps in the vertical (safe) configuration

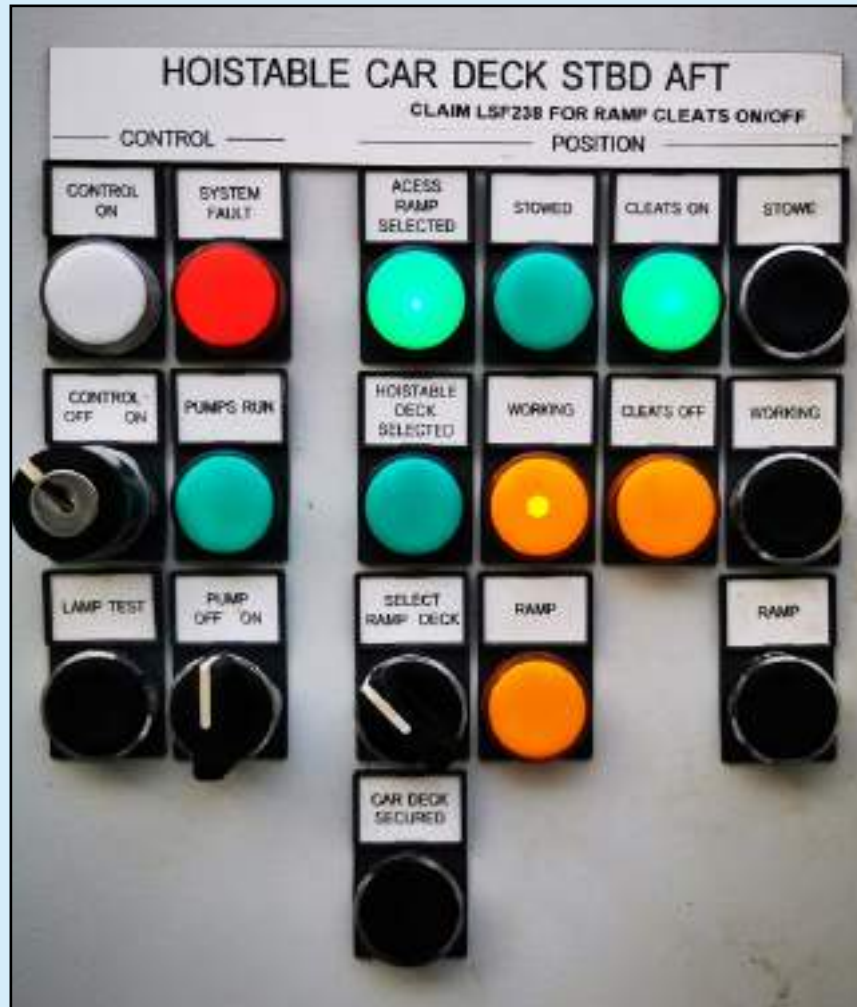
Figure 2: The hoistable car deck control panel

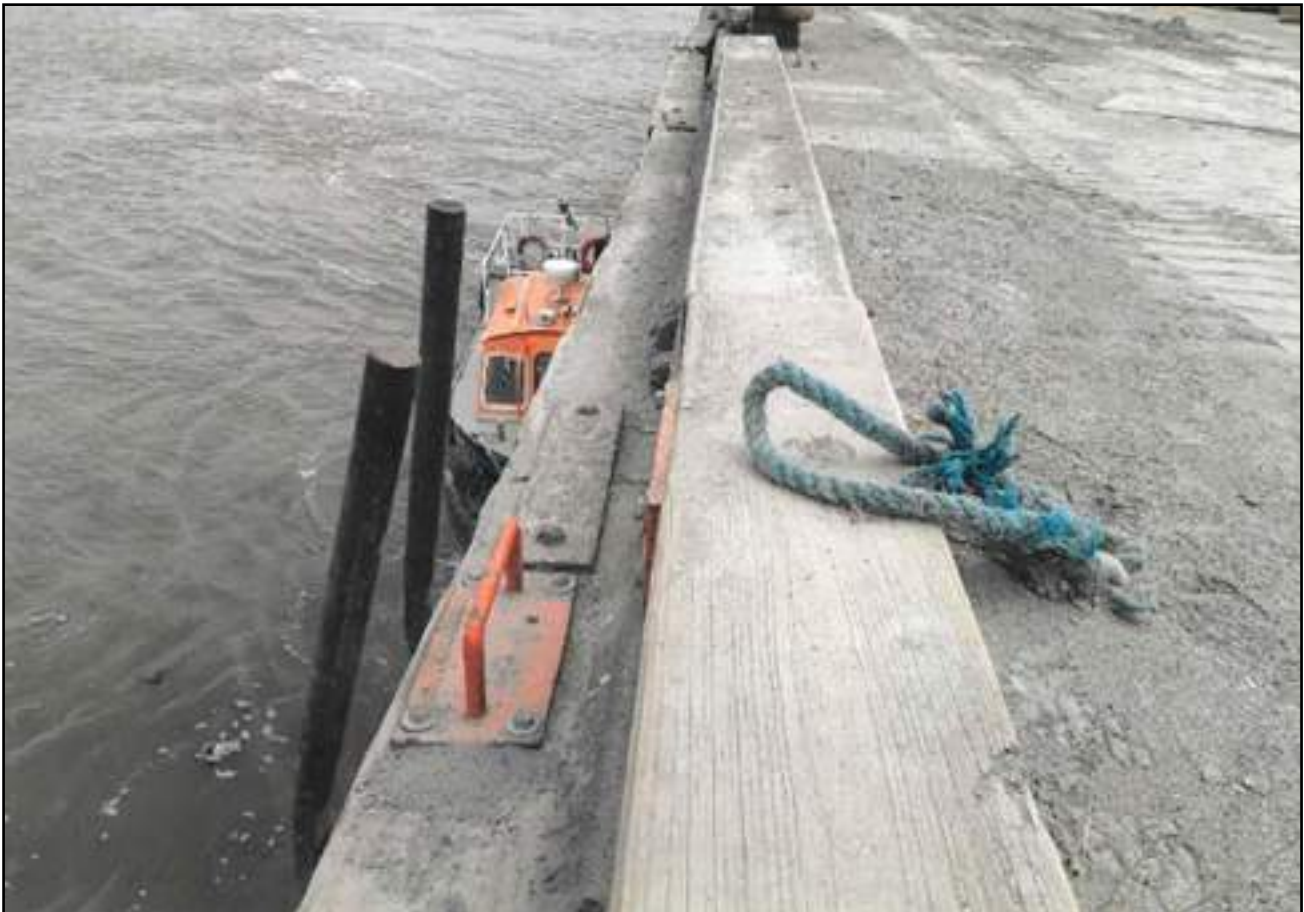
Figure 3: Quayside showing ladder and loose aggregate

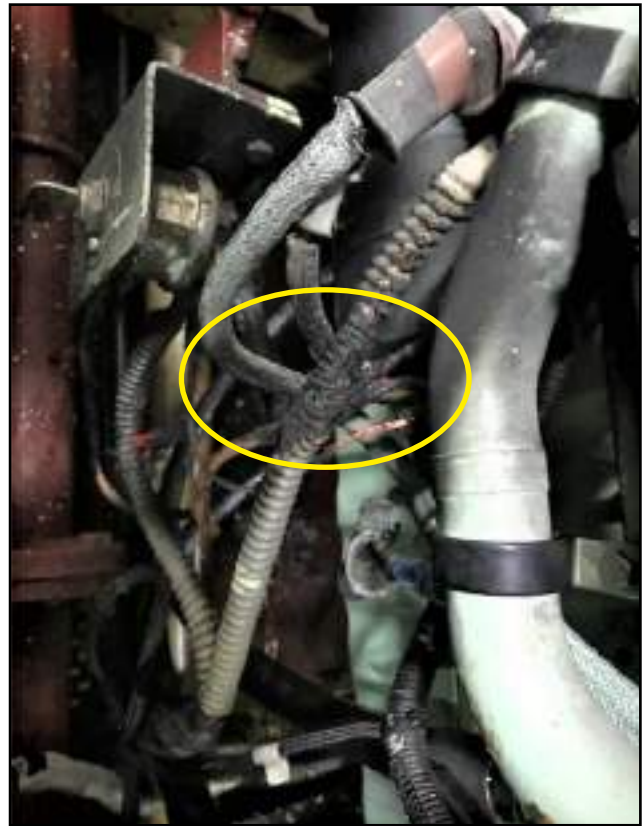
A subsequent examination of the heat damaged starter motor and cabling (see figure) identified that the electrical wiring had been incorrectly connected. On that particular engine model, some of the positive side cabling was coloured black instead of the

Figure: Heat damaged electrical cabling

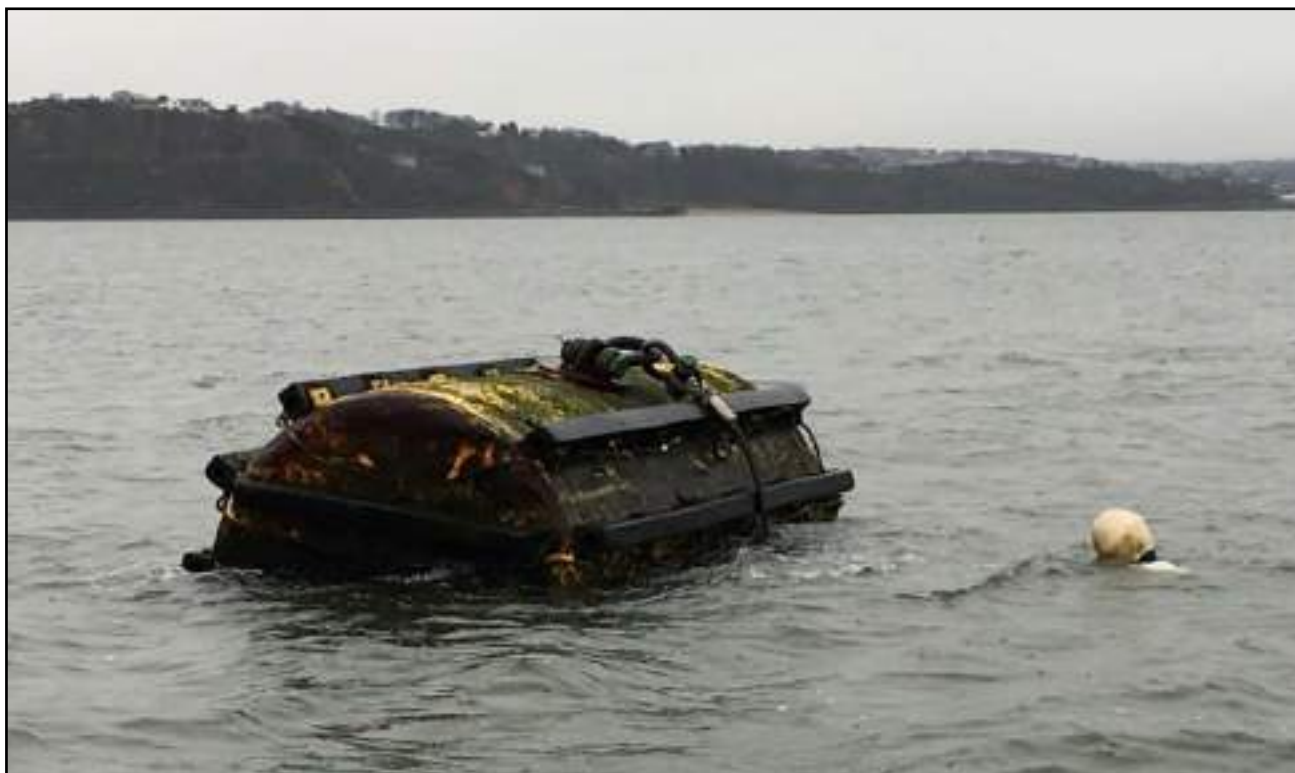
As the crew member finished rigging the searchlight, and the second crew member bent over to turn on the radar, the craft hit an unlit mooring buoy covered with heavy marine growth (Figure 1). The impact caused the bow to lift and roll to port, and the outboard engine skegs became caught on mooring pick-up lines attached to the buoy. The boat stopped instantly, propelling the forward crew member out of the boat and resulting in the crew member who was turning on the radar hitting his head on the handrail in front of him, causing a cut above his left eye.

Figure 1: Unlit mooring buoy, with significant marine growth

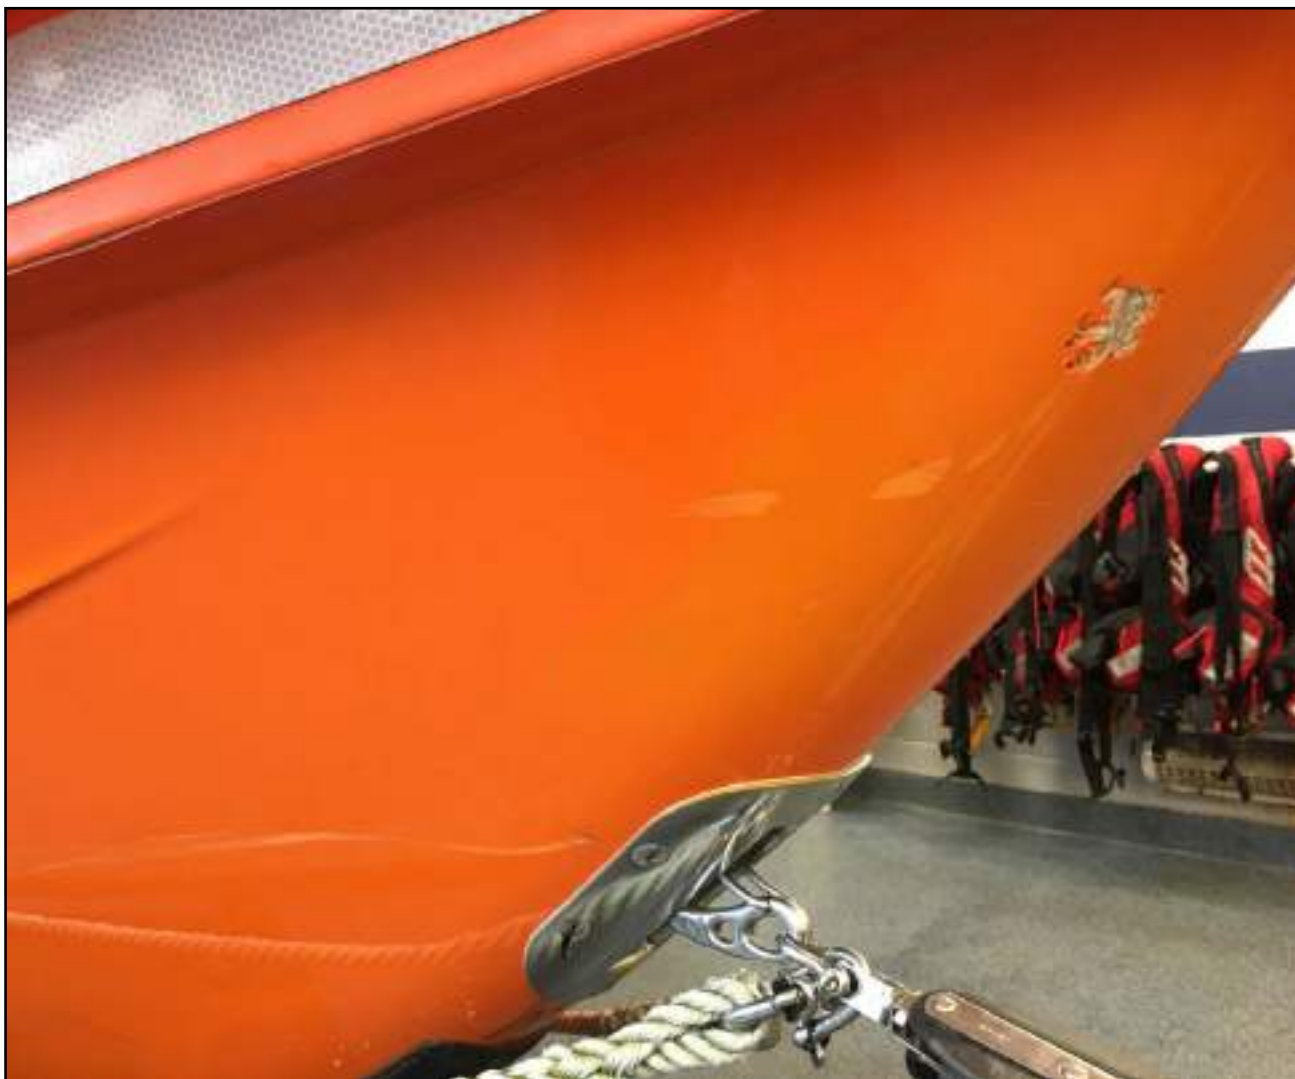
The craft returned to base and no serious injuries had been sustained. The boat was taken out of service for assessment, and after repairs to minor gelcoat damage (Figure 2) was returned to service.

Figure 2: Damage to gelcoat

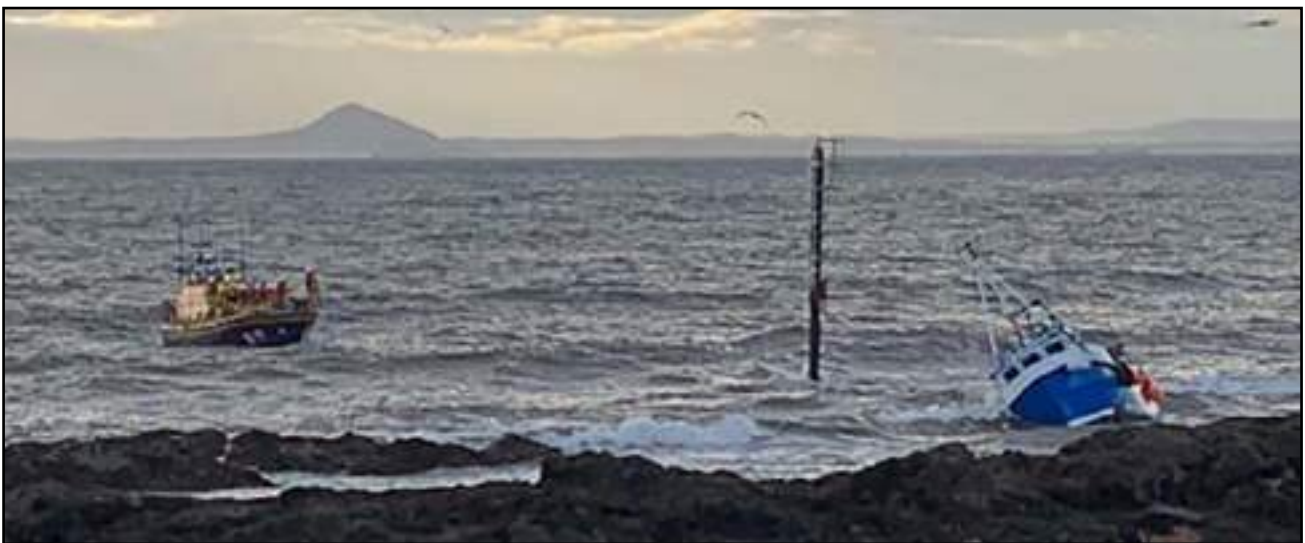
The fishing vessel's propeller was almost certainly fouled by a line from an unmarked creel fleet that had been laid close to the harbour entrance. The propeller wound this in tightly, jamming the shaft and stopping the engine. With no way of quickly clearing the fouled propeller, and poor holding ground for an anchor, there was little more the skipper could do.

Figure 1: Fishing vessel aground on rocks
