# **SAFETY DIGEST**

**Lessons from Marine  
Accident Reports  
1/2021**

**SAFETY DIGEST**  
**Lessons from Marine Accident Reports**  
**No 1/2021**

April 2021

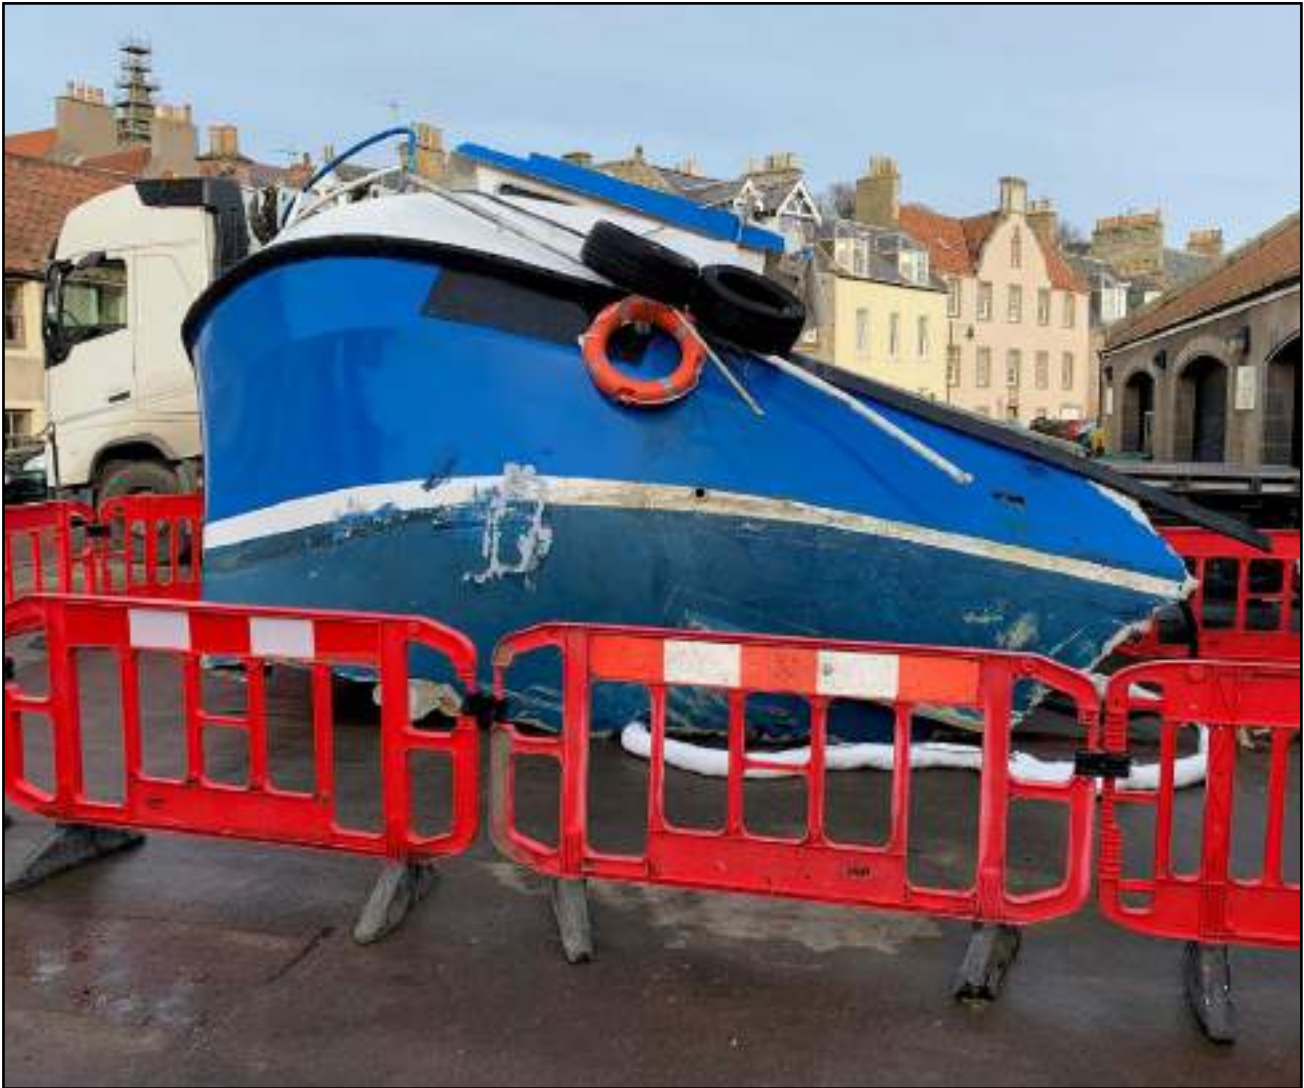
Figure 2: Bow section ashore

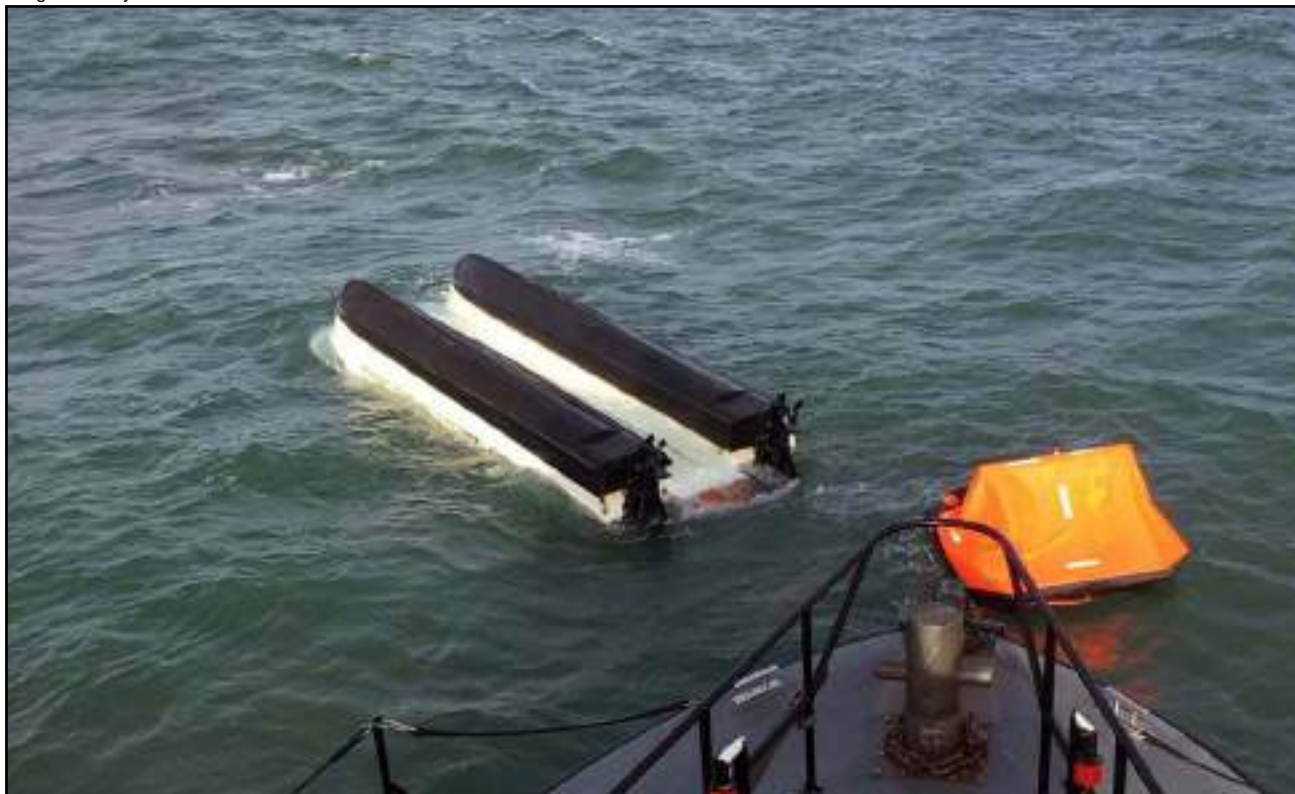
Figure 3: The catamaran fishing vessel capsized and the inflated liferaft

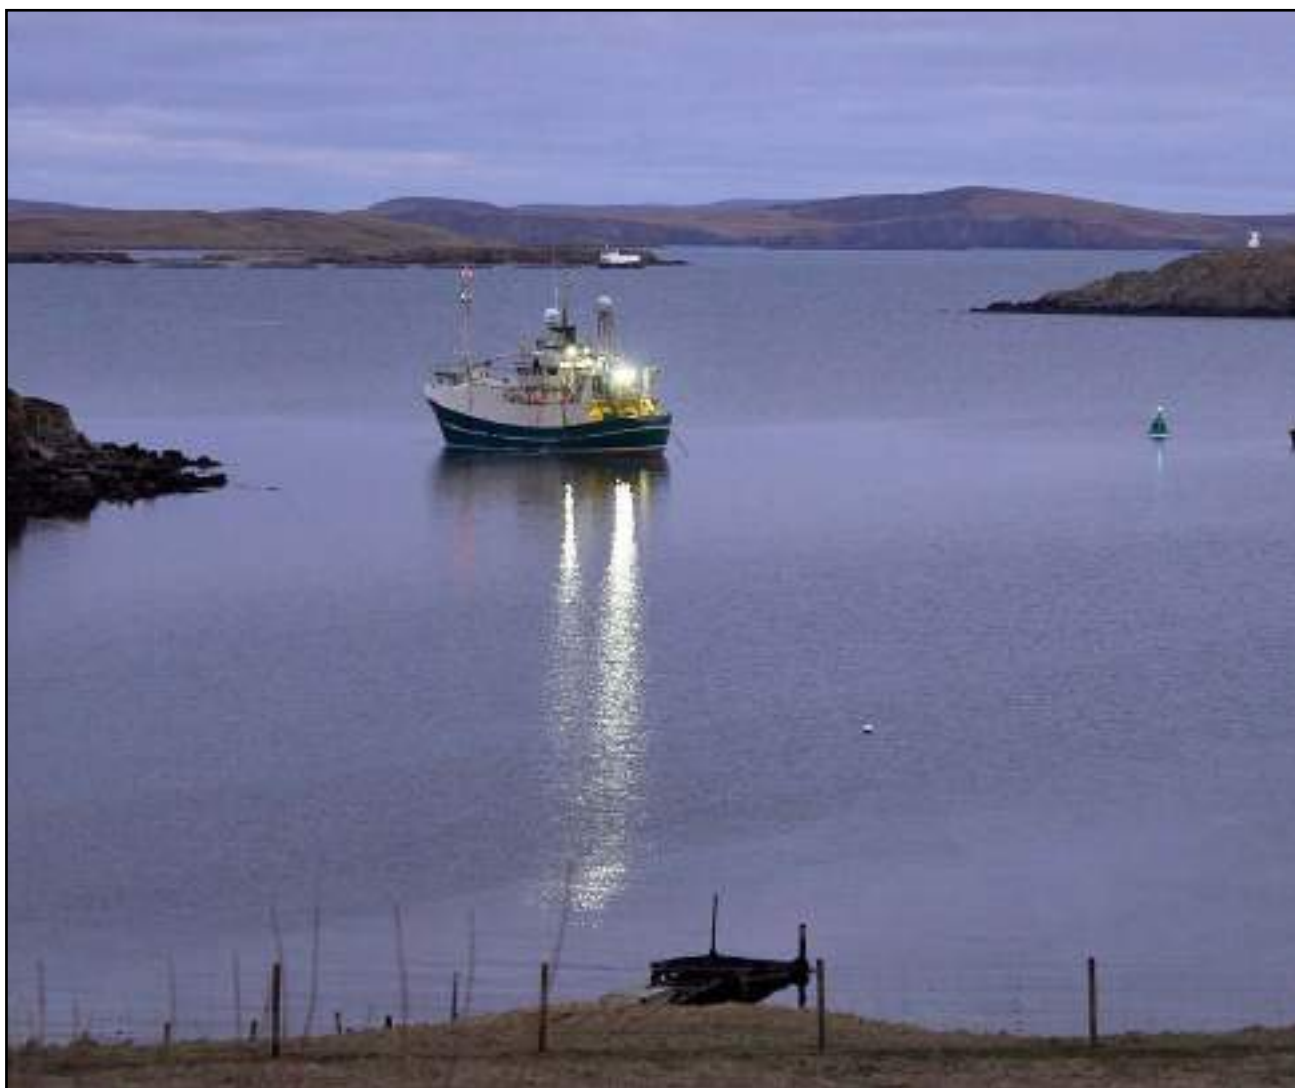
Figure 2: Vessel aground

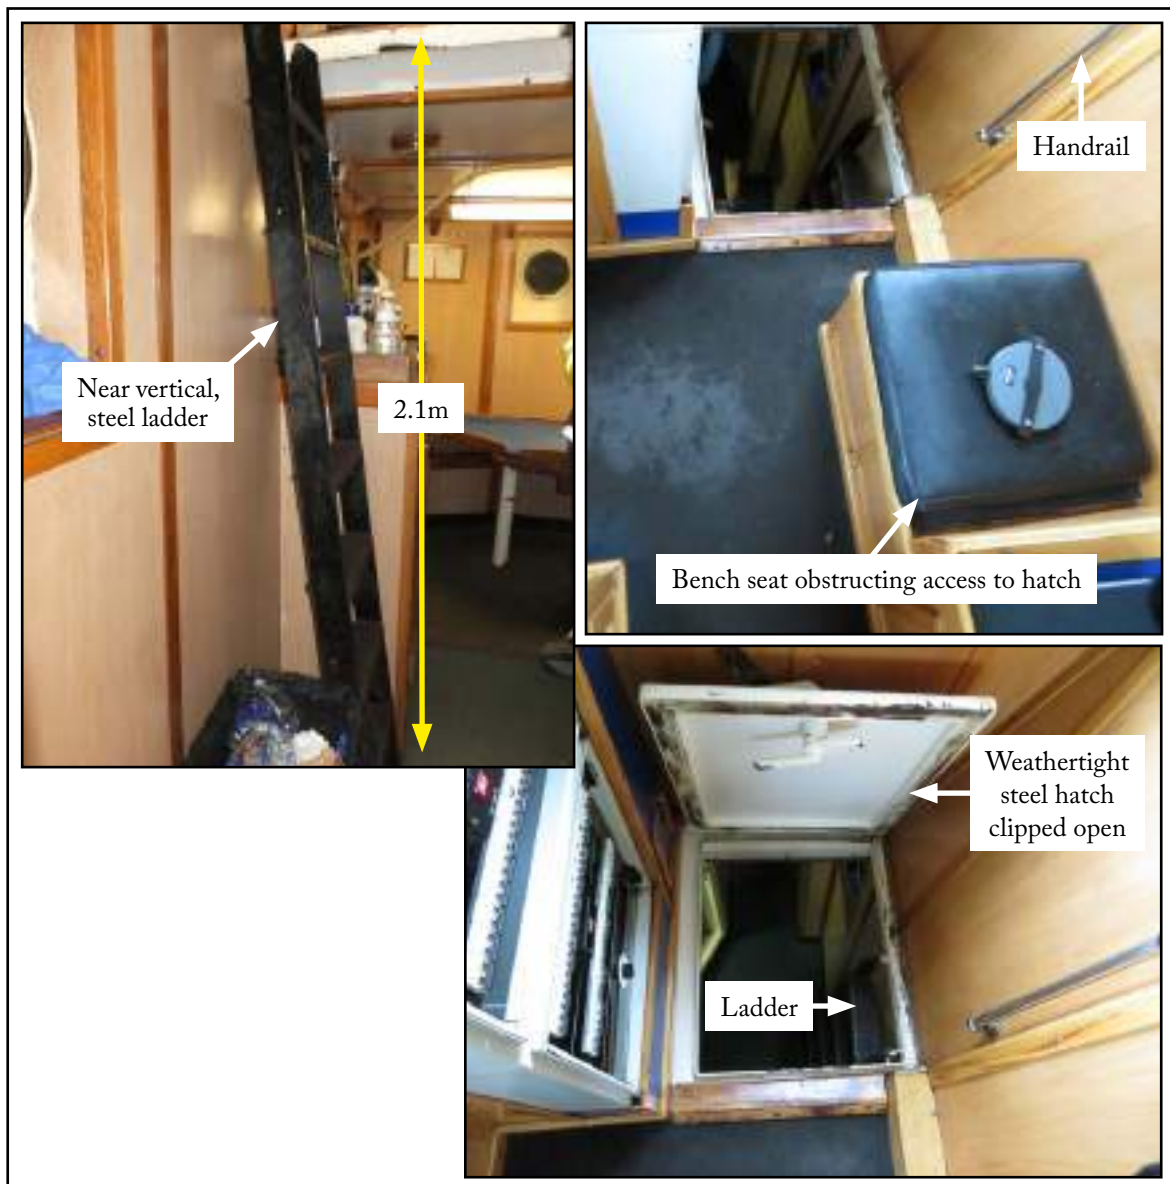
Figure: Access via the wheelhouse hatch

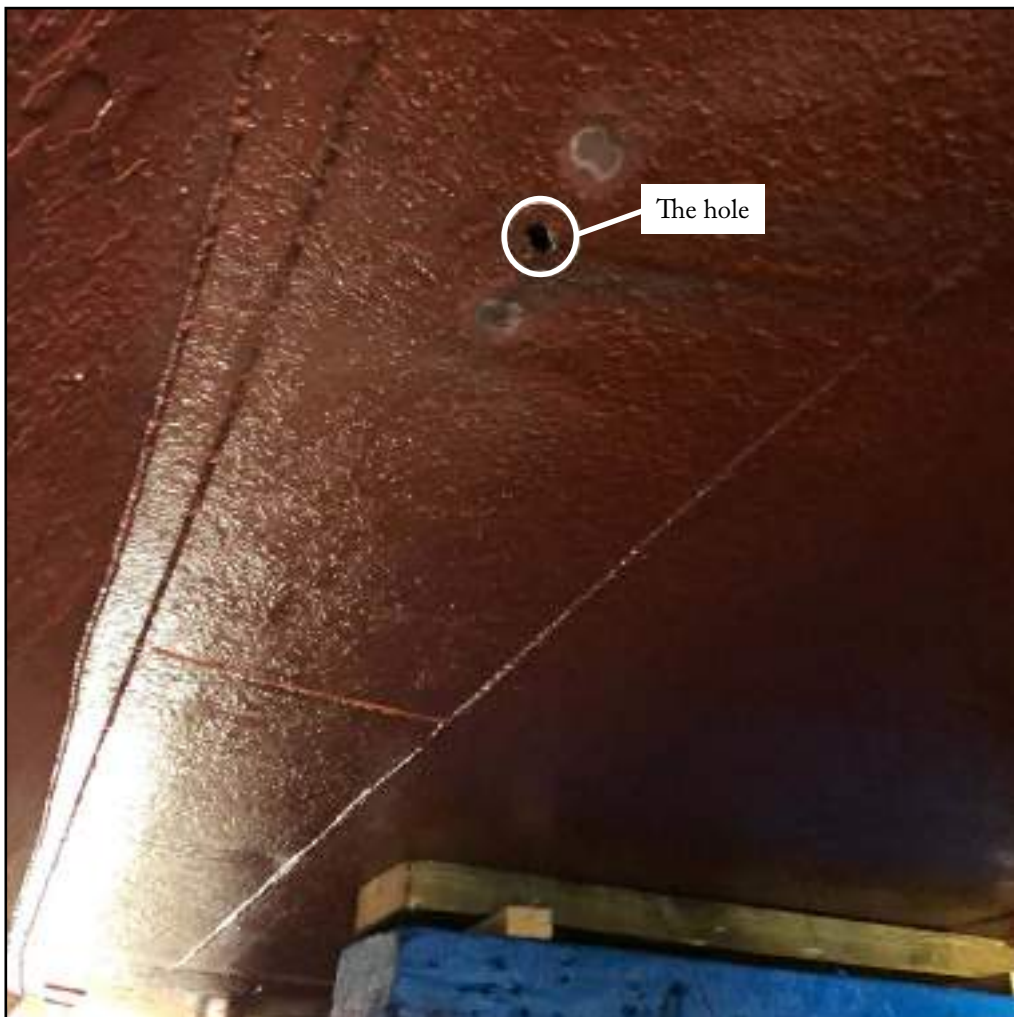
When the helicopter arrived, it lowered its powerful, petrol-driven salvage pump. Once this pump was set up and running, the situation was brought under control. As the water level reduced, the engineer was able to gain access to the fish hold's bilge well where the suctions were blocked by debris. The fishing boat then made its way safely back to harbour under its own power, escorted by the lifeboat. When the fishing boat was lifted out of the water, a 25mm diameter hole was found in the shell plating under the fish hold (see figure).

Figure: The 25mm hole in the fishing vessel's shell plating, observed when the vessel was lifted out of the water.

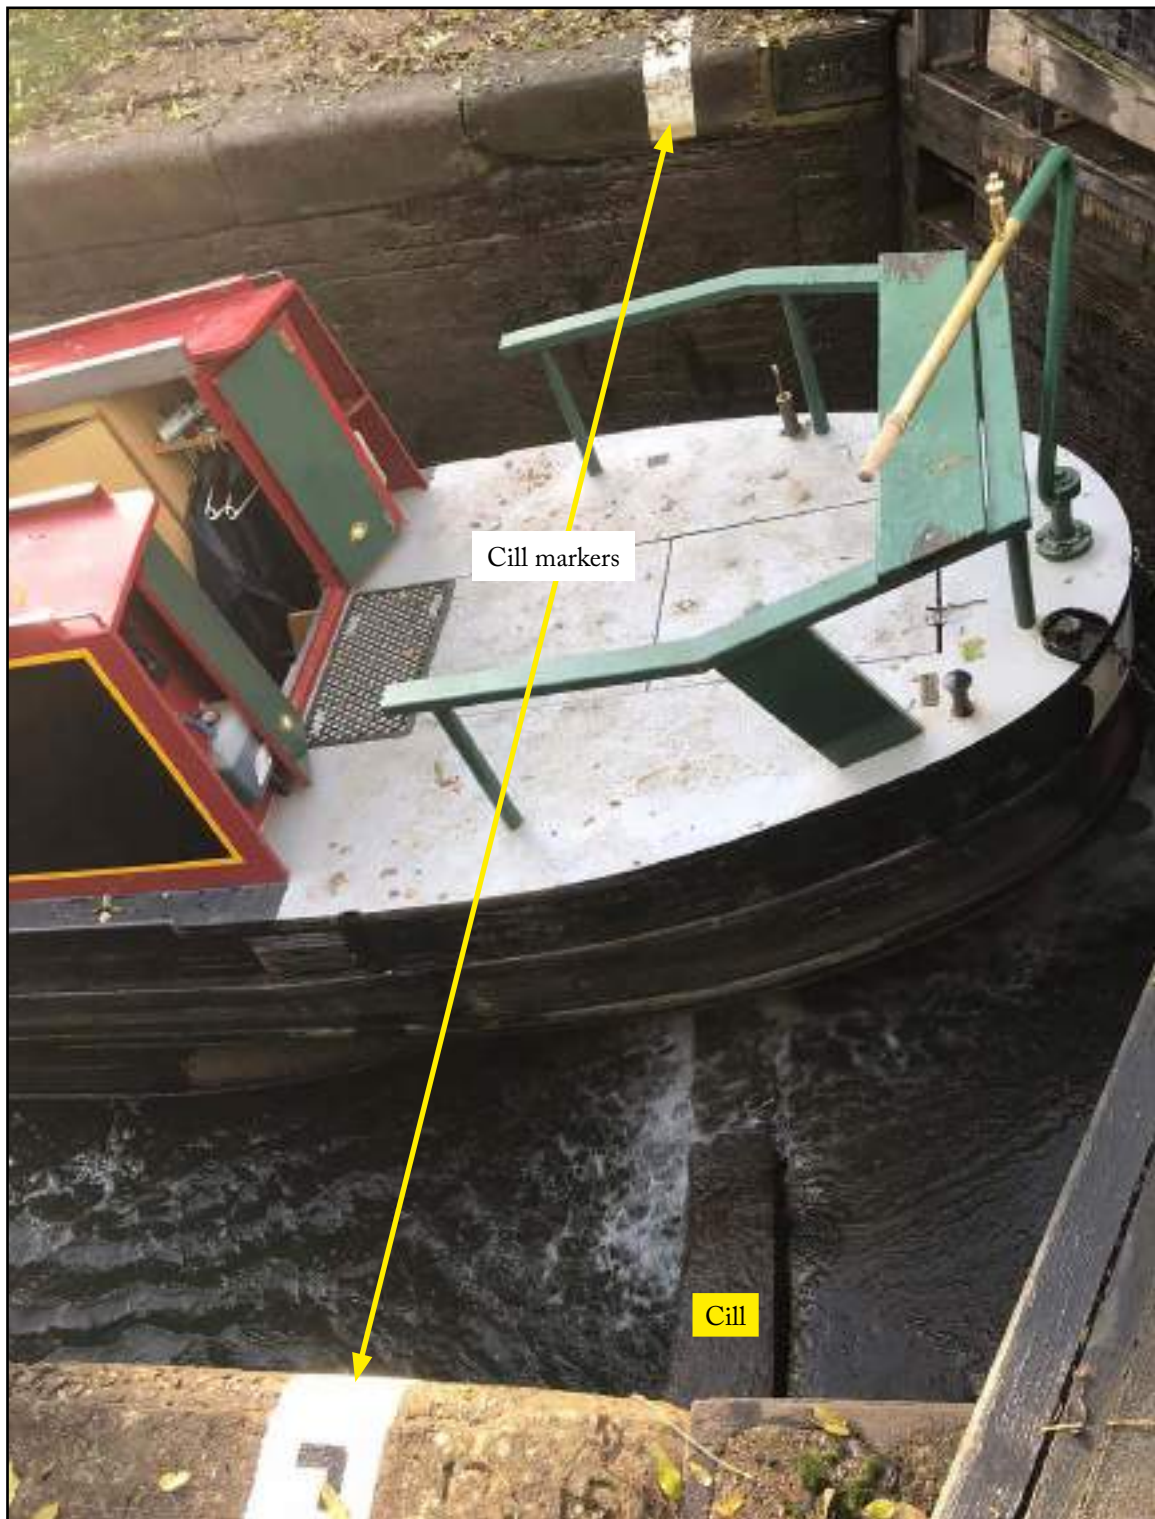
Figure 2: Hire boat's stern resting on the cill

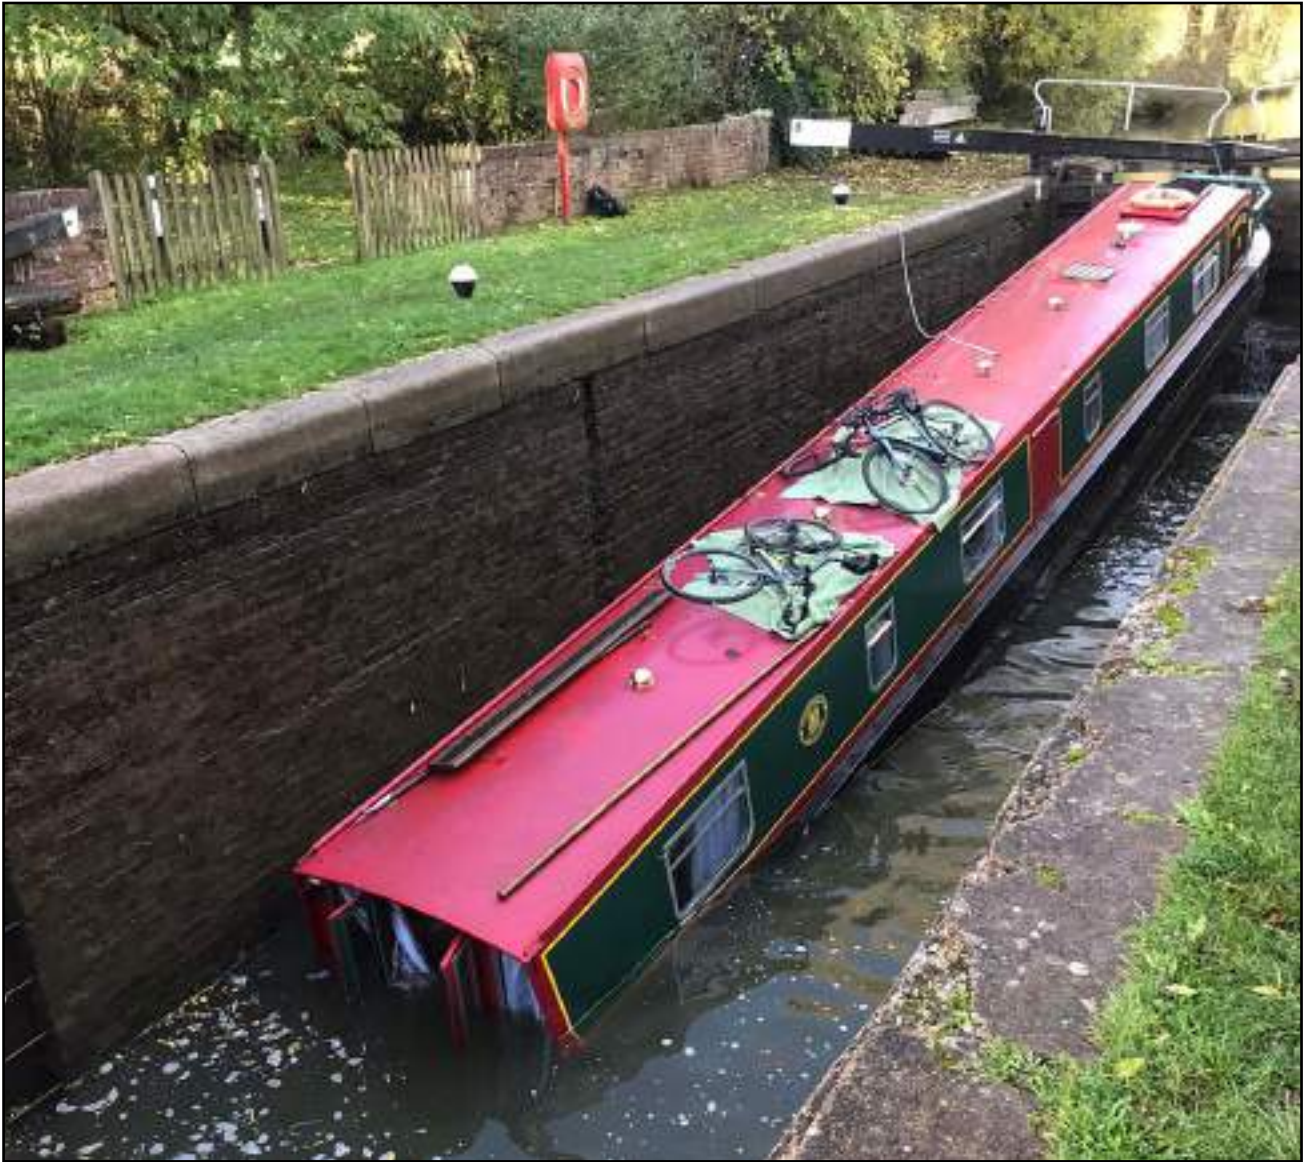
Figure 3: Hire boat's bow fully immersed

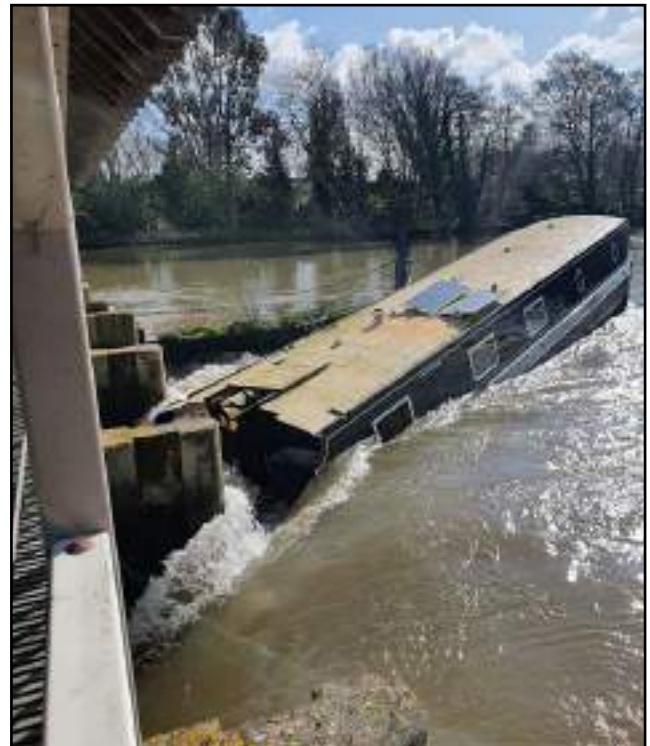
Figure 1: Narrowboat partially sunk on weir

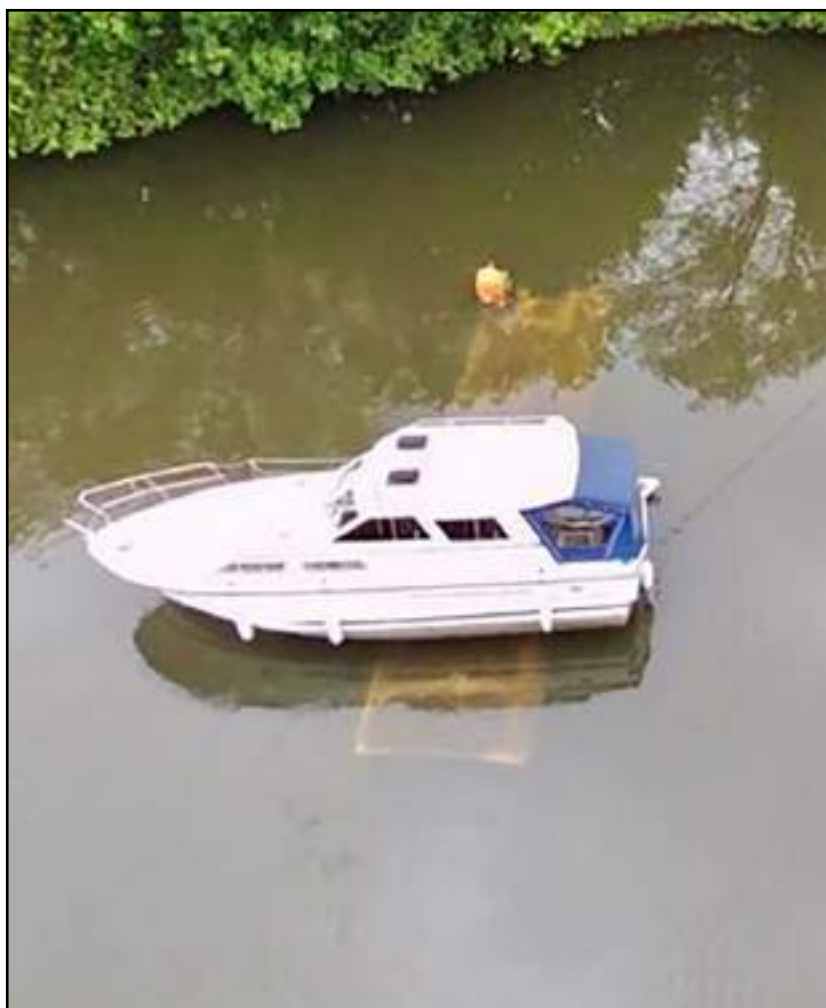
Figure 2: Motor cruiser grounded on submerged wreck
