SAFETY INVESTIGATION REPORT

REPORT NO.: 13/2021

May 2021

MV APL CALIFORNIA **Serious injury to a crew member** **while letting go the towline** **at the port of Ningbo, China** **14 May 2020**

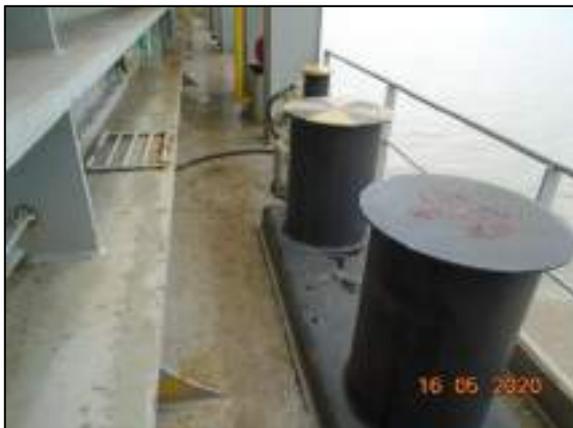
The vessel was fitted with mooring equipment at its forward upper deck area, on her port and starboard sides. The equipment was installed abreast of Bay 15 and consisted of two mooring bitts and an air-driven capstan (Figure 1). The capstan had a rated load of 0.4 mt and a speed of 34 m min⁻¹.

Figure 1: Mooring bitts where the tug's line was made fast for departure

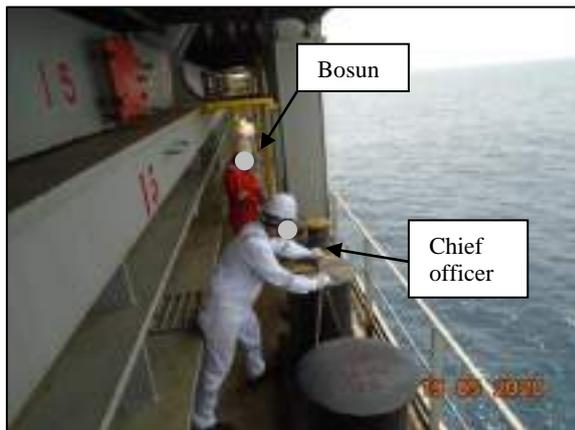
ordered the forward party to cast off the forward tug's line. Upon arriving near Bay 15, the bosun cleared the pick-up gear of the tug's line and made turns of it around the nearby capstan, to release the tug's line from the vessel's mooring bitts. Once tension was taken on the capstan, the chief officer cleared the tug line's eye from the mooring bitts (Figure 2).

Figure 2: A photo simulation of the bosun holding on to the pick-up gear and the chief officer clearing the eye of the tug's line from the mooring bitts

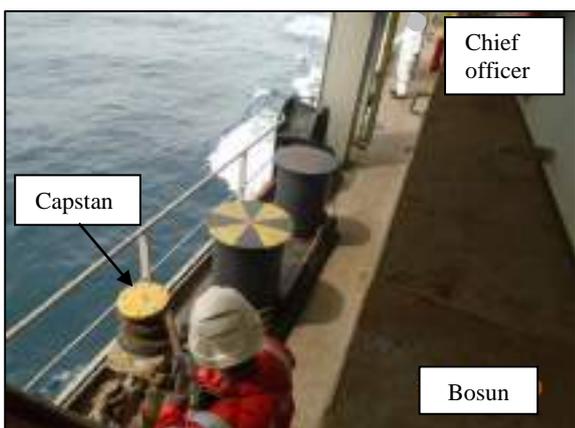
The bosun then started to control the lowering of the tug's line by easing the tension on the pick-up gear (Figure 3). At this stage, the chief officer moved further aft to keep clear of the moving line.

Figure 3: A photo simulation indicating the bosun and chief officer's positions while the tug's line was being lowered

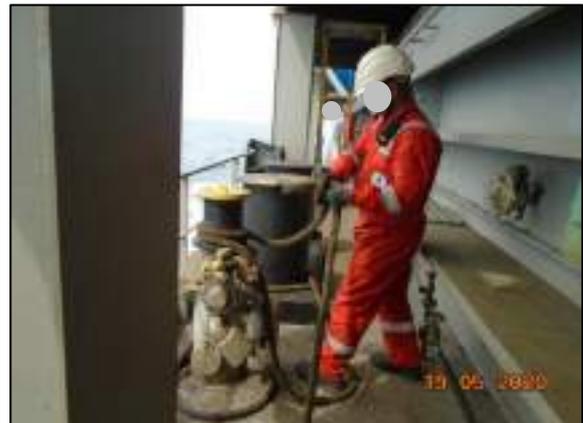
At 2118, the eye of the tug's line reached the waterline, and the chief officer reported to the bridge that the forward tug was cast off. At this time, while the pick-up gear was still moving under tension, the bosun noticed that the vessel's messenger line was still attached to the pick-up gear by a knot. While he attempted to disconnect these ropes⁶ (Figure 4), his left leg was caught between the pick-up gear and the mooring bitts (Figure 5).

Figure 4: A photo simulation of the bosun attempting to disconnect the messenger line and the pick-up gear

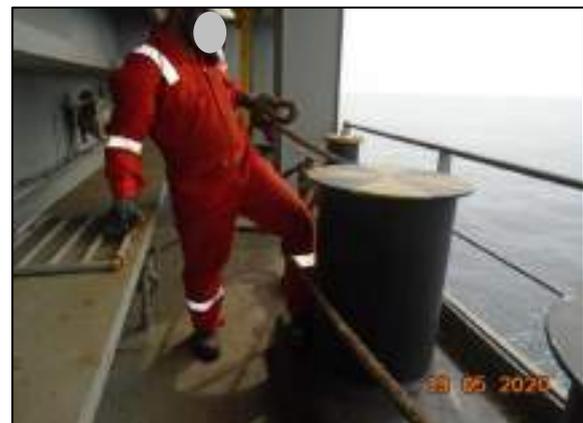
Figure 5: A photo simulation of the bosun's left leg getting caught in between the pick-up gear and the mooring bitts

While the tug's line was being retrieved by the tug during the casting off operation, the bosun realised that the vessel's messenger line and the tug's pick-up gear were still attached. During an attempt to undo the knot connecting these lines, his left leg was caught by the running line. Consequently, his leg was pressed against the mooring bitts, leading to serious injuries.

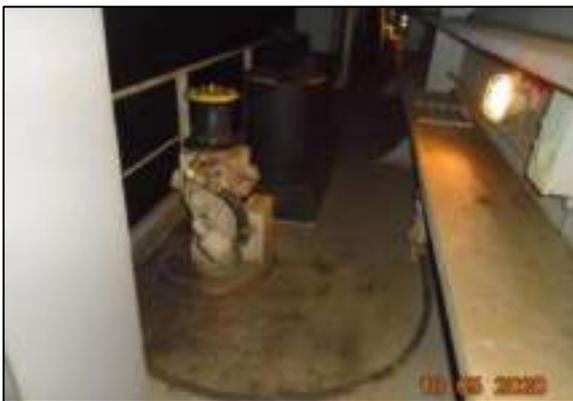
Additionally, since the operation was being carried out during night-time, the crew had to rely on the fixed illumination fitted on deck, which emitted a yellow light (Figure 6).

Figure 6: Accident site illuminated at night-time

The fixed light's position was well intended to illuminate the work site. However, its position could have also contributed to shadows being cast in the area, while crew members handled the ropes. The shadows may have been the cause of the bosun's initial oversight of the attached lines as well as of his foot position while he focused on releasing the vessel's messenger line.
