# Machinery failure on *HC Rubina* and subsequent contact with the wharf

Brisbane, Queensland | 29 October 2013

**ATSB Transport Safety Report**  
Marine Occurrence Investigation  
305-MO-2013-012  
Final – 14 November 2014

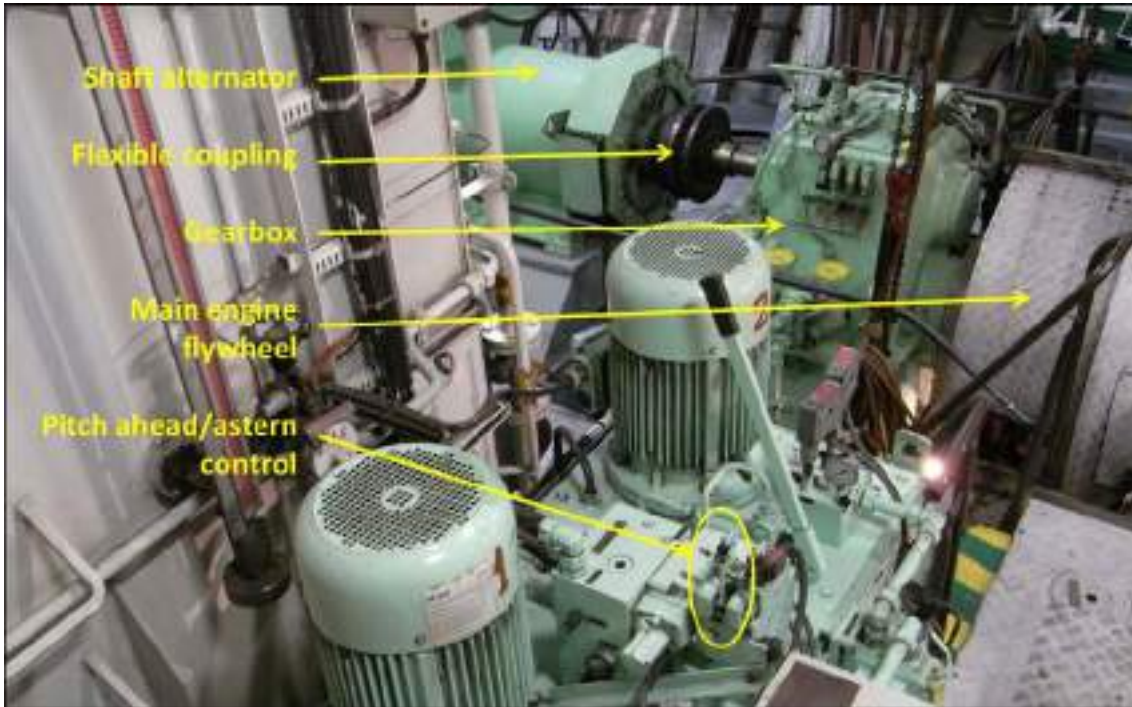
Figure 4: Photograph with the local control station and flexible coupling (guard removed)

At about 1958, the shaft alternator flexible coupling catastrophically failed. The aft end of the engine room quickly filled with smoke and power to the bow thruster was lost. The second engineer ran from the CPP local control station, which was about 3 m from the flexible coupling, to the forward end of the main engine to escape the smoke. The propeller pitch setting was left between 3 and 5 per cent ahead.

At the time of the incident, the pitch was being operated from the local control station (Figure 4) following a complete failure of the pitch control system. The pitch order was being relayed from the bridge via telephone to the second engineer, who was manually operating the ahead and astern pitch control hydraulic valves until the required pitch was achieved.

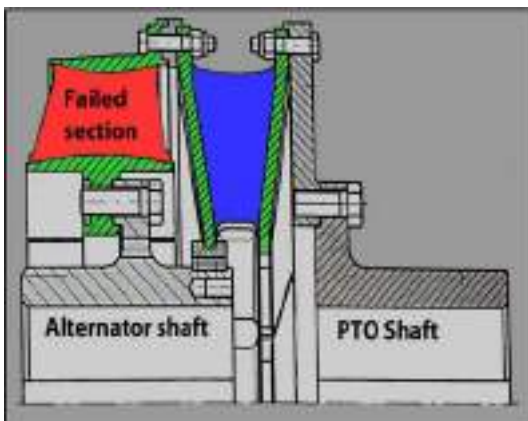
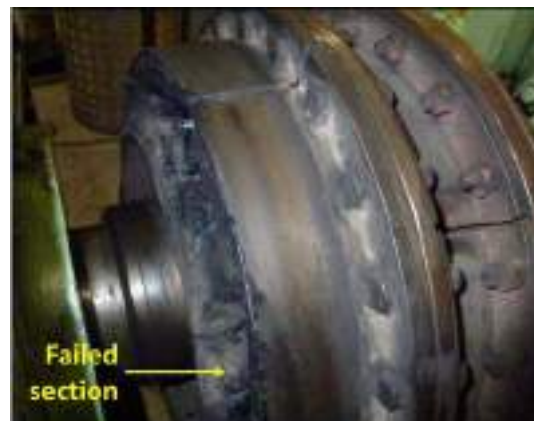
Figure 5: Shaft alternator flexible coupling

The coupling (Figure 5) transmitted the output power to the shaft alternator through an annulus rubber ring (red). The annulus ring was bonded to steel plates (green) and radial rubber segments (blue) which were also bonded to steel plates (green).

According to the manufacturer, the condition of the flexible coupling deteriorated as a result of loading and age. Therefore, they recommended it be replaced every 12 years.

At the time of this incident, *HC Rubina* was 14 years old and there were no available records to indicate that the coupling had ever been replaced. Further, no electronic job histories could be found for this task, or any task, prior to the middle of 2008. No other records were available relating to the maintenance of the coupling. Therefore, the ATSB concluded that the coupling was probably the original installed item and had exceeded its prescribed service life, being 14 years old.

While the nature of the damage sustained prevented the ATSB from specifically identifying the coupling failure mechanism, it was likely that the failure arose because it had deteriorated through age, to a point where it was no longer capable of carrying its rated load.

The Australian Transport Safety Bureau recommends that IMM Shipping takes action to address the lack of instructions in the planned maintenance systems of its managed ships, to ensure that ship equipment is maintained in accordance with manufacturers' requirements.
