Report on the investigation of the  
failure of the controllable pitch propeller of the cargo ship

***Saffier***

resulting in heavy contact with a berthed tug

25 June 2011

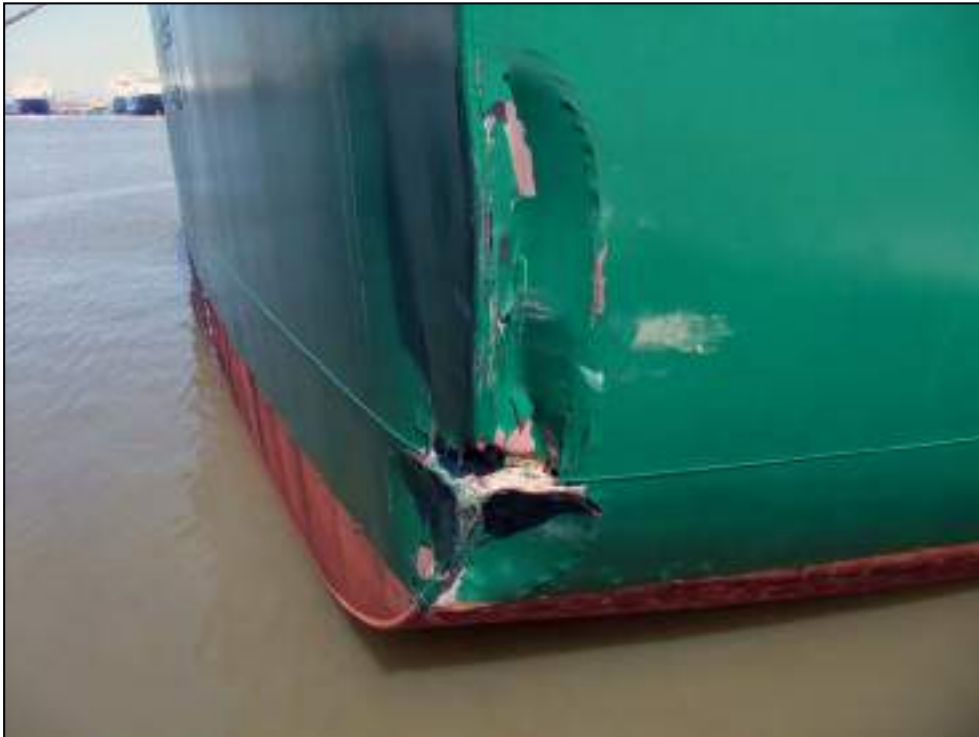
**Figure 2:** Damage to *Saffier*

The area around *Saffier*'s starboard quarter was split approximately 1m above the waterline. The damage penetrated into the workshop area and the afterpeak ballast tank (**Figure 2**). The tug *Svitzer Ferriby* suffered minor damage to its fender ring and a bracket holding the fender ring to the hull was distorted (**Figure 3**).

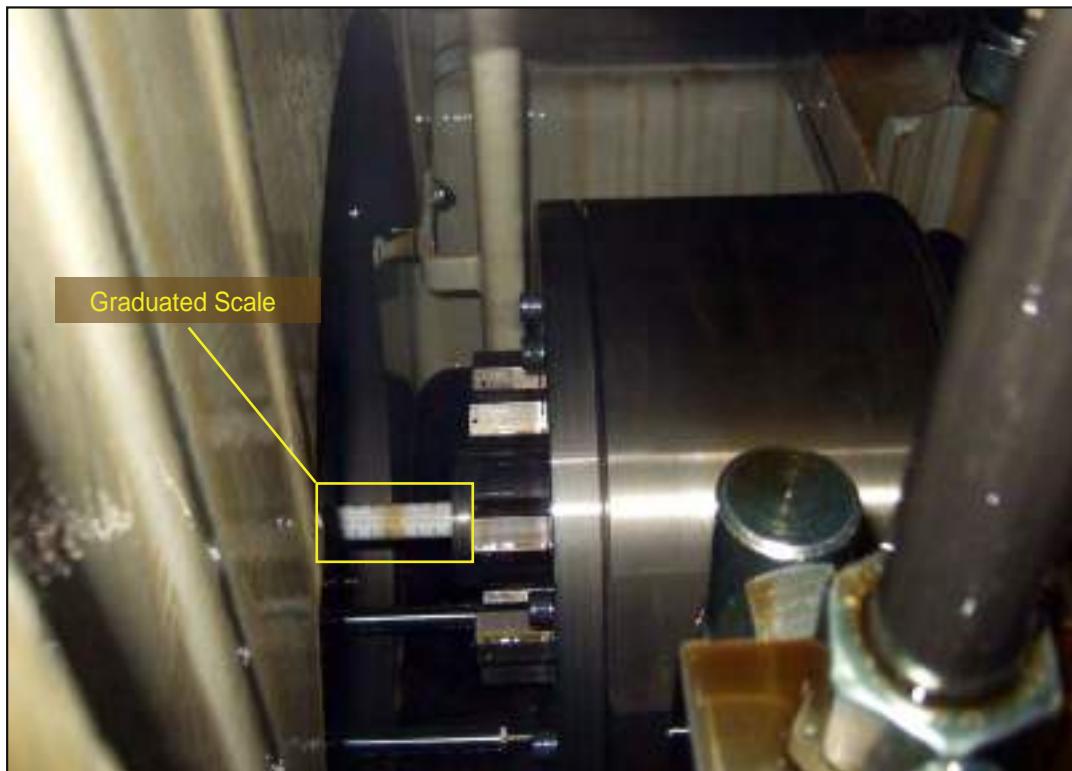
**Figure 4:** Graduated scale indicated CPP servo travel

The physical travel of the propeller blade servo actuating mechanism could be measured on a graduated scale which was accessed by opening an inspection window on the gearcase. The nominal position on the graduated scale for full ahead pitch was 52mm aft of the zero position and the position for full astern pitch was 40mm forward of zero position (**Figure 4**).

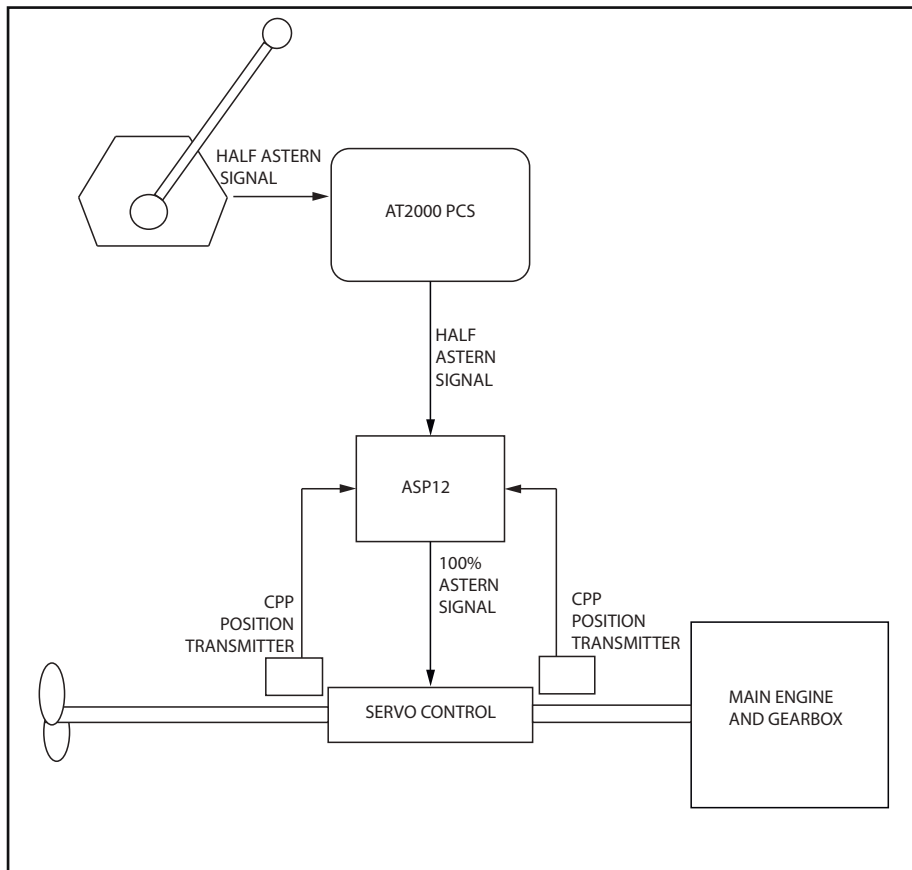
**Figure 11:** Half astern demand translated to full astern by AT2000 PCS

This resulted in the AT2000 PCS calibrating itself incorrectly, causing the propeller pitch to reach the designed 'full astern' position prematurely, when the pitch lever was in the 'half astern' position. When the setting of potentiometer P4 was reduced, both the ahead and astern pitch responses were found to be correct.

It was conclusively demonstrated from the tests conducted on the simulator at MAN's Frederikshavn facility that the mismatch between astern pitch demand and response was caused by the incorrect adjustment of potentiometer P4, representing the astern pitch feedback. While the ahead pitch feedback adjustment was set in a methodical way in order to load the engine correctly, there was no opportunity to adjust the astern pitch feedback as the propeller pitch response was not verified in the full astern position. Unfortunately, the service engineers' approximate setting of potentiometer P4 resulted in a feedback current of 9.75mA, which equated to an astern pitch of 155%.

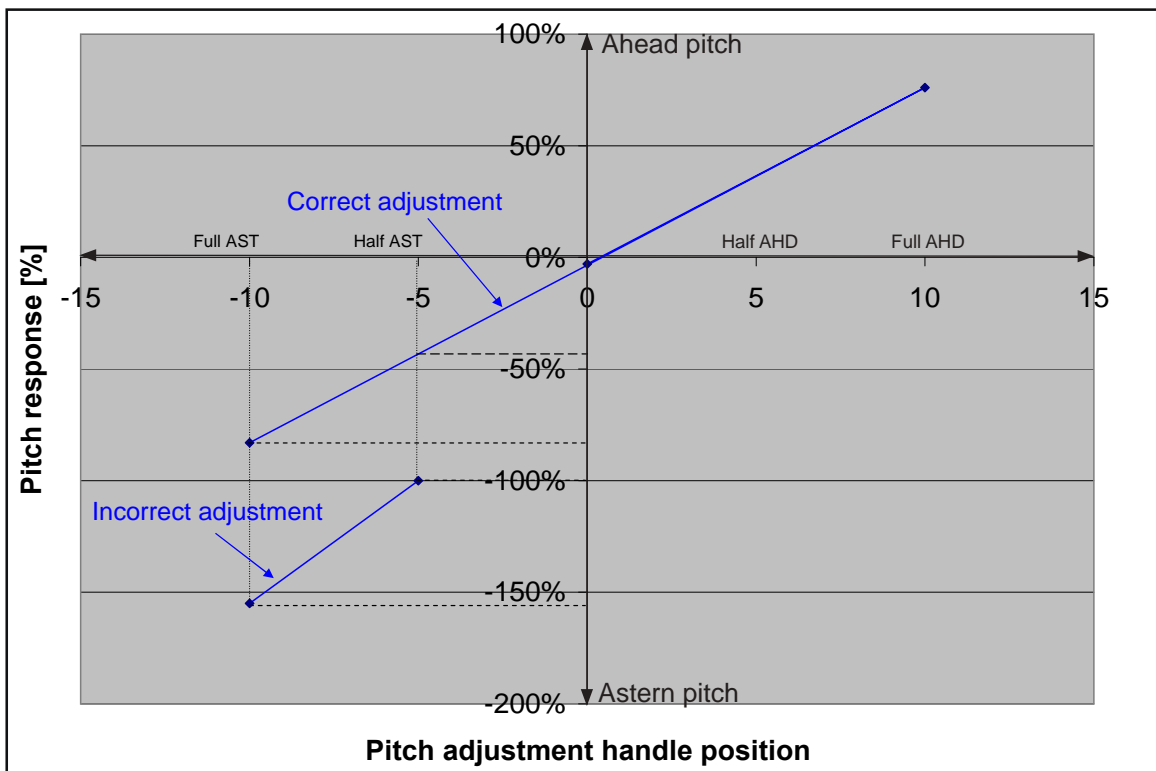
**Figure 12:** CPP behaviour with correct and incorrect adjustments demonstrating how the pitch supplied could significantly exceed pitch demanded due to incorrect adjustment

6. A mismatch between the amount of astern pitch demand and response was caused by the incorrect adjustment of potentiometer P4 in the ASP12 unit. This resulted in the incorrect calibration of the control system with the net effect that, when 100% astern pitch was demanded, the propeller blades were driven to 155% astern. [2.4.1]
