Annual Digest
Reports and Insight Articles

2020

Annual Digest of Reports and Insight Articles 2020

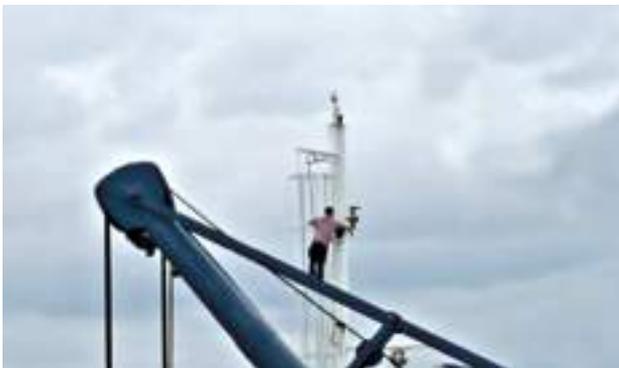
Working aloft with no safety harness or PPE

After identifying the ISM managers, CHIRP emailed the DPA who engaged immediately, allowing CHIRP to pass over details of the report. The following day the DPA contacted CHIRP with the information that the photographs in the report did indeed show a member of the ship's crew. The DPA said this was very disappointing as the actions shown were completely contrary to the vessel's SMS. Furthermore, earlier in the month the DPA had sent out a fleet-wide safety bulletin emphasising the need to complete risk assessments and permits to work for all hazardous activities.

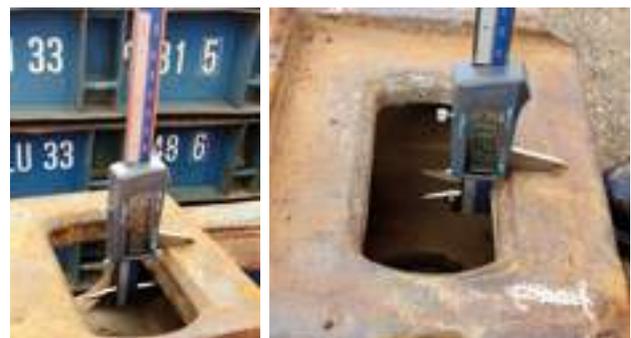
Inspection of the flat involved showed that the top plate thickness of the lifting socket of this type of unit is (at approximately 20mm) some 8mm thinner than the standard fittings on other more modern flats and the industry standard (approx. 28mm). Given that the top of the plate is chamfered, only a parallel plate thickness of 8-10mm is available for the tab to connect with. This increases the risk of the tab on the lug moving enough to enable the lug to twist and disconnect especially if there was a twist in the strop. The light rain at the time may also have lubricated the surfaces.

At ≈20mm the top plate thickness was 8mm thinner than more modern "flats" and the current industry standard, ≈28mm

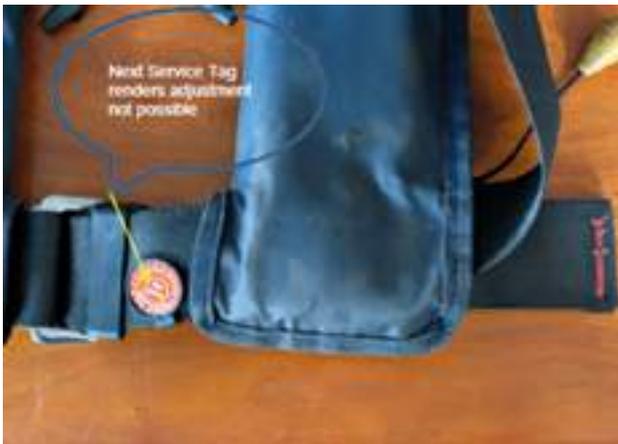
CHIRP engaged with the reporter to confirm that the 'next service' tags in question had been fitted by a third-party service centre – they had been. After checking other vessels in the company, the reporter advised CHIRP that four other ships had equipment serviced by the same service provider. However, it appeared that this was an isolated incident which had not been replicated elsewhere. The DPA forwarded full details to the servicing company who gave assurances that it would not happen again.

Highlighting that the positioning of the service tag renders waist strap adjustment impossible

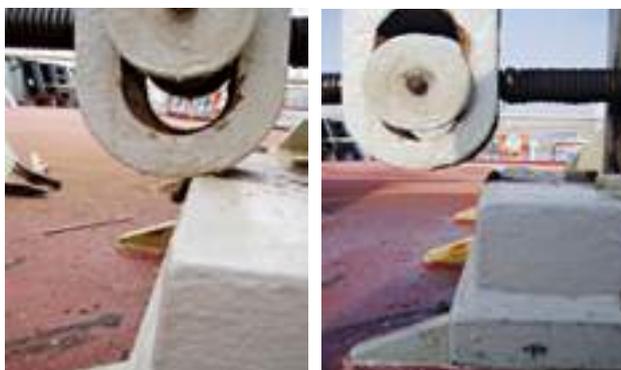
The reason for the freedom of movement was that the crosshead, located between the brake application shaft and the brake tensioning plates, was in contact with the windlass foundation, as shown in the photograph below:

Incorrect Brake Adjustment Correct Brake Adjustment

The bottle screw was then tightened to the correct setting, i.e. allowing the gypsy to rotate freely in the brake 'off' position, but in the brake 'fully on' position the hydraulic motor could not rotate the gypsy. The clearance between the crosshead plates and the foundation with the brake fully applied was in the region of some 30 – 35mm.

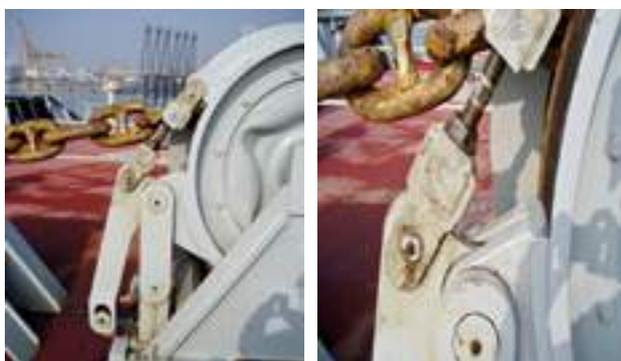
Brake 'Fully On' Bottle Screw Adjustment

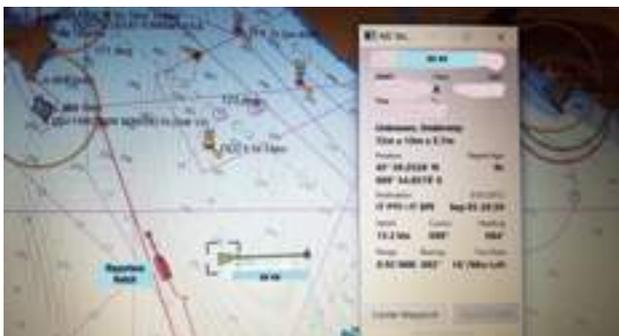
It was a clear night with good visibility, and we were approaching the outer reaches of our destination port, when we noticed a power-driven vessel approaching from our port side. We observed it visually and on our AIS unit (Note: the ketch's AIS was a receive only unit, not a transponder). We were making 5.8 knots under power and the approaching vessel was making 13 knots. The AIS showed a CPA of around 100m so we closely monitored the approaching vessel expecting it to alter course to starboard and pass astern of us. Our navigation lights were on and bright but the approaching vessel closed without altering course, so we turned on our deck lights to further illuminate our ketch and reduced speed to 2 knots. As the approaching vessel remained on what appeared to be a collision course, I altered course hard to starboard and eventually completed a full 360° round turn. Once the other vessel had passed, I resumed my original course. I tried calling the other vessel on VHF Channel 16 to alert her to the near miss, but there was no reply. I then took a screen shot of the AIS.

Screen shot of AIS display after the round turn to starboard

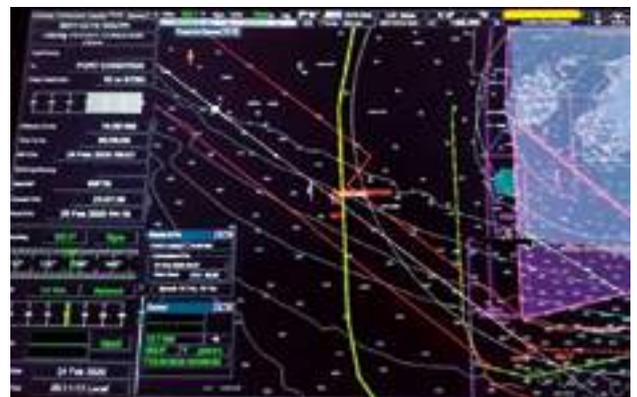
The reporter included a screen shot of the Radar/AIS clearly showing the reported ship transiting within the adjacent PSSA.

Screen shot of the Radar/AIS showing the reported ship transiting within the adjacent PSSA.

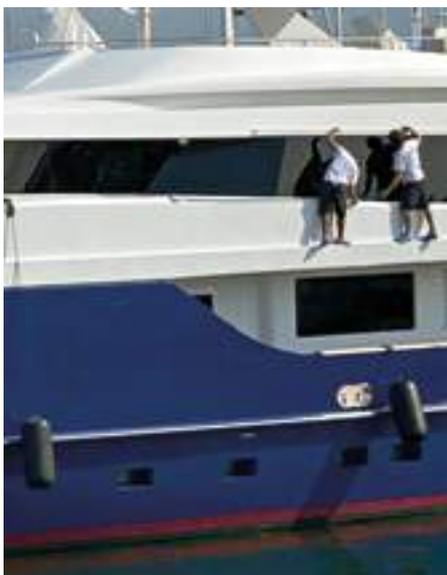
Figure 3 – Another example of poor safety culture in the superyacht sector.

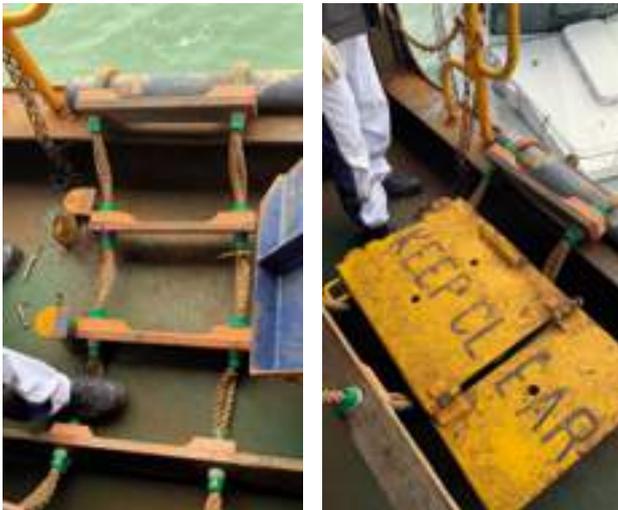
They say a picture paints a thousand words – this clearly demonstrates the appalling lengths that some mariners will go to with respect to endangering life.

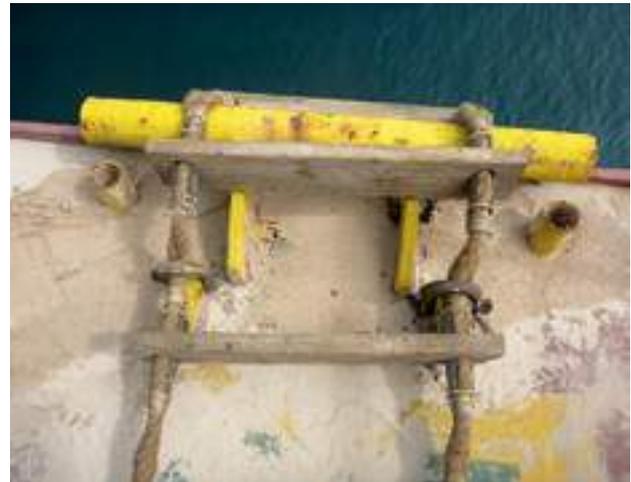
Pilot ladder incorrectly secured to the deck using D-shackles to choke the side ropes.

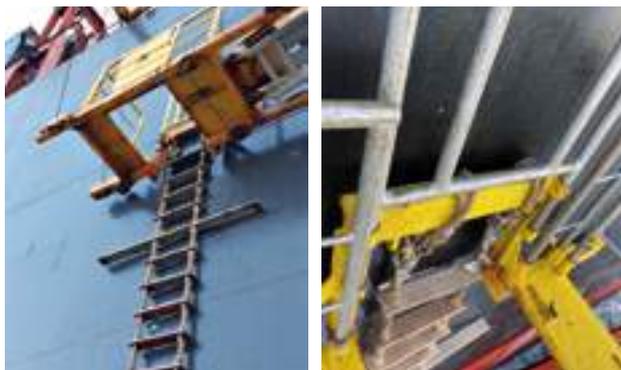
2 examples of non-compliant 'trapdoor' pilot boarding arrangements

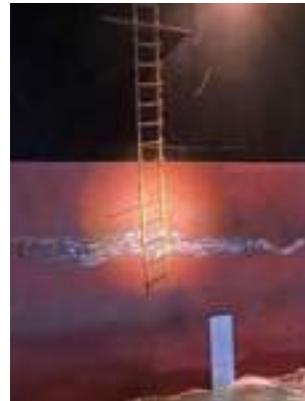
▲ Second ladder rejected due to very loose whippings

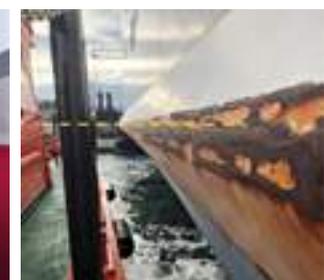
Examples of ship side features that render the vessels non-compliant by design

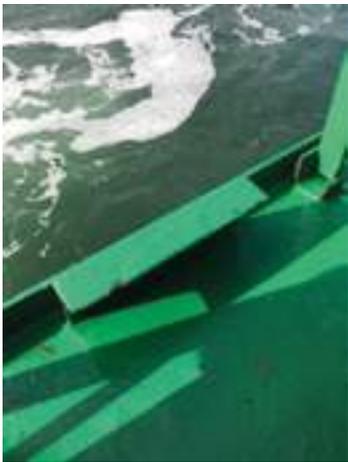
Notorious offender...

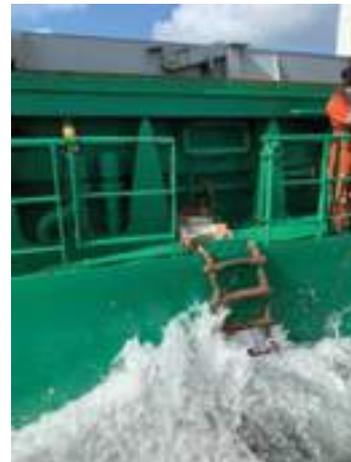
Notorious offender, and it's not even a pilot ladder. As we say: non-compliant as hell.

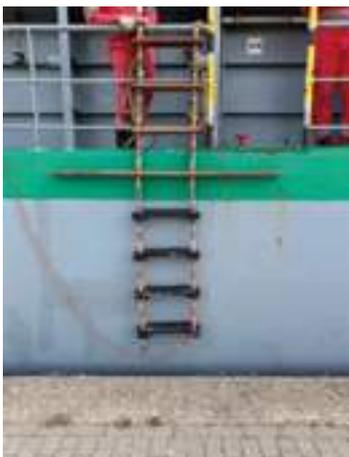
This setup means you have to stumble sideways to reach the entrance.

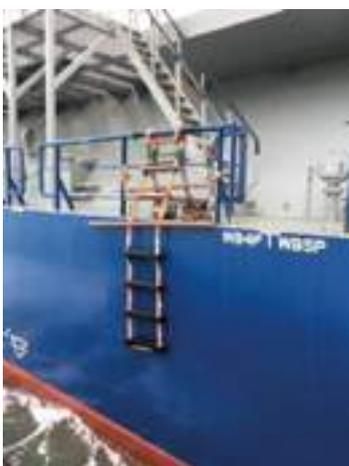
Sideway shuffle again – how strong is the railing?

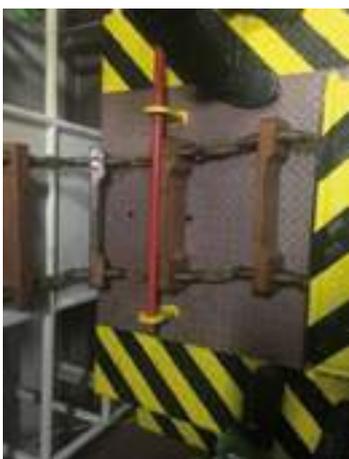
4. Platform placed over the securing area of the ladder

Always a surprise when you lift the lid.

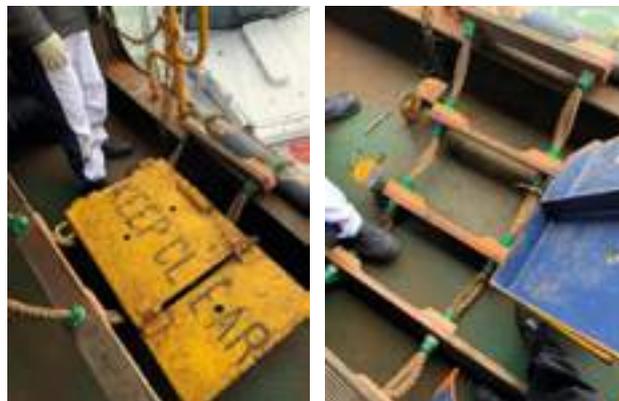
Looks like a safe access but the 3cm piece of steel is the only thing between life or death.

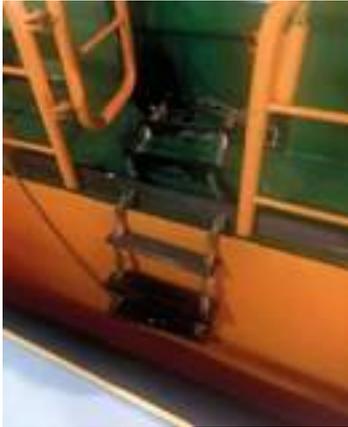
Another spreader used as a securing method.
