Marine safety investigations & reports

Engine room fire on board *MPV Everest*, Southern Ocean, 5 April 2021

MO-2021-003

Phase: Evidence collection

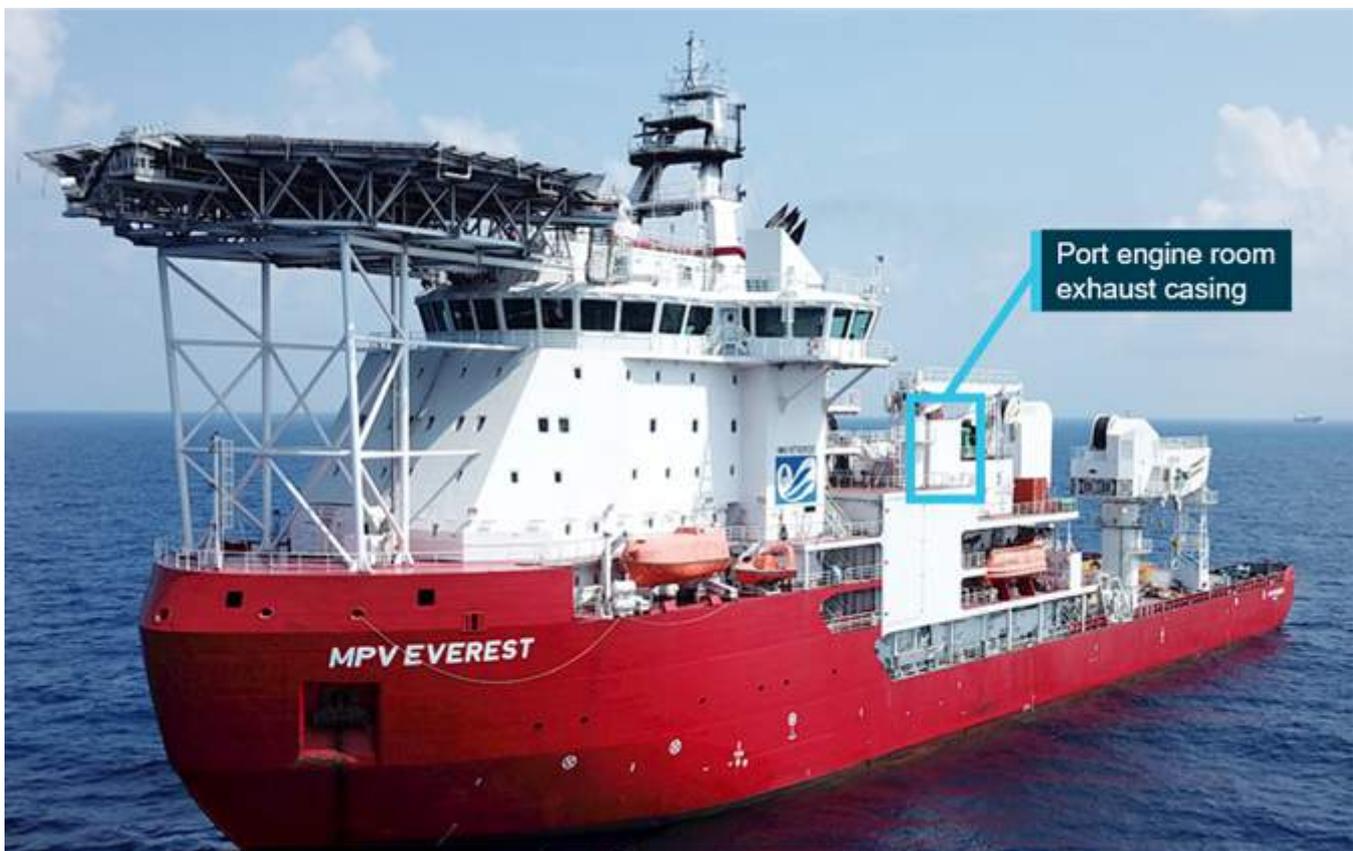
Figure 3: *MPV Everest*

At about 0925, recorded data from the ship's integrated automation system (IAS) showed a routine fuel transfer to top-up the port fuel oil settling tank (located in the port engine room) was started. About an hour later, the ship's master and doctor were in the master's office, located one deck below the navigation bridge (bridge), which overlooks the main and upper accommodation decks aft. Shortly before 1100, they saw large flames erupting from the open louvres in the port engine room's exhaust casing located one deck above the upper accommodation deck, aft of the accommodation block (Figure 3).

Note the location of the port engine room exhaust casing above deck.

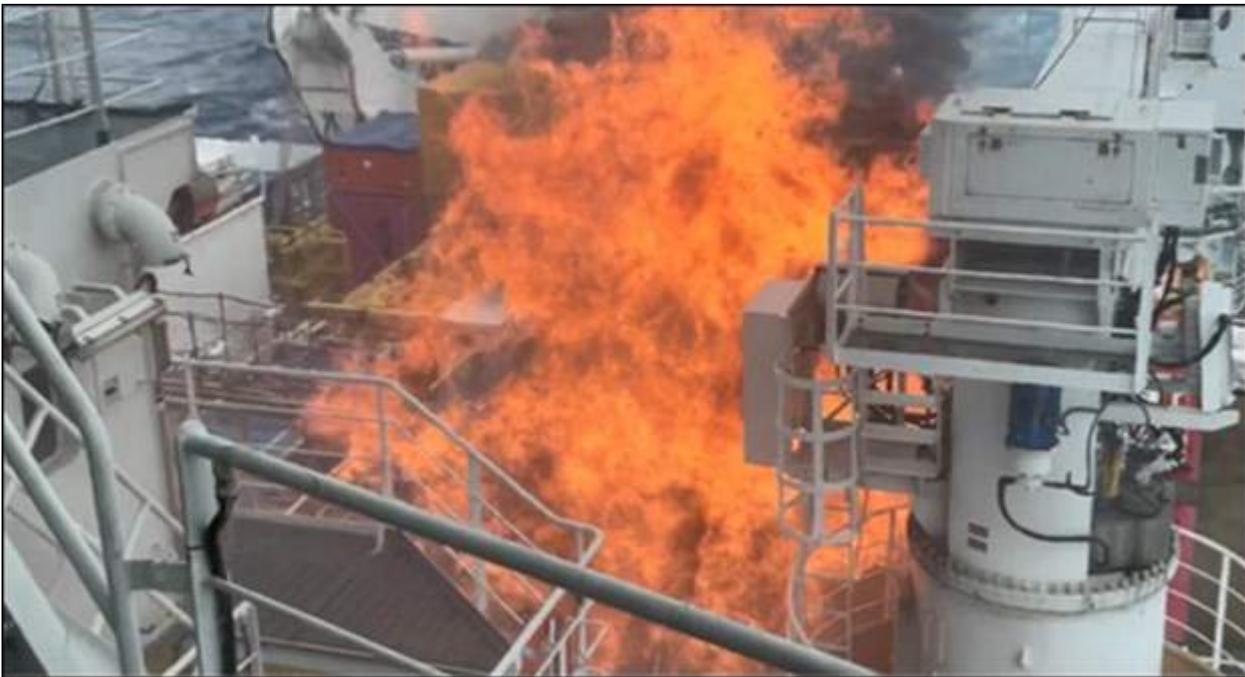
The flames quickly engulfed two rubber watercraft and equipment stowed inboard of the exhaust vent casing and set them alight (Figure 4). The master hurried up to the bridge and raised the alarm by announcing on the ship's public address system that there was a fire, instructing crew and expedition staff to report to their emergency muster stations. As expedition staff began mustering at their stations on the forecastle deck, the ship's crew were preparing fire-fighting equipment and hoses.

Figure 4: Flames from the port engine room exhaust casing

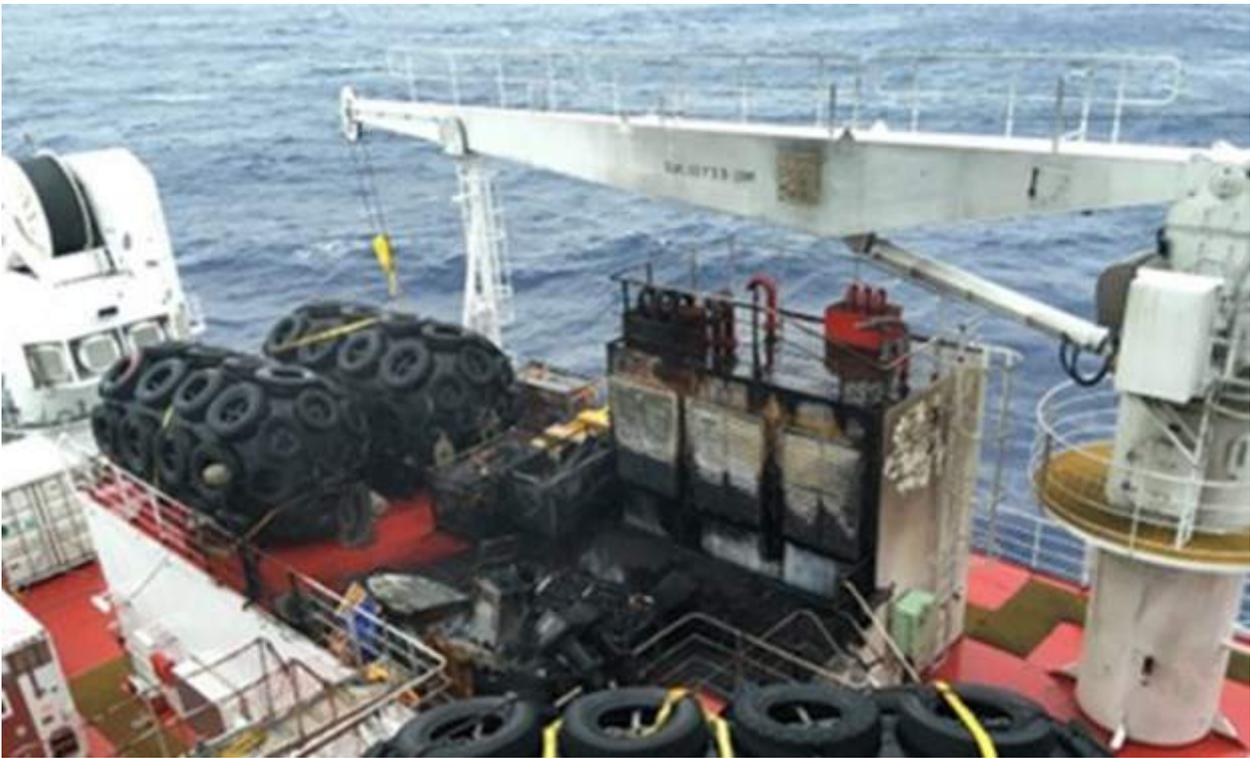
The fire resulted in two AAD watercraft being destroyed on deck along with some other associated equipment in the vicinity (Figure 5). The fire also resulted in substantial damage to the port engine room including to machinery and electrical cabinetry (Figure 6).

Figure 5: Fire damage on deck including the burnt-out watercraft adjacent to the casing

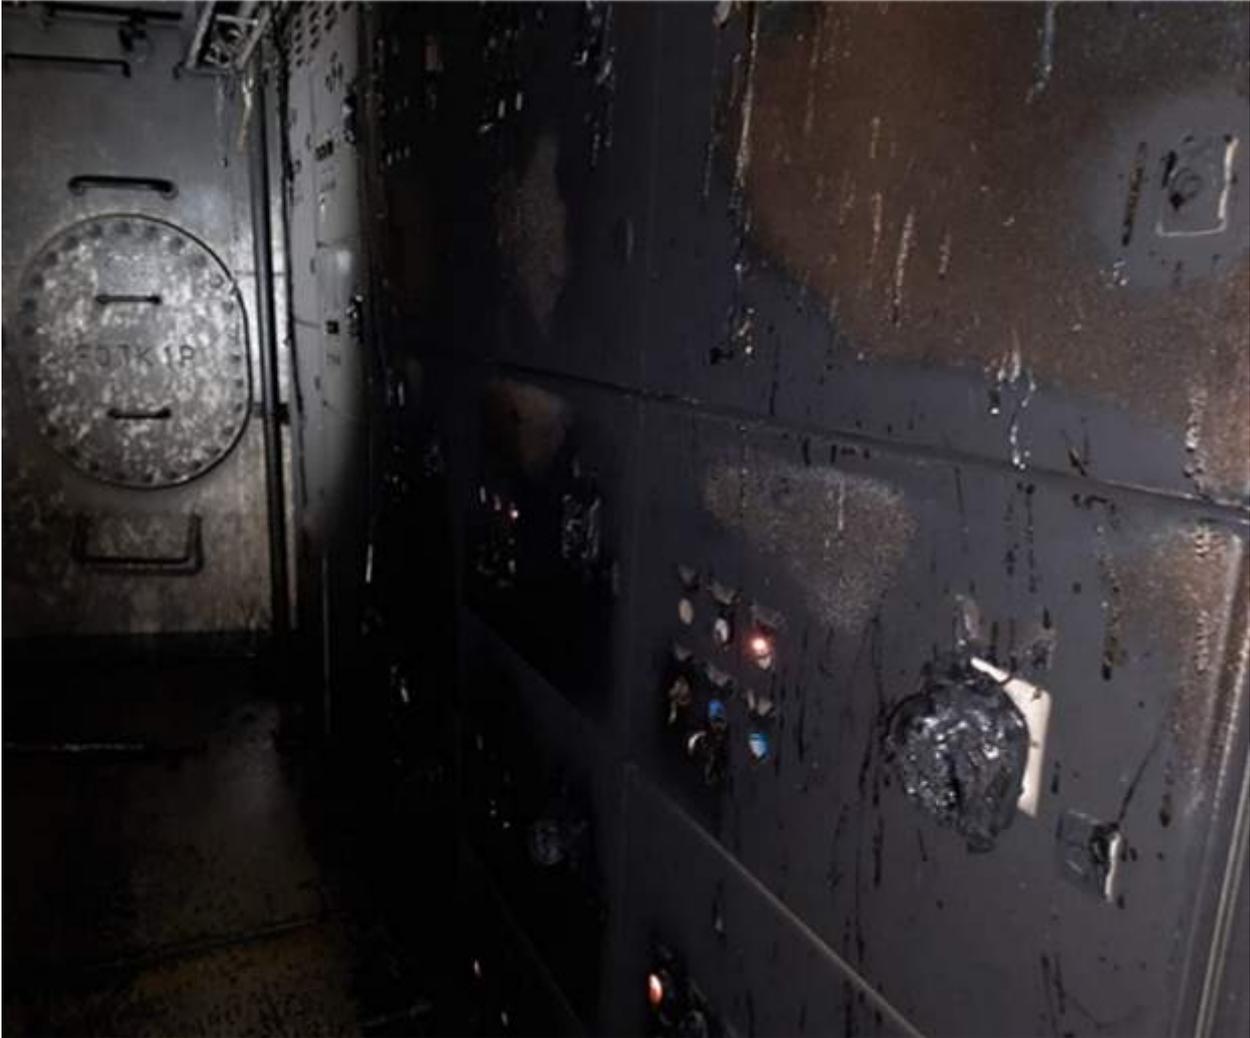
Figure 6: Fire damage inside the port engine room

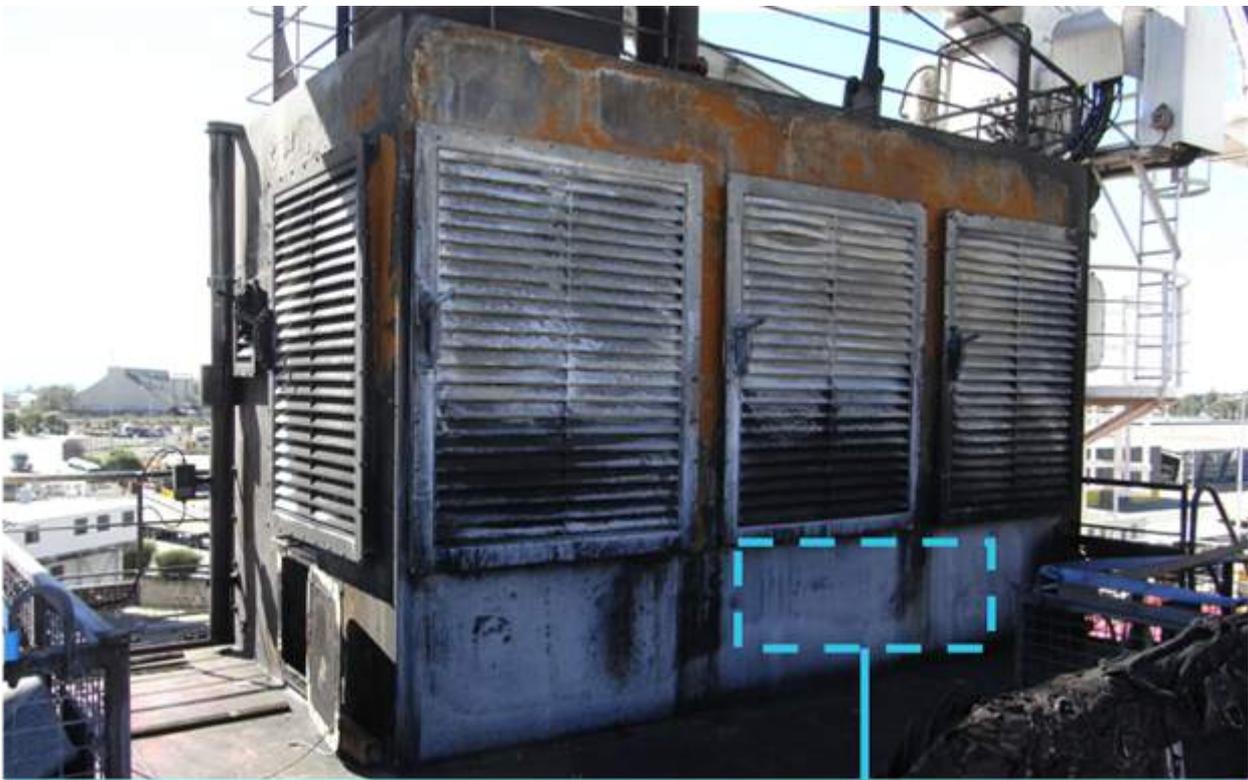
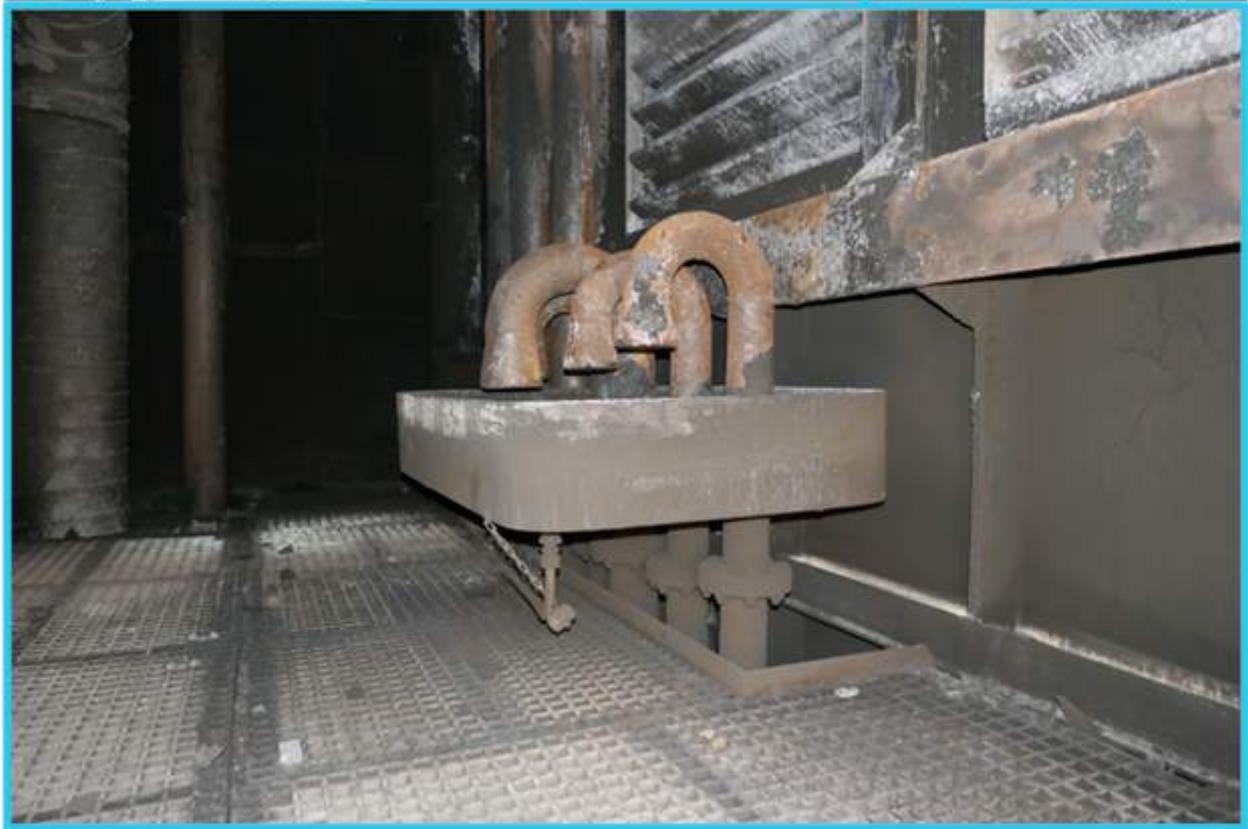
During initial inspections of the fire-damaged engine room, the crew observed fuel oil dripping down into it from within the exhaust vent casing above. In addition to the exhaust piping for the engines, air vent pipes for several engine room fuel oil tanks and other spaces are situated within the casing. Some of these vent pipes terminate on top of the casing while others terminate internally within the casing (Figure 7). Those that terminated inside the casing, included the port fuel oil settling tank that was being filled on the morning of the fire. The IAS data indicates that this tank probably overflowed sometime after 1030 that morning.

Figure 7: Port engine room exhaust casing (inset photo: close up of internal vent pipes)
