# National Transportation Safety Board

## Marine Accident Brief

### Collision of Cargo Vessel *Nomadic Milde* and Bulk Carrier *Atlantic Venus*

| <b>Accident type</b> | Collision | <b>No.</b> DCA20FM017 |

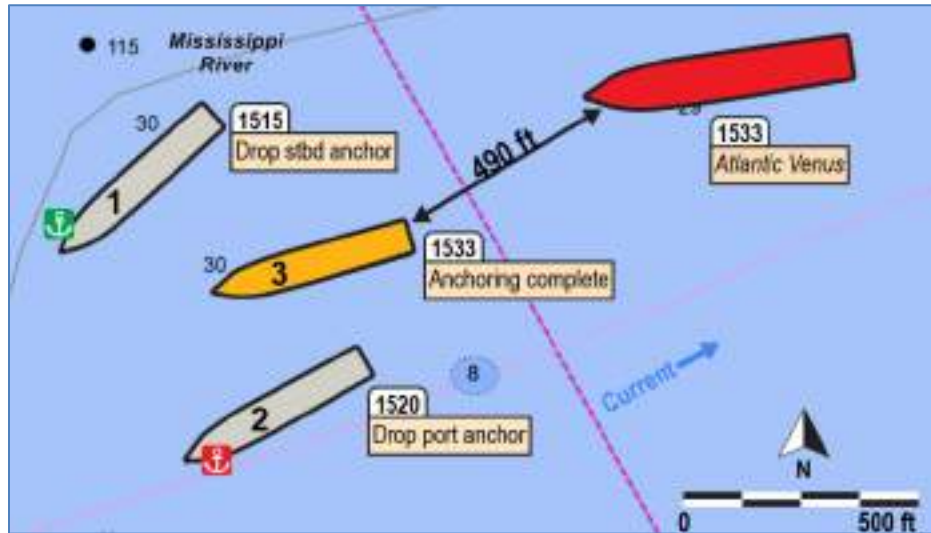
*Nomadic Milde* positions from the vessel’s voyage data recorder (VDR). The green anchor icon indicates the starboard anchor drop position, and the red anchor icon indicates the port anchor drop position. Scale approximate. (Background source: NOAA ENC 6LA54M)

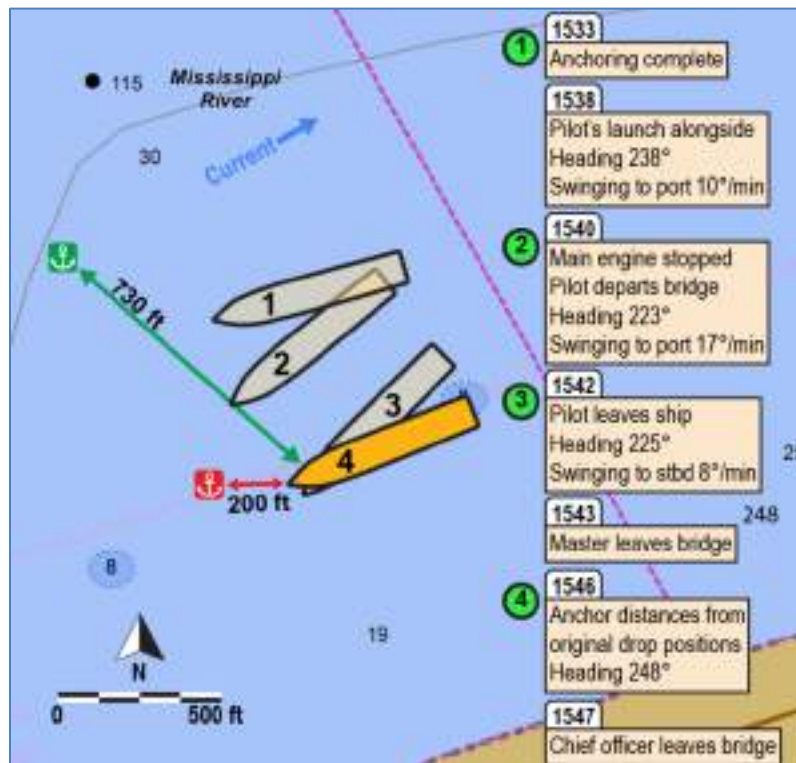
*Nomadic Milde*’s initial movements from 1533 to 1547 from the vessel’s VDR, scale approximate. The green anchor icon indicates the starboard anchor drop position, and the red anchor icon indicates the port anchor drop position. (Background source: NOAA ENC 6LA54M)

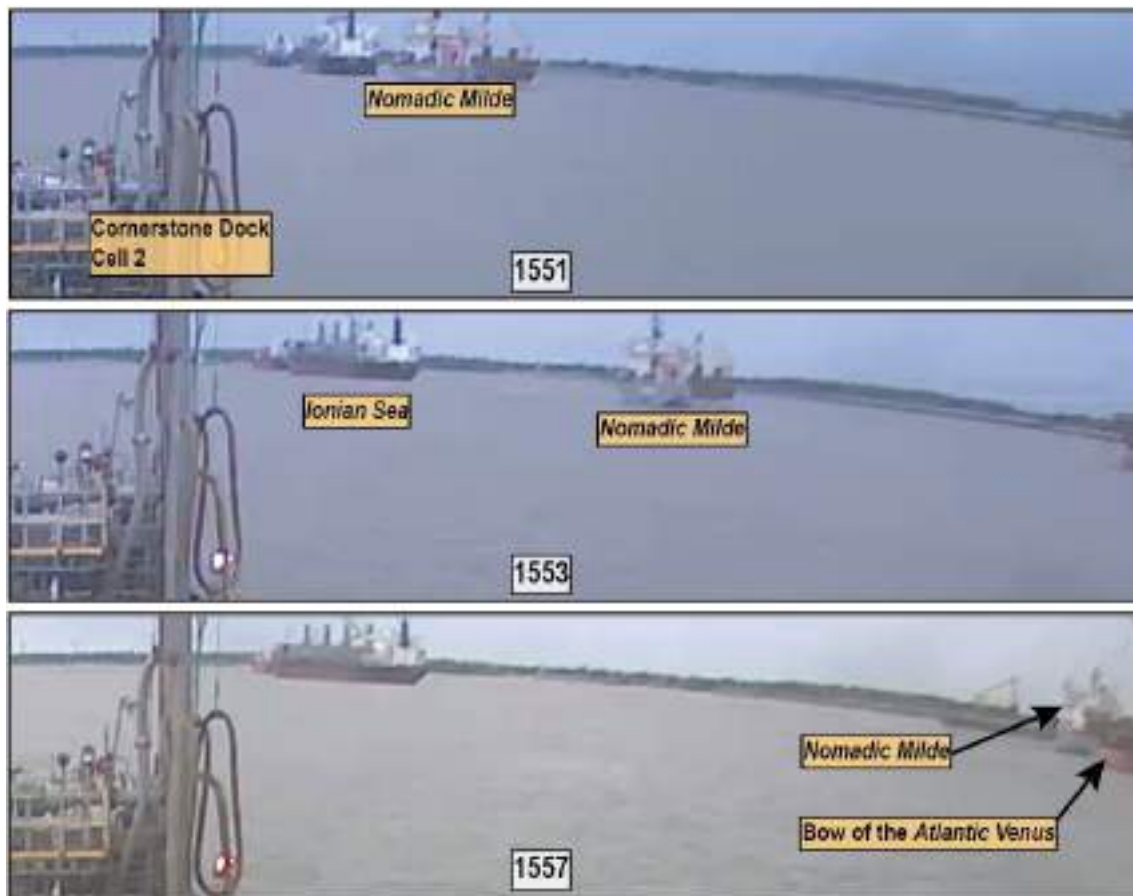
About 1550, from a heading of 264°, the *Nomadic Milde*’s rate of turn began to increase to starboard. Closed-circuit television (CCTV) at the nearby Cornerstone Chemical Dock at mile 114.5 recorded the *Nomadic Milde*’s bow falling off to starboard and moving away from the right descending bank. At 1554, the *Nomadic Milde*’s ECDIS recorded its speed to be about 1.8 knots over ground. At 1557, the *Nomadic Milde* appeared to stop moving and hang in position about 350 feet off the starboard bow of the *Atlantic Venus*.

Footage from 1551, 1553, and 1557 (top to bottom) from the Cornerstone Chemical Dock showing the *Nomadic Milde* dragging anchor downriver towards the *Atlantic Venus*.

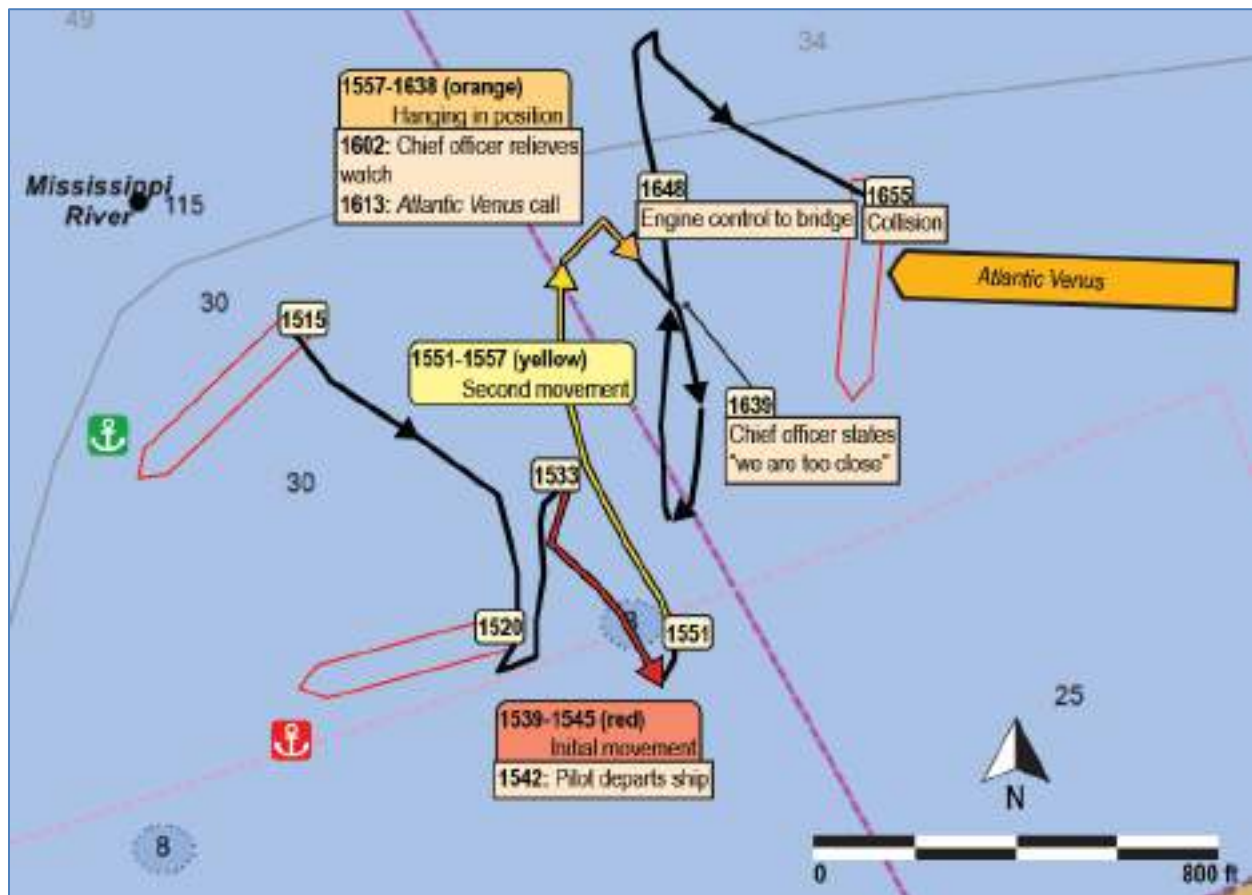
GPS positions of the *Nomadic Milde* from the vessel's ECDIS, from the time the *Nomadic Milde*'s starboard anchor was let go at 1515 to the collision with the *Atlantic Venus* at 1655. The green anchor icon indicates the starboard anchor drop position, and the red anchor icon indicates the port anchor drop position. Note: the GPS receiver is located on the main mast above the bridge of the *Nomadic Milde*. Scale approximate. (Background source: NOAA ENC 6LA54M)

The *Nomadic Milde*'s positions and headings suggested that the *Nomadic Milde* did not initially settle at its original anchor position. After the starboard anchor was let go, the ship moved about 730 feet away from the original starboard anchor drop position towards the right descending bank, a distance double the amount of chain that was set on the anchor, indicating that the starboard anchor likely dragged. The initial 6-minute anchor drag began within 10 minutes of when the pilot had informed the master that the anchoring was finished. The pilot departed the bridge while the vessel was still moving, although he said he had no concerns about the *Nomadic Milde* holding anchor. Had he noticed the initial drag of the *Nomadic Milde*, he may have remained with the vessel. Additionally, had the bridge team detected the initial drag before the pilot departed the vessel, or if the master had voiced any concern, they may have been able to request that the pilot remain with the ship to attend to the issue.

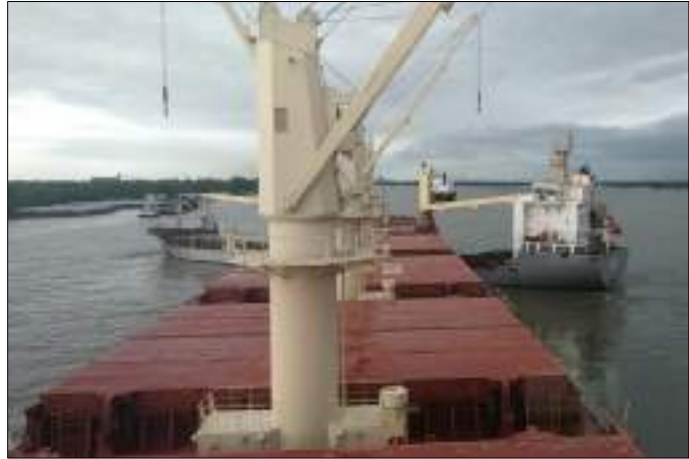
At 1655, the port side of the *Nomadic Milde* collided with the bulbous bow and anchor chains of the *Atlantic Venus*. Both vessels remained in contact: the *Atlantic Venus* was facing up river, and the port side of the *Nomadic Milde* was laying up against the bulbous bow of the *Atlantic Venus* with its bow facing the right descending bank. At 1659, the second officer of the *Nomadic Milde* informed VTS that they had collided with the *Atlantic Venus*. Neither vessel reported any flooding. With the *Nomadic Milde* broadside to the current and pushing on the bow of the *Atlantic Venus*, both vessels moved towards the right descending bank and closed on the Cornerstone

Image from video taken at 1701 from the bridge of the *Atlantic Venus* with the *Nomadic Milde* lying against its bow. (Source: *Atlantic Venus* crewmember)

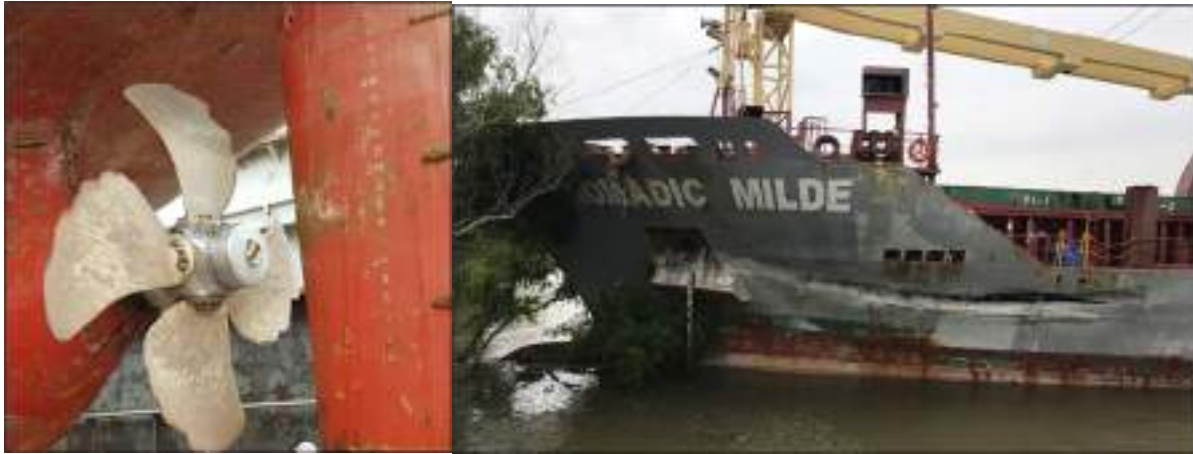
**Damages.** The *Nomadic Milde* lost its starboard anchor with 4 shots of anchor chain just before it hit the dock, and its starboard anchor windlass was damaged. The anchor was later recovered. The contact with the Cornerstone dock left an approximate 25-foot gash aft of its port anchor pocket, as well as an indentation and a fracture to the portside shell plating in the vicinity of the no. 5 port wing ballast tank from the contact with the bulbous bow of the *Atlantic Venus*. The propeller had numerous indentations and fragments missing from each blade. There was damage to the portside bilge keel, and there were multiple anchor chain abrasion markings at the bulbous bow on the portside hull area, and in the vicinity of the propeller. An estimated 13 gallons of stern tube lube oil were released into the river from a broken propeller hub seal. Damage and repair costs were estimated at between \$5.5 and \$6 million.

**Left:** Postaccident damage to the *Nomadic Milde*'s propeller. (Source: Intership Navigation Co. Ltd)  
**Right:** *Nomadic Milde* on the right descending bank at the Cornerstone Dock showing a gash in the hull aft of the port anchor pocket. (Source: US Coast Guard)
