Capsizing of Roll-on/Roll-off
Vehicle Carrier *Golden Ray*
St. Simons Sound, Brunswick River,
near Brunswick, Georgia
September 8, 2019

Marine Accident Report

NTSB/MAR-21/03
PB2021-100930

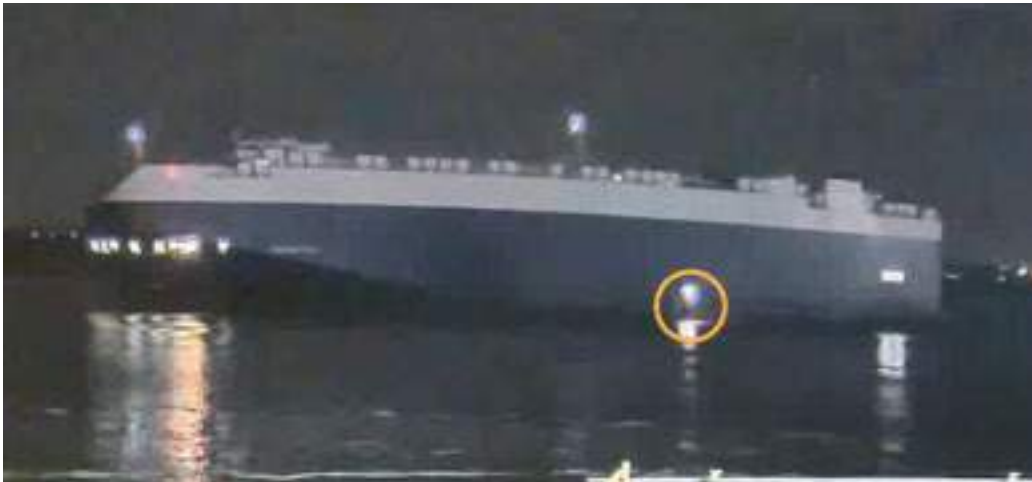
About the same time, the master ordered the crew to open the portside pilot door (side port), located on deck 5, in preparation for the pilot's planned departure just outside of the Port of Brunswick at the sea buoy (see figure 3). The pilot door was a watertight hatch in the side shell that opened and closed locally by an electronic/hydraulic system; the door was 7 feet (2.1 meters) high and 7 feet (2.1 meters) wide. After supervising the opening of the portside pilot door, the chief officer went to his stateroom. The crewmembers left to conduct other duties, and no one remained at the open door as the vessel proceeded outbound.

Figure 3. The *Golden Ray* departing Jacksonville, Florida, about 0130 on September 7. The light amidship is the open portside pilot door. (The lights on the blue hull at the bow and stern are mooring line stations.)

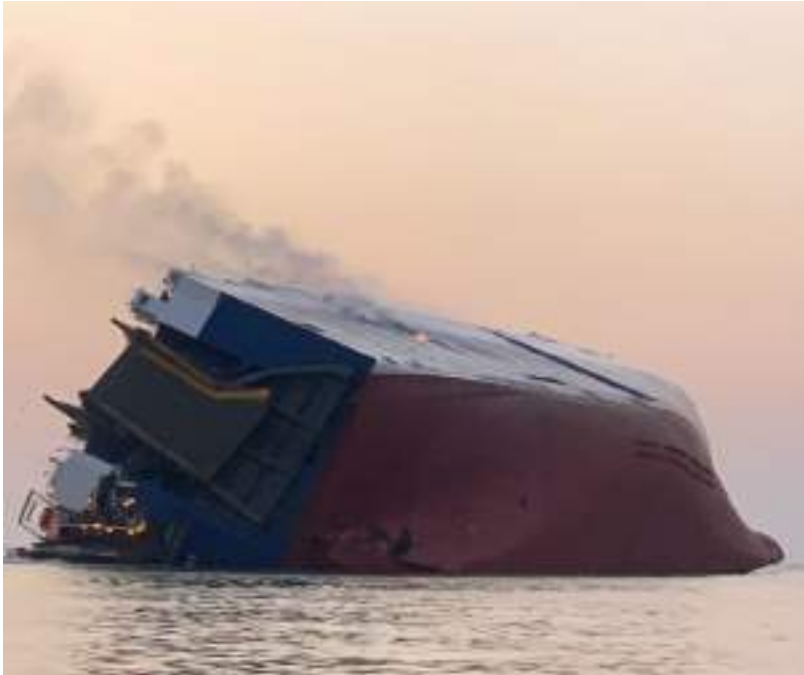
About 0430, first responders noticed smoke and flames on the starboard side of the *Golden Ray* in the area of the vehicle decks (see figure 5). The cargo hold contained combustible materials, including tires and plastic components in the vehicles. Because of the reported thick, black smoke

Figure 5. Stern view of the grounded *Golden Ray* after the heeling event. Flame and smoke emanate from the starboard side in the area of the cargo decks. Photo taken 6 hours after the heeling event.

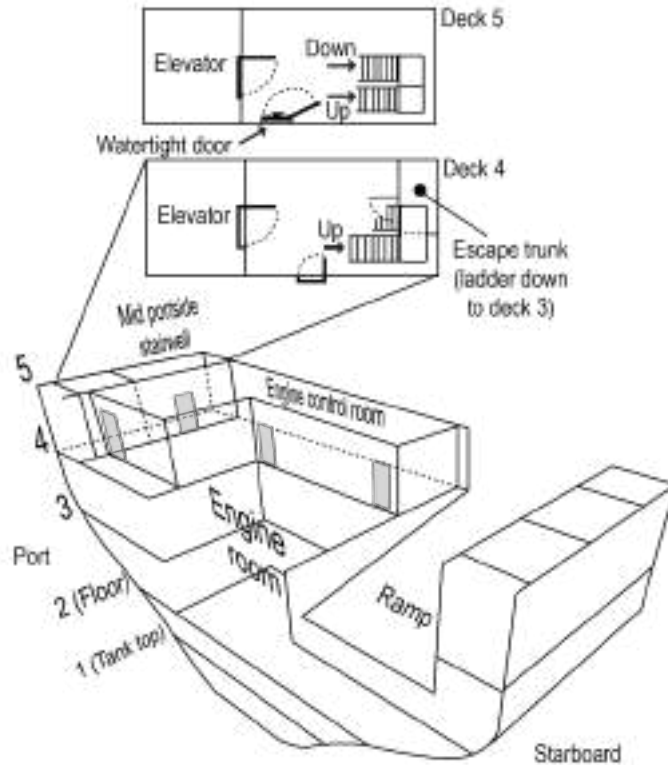
Figure 6. Simplified diagram showing a portion of the engine room and engine control room exits. Doors shaded gray.

the mid-portside stairwell—the primary stairwell serving the engine control room and engine room—but were blocked by incoming water, which was entering the stairwell from an open watertight door on deck 5. The engine control room also had three other doors facing aft that accessed the engine room directly (see figure 6).

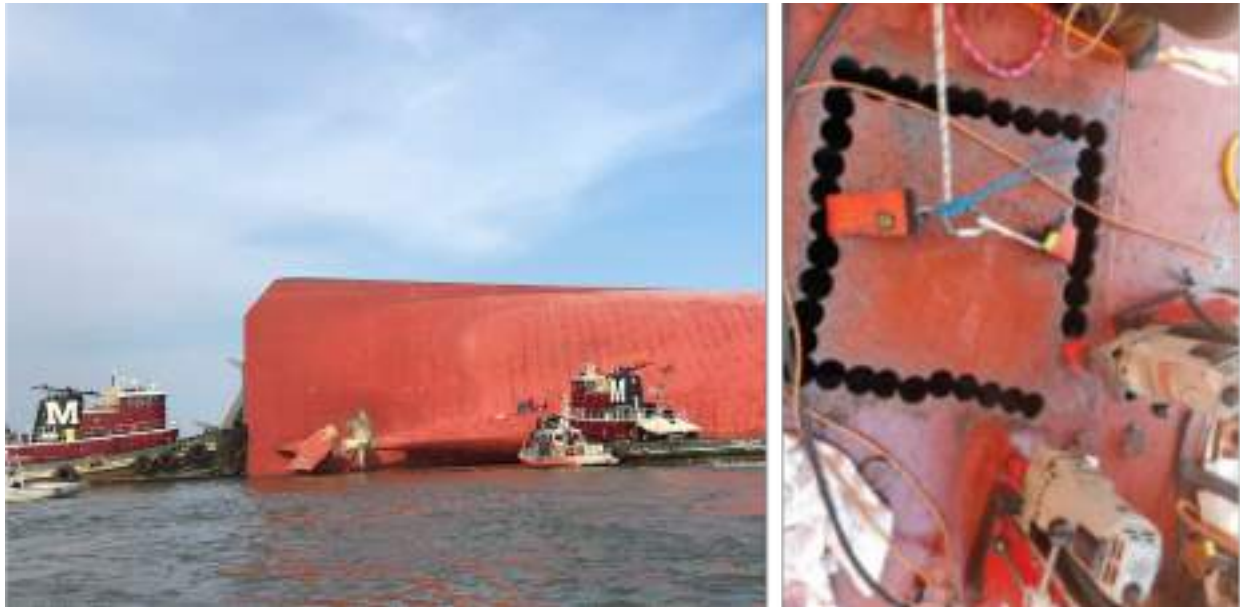
Just over 16 hours after the accident, at 1812 on September 8, first responders reported hearing tapping noises from within the vessel. The following day, the Coast Guard, working closely with Donjon-SMIT and Defiant Marine (both salvage and first responder companies), and Elevated Safety (who were experts in confined-space rescues), as well as Glynn County Heavy Rescue-8 and the Georgia Department of Natural Resources, developed what they determined to be the safest plan to rescue the engineers, which included procuring cold cutting equipment to safely create an escape access into the hull. It was expected to take about 14 hours to get the equipment on site. About 1300, responders drilled a 2.5-inch hole through the hull and made

contact with the engineers (see figure 7). An atmosphere reading of the engine room showed its temperature was as high as 155°F. Realizing that the internal atmosphere was extremely hazardous to the engineers, the rescuers continued drilling holes to create a square access opening into the hull rather than wait for the requested cold cutting equipment to arrive.

Figure 7. Emergency responders attempt to rescue the trapped engineers and cadet (left). Responders drilled holes into the hull to access the engineers (right).

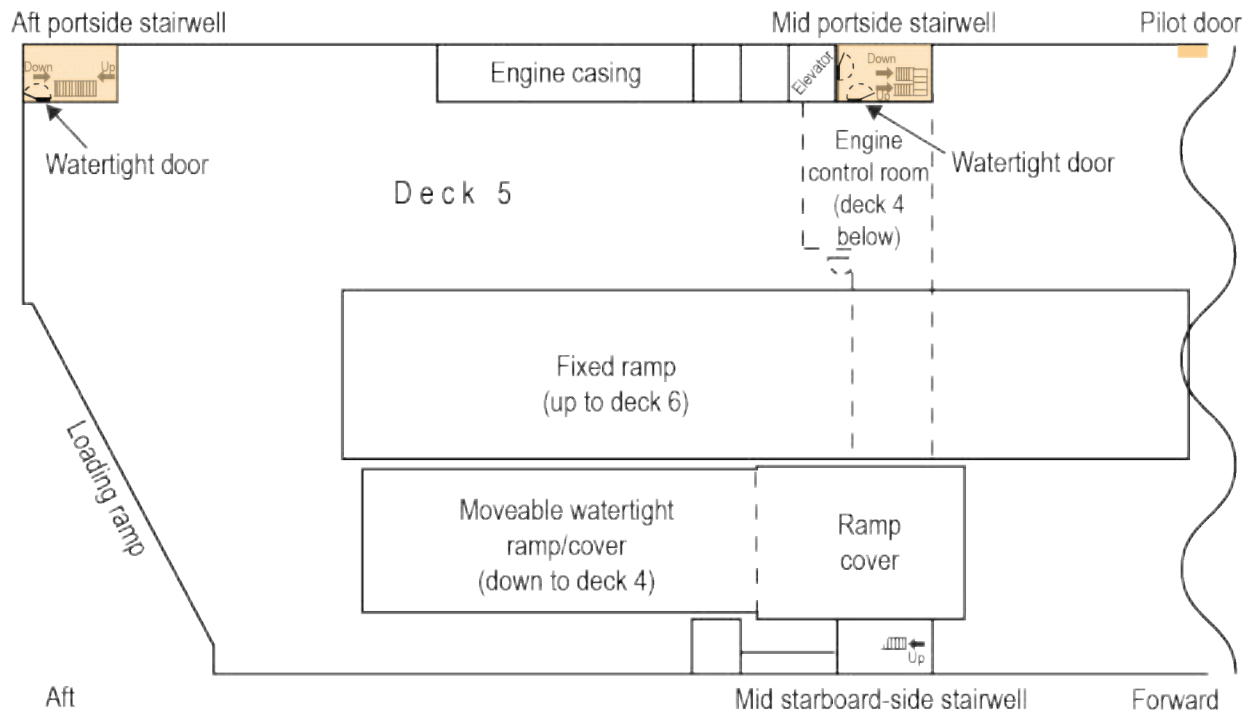
The IMACS data showed that in addition to the portside pilot door, the watertight doors to both the aft and mid portside deck 5 stairwells were open at the time of the accident and had been open since 2341 on September 7 before the vessel departed the Colonel's Island Terminal. The mid portside stairwell, about 75 feet (22.9 feet) aft of the pilot door, served as the primary access to the engine room and the engine control room on deck 4; the escape trunk stairwell serving the lower engine room exited to this stairwell at deck 4 (see figure 11).

Figure 11. Simplified overhead plan of the aft portion of deck 5. The stairwells with open watertight doors and the pilot door are highlighted. Dashed lines indicate spaces on deck 4 below.

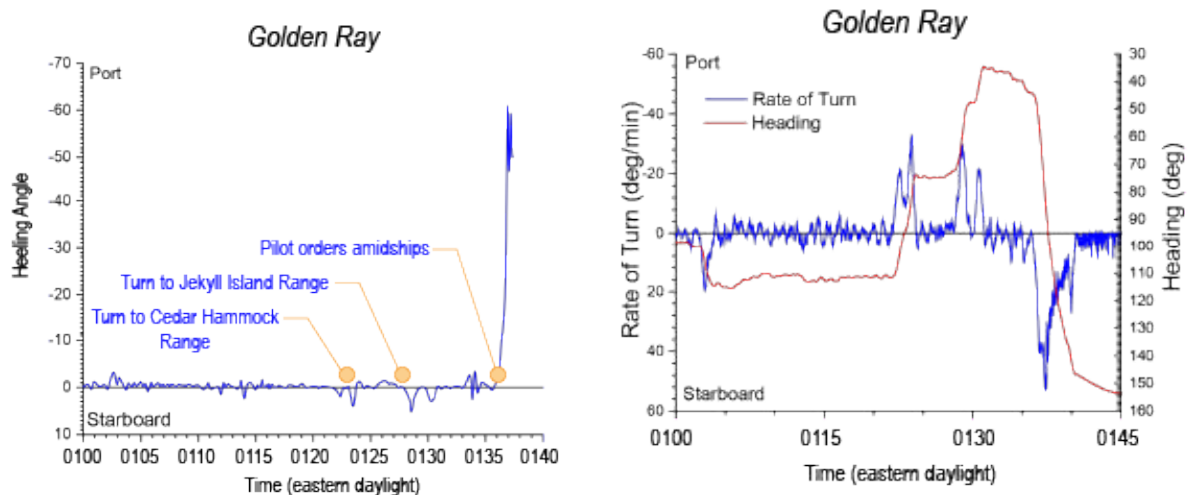
After the accident, the NTSB used data from the *Golden Ray*'s VDR and IMACS to determine the forces acting on and their effect on the vessel at the time of the accident. The study showed that from an initial heel of about 8° at 0136:00, the vessel heeled past 50° in about 50 seconds (by 0136:50) and reached over 60° in less than a minute, while its starboard rate of turn increased from about 2° per minute to over 40° per minute (see figure 14).

Figure 14. Graphs from the *Golden Ray* performance study by the NTSB. Left: heeling angle through the transit, including previous two left turns. Right: heading and rate of turn through the transit.

According to the study, the heeling of the vessel was driven by a moment created by hydrodynamic side force on the hull at a distance below the center of gravity during a starboard turn at 12–13 knots. The hydrostatic stability (buoyancy) resisting the heel was much less than would be expected for the reported GM of 2.45 meters (8 feet) and instead was consistent with a GM of approximately 0.45 meters (1.5 feet). The study also found that although the effect of wind could not be calculated precisely, the low magnitude of the heeling moment from wind relative to other sources of heeling moment was not significant. The study found that the vessel's center of gravity was significantly higher than reported, leading to the lack of roll resistance.

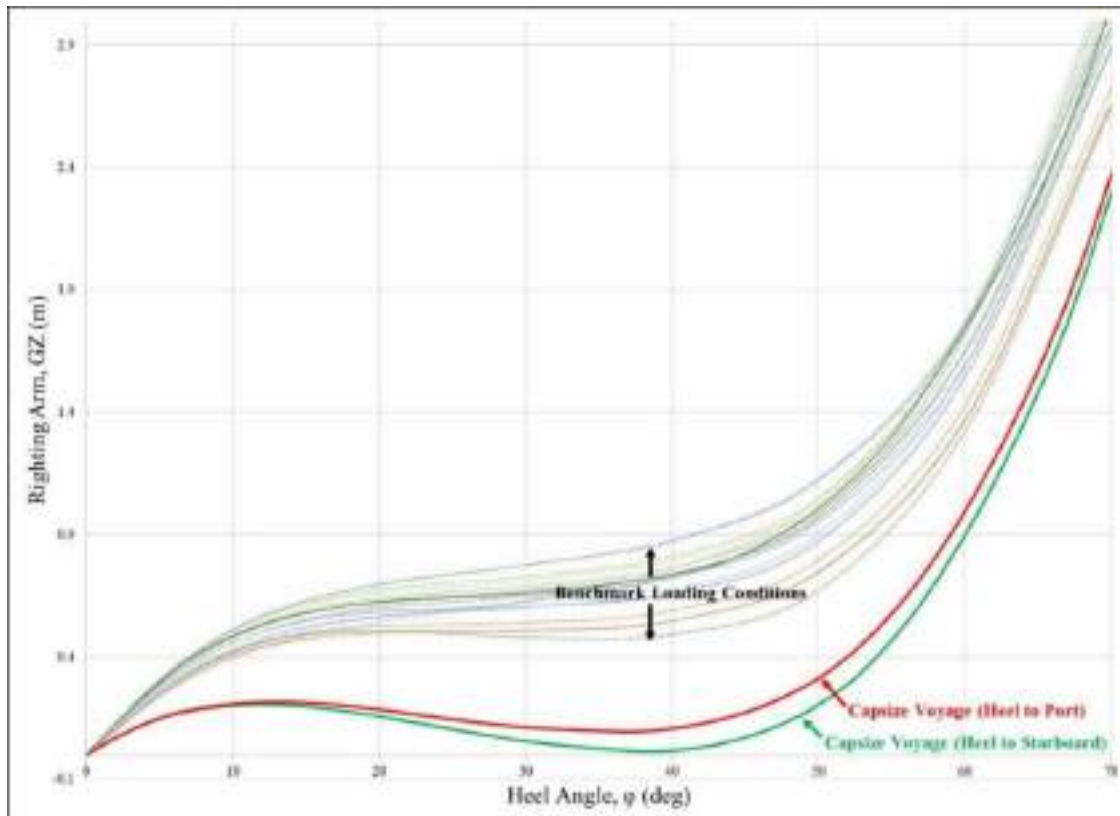
In order to determine the vessel's intact stability, the MSC generated righting arm curves for the *Golden Ray*, and the results were compared with the 2008 IS Code standards for stability. Both righting arm curves generated by the MSC had "significantly lower righting arms and area under the righting arm curve than all benchmark conditions from the T&S Booklet." When 2008

IS Code criteria were applied to these righting arm curves, the MSC found that with the vessel's loading condition, the area under the vessel's righting arm curve between 30° and 40° was particularly limited, and it failed to meet the 2008 IS Code (see figure 16). Because there was limited area under the righting arm curve, the MSC determined that the vessel did not meet the area ratio criteria of the 2008 IS Code's severe wind and rolling criteria. The MSC concluded that the vessel, as loaded, had an extremely low righting energy, which prevented it from withstanding further adverse static or dynamic heeling effects and enabled the vessel to capsize due to the centrifugal force experienced by the vessel throughout the starboard turn.

Figure 16. Righting arm curves generated from the MSC analysis of the *Golden Ray* during the accident voyage compared with benchmark righting arm curves chosen from the vessel's T&S Booklet loading conditions.

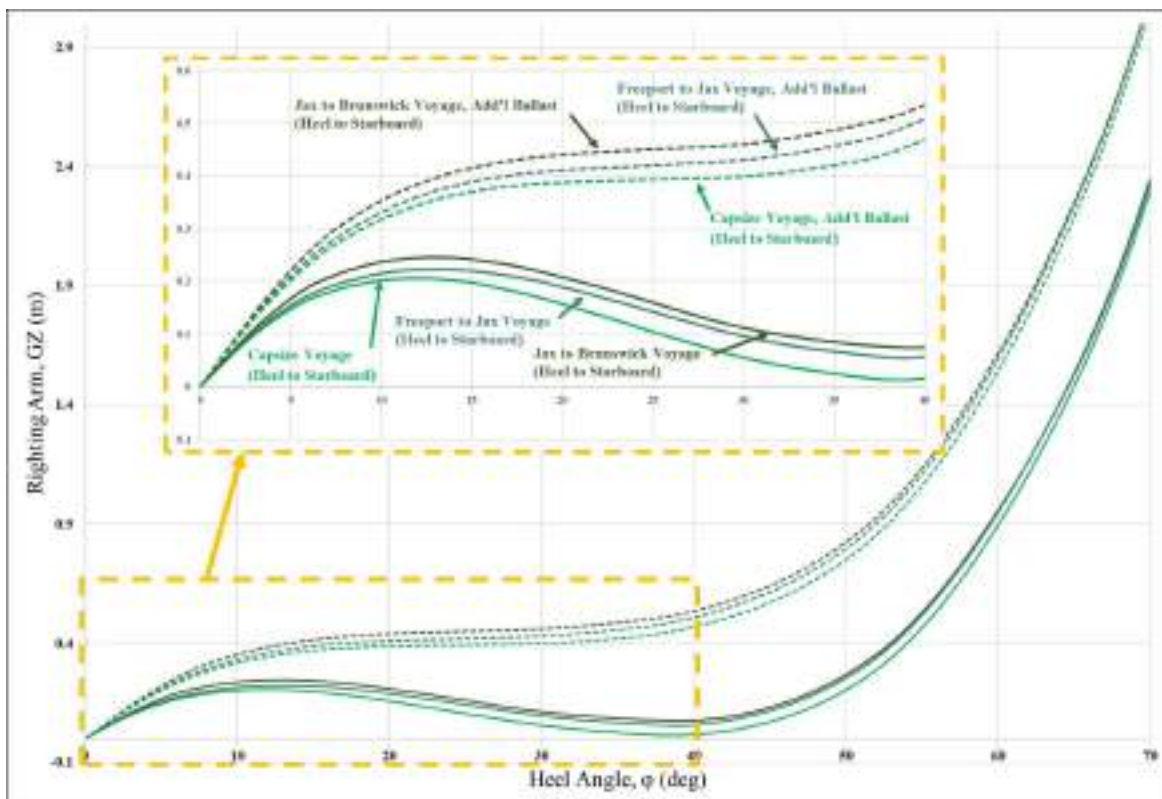
The MSC analysis also found that, although the vessel had more righting energy for the two preceding voyages than during the planned accident voyage, it was not in compliance with all of the minimum righting arm requirements of the 2008 IS Code during either because the area under the vessel's righting arm curve between 30° and 40° was insufficient. The MSC report stated that "failure of the IS Code criteria...is an indicator that the vessel poses a higher risk of capsize given exposure to certain dynamic conditions such as severe wind, waves and faster speed/tighter radius turns," and it was possible that the *Golden Ray* "could have capsized on a previous voyage if it had been exposed to more severe adverse conditions."

The MSC report also stated that if the *Golden Ray* had maintained an additional 1,492 MT of ballast (1,500 MT was loaded after departure from Freeport and then discharged before the vessel arrived in Jacksonville in order to meet the port's draft requirements), the vessel would have been in compliance with the 2008 IS Code during both previous voyages and the accident voyage (see figure 17). The MSC also noted that, with the additional ballast, the vessel's theoretical initial GM for those voyages would have been 2.25 meters (7.4 feet) for the accident voyage, 2.4 meters (7.9 feet) for the voyage from Freeport, and 2.47 meters (8.1 feet) for the voyage from Jacksonville. (For comparison, the MSC calculated the initial GM for the representative loading condition to be 1.76 meters (5.8 feet) for the accident voyage, 1.84 meters (6 feet) for the voyage from Freeport, and 1.91 meters (6.3 feet) for the voyage from Jacksonville.)

Figure 17. Theoretical righting arm curves (dashed green lines) generated from the MSC analysis of the *Golden Ray* during the accident voyage and previous two voyages with an additional 1,492 MT of ballast. The righting arm curves (solid green lines) generated from the MSC analysis for the vessel in the representative loading condition for each voyage are shown for comparison.

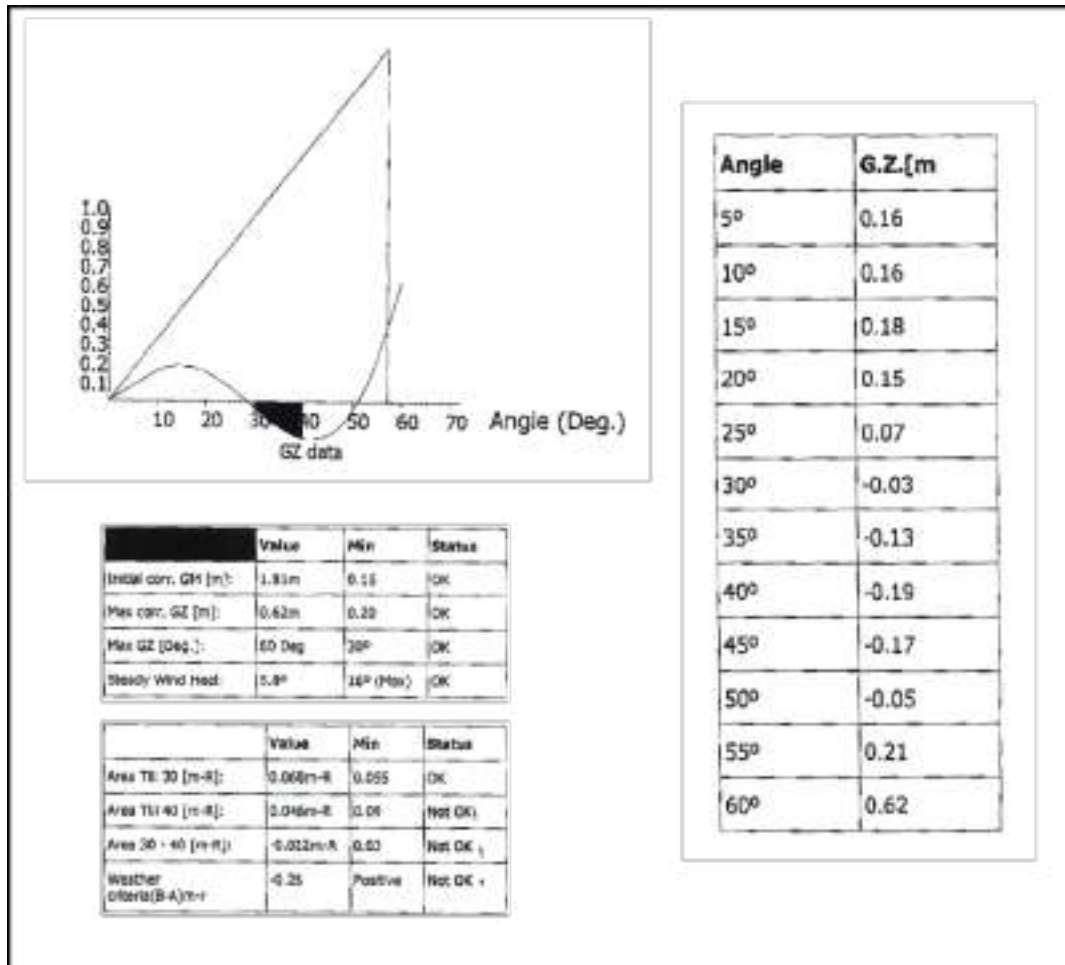
Hyundai Glovis. The charterer conducted a simulated stability analysis of the *Golden Ray* using the LOADCOM computer on board the *Silver Ray*, a vessel of the same class as the *Golden Ray* (Hyundai Glovis Co. Ltd. 2020). This simulation used vessel data and conditions collected by the charterer and was not observed by the Coast Guard or the NTSB. The simulation calculated that the GM of the *Golden Ray* was 1.8 meters (5.9 feet), indicated that the righting arm curve for the *Golden Ray* at the time of the accident was extremely low, and showed a LOADCOM status of “Not OK” for three stability requirements (see figure 18). Additionally, the righting arm curve showed negative stability after a heel of about 25°.

Figure 18. Righting arm curve calculated on the *Silver Ray's* LOADCOM stability computer based on the *Golden Ray's* vessel data from the accident. Note that three of the stability requirements have a status of “Not OK” and the righting arm (GZ) is negative beyond 25°.
