MARINE ACCIDENT
INVESTIGATION BRANCH

SAFETY DIGEST

**Lessons from Marine
Accident Reports
2/2021**

No 2/2021

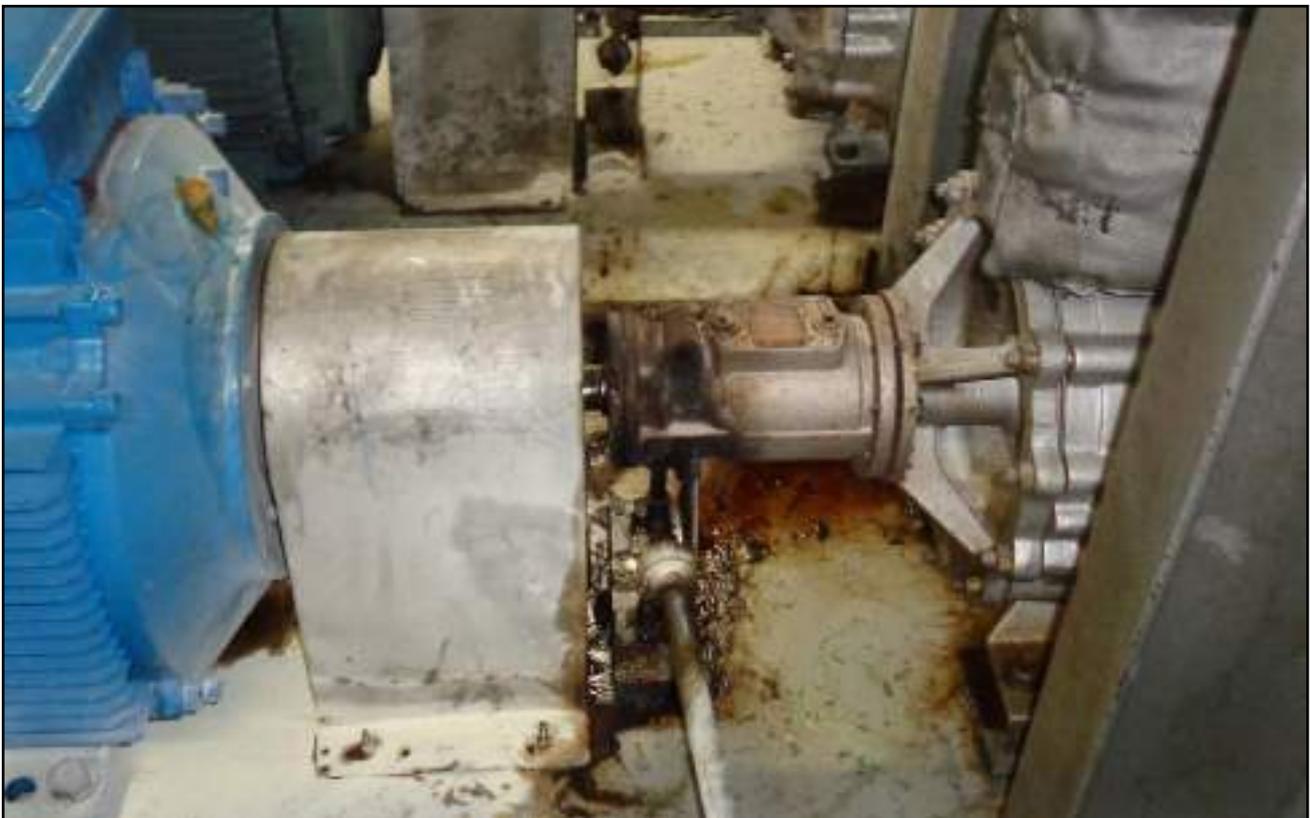
The cause of the fire was later found to be a failed pump bearing that had overheated, damaging the adjacent mechanical seal. The failure of the seal resulted in oil spraying out and igniting on the bearing's hot surfaces.

Figure: The scene of the fire, showing the fire damage around the coupling and leaked oil

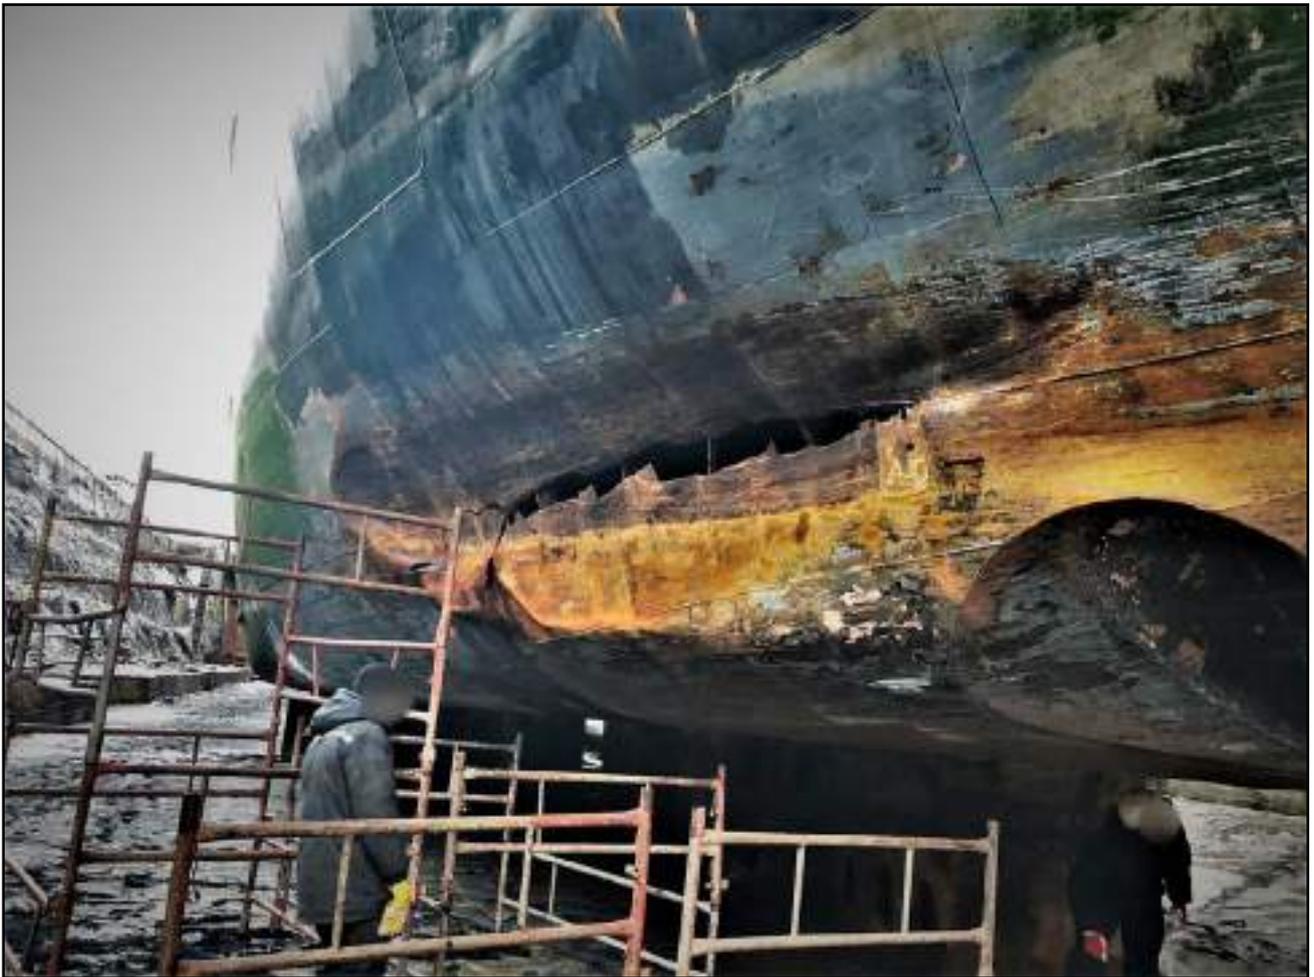
During an outbound river passage under pilotage, a general cargo vessel grounded and suffered damage to its hull plating (see figure). Despite both the bridge team and pilot feeling the contact, no report of the grounding was made to the local Vessel Traffic Service (VTS) and the vessel proceeded to sea as usual after disembarking the pilot. Hull damage was not confirmed until the day after the incident and the full extent not realised until the vessel had completed its sea passage and entered a dry dock.

Even though the initial damage assessment did not identify a breach of the hull, the next day an area of deformation in a cargo hold led to the discovery of a significant breach. The vessel was sent to a repair yard immediately on its next arrival and dry docked.

Figure: Damage to the general cargo vessel's hull plating

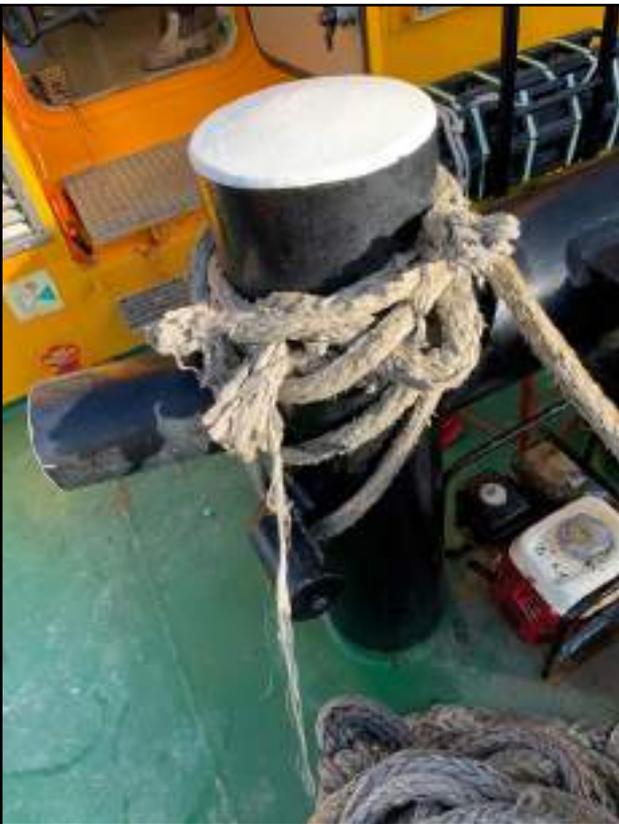
Figure 2: H post, showing cut line

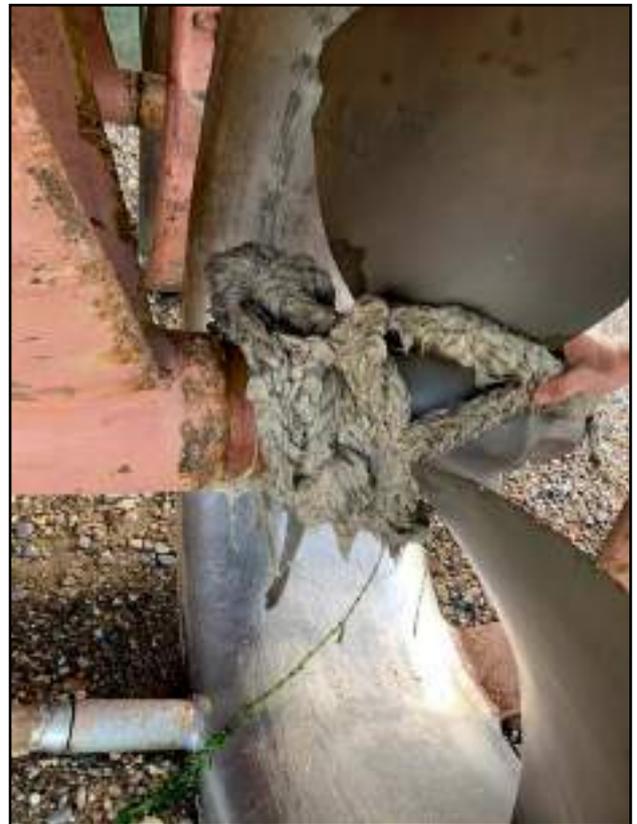
Figure 3: Fouled propeller

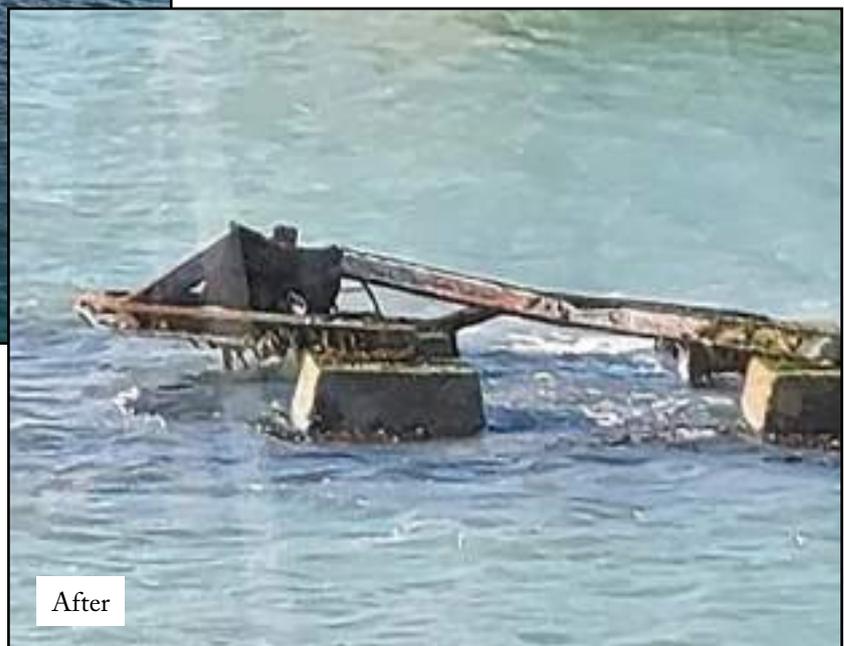
Acting quickly, the deckhand told the master and the thruster was stopped; however, this action came too late to prevent the ferry's stern making heavy contact with a navigation mark at the end of a nearby submerged slipway. The navigation mark was demolished (Figure 1); however, there was only cosmetic damage to the ferry's paintwork.

Figure 1: The navigation mark before and after the incident

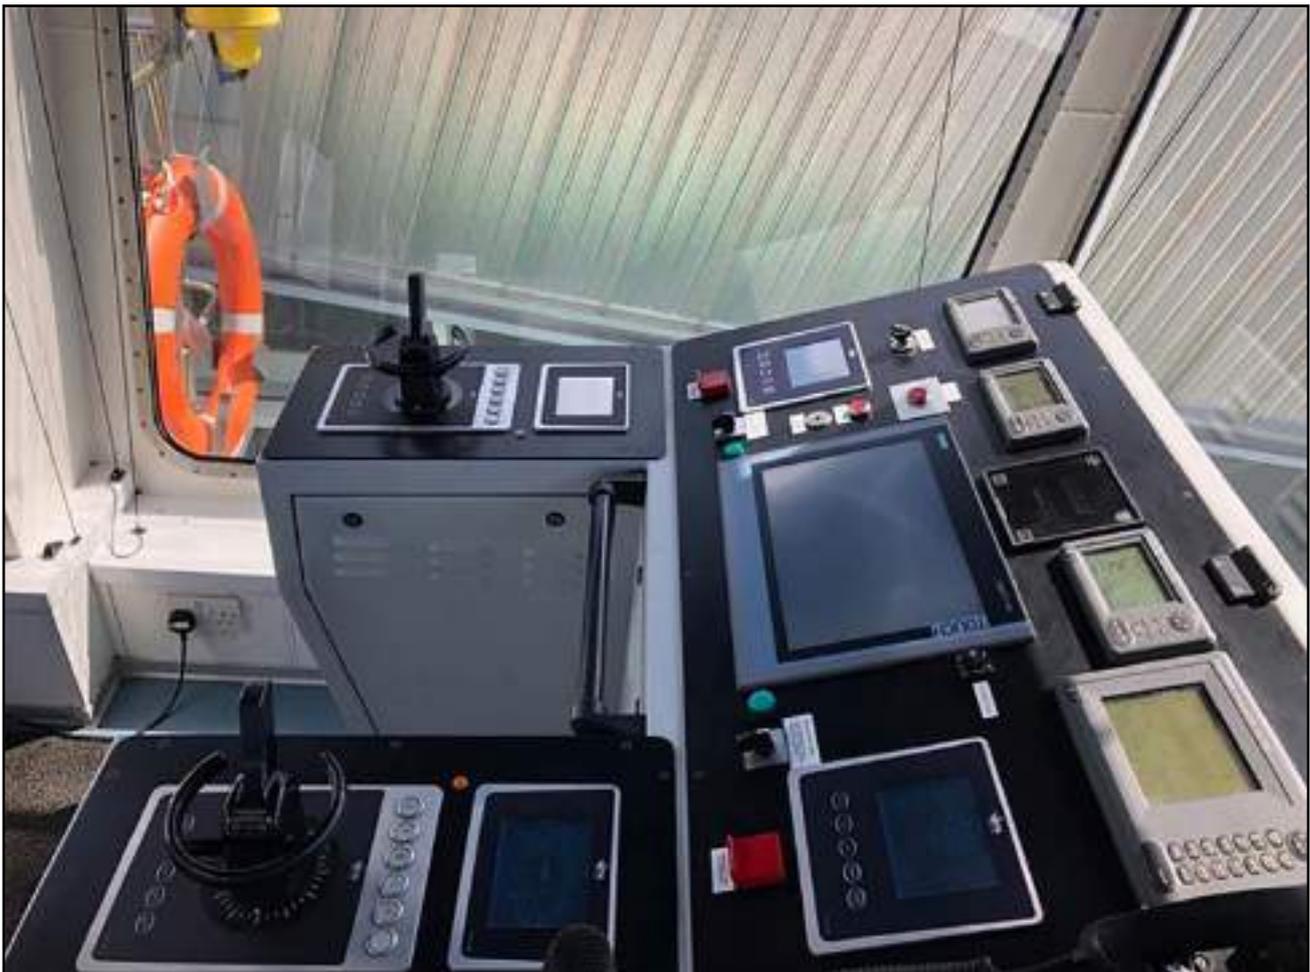
2. The bridge control panels were of a modern design with flat panel digital displays (Figure 2) and the ferry had excellent all-round visibility with full height bridge windows. However, this made the control panels vulnerable to light reflection, potentially making them difficult to read. This issue had been discussed by crews and the company, although no change to the design had been incorporated.

Figure 2: The bridge control panel, showing flat glass-style displays and tall bridge windows

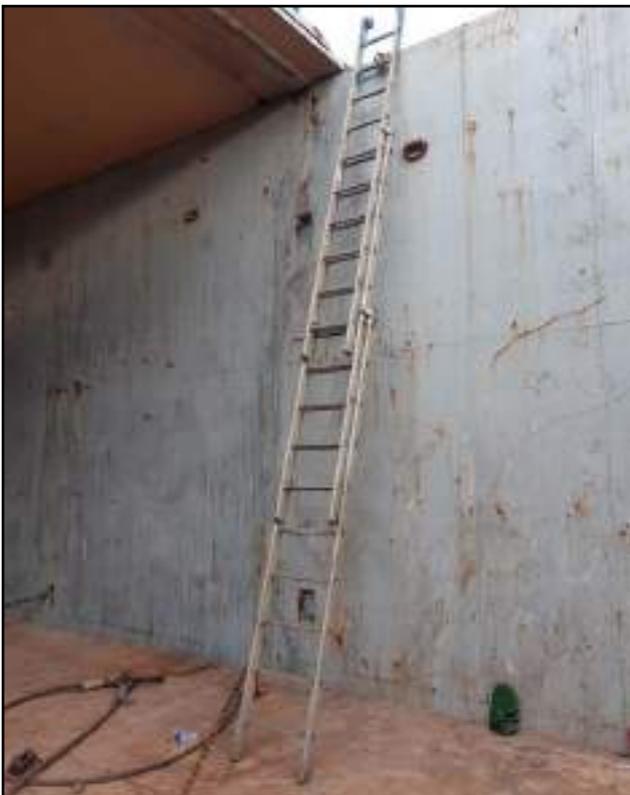
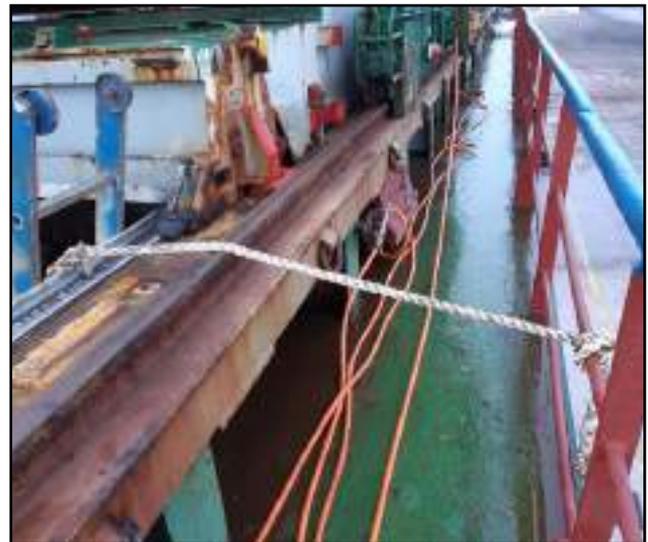
Figure 1 is a post-accident reconstruction of the ladder arrangements, noting that the securing rope shown was not present when the accident happened.

Figure 1: Post-accident images of the ladder arrangements (securing rope not present when the fall occurred)

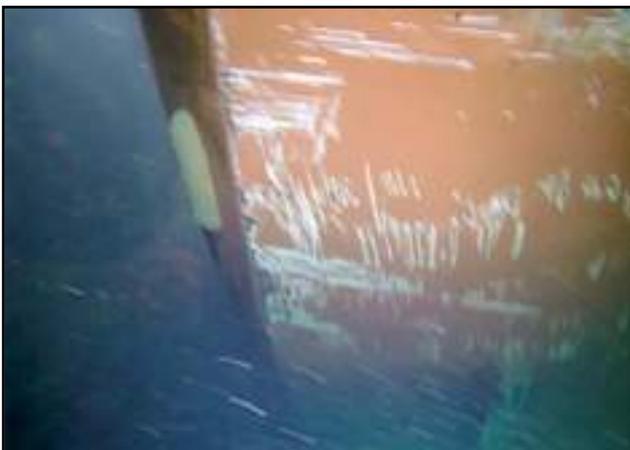
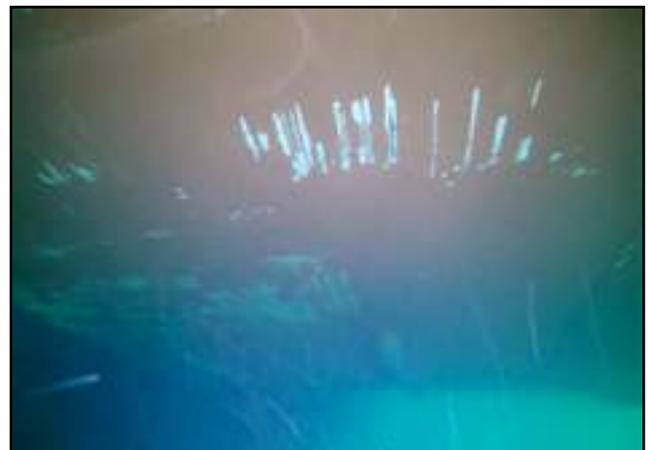
On its return to base, it was decided to slip the vessel. Once dry, this revealed a badly damaged area of hull requiring replacement together with some framing that required repair. There was also some minor damage to the port rudder linkage.

Figure 1: Dive survey photos, showing hull scrape damage

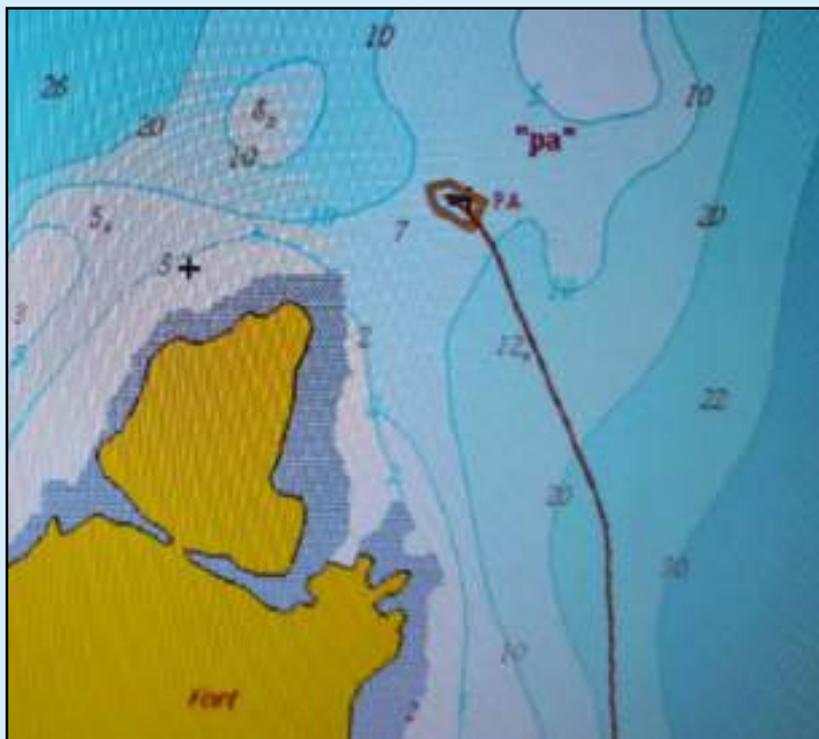
2. Safe navigation requires full understanding of equipment limitations and close attention to the position of the vessel. The electronic chart plotter displayed the rock clearly, but at smaller scales; this may have been obscured by the waypoint mark or the vessel's own symbol (Figures 2, 3 and 4). A key technique in using electronic charts is to make frequent changes of range scale to get an overview of hazards ahead as well as checking for dangers closer to the vessel. This is particularly important in confined coastal waters and when using systems that do not alarm on dangers.

Figure 2: Chart plotter view with rock symbol covered by vessel shape

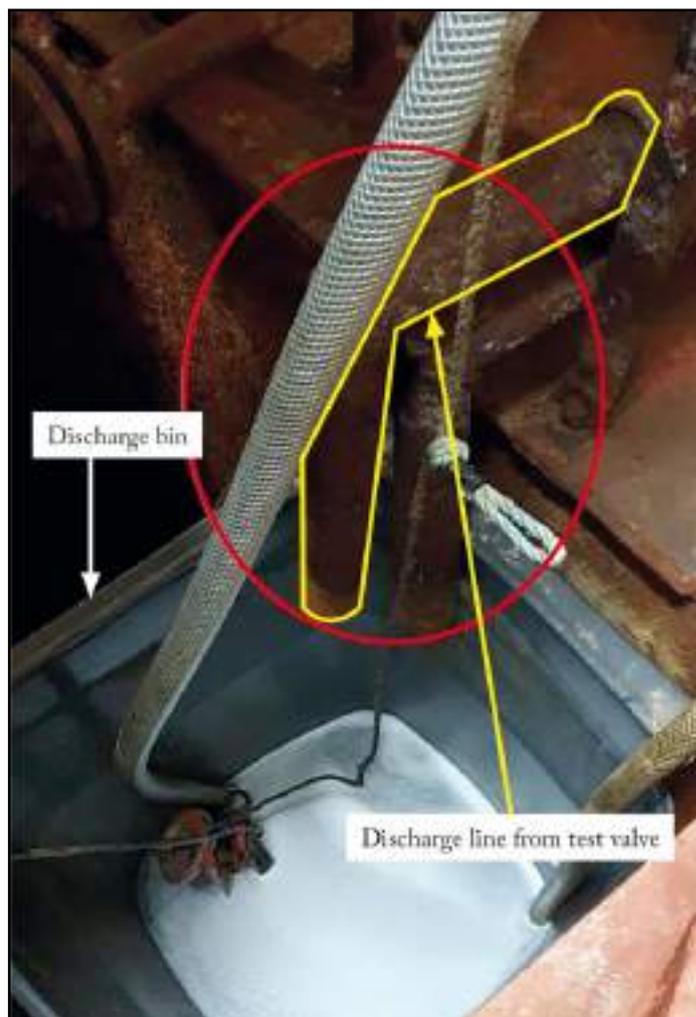
On investigation it was established that, the previous day, the duty engineer had been carrying out routine maintenance on the sprinkler system but had become distracted and forgotten to close the test valve. The test valve discharged under the closed deck plating into a bin sat in the bilge (Figure 1), which would then be pumped out once testing was complete.

Figure 1: The discharge line from the test valve into the bin

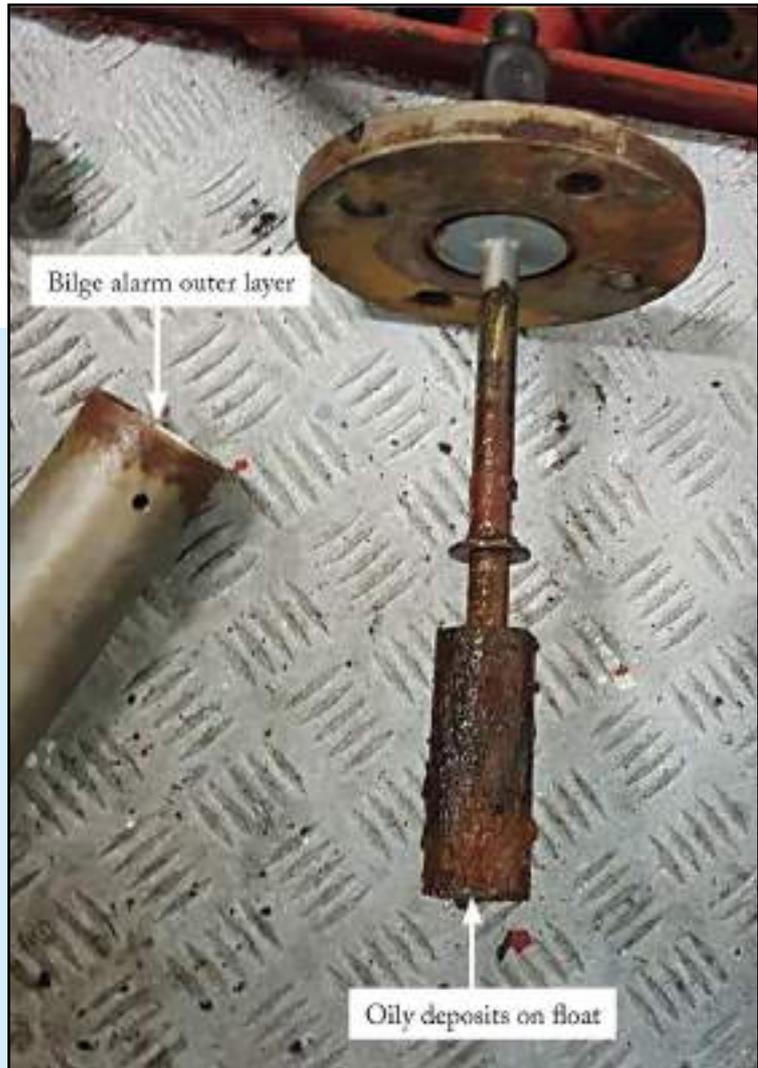
On further inspection, the bilge alarms in the space were found to be clogged with oily deposits (Figure 2). As a result, seawater had been allowed to flow unchecked and unnoticed into the vessel for approximately 18 hours.

2. The bilge alarms were tested every 4 months, the last test being 3 months prior to this incident. On that occasion and at times previously, notes had been left in the planned maintenance system that oily deposits had been found and cleaned off before the alarm could be successfully tested. The task was signed off as successful and the unsafe condition was not raised with the chief engineer and so no solution was sought. Planned maintenance systems will only work effectively if defects are proactively reported to the appropriate level of vessel or shore management, so that persistent problems can be resolved.

Figure 2: The disassembled bilge alarm, showing the build up of oily deposits on the float

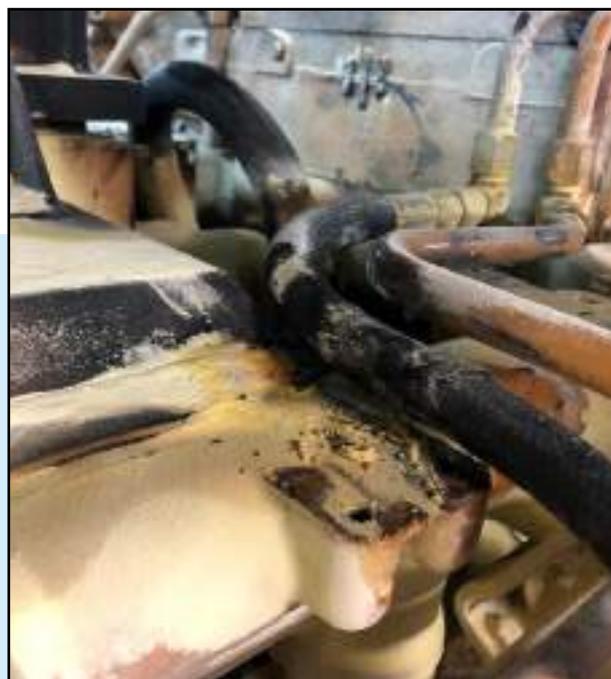
A post-accident investigation found that the fire was caused by fuel igniting when it sprayed onto the engine's exhaust after a flexible hose had failed. The failed fuel hose had been chafing on the engine, resulting in its eventual failure. Moreover, the investigation found that the hose was suitable for use with fuel systems; however, due to some previous maintenance, the hose's run had been moved from its original position, resulting in it making contact with the engine's manifold block (see figure).

Figure: Fire damage to the flexible fuel hose

1. The use of flexible hoses for fuel lines is entirely acceptable and they can provide a good technical solution for connecting systems in difficult situations. The post-accident report found that this hose was suitable for the task. However, to prevent contact damage, flexible hoses need to be supported by clips and kept separated from other lines and hot machinery. If flexible hoses are disturbed due to maintenance, it is important that they are restored to their original position and all clips and supports replaced. Flexible hoses should also be inspected periodically to ensure that they remain in the correct position and are not degrading.

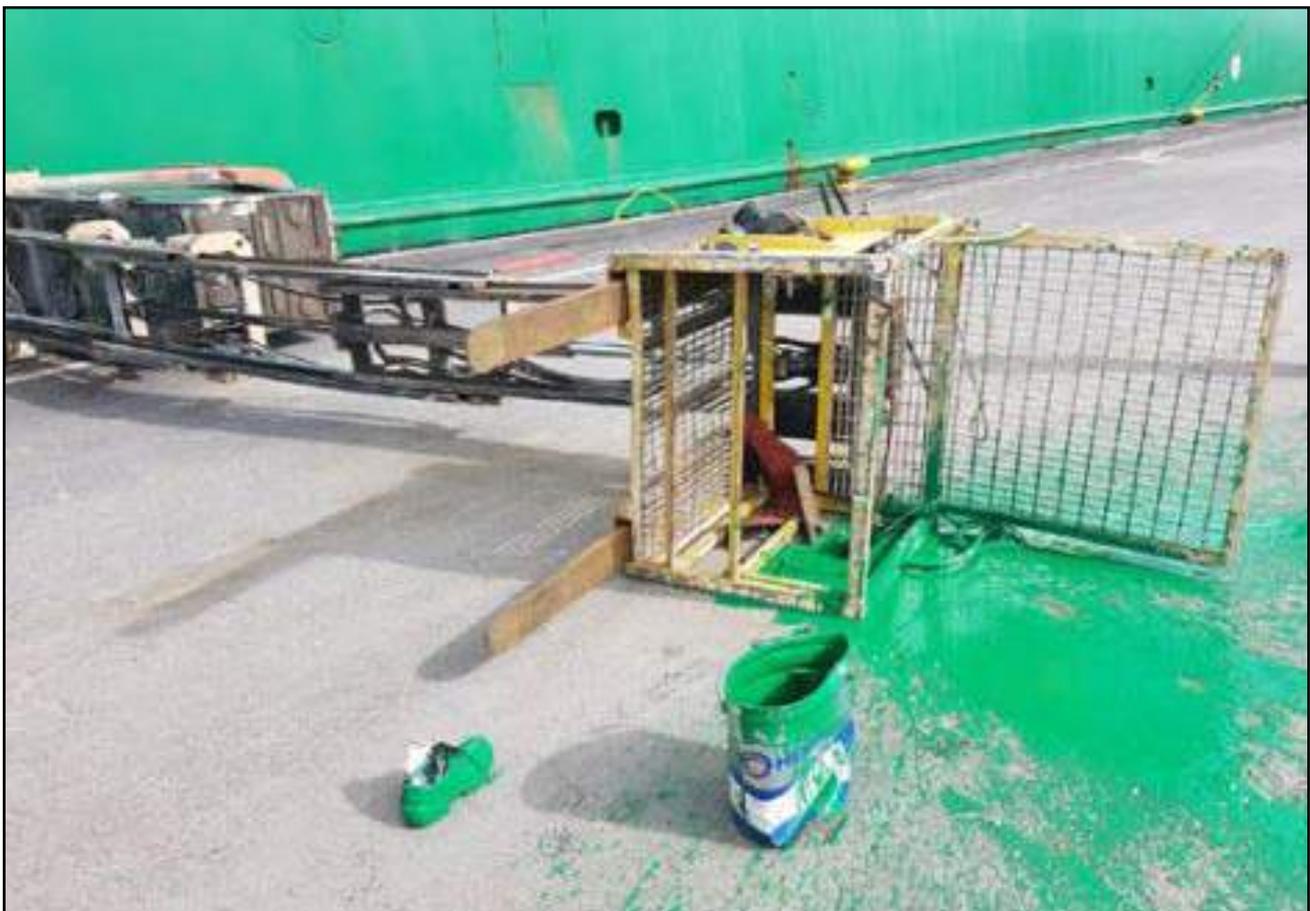
Figure: Toppled forklift truck

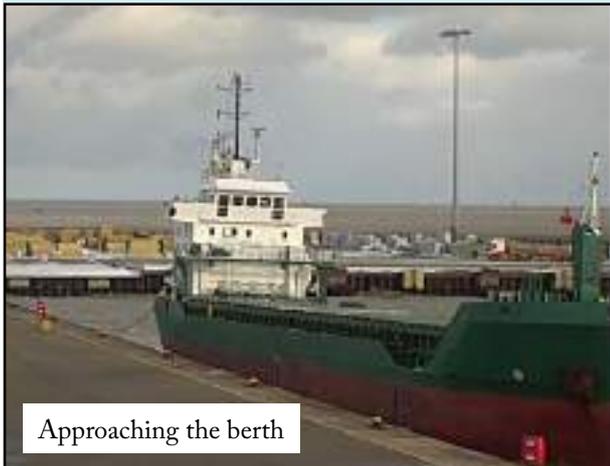
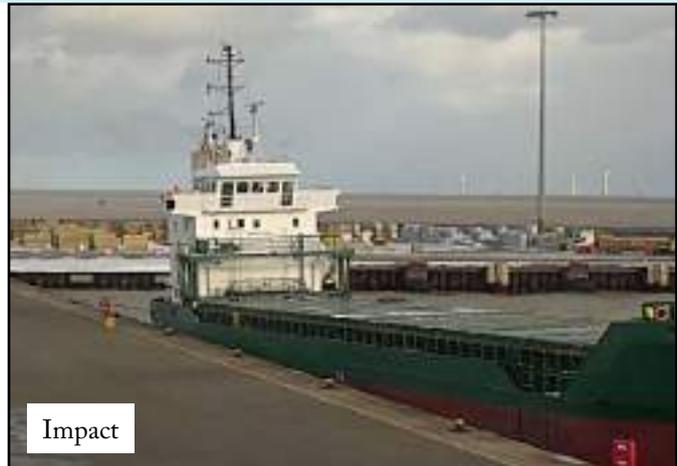
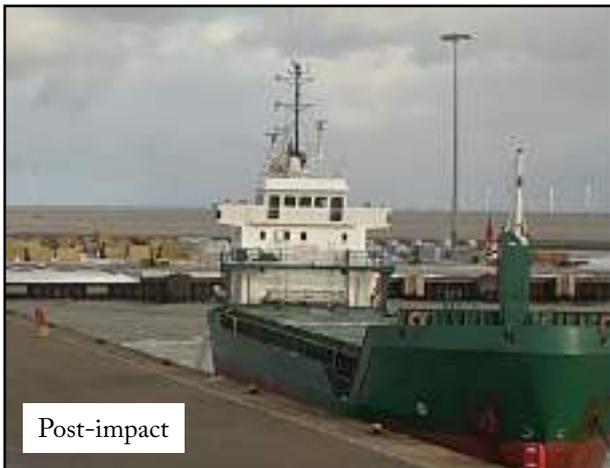
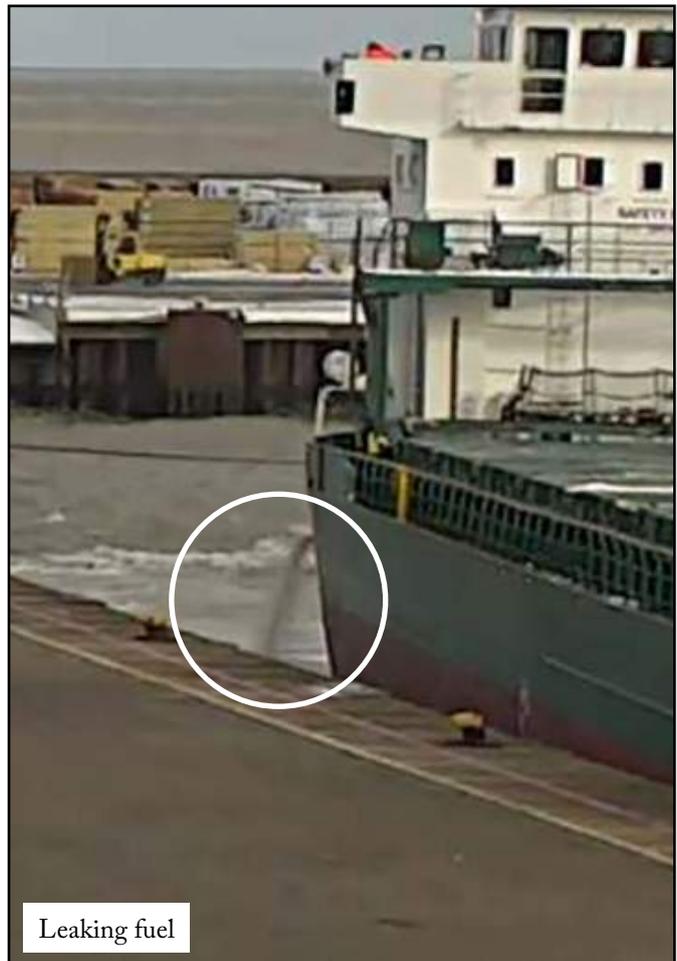
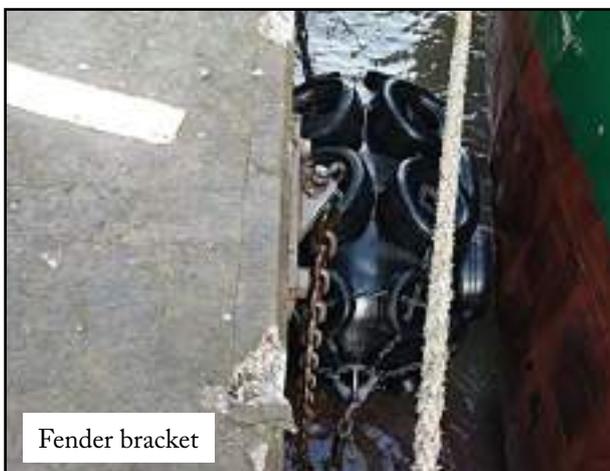
Figure 2: CCTV of accident sequence with fender bracket and leaking fuel

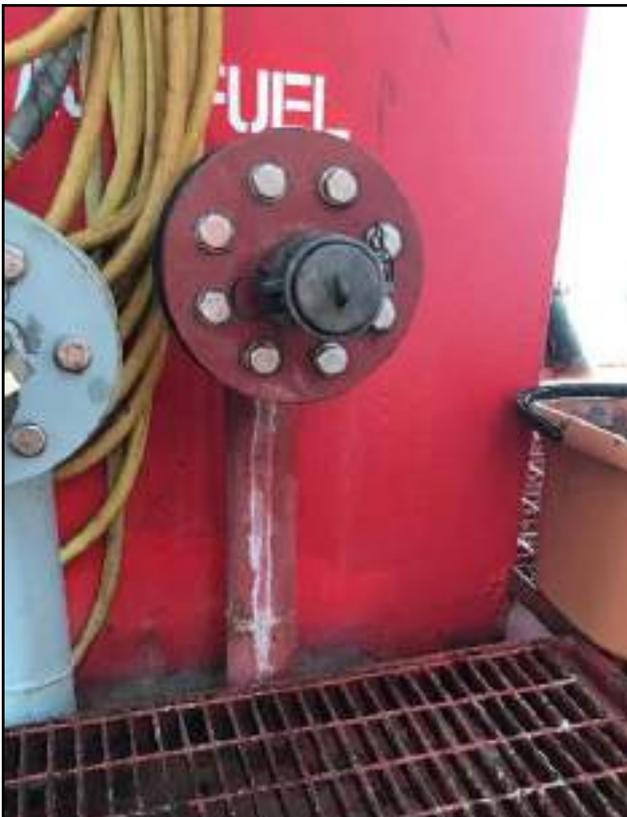
Figure 2: The workboat's fuel discharge manifold

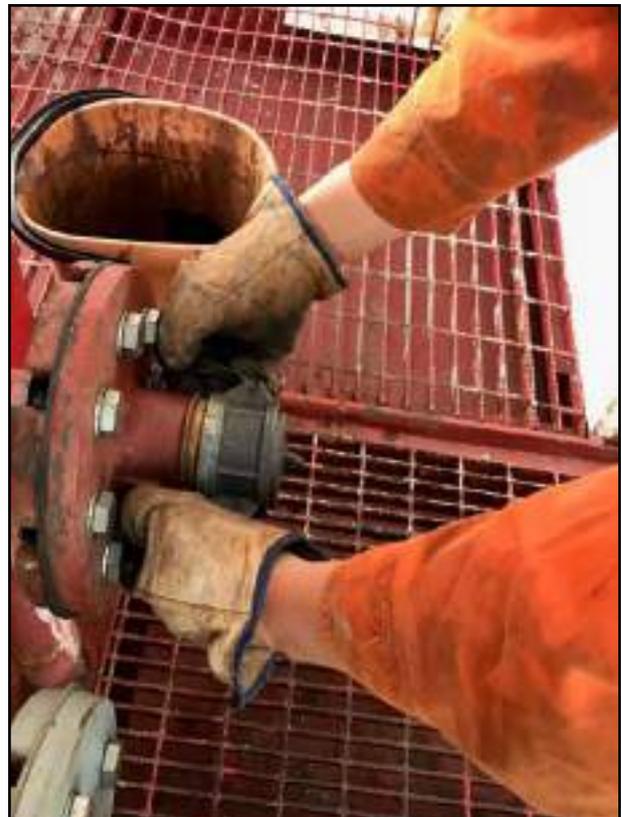
After stopping the fuel transfer pump, the crewman attempted to release the blanking cap on the discharge manifold in order to connect the fuel hose. As the two securing clips were released, the blanking cap flew off with an explosive force, striking the crewman on the leg. The crewman suffered lacerations, a fractured limb, and was off work for 6 weeks. Although the accident involved a pressurised fuel system, there was no pollution.

Figure 3: Reconstruction of the removal of the blanking plate when the system was pressurised

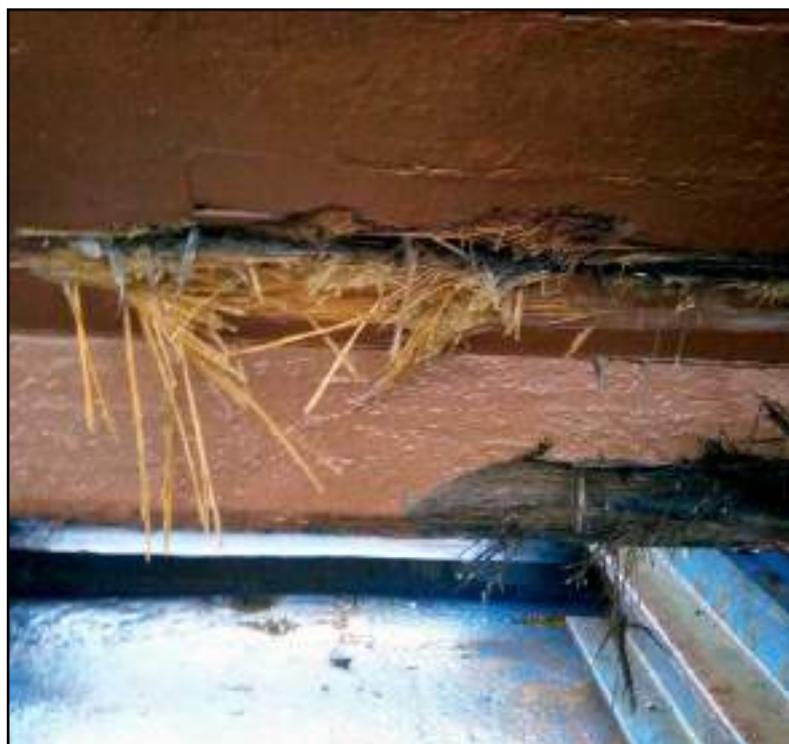
Figure 2: Damage to keel and hull planking

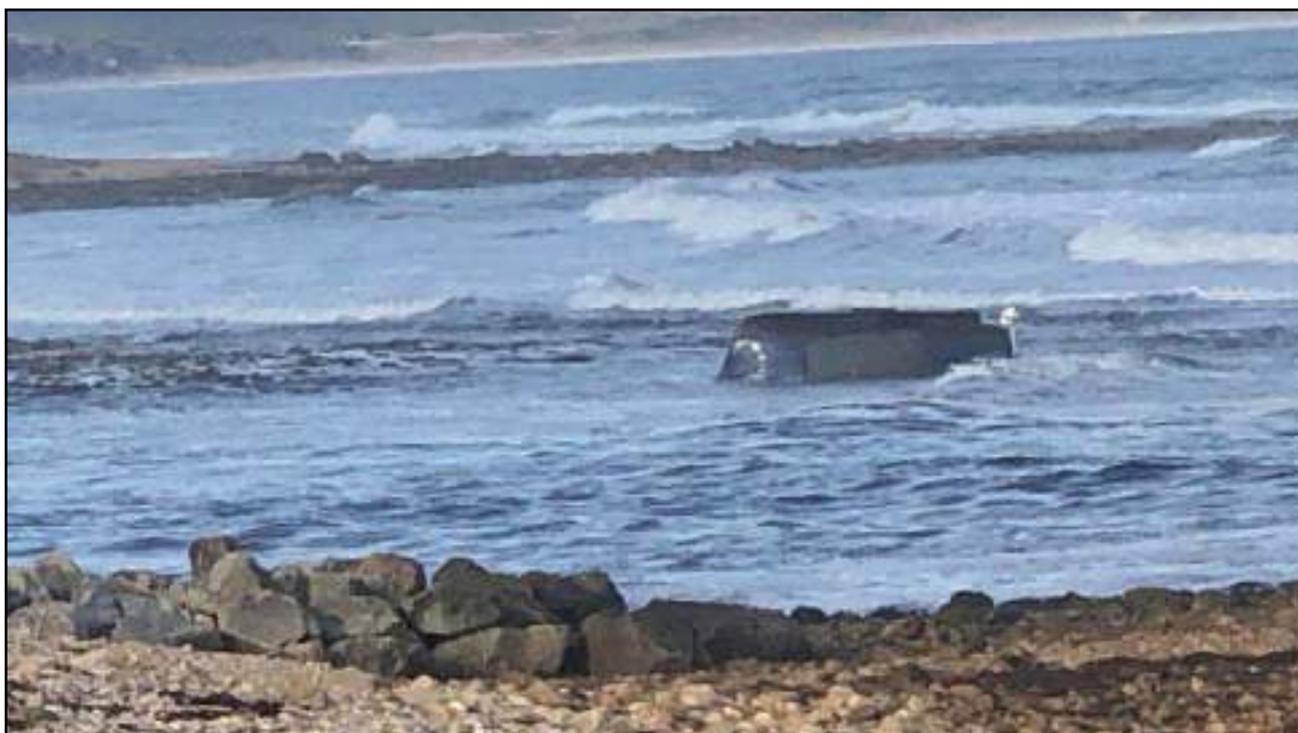
Figure: Vessel capsized and inverted

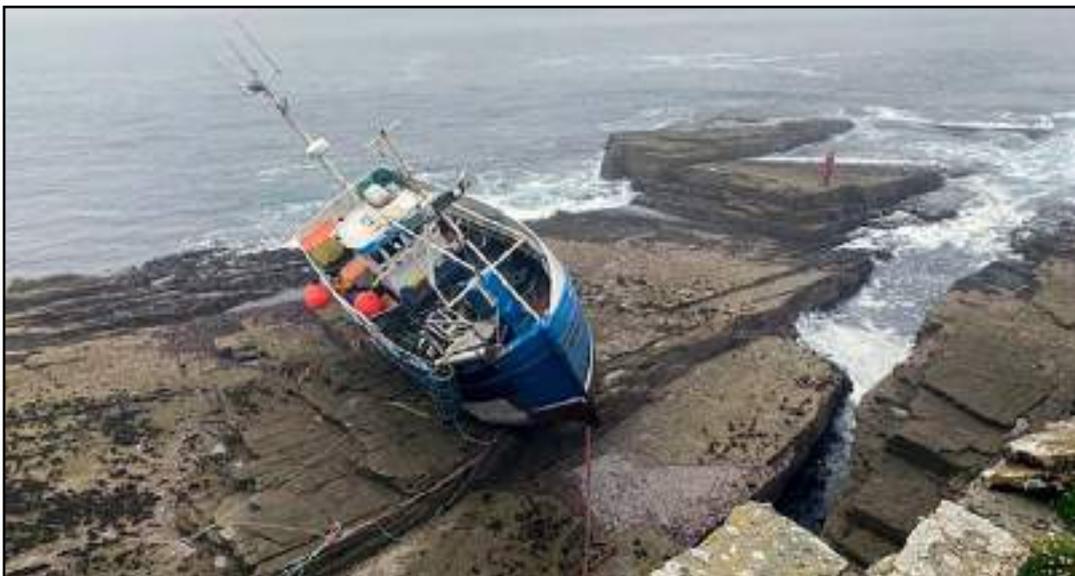
As the tide fell, the sea receded from the rocks and the fishing boat was left high and dry (see figure), so the crew walked ashore to safety. The boat's hull was damaged by the grounding and it could not be repaired.

Figure: Grounded fishing boat

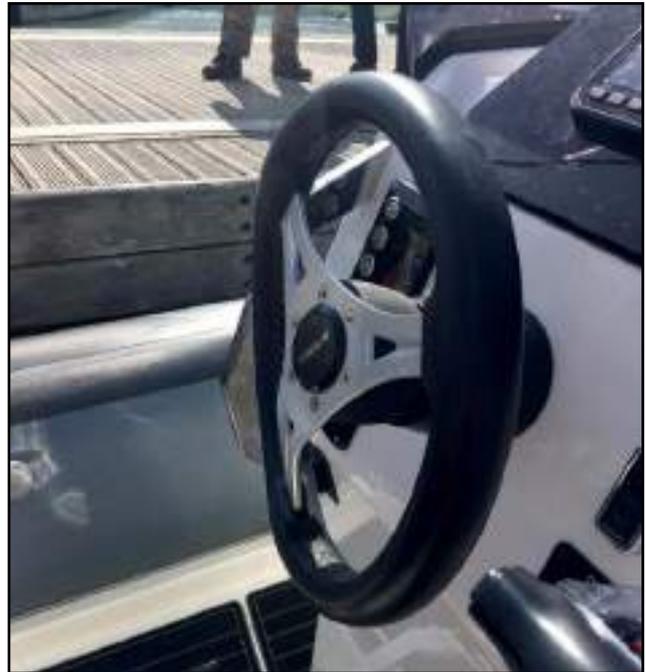
Figure 1: Buckled steering wheel

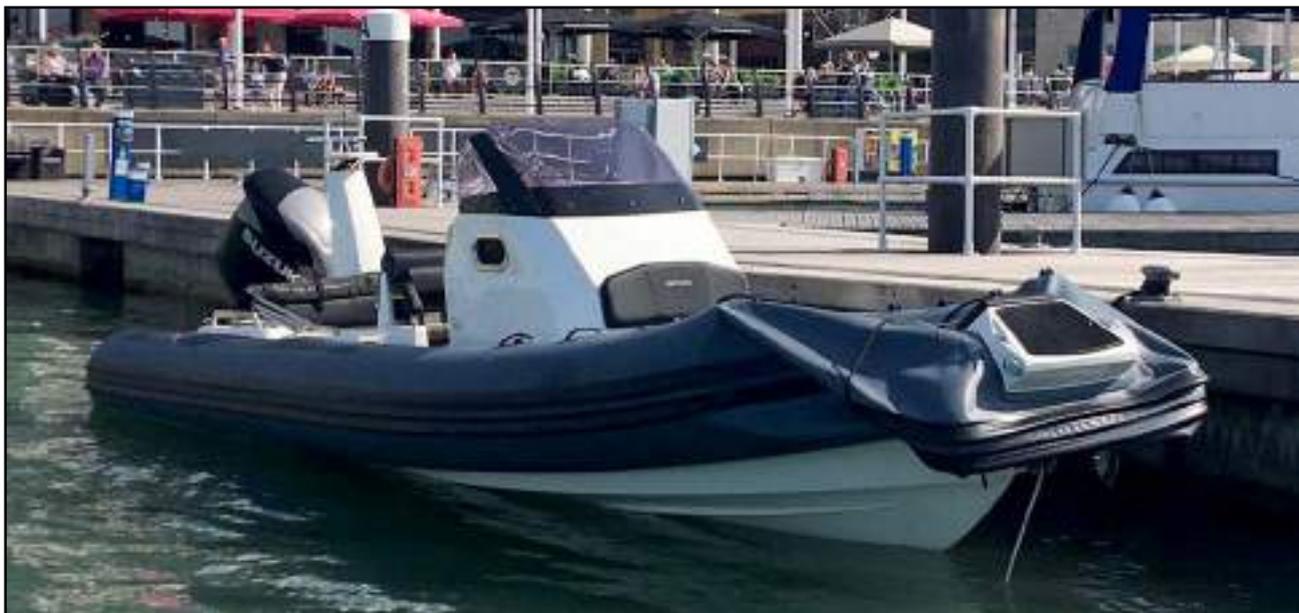
Figure 2: The RIB, showing damaged tubes

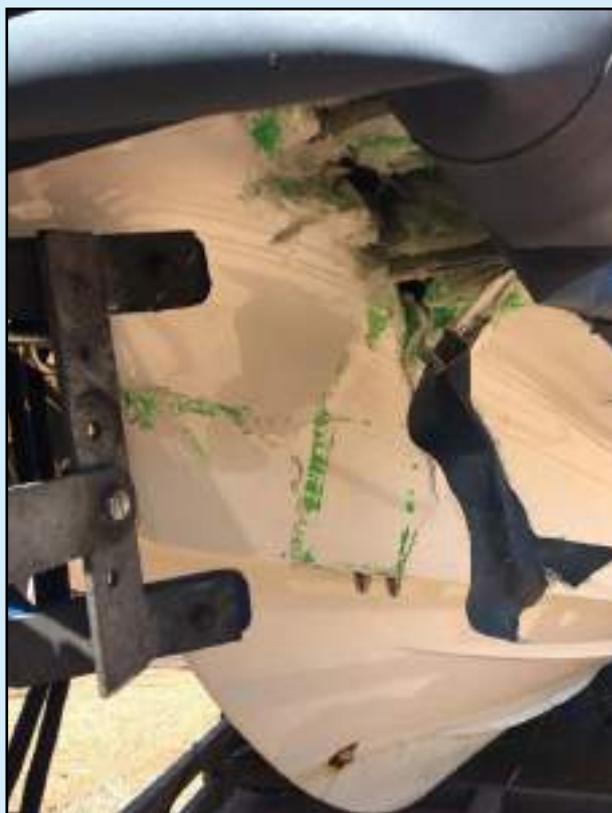
Figure 3: Damage to bow section, showing green paint

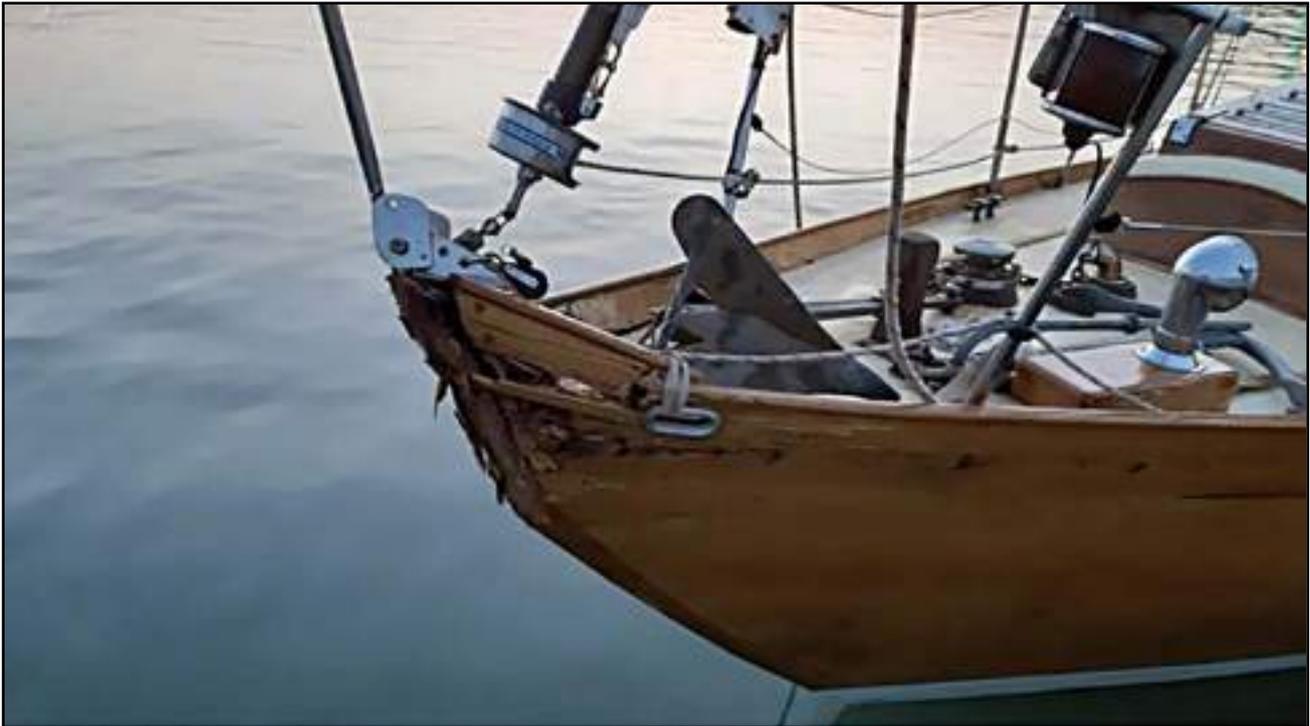
Figure 2: Damage to the classic yacht's bow
