SB2/2021

Fatal crushing injury of a crewman on the upper vehicle deck of the roll-on roll-off ferry

Clipper Pennant

MAIB SAFETY BULLETIN 2/2021

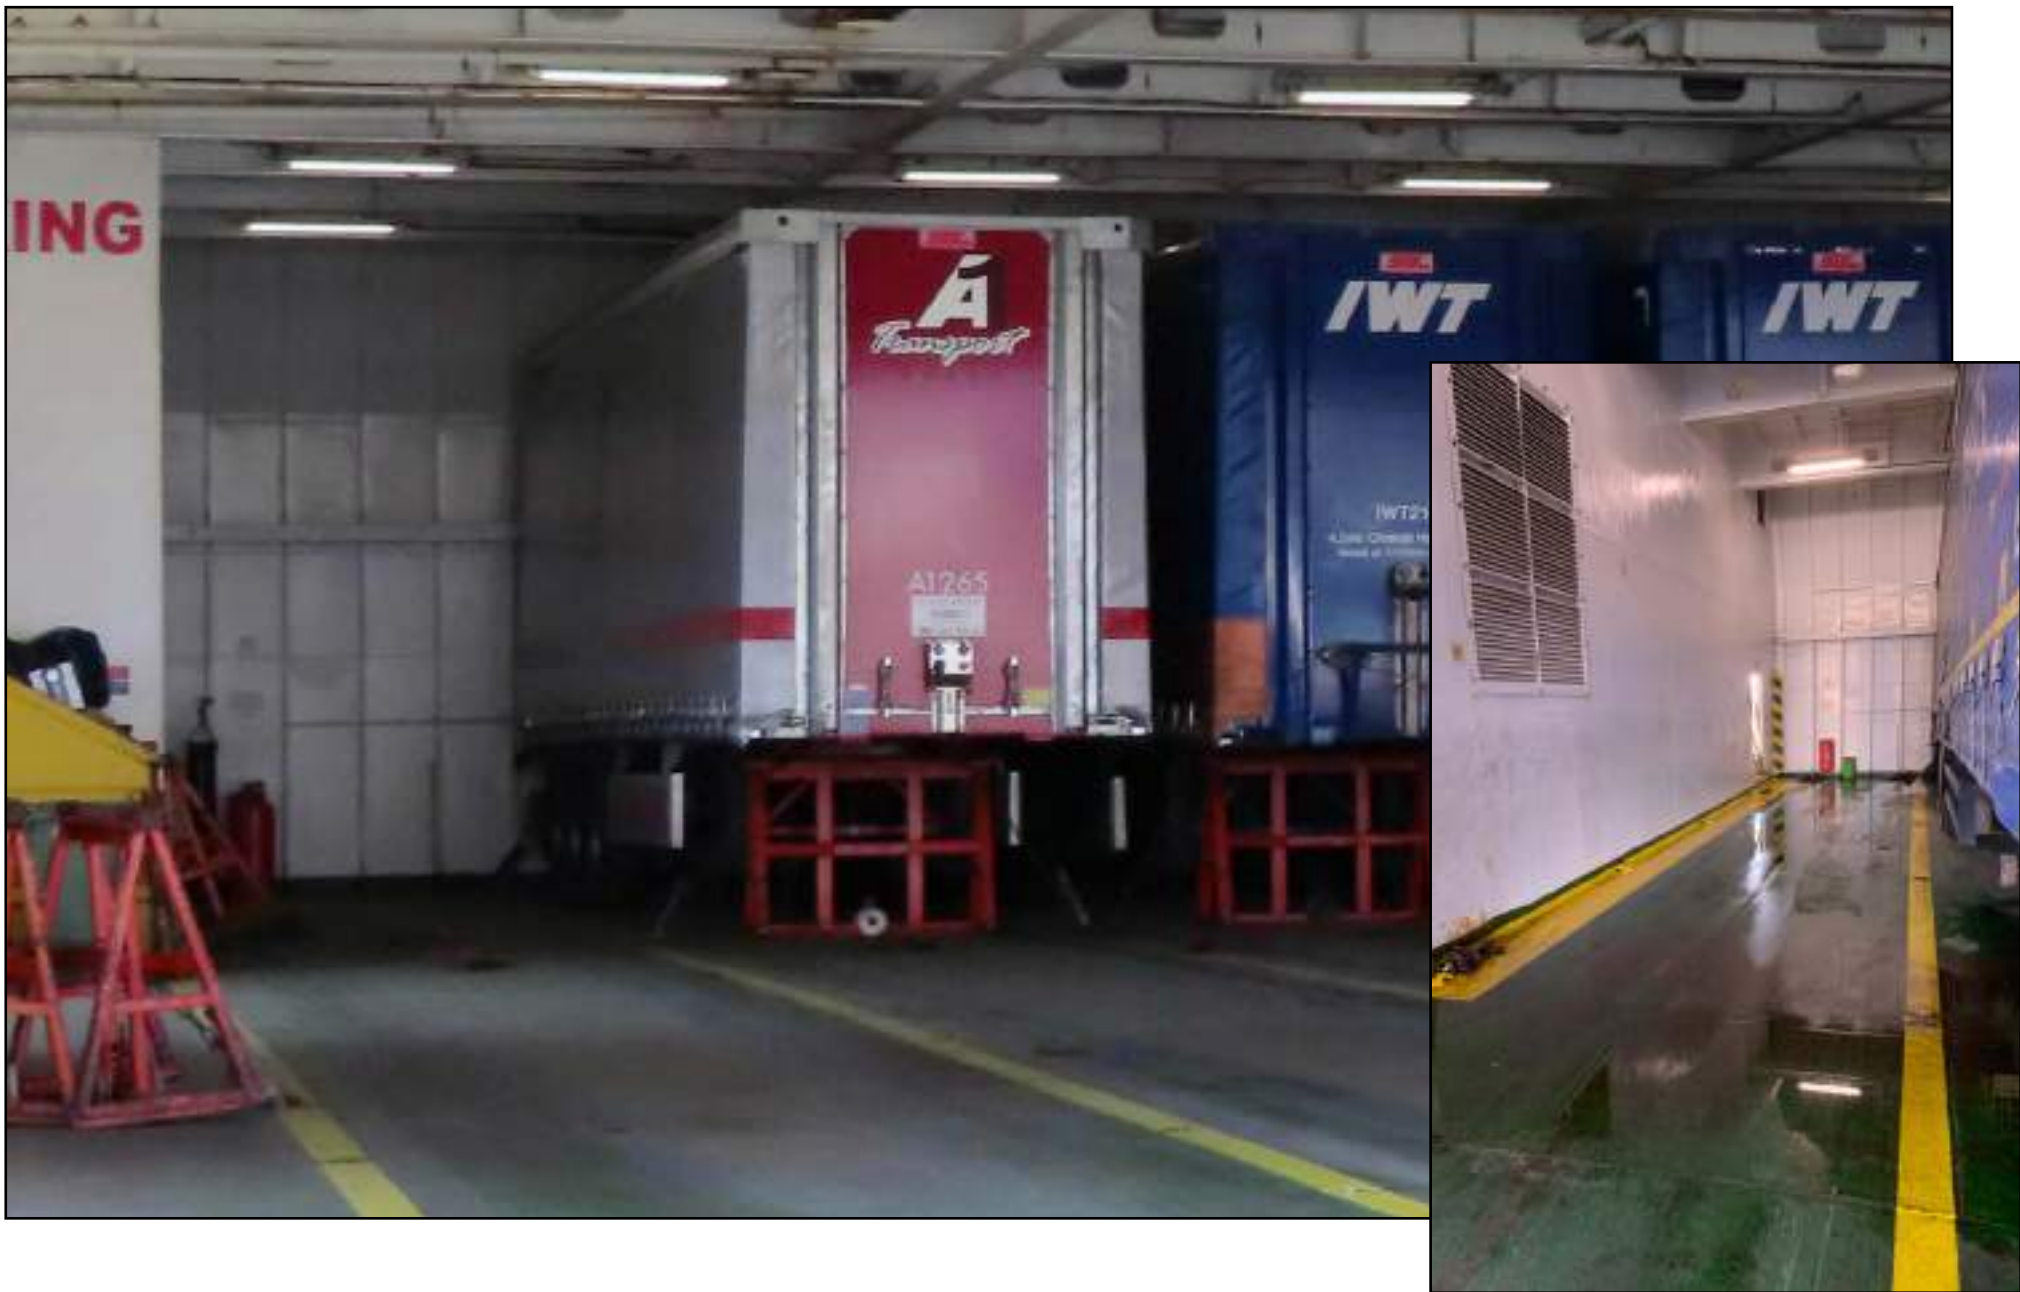
The accident occurred after the bosun had directed a tractor unit driver to push a semi-trailer into its stowage location, between a semi-trailer that had already been lashed and the bulkhead at the port forward end of the upper vehicle deck (**Figures 1 and 2**). As the semi-trailer was being manoeuvred, the bosun had positioned himself between the moving semi-trailer and the vessel's structure, resulting in the crushing accident.

All aspects of this accident are under investigation by the MAIB and a full report explaining the causes and circumstances will be published in due course. Nevertheless, it is apparent from the initial evidence collected that there is an extreme risk of crushing injuries in stowage spaces adjacent to the vessel's structure, with limited areas to remain clear or escape.

Figure 1: Reconstruction of the semi-trailer parking arrangement, with inset view of the space (post-accident)

Use of the port forward cargo stowage spaces has been temporarily suspended by the vessel's operator, pending further investigation and assessment.

- Review their cargo handling procedures to identify the hazards associated with stowage spaces where there may be limited areas for escape.
- Conduct a specific risk assessment for all such spaces. These spaces should then be marked and, unless appropriate mitigating measures can be put in place, not used.
- Ensure that onboard safety procedures and crew safety briefings reflect the guidance in COSWP Section 27.6.3.

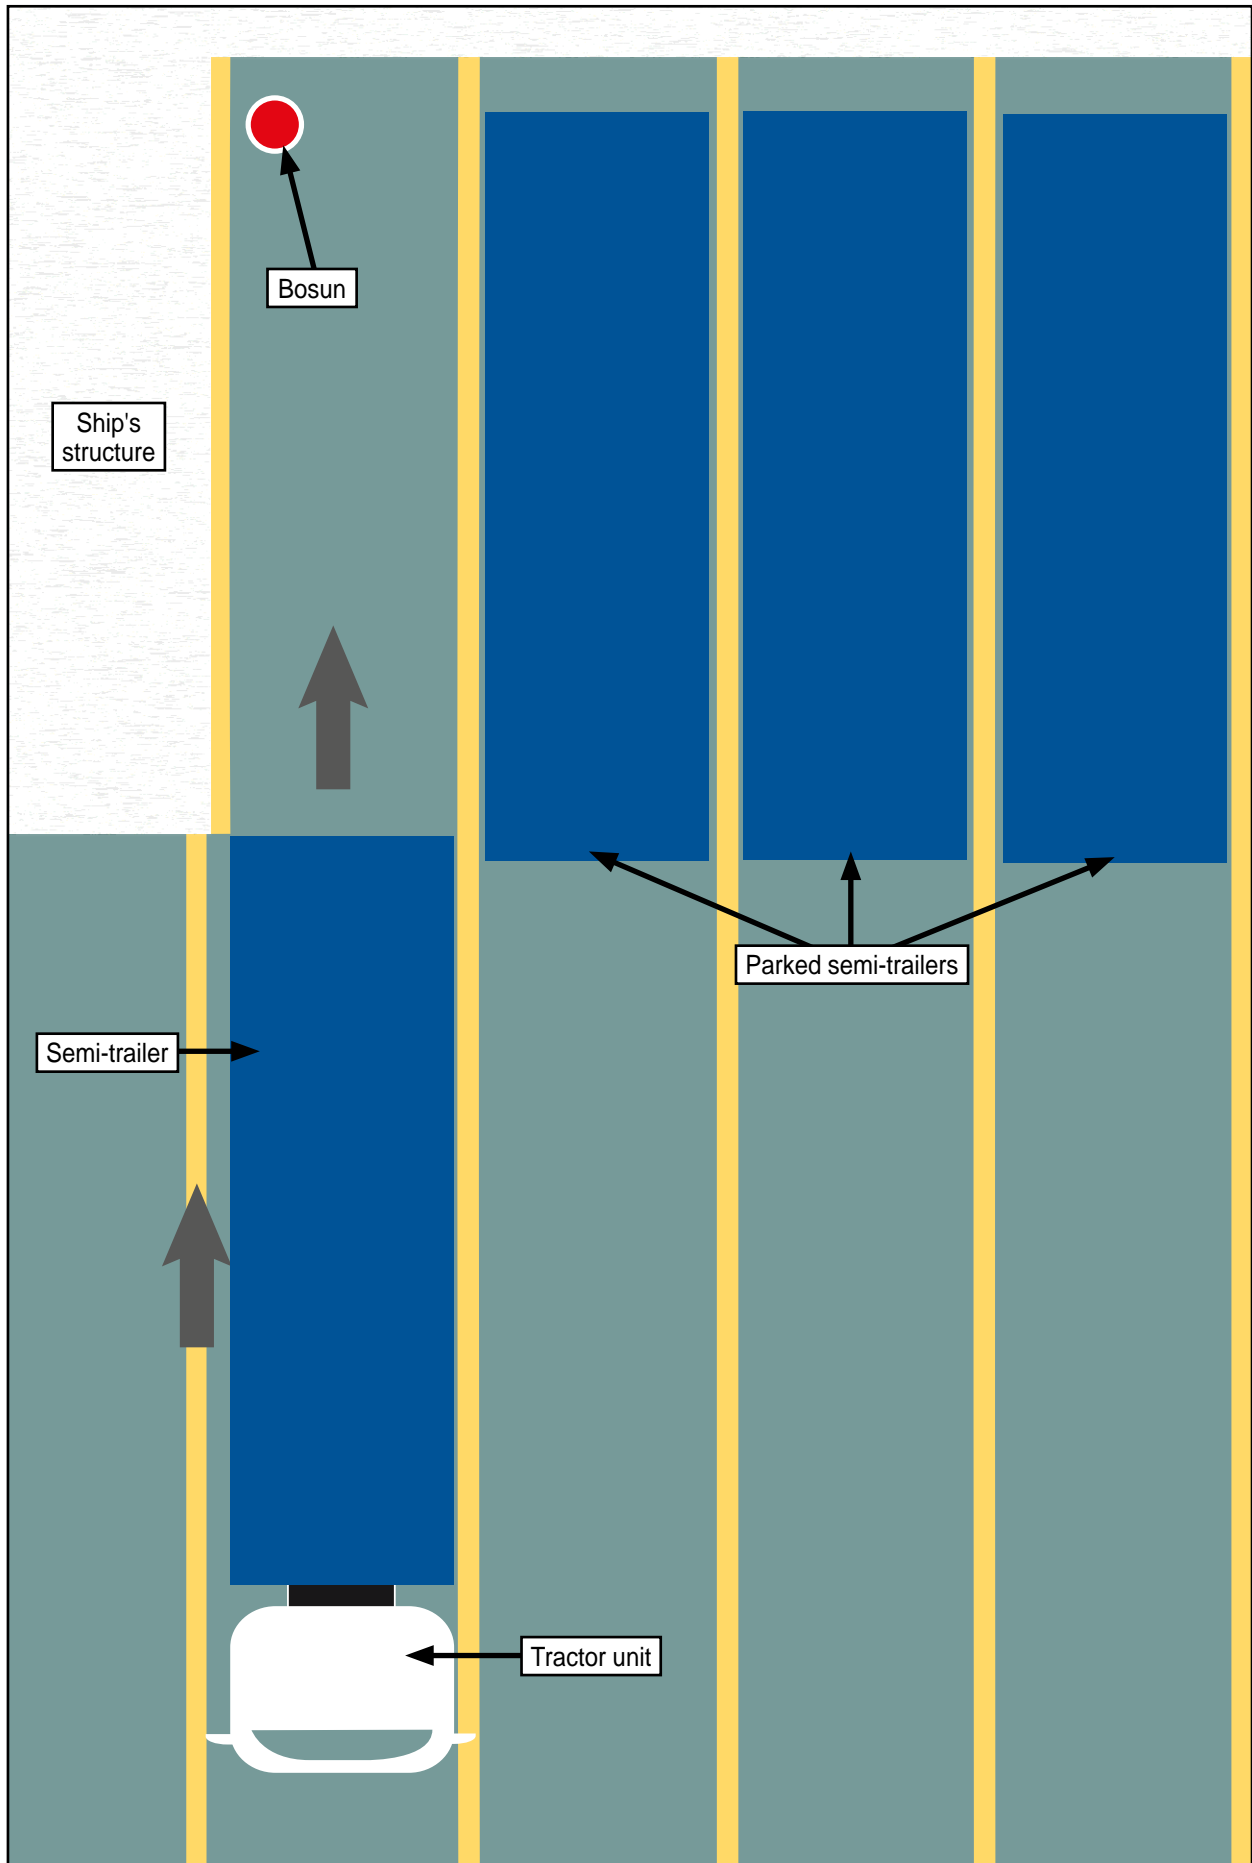
Figure 2: Graphic showing plan view of the semi-trailer's approach to the parking space
