The Bahamas
Maritime Authority

Marine Safety Investigation Report

into an engine room fire onboard Pride of Hull
on 20 October 2020

Date of Issue: 30 November 2021
Bahamas Maritime Authority
120 Old Broad Street
LONDON
EC2N 1AR
United Kingdom

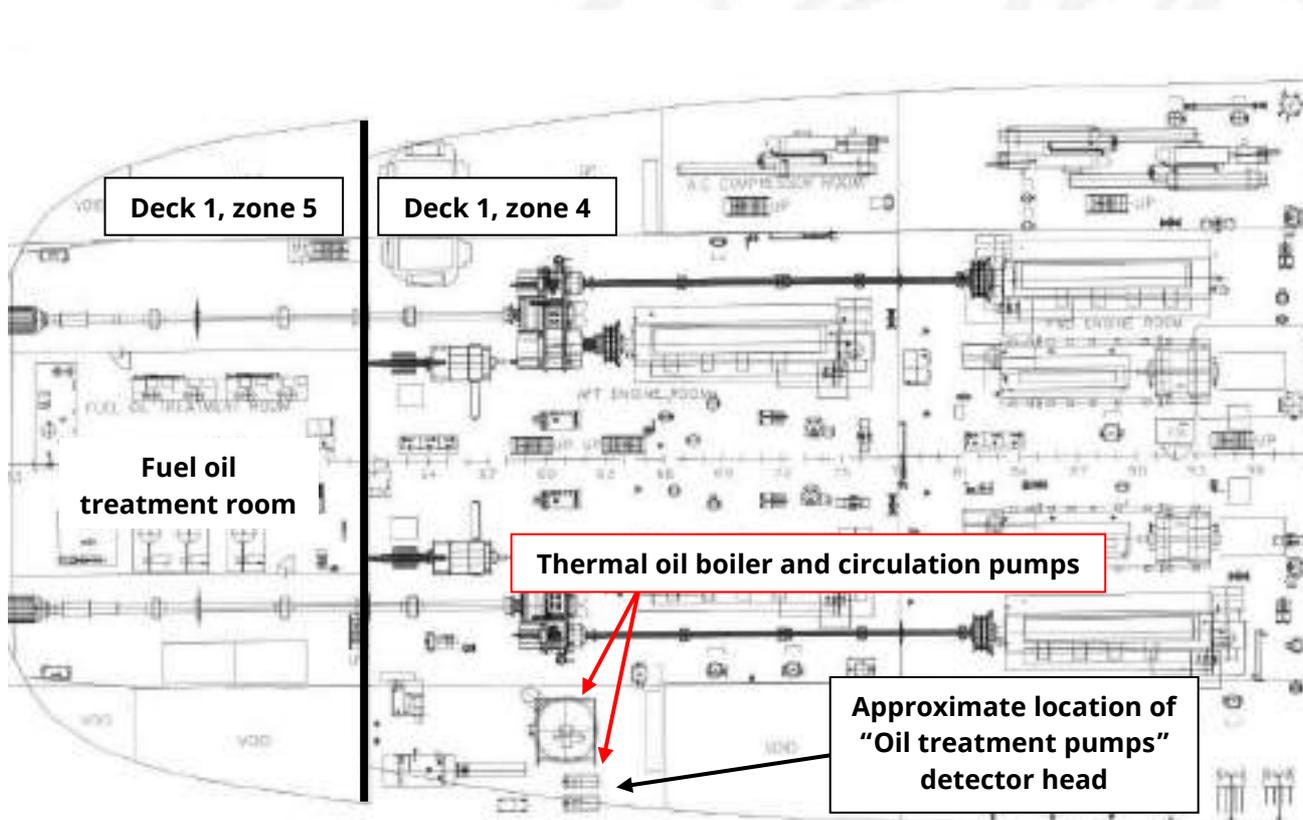
General arrangement plan with “oil treatment pumps” and fuel treatment room identified

The naming of the fire detector section that incorporated the thermal oil circulation pumps as "Oil treatment pumps" created confusion and resulted in a delay in confirming the existence of the fire and its location.

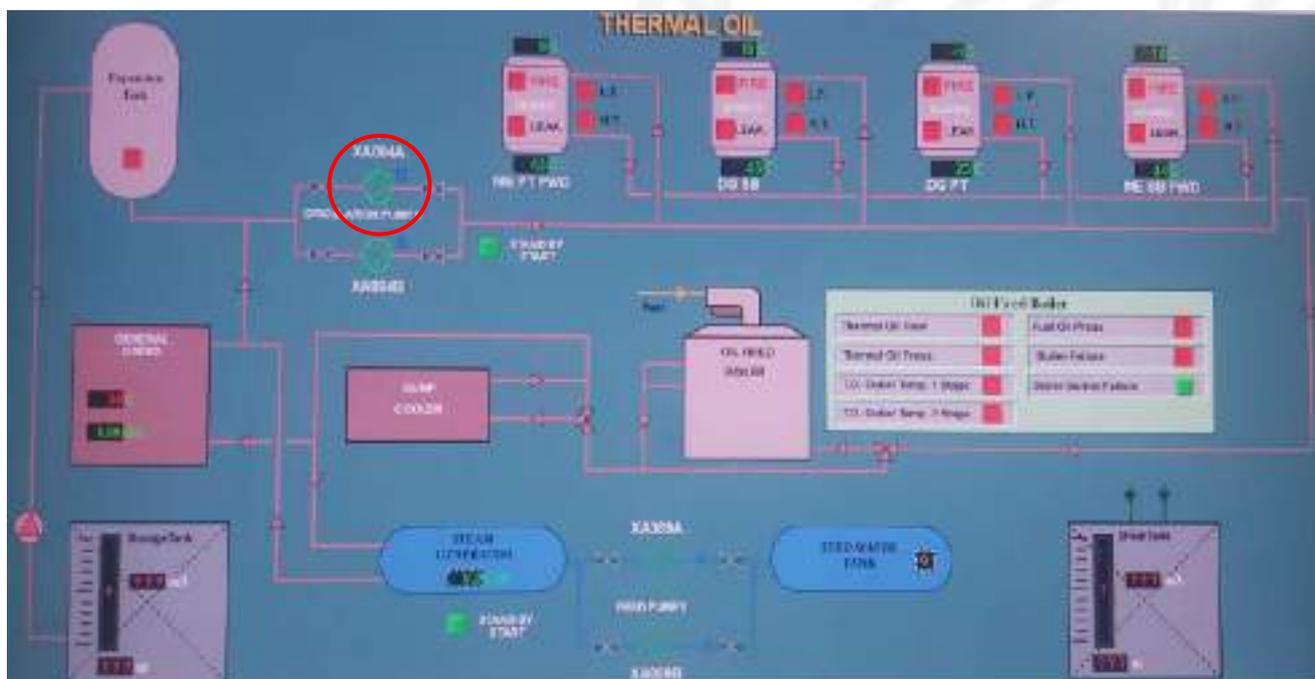
Post-fire scene examination identified that thermal oil circulation pump #1 was the seat of the fire.

Thermal oil system overview. Circulation pump #1 ringed

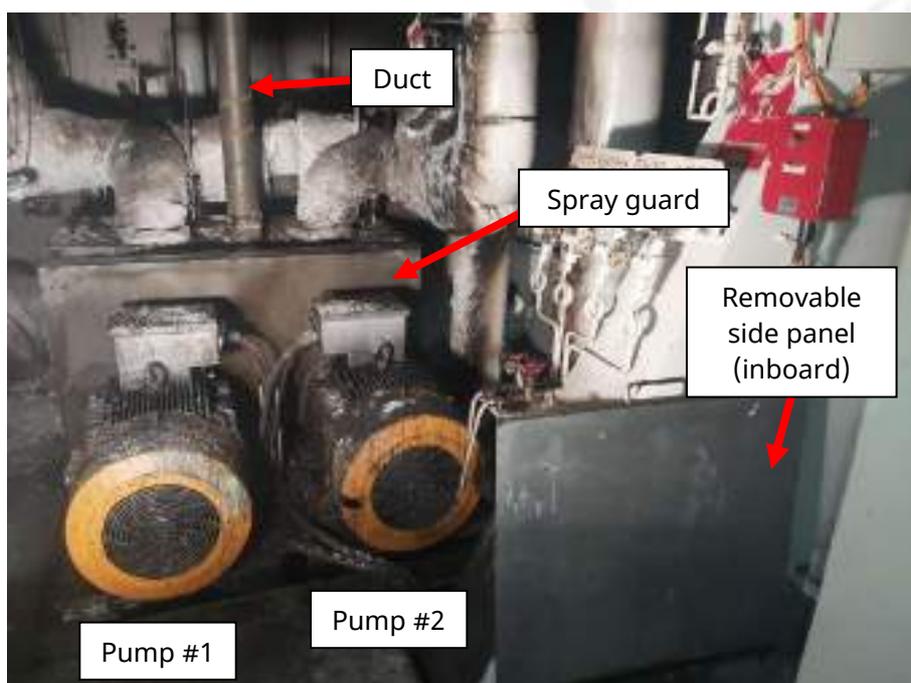
The thermal oil circulation pumps had a spray guard fitted to retain oil in the event of a seal failure. The original spray guard was manufactured onboard and installed by the engineering team in 2001. Removable side panels were added in 2017 and a duct, connected to the engine room ventilation system, was added in July 2018. At the time of the fire, the side panels were not in position.

Thermal oil circulation pumps with spray guard arrangement, seen from aft (post fire)

Considering the identified cause of ignition, the open sides and ventilation duct are not considered to have had an impact on the cause of the fire but may have limited the effectiveness of the spray guard in terms of containment.

- Replaced Pride of Hull's thermal oil pumps and reviewed the condition monitoring plan within the planned maintenance system.
 - Provided fleetwide guidance on the principals of installation of spray guards.

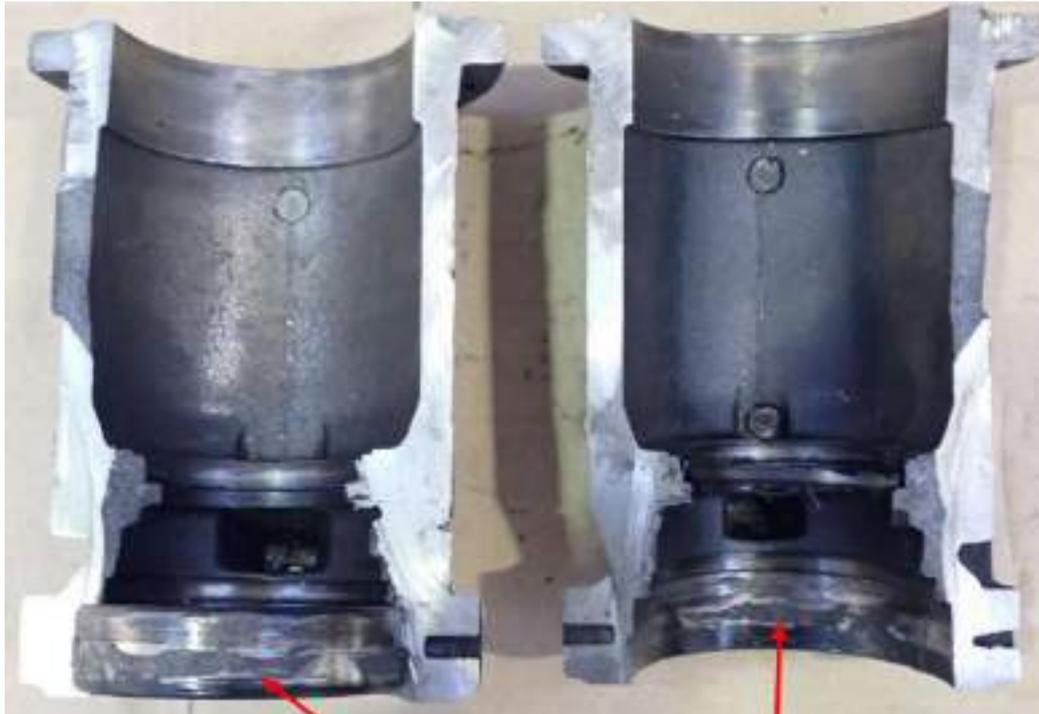
Metallurgical examination identified that the damage to the pumps was consistent with a bearing failure and fire originating at pump #1. The pattern of damage to pump #1 indicates that the impeller end bearing failed first and the drive end bearing collapsed shortly afterward. This collapse led to the drive end bearing’s outer race rotating in the bracket housing, which resulted in extreme frictional heating, generating temperatures in the order of 1,200°C - well in excess of the thermal oil’s autoignition temperature. Due to the failure of the mechanical seals and circlips, there was a path for the thermal oil to reach the hot spot internally as well as spray to make contact externally.

Thermal oil pump #1's bearing housing, split longitudinally. Arrows show the drive end bearing's outer race fused to the housing (left) and heat affected longitudinal band (right).

The metallurgical examination of the pumps did not conclusively identify the reason for the initial bearing failure. Both the bearings were Allweiler parts, of correct design for application and had failed after a relatively short period of operation. However, it was identified that the surface of the bracket housing in which the impeller end bearing sits was pitted and "possibly slightly" worn. This may have affected the fit of the bearing and potentially led to premature failure.

- The fire was caused by a series of mechanical failures in thermal oil circulation pump #1. A bearing failure created a hotspot of around 1,200°C, this also resulted in failure of the mechanical seals and circlips which created a route for the thermal oil to come into contact with the hotspot, well in excess of its autoignition temperature.

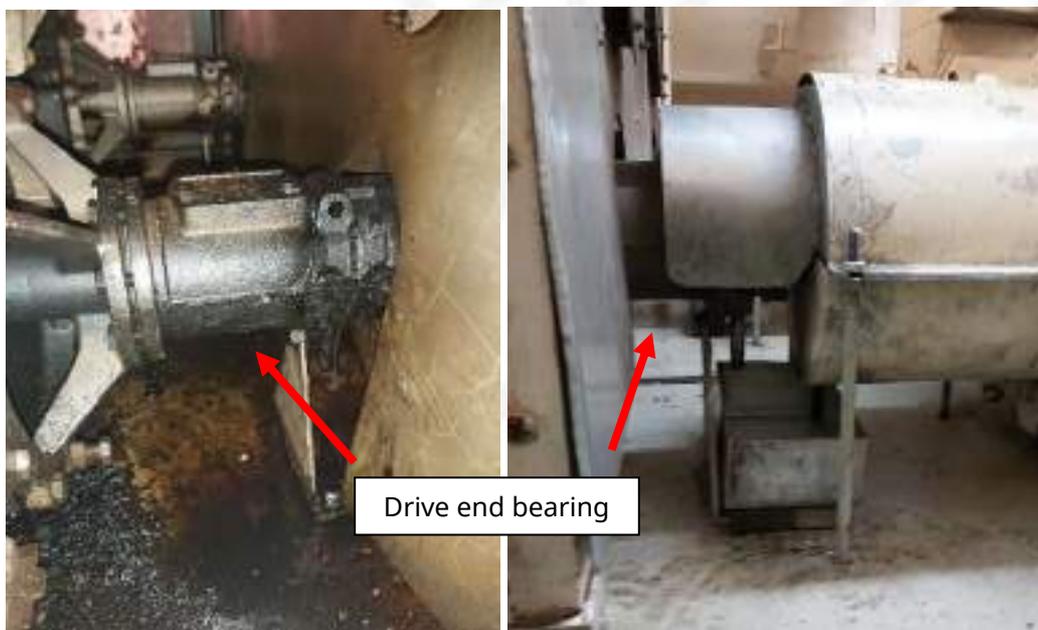
The thermal pumps' spray guard was fitted in response to thermal oil circulation pump seal failures experienced onboard the Pride of Hull and its sister ship, the Pride of Rotterdam, shortly after entering service¹⁰. Both vessels fitted spray guards of a similar design: providing protection forward, above and aft of the circulation pumps. The design differed in their exact placement: on the Pride of Hull the guard's aft end incorporated the drive end bearing whilst on the Pride of Rotterdam's the drive end was covered by a separate, smaller guard.

**Spray guard position in relation to drive end bearing
Pride of Hull (left) and Pride of Rotterdam**

After a bearing failure resulting in pressurised oil release and activation of the Hi-Fog in 2017, the spray guards on both vessels were adapted to “box in” the pumps on all sides. On Pride of Hull, this resulted in the pumps overheating. In response, the engineering team added ducting to provide air from the ventilation system. The forced air did not resolve the overheating and the side panels were subsequently removed.
